Final Acceptance – Punchlist from DPW Stormwater

Project Name:	Timberline Landscaping
EDARP Filing Number(s):	CON185, PPR1718
ESQCP Number:	ESQ185
Attendees:	DPW : Joshua Augustenborg, Ben Jones, Glenn Reese, Brad Walters and David Parkerson Developer: Tim Emick and Cameron Emick
Date of Walk-Thru:	January 25, 2023
Walk-Thru Number:	1

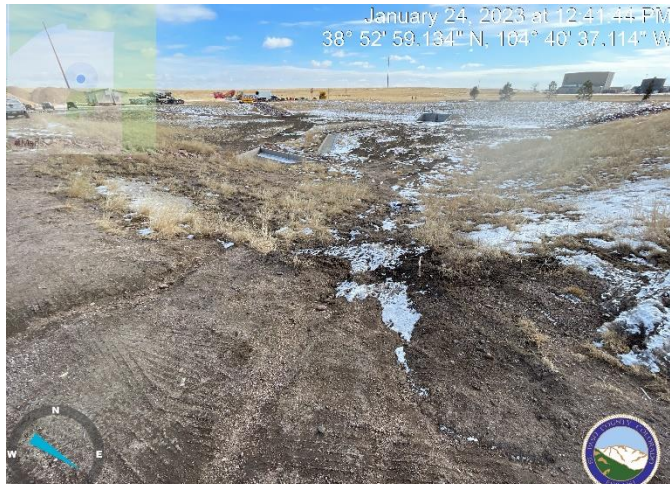
- Storage lot/gravel driveway. Berm up top of slope of northwestern corner of pond embankment adjacent to concrete riprap rundown. Runoff is bypassing the rundown, causing erosion blowout. Subsequent sediment discharge from top of gravel parking lot into pond also needs to be cleaned out. See photos #1, 2 and 3.

Photo 1: Storage lot/gravel driveway. Berm up top of slope of northwestern corner of pond embankment adjacent to concrete riprap rundown. Runoff is bypassing

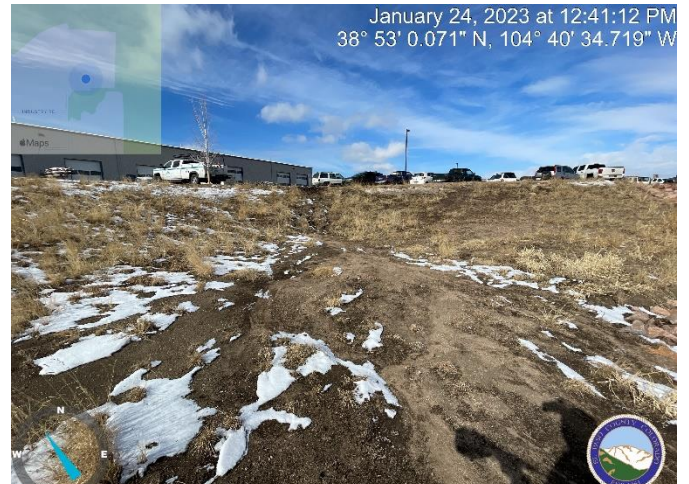
Photo 2: Subsequent sediment discharge from top of gravel parking lot into pond also needs to be cleaned out. Reference photo #1.

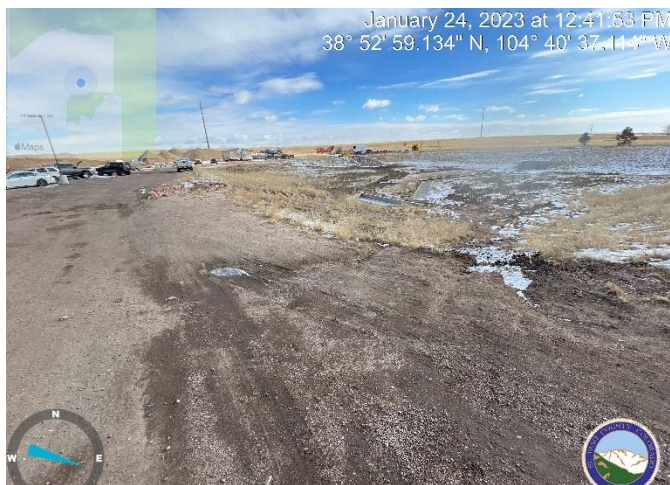
Photo 3: Storage lot/Gravel driveway. Top left corner adjacent to concrete lined forebay (North). Berm up top of slope. Bypassing causing erosion blowout.

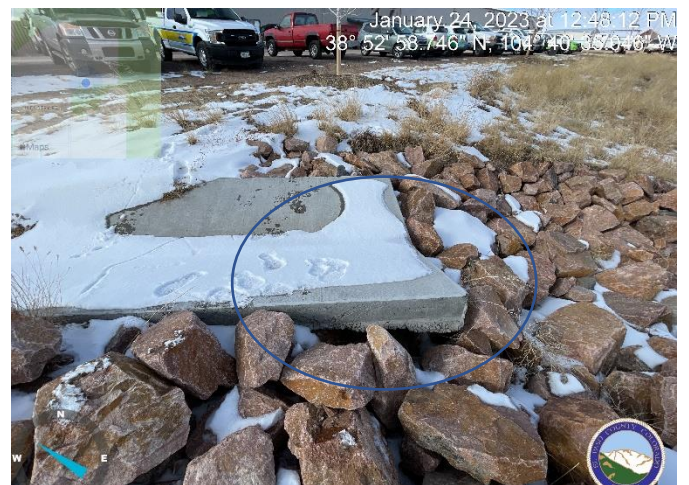
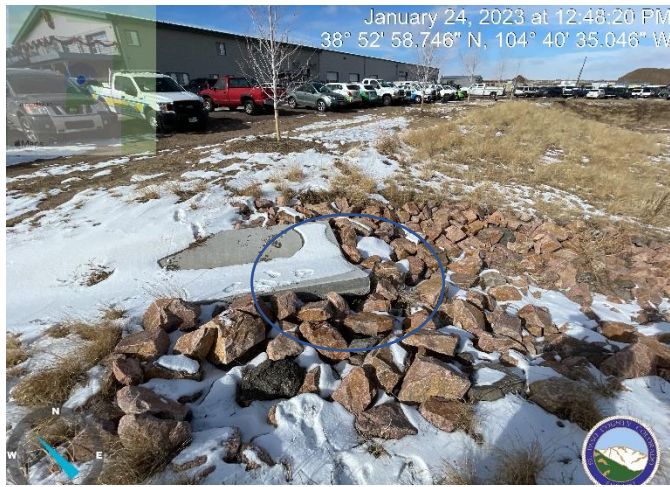
- Concrete channel at southwest corner of pond is undercut. Voids need to be filled with non-erosive material as to not compromise structure. See photo #s 4 and 5.

Photo 4: Concrete channel at southwest corner of pond is undercut. Voids need to be filled with non-erosive material as to not compromise structure.

Photo 5: Concrete channel at southwest corner of pond is undercut. Voids need to be filled with non-erosive material as to not compromise structure.

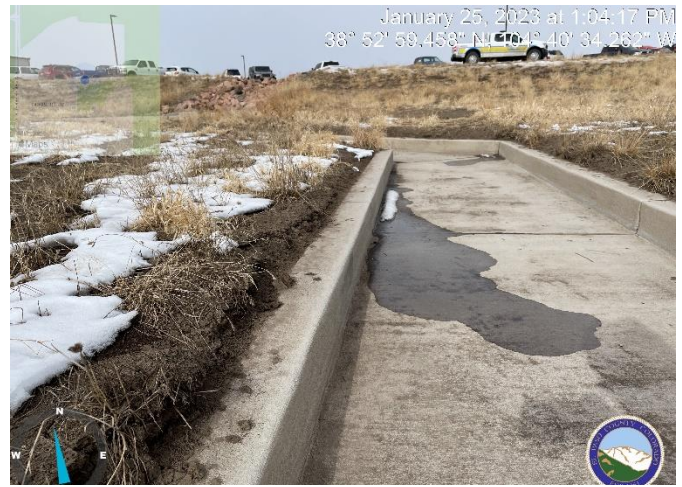
Photo 6: Pond bottom is above grade of low flow channel top of curb. Bring grade down to match top of curb, at 4% min slope per sheet ST05.

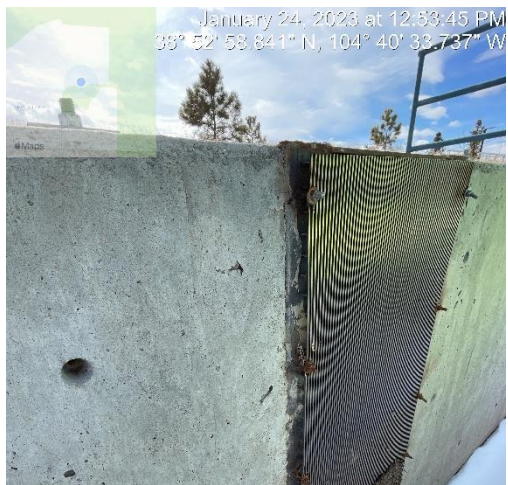
Photo 7: Gap between trash screen and concrete, needs to be flush.

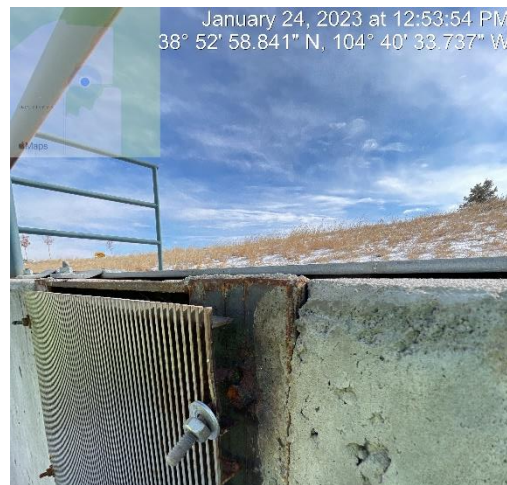
Photo 8: Trash screen bolts and nuts need to be replaced. Rusty and falling off structure.

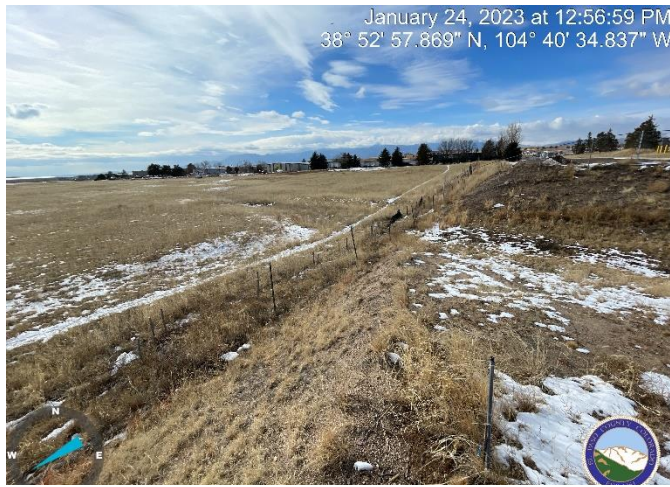
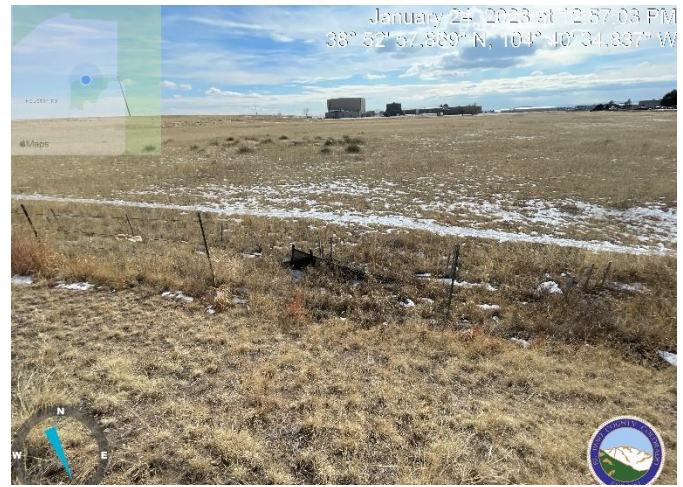
Photo 9: Remove temporary perimeter control measures site wide.

Photo 10: Remove temporary perimeter control measures site wide.

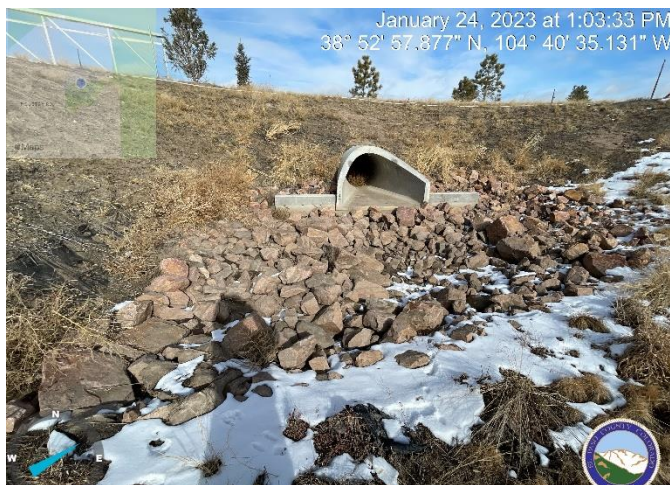
Photo 11: Low tailwater riprap basin. Plan detail calls for 24' L and measures 17' L in field. Reference sheet ST05A of GEC plan.

- Low tailwater riprap basin. Plan detail calls for 24' L and measures 17' L in field. Reference sheet ST05A of GEC plan. See photo #11. Since riprap cannot be extended to 24' due to the property boundary, check with Engineer of Record that 17' is acceptable for erosion protection and reflect change on as-builts.

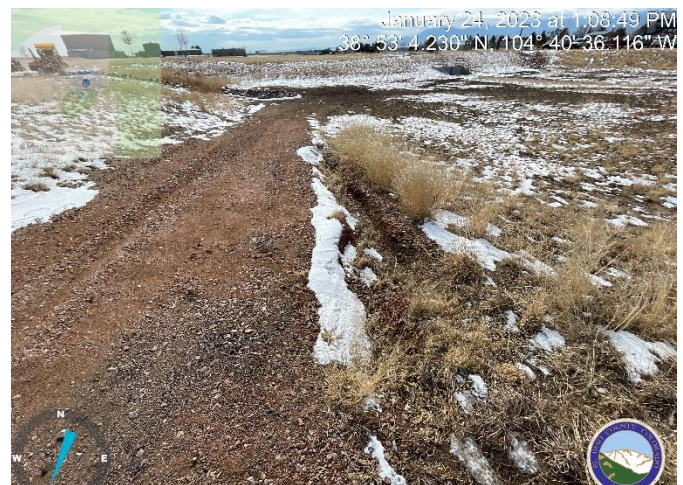
Photo 12: Maintenance access rd. Repair erosion rill atop of rd. Maintenance access rd. need to be redefined per detail. Reference sheet ST03 of GEC plan.

- Maintenance access road. Reference sheet ST03 of GEC plan.
 - Repair erosion rill atop of road. See photo #12.
 - Reestablish road throughout pond per detail. Road currently buried in sediment throughout much of the pond bottom. Call Stormwater inspector when potholing road (as discussed at FA walk) to show depth of road section (supposed to be 6" depth in some places and 12" depth in others, per details).

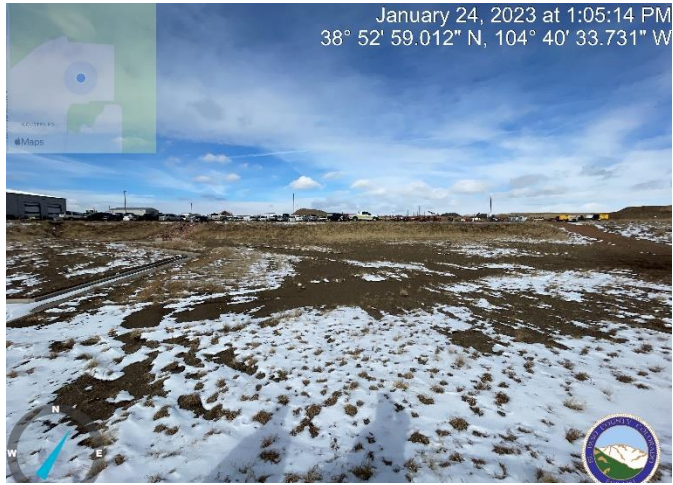
- Sparse vegetation throughout bottom of pond structure. See photo #13.
- Sparse vegetation around pond outlet pipe. Seed did not take on steep slopes. TRM called for on sheet ST03.

Photo 13: Sparse vegetation throughout bottom of pond structure. Sparse vegetation around pond outlet pipe. Seed did not take on steep slopes. TRM called for on
