December 2, 2021  
Revised March 2, 2022

Tuscany Homes  
1825 Austin Bluffs Parkway, Suite 100  
Colorado Springs, Colorado 80918

Re: Geologic Hazard Investigation  
Tax Schedule No. 74080-00-074  
570 Day Spring View  
Site S-309 Addition to Crystal Park Subdivision No. 2  
Manitou Springs, Colorado

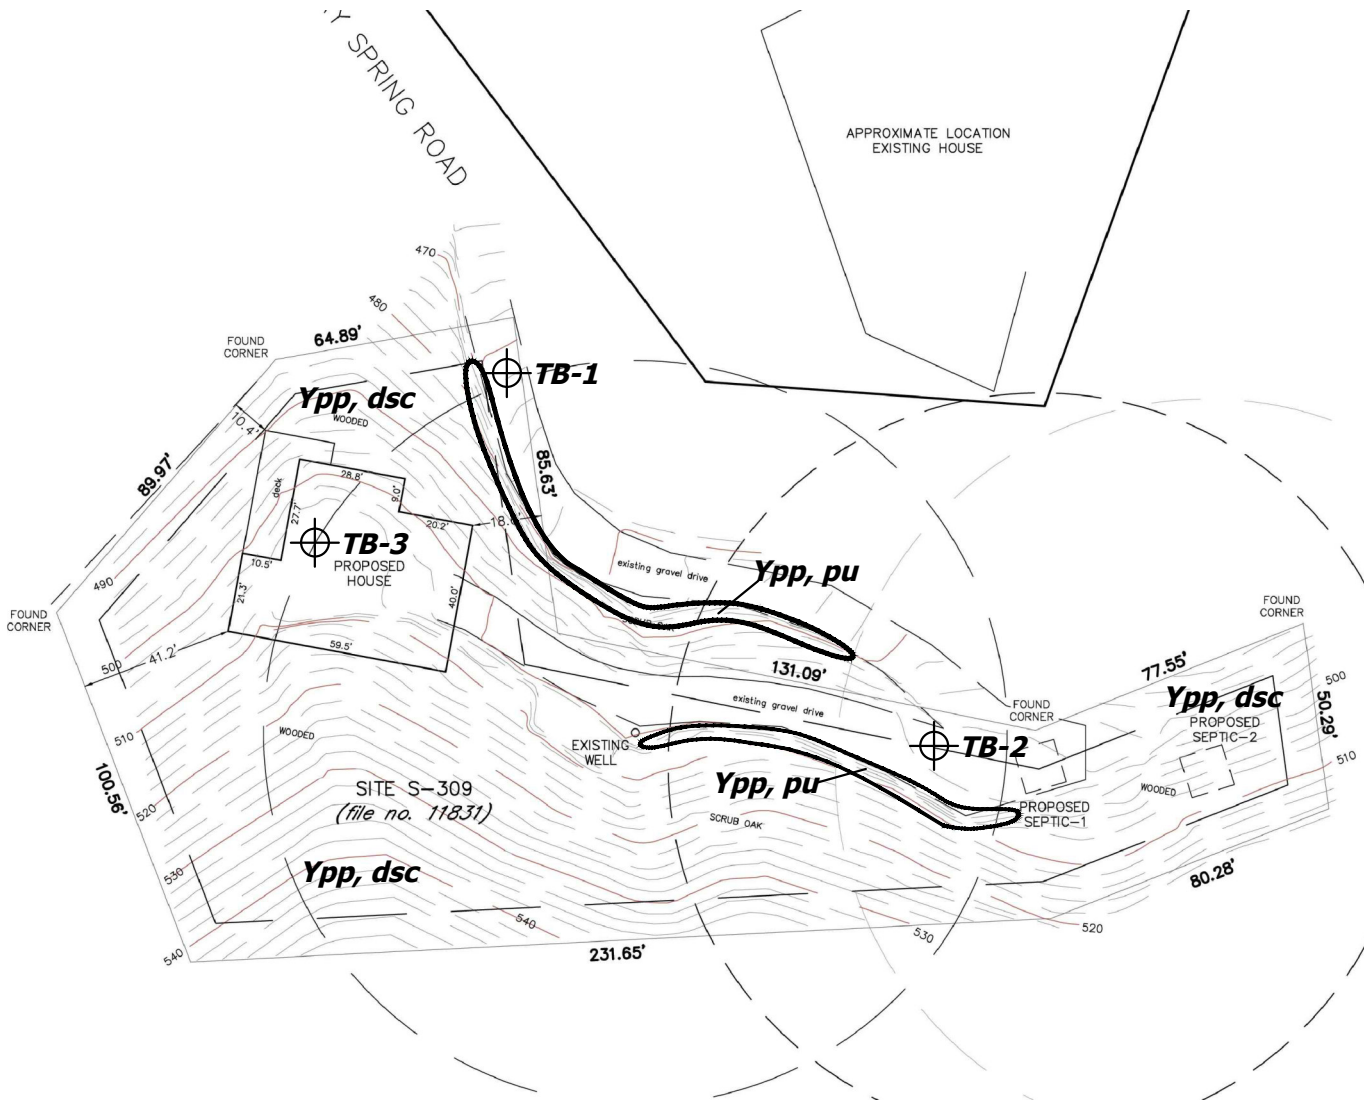
**FIG NO.:**  
**5**

The geologic hazards identified on this site include downslope creep and potentially unstable slopes which are indicated on the Geology/Engineering Geology Map, Figure 5. In accordance with the Geologic Hazards Ordinance of El Paso County, the following geologic hazards have been addressed:

The areas identified with this hazard include the majority of the site as shown on Figure 5. No signs of recent slope failures were observed on the site. In these areas of downslope creep, we would anticipate lateral and vertical movement of the near surface soils in the downslope direction. Additionally, areas along the driveway cut have been identified as potentially unstable slopes. The design of foundations in these areas should account for this additional pressure. A typical lateral pressure diagram is included in Figure 6. Additionally, the foundation should be designed to withstand pressures where steeper areas slope away from the foundation. These areas are acceptable as building sites with the following constraints on construction.

Moderate to steep slopes exist across the site. Areas of downslope creep and potentially unstable slopes have been shown on the Geology/Engineering Geology Map Figure 5. Areas identified as downslope creep are located across the site and the potentially unstable slopes are located along the existing driveway cut. In these areas, we would anticipate lateral and vertical movement of the near surface soils in the downslope direction. The foundation should be designed to account for these additional pressures. Tie-beams and buttresses are recommended to stiffen the foundation system. We recommend stepping the foundation down in the area of the moderate to steep slopes. Specific recommendations should be made when the site plan and foundation design are completed. Cuts should be avoided on the potentially unstable slopes unless analyzed for slope stability. This includes cuts made for terracing and landscaping.

Building is possible in these areas if the following engineering and construction mitigation steps are taken. This type of movement will increase lateral pressures against foundation walls on the uphill side of structures. The design of foundations in these areas should account for this additional pressure. A typical lateral pressure diagram is included in Figure No. 6. Additionally, the foundation should be designed to withstand pressures where steeper areas slope away from the foundation. Tie beams and buttresses are recommended to stiffen the foundation system. We recommend stepping the foundation down in the area of the moderate to steep slopes. Cuts should be avoided on the potentially unstable slope unless specifically analyzed for slope stability and held by engineer-designed retaining walls. This includes cuts made for landscaping and terracing. Proper control of drainage at both the surface and in the subsurface is important. Saturation of materials should be avoided that may create unstable conditions. Areas of ponded water should be avoided. Utility trenches and other subsurface features should not be permitted to become water traps which may promote saturation of

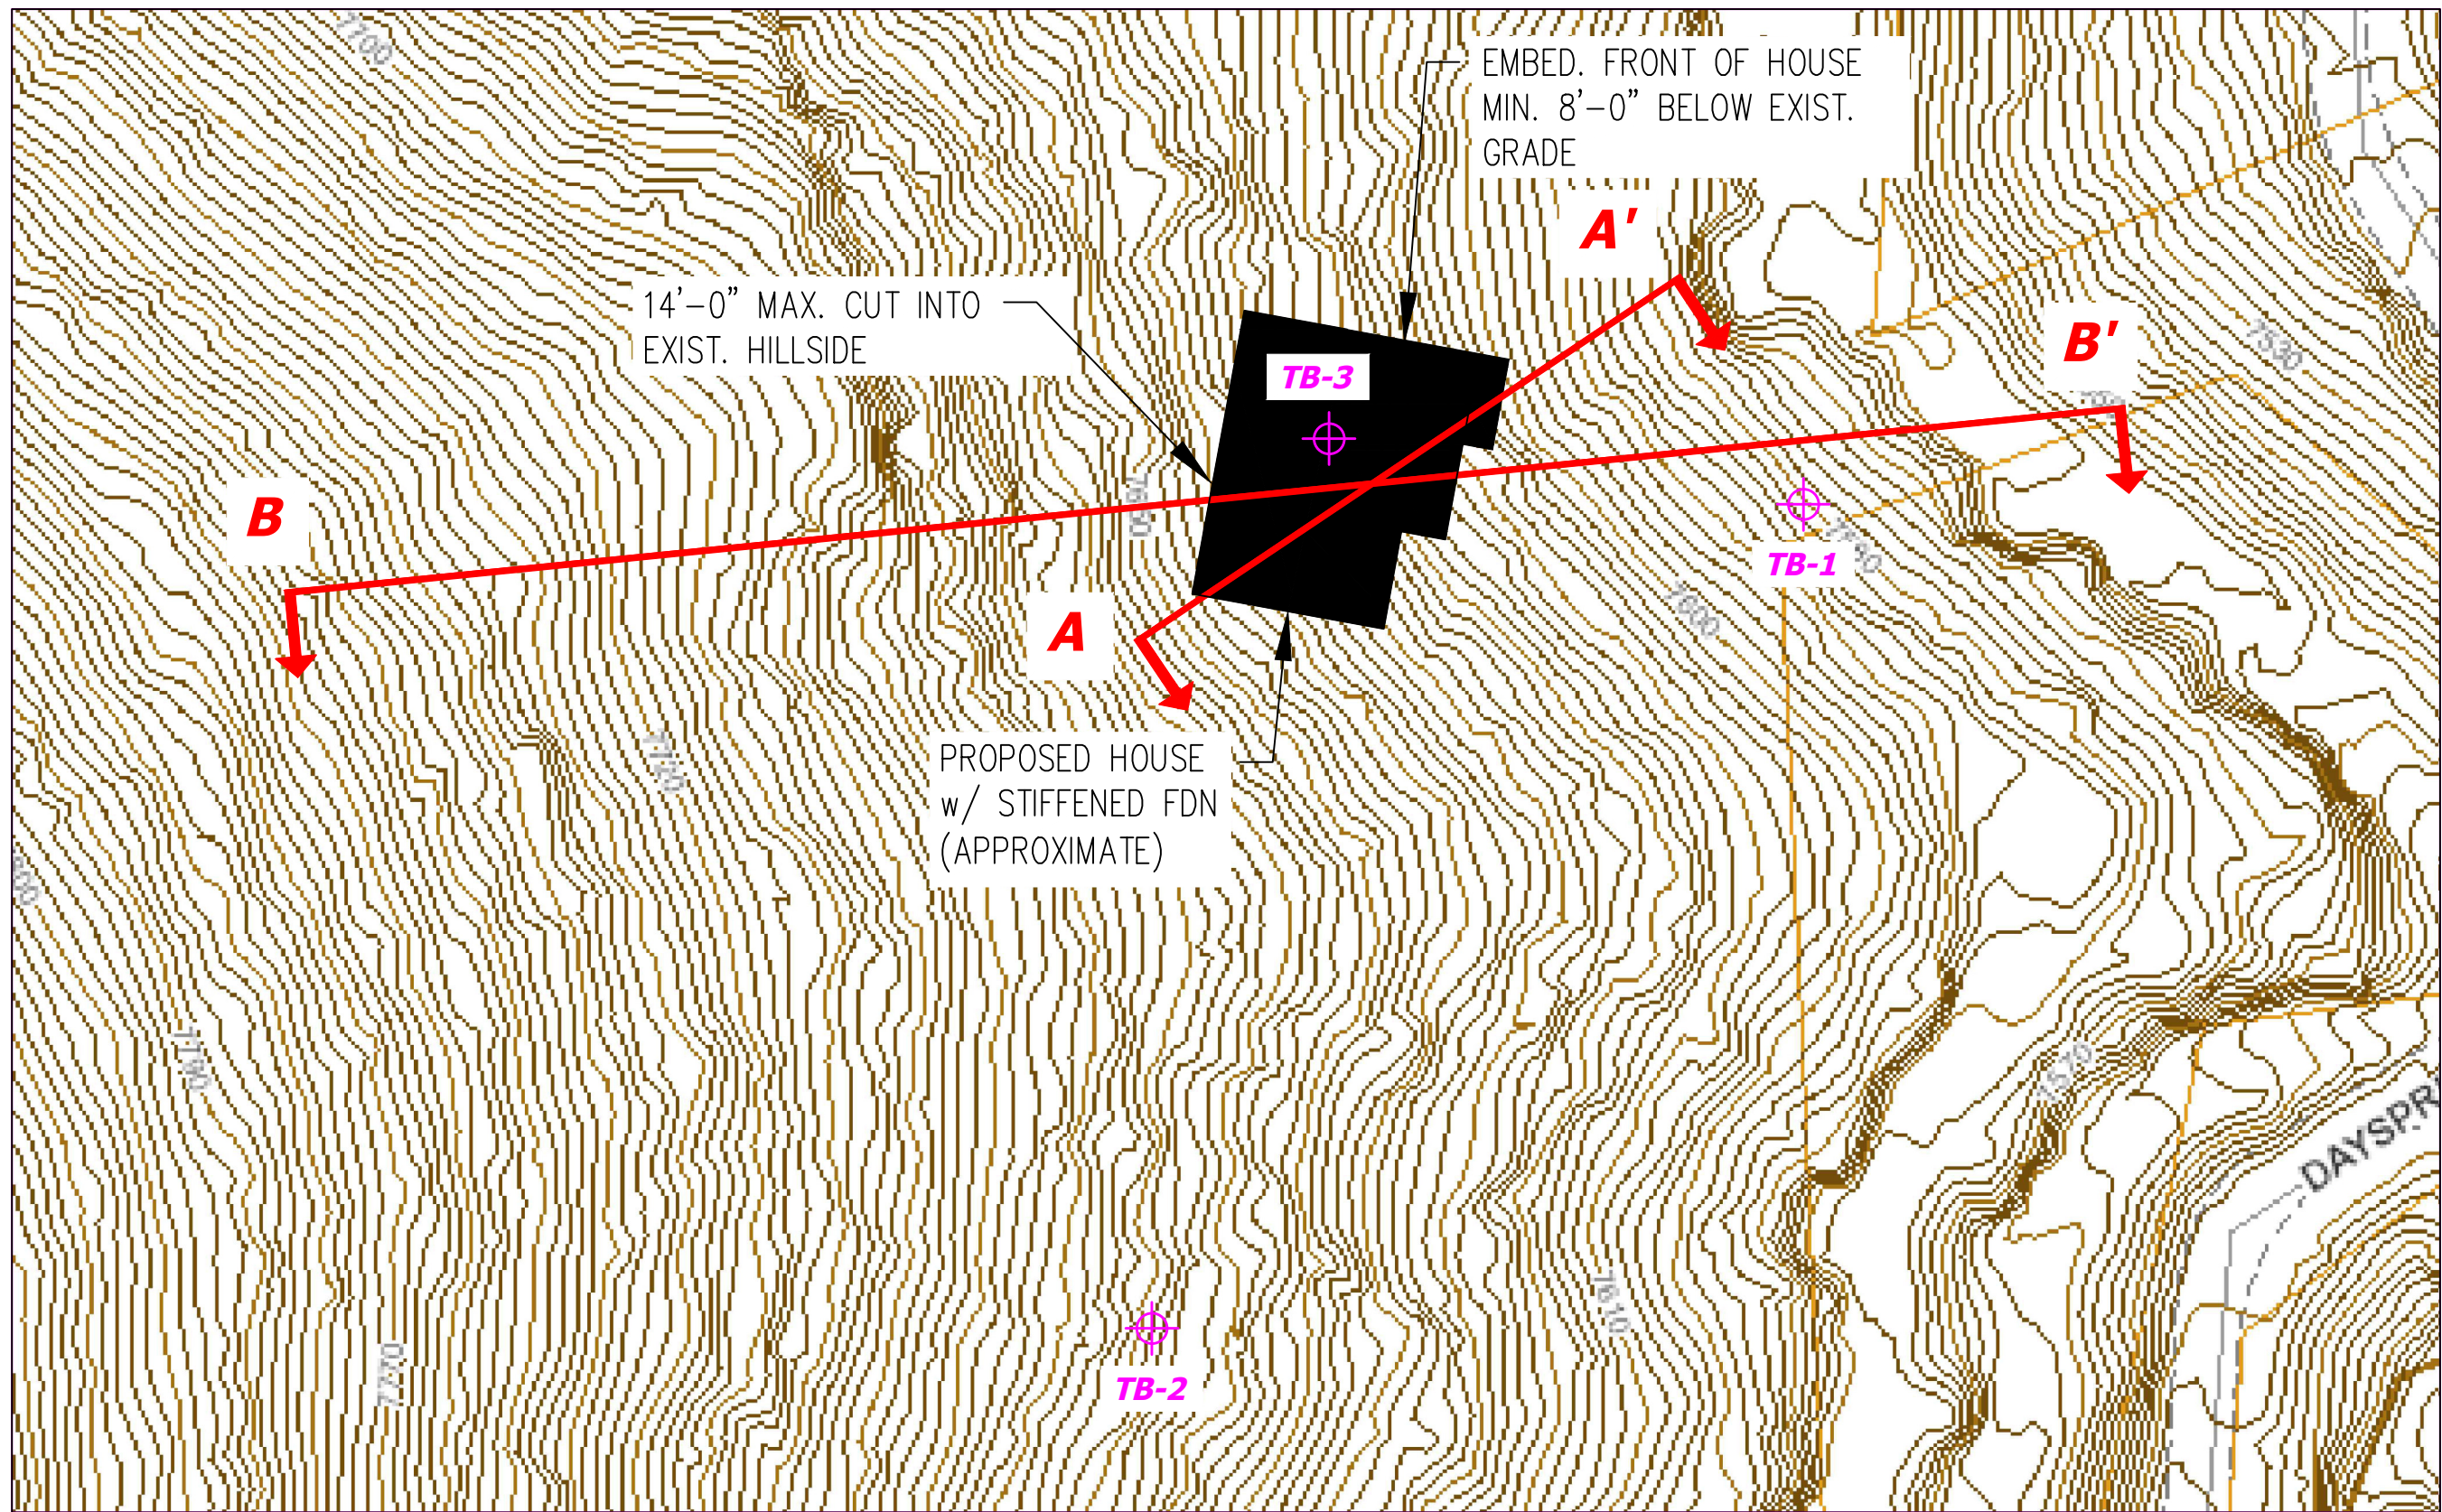
SLOPE SECTION MAP  
570 DAY SPRING VIEW  
MANITOU SPRINGS, CO  
FOR: TUSCANY HOMES

Slope Stability Analyses were conducted utilizing the GSTABL7 computer program to evaluate the stability of the proposed structure. The sections analyzed (A-A' and B-B') are shown on the Slope Stability Section Map, Figure 7. Slope stability analysis results are included in Appendix D. The sections were analyzed for the existing and proposed conditions with an elevated water table. Soil strength values used for the program were as follows.

Slope Stability Analyses were conducted utilizing the GSTABL7 computer program to evaluate the stability of the proposed structure. The sections analyzed (A-A' and B-B') are shown on the Slope Stability Section Map, Figure 7. Slope stability analysis results are included in Appendix D. The sections were analyzed for the existing and proposed conditions with an elevated water table. Factors of safety of 0.8 to 1.8 were obtained for the existing conditions and proposed conditions. The existing slope factor of safety of 0.8 will be retained by the proposed structured with a stiffened foundation. The results are summarized in the table in the Slope Stability Section of this report. The proposed house will need a stiffened foundation, the foundation on the eastern side of the structure immediately upgradient of slope must be embedded a minimum of 8' below existing grade. A 14' maximum allowable cut into existing slope.

- <sup>1</sup> – Proposed house with stiffened foundation.
- <sup>2</sup> – Foundation on the eastern side of the structure immediately upgradient of slope must be embedded a minimum of 8' below existing grade.
- <sup>3</sup> – 14' maximum allowable cut into existing slope.

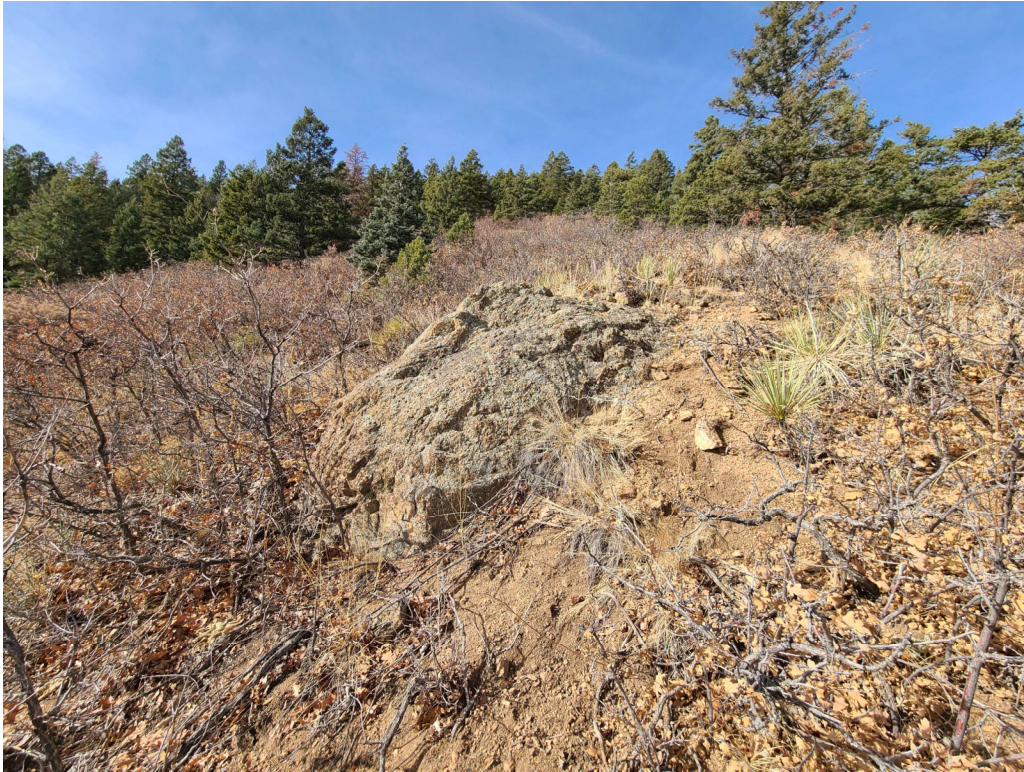
**Looking towards  
granite outcrop  
upslope of the  
proposed building  
area.**

Mitigation: We recommend stabilization by removal of smaller loose rocks, often referred to as scaling. Any scaling should be performed under existing conditions prior to any earthwork that would remove existing vegetation and change soil characteristics that could alter where the rocks roll. Temporary barriers should be used to protect existing buildings during scaling operations. Periodic monitoring will be necessary to determine areas where erosion over time has destabilized other rocks and stabilized rocks. Any larger rocks observed overtime that need stabilized. This will likely involve the use of Portland cement grout placed at the base of unstable rocks to prevent dislodgement. Additional observations should be made to determine what rocks should be stabilized prior to construction. A well-defined swale should be created to direct surface flows and debris around the structure. Surface debris and runoff should be intercepted with a well-defined swale and directed around the structure.

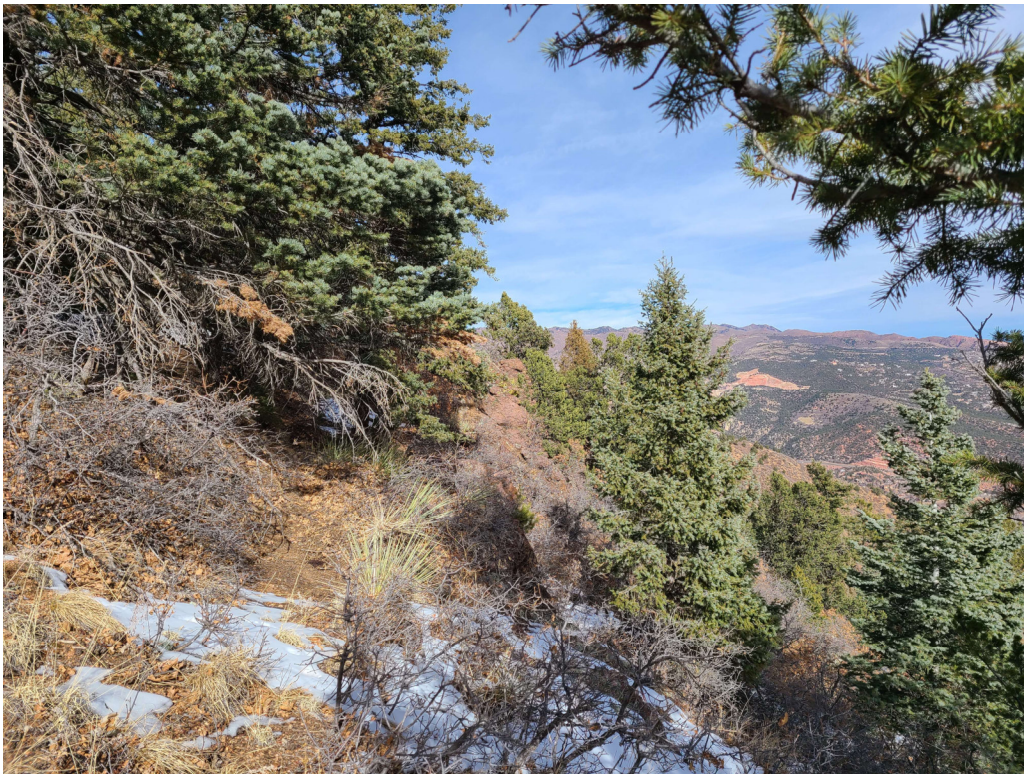
**Looking west towards  
outcrop upslope and  
southwest of the  
proposed building  
area.**

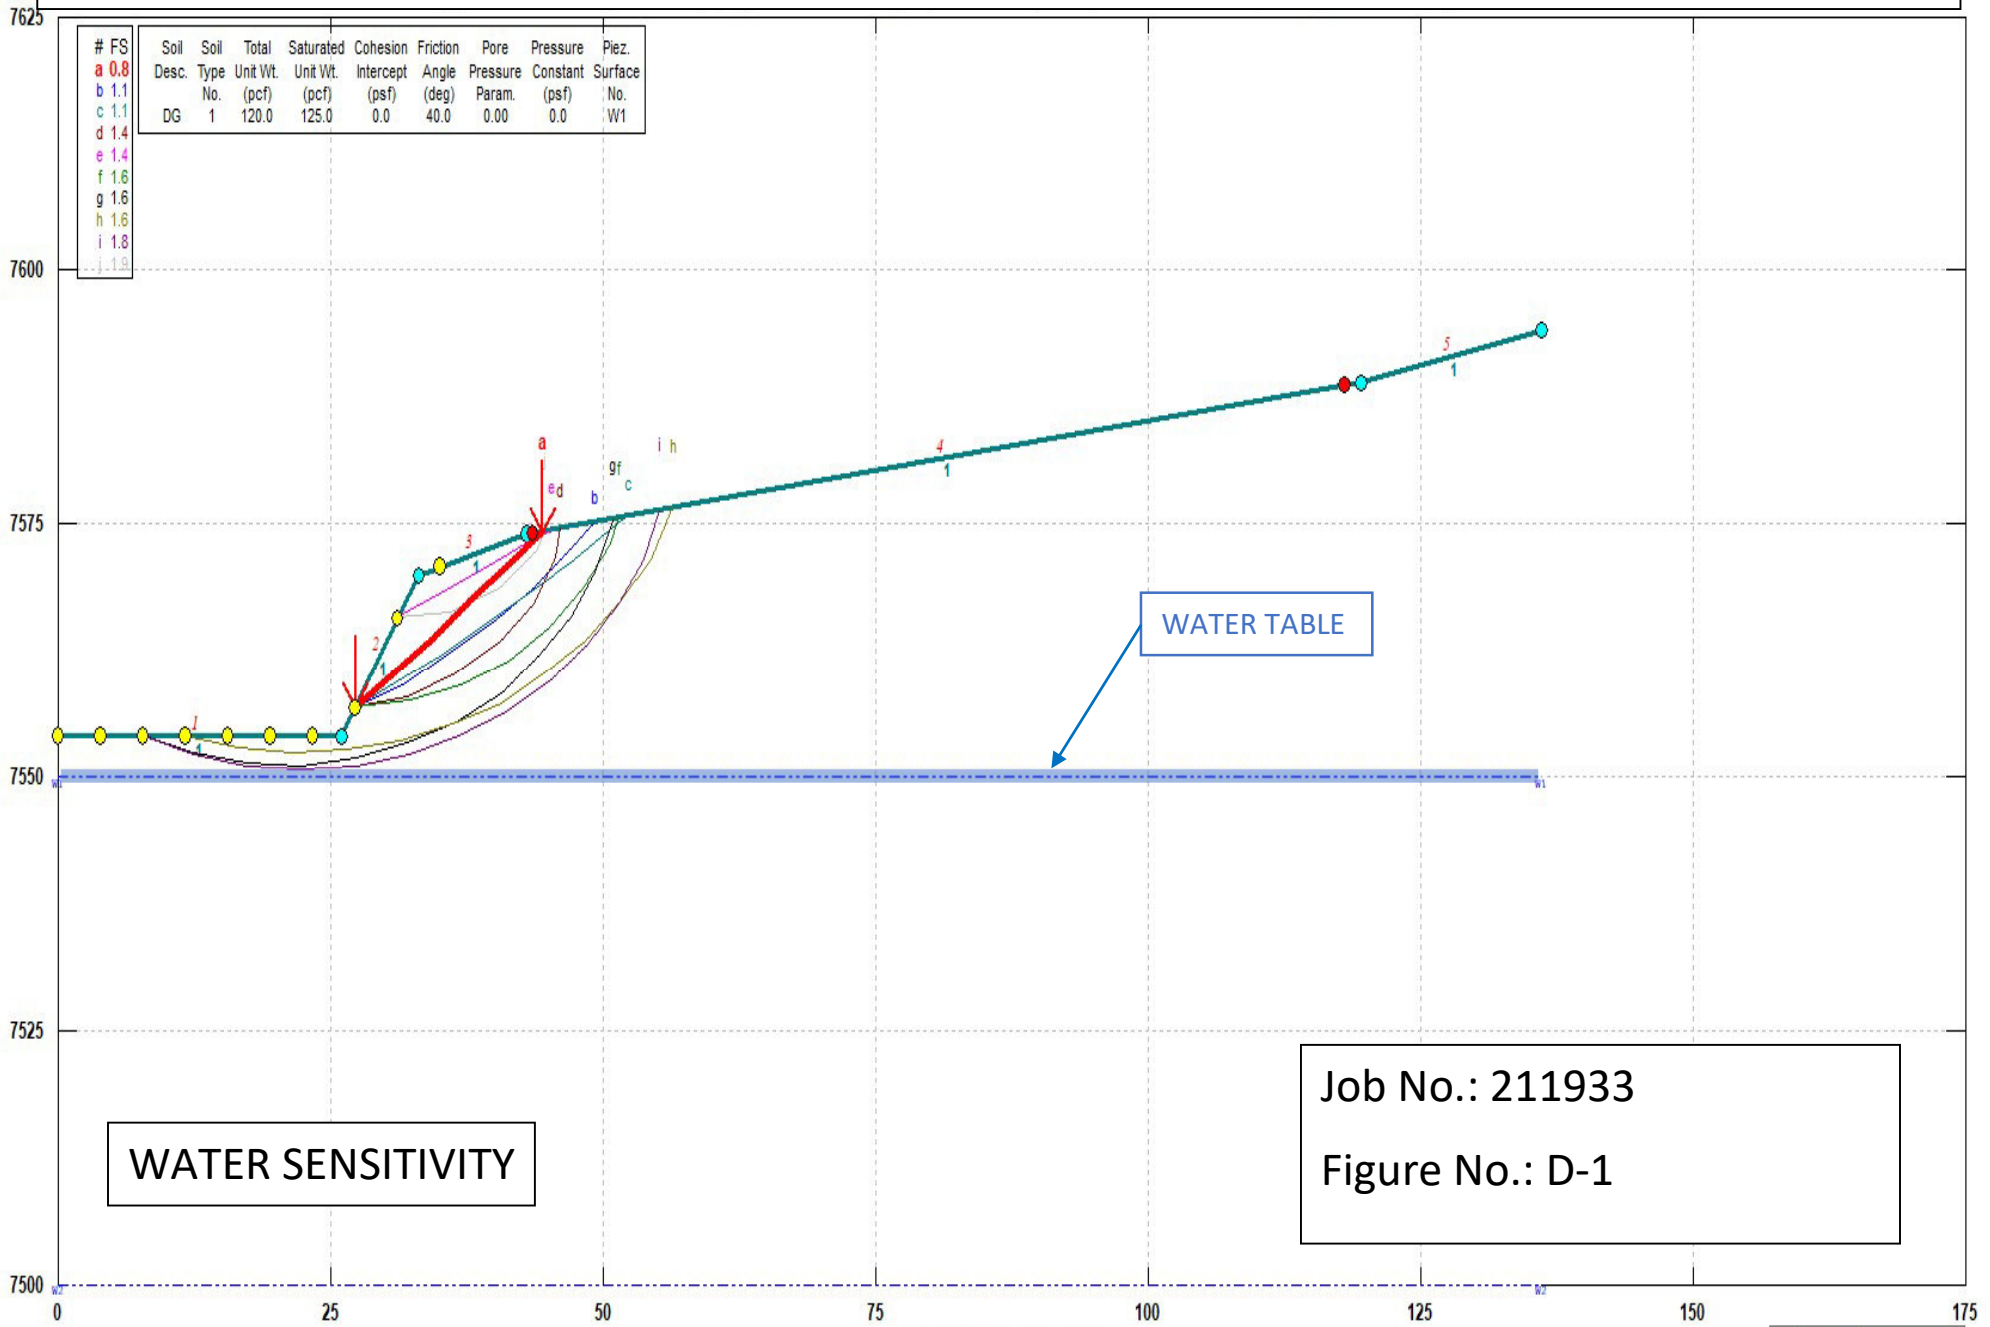
Job No.: 211933  
Figure No.: D-1

Figure No.	Section	Analysis	Water Table	F.O.S	Description
D-1	A-A'	Existing (Circular)	High	0.8	Initiation and termination points of analysis modified to encompass existing slope. Circular failure surface analyzed.
D-2	A-A'	Proposed (Circular)	High	1.5	Initiation and termination points of analysis modified to encompass proposed building cut/pad. Circular failure surface analyzed. <sup>1, 2, 3</sup>
D-3	B-B'	Existing (Circular)	High	1.6	Initiation and termination points of analysis modified to encompass existing slope. Circular failure surface analyzed.
D-4	B-B'	Existing (Circular)	High	1.8	Initiation and termination points of analysis modified to encompass existing slope. Circular failure surface analyzed.
D-5	B-B'	Proposed (Circular)	High	1.6	Initiation and termination points of analysis modified to encompass proposed building cut/pad. Circular failure surface analyzed. <sup>1, 2, 3</sup>
D-6	B-B'	Proposed (Circular)	High	1.6	Initiation and termination points of analysis modified to encompass proposed building cut/pad. Circular failure surface analyzed. <sup>1, 2, 3</sup>

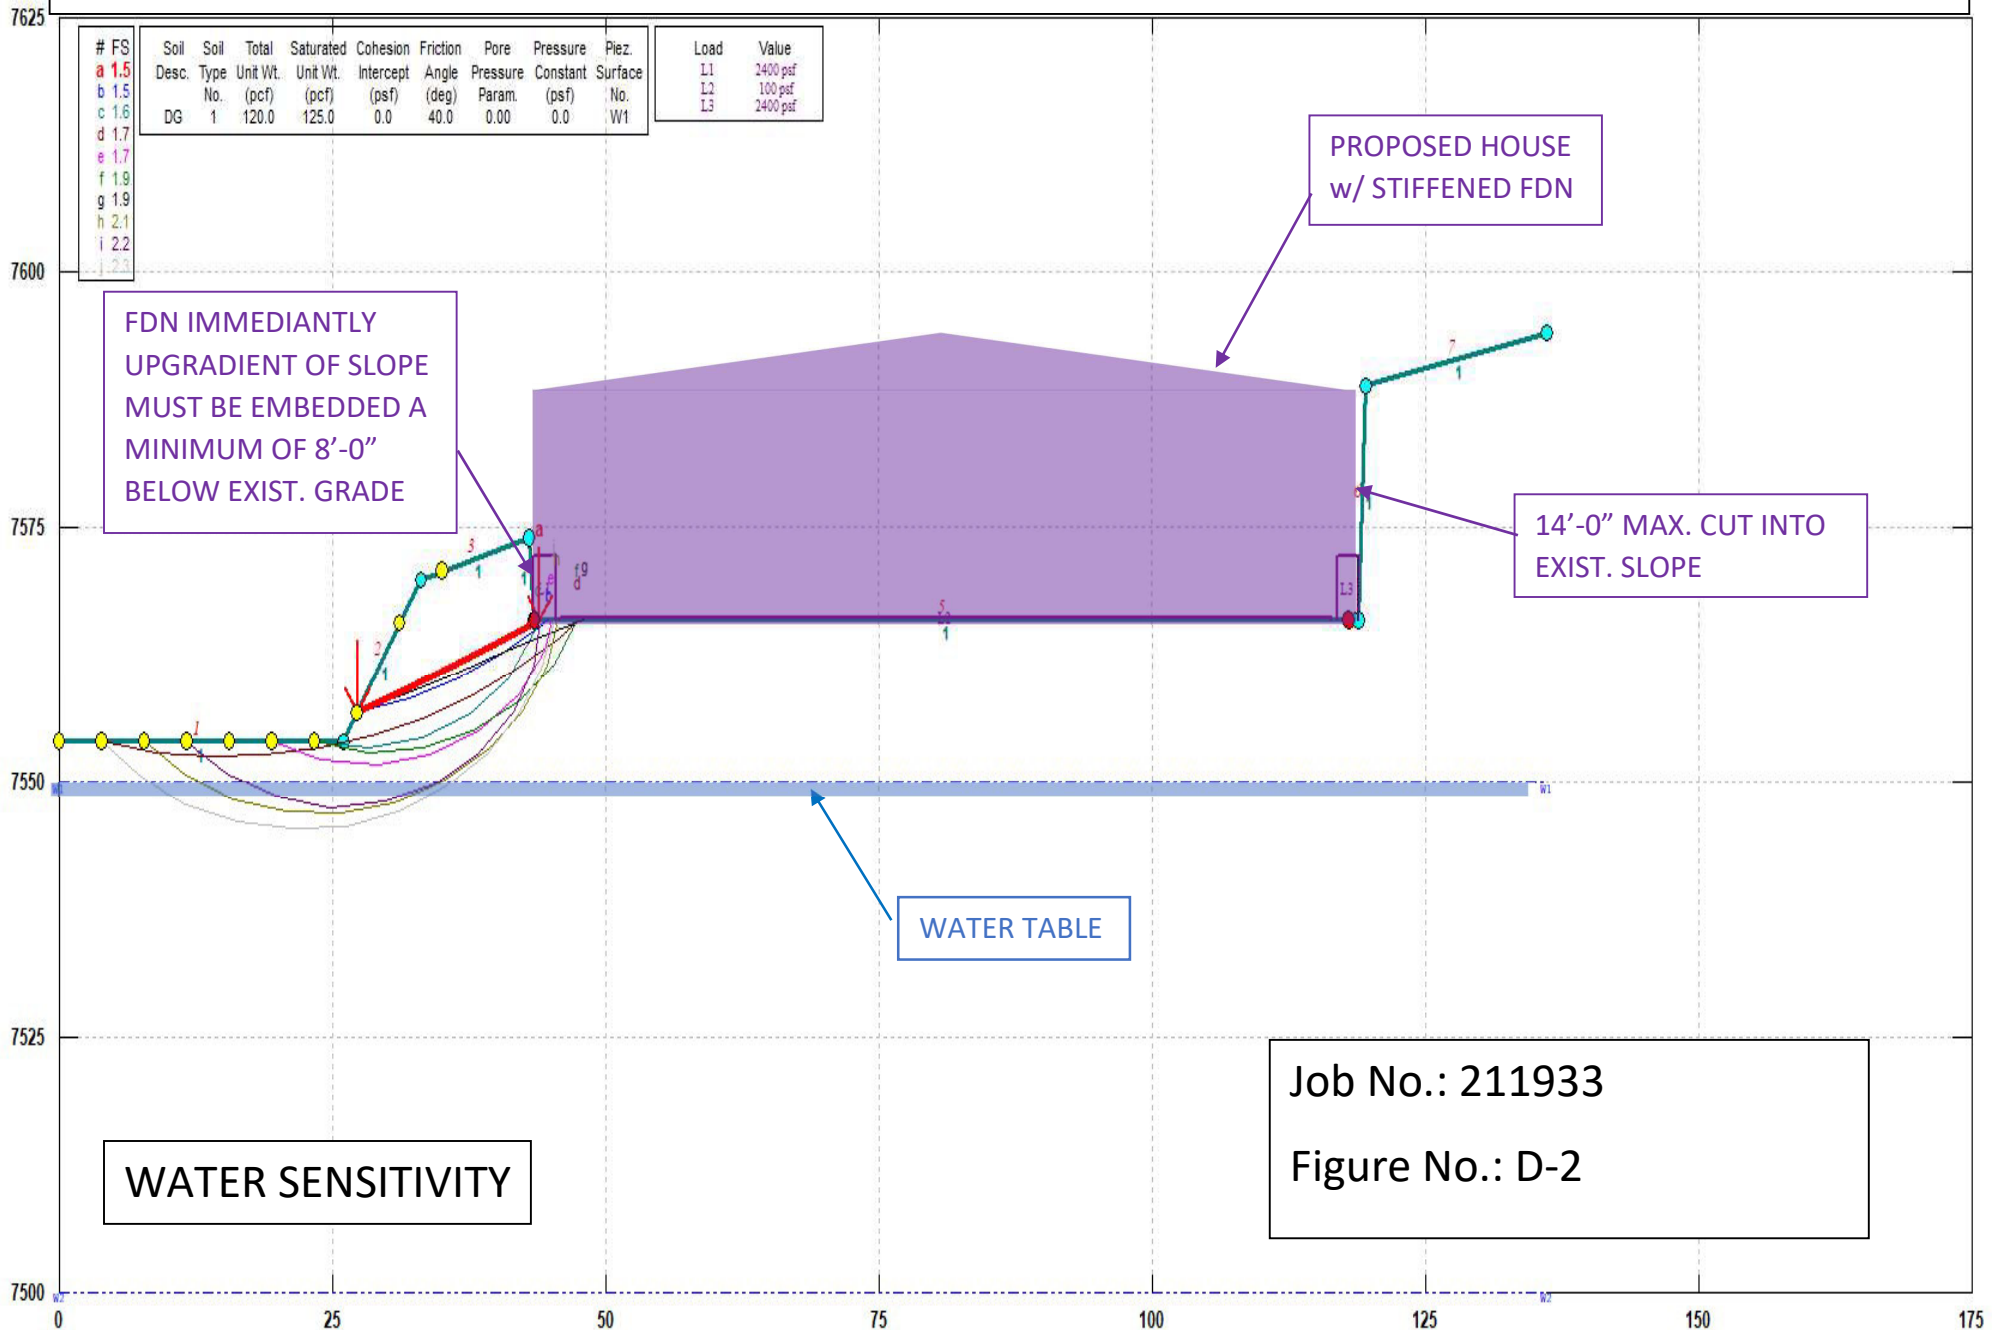
# TUSCANY HOMES – 211933– A-A - PROPOSED

FDN IMMEDIANTLY UPGRADIENT OF SLOPE MUST BE EMBEDDED A MINIMUM OF 8'-0" BELOW EXIST. GRADE

PROPOSED HOUSE w/ STIFFENED FDN
