EL PASO COUNTY CONSTRUCTION STORMWATER SITE INSPECTION REPORT

Facility Name: Abert Ranch	Permittee: Eric Leffler
Date of Inspection: 09/22/2021	Weather Conditions: Sunny
Permit Number: SF1911	Disturbed Acreage: ~2
Phase of Construction: Active	Site Qualified Stormwater Manager: Please provide this information!
Inspector Name: Molly Galloway	Site Contact Info: Michael Turner

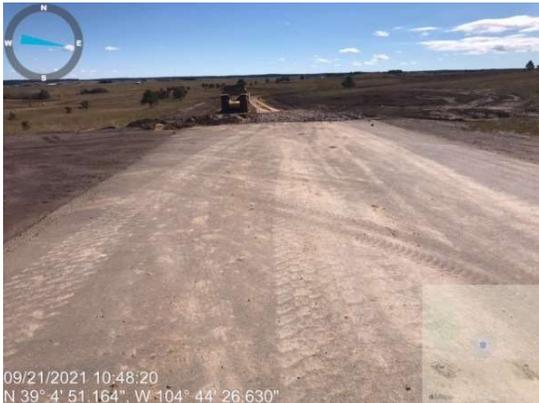
VTC implemented at eastern end of Silver Nell Drive, but sediment tracking on to paved road is still present. Implement more rigorous street sweeping program.

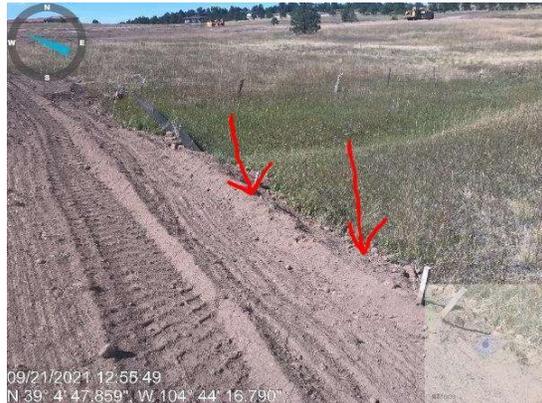
Settlers Ranch Road	Silt fence perimeter control measure	Maintain overburdened silt fence along Settlers Ranch Road. Please see photo for details. Other initial silt fences in good condition.
---------------------	--------------------------------------	--

Silt fence overburdened along Settlers Ranch Road.

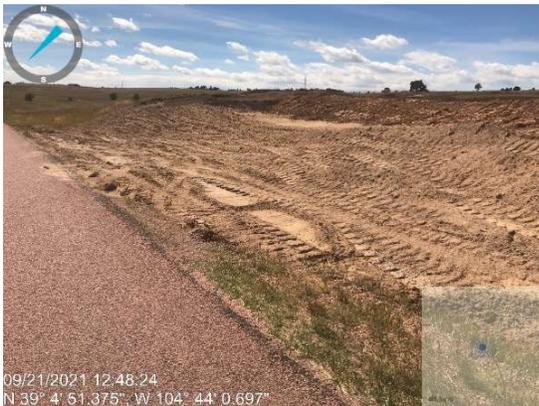
Location	Missing Control Measure	Description of Corrective Action
Steppler Road and new road	Failure to implement perimeter control measures	Failure to implement perimeter control measures as per plans (sheet C1.13) in the field at Steppler Road. Please see photos for additional information.

Implement control measures as per plans at Stepler Road

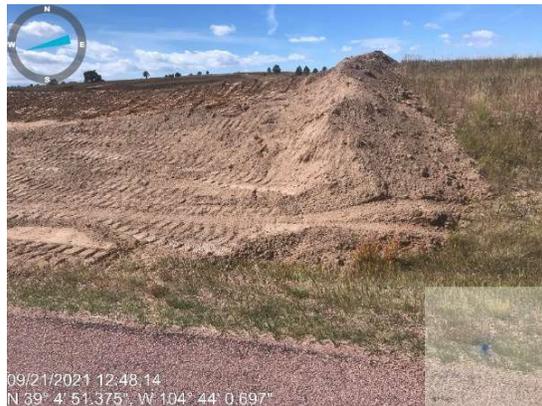
Implement control measures as per plans.

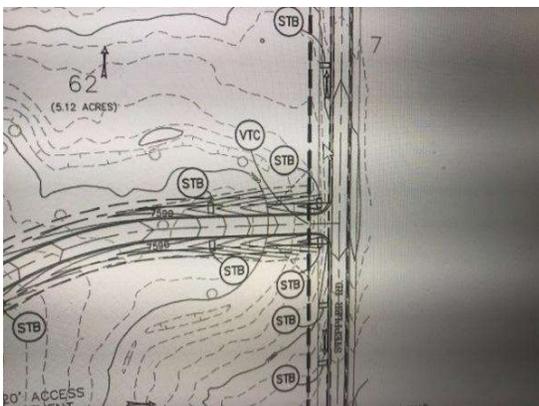
Implement control measures as per plans (sheet C1.13) in the field at Stepler Road. Failure to implement VTC and SBBs.
