Re: Soil, Geology, and Geologic Hazard Study
Johnson Subdivision No. 1
Parcel No. 61000-00-157
14502 Highway 83
El Paso County, Colorado

Delroy Johnson
Soils, Geology, and Geologic Hazard Study-Revised
Johnson Subdivision No. 1
14502 Highway 83
Parcel No. 61000-00-157
El Paso County, Colorado

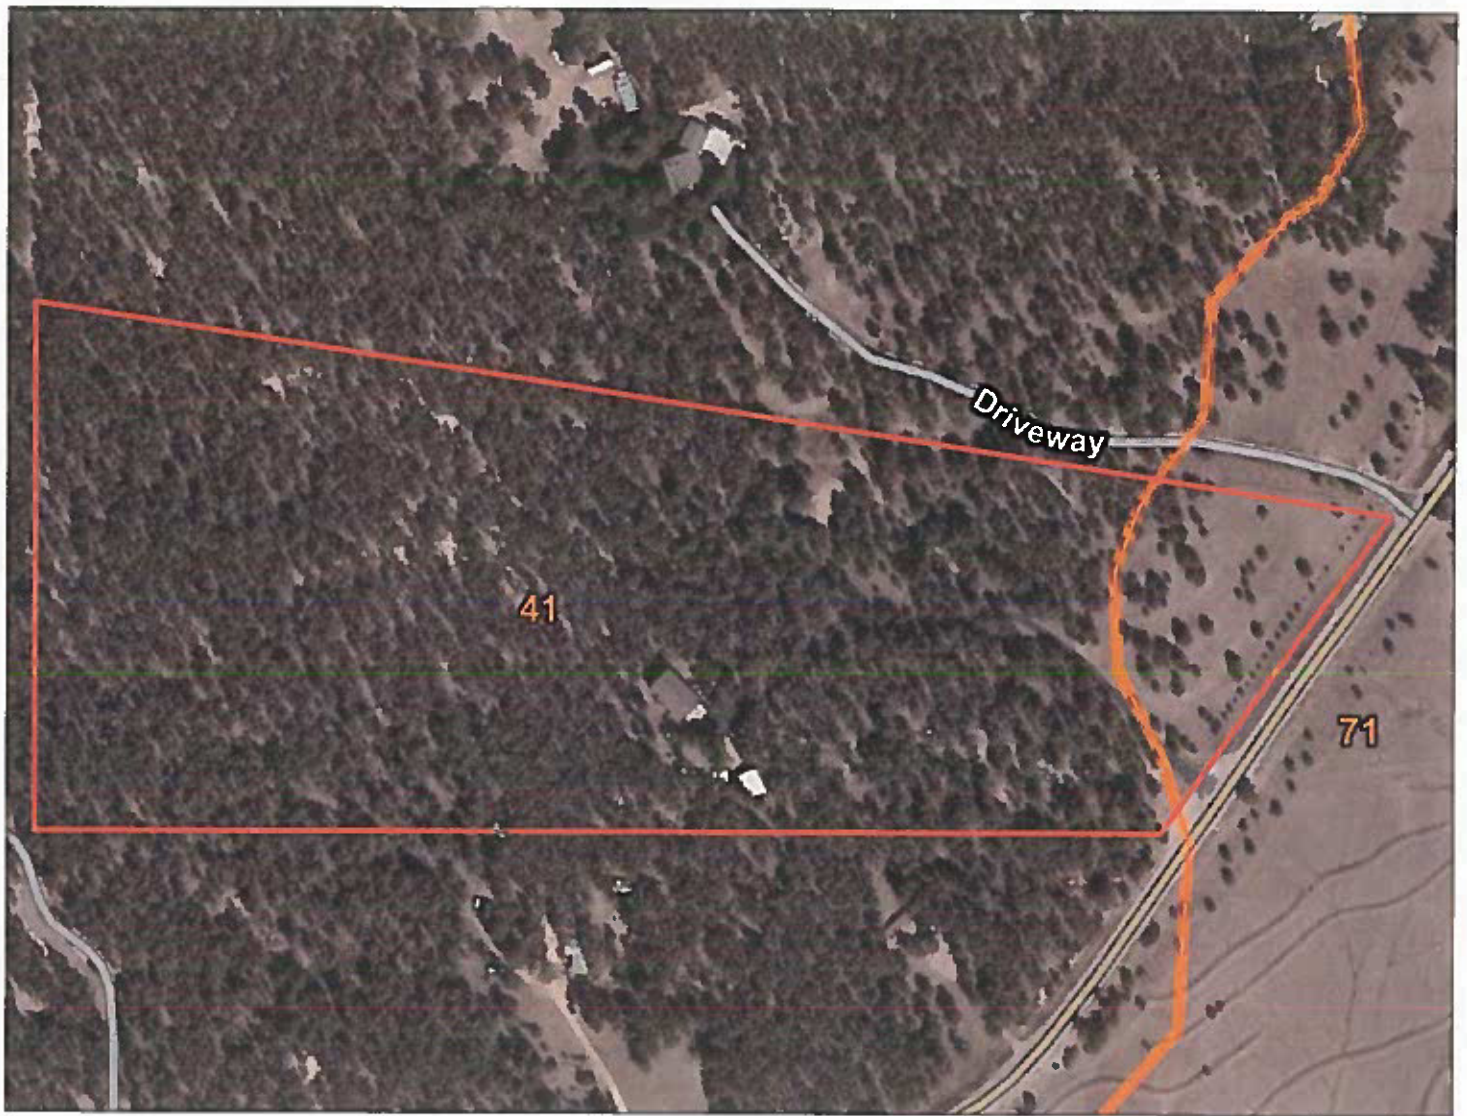
SOIL SURVEY MAP
JOHNSON SUBDIVISION NO. 1
14502 HIGHWAY 83
EL PASO COUNTY, CO.
FOR: DELROY JOHNSON

The Natural Resource Conservation Service (NRCS) (Reference 1, Figure 4), previously the Soil Conservation Service (Reference 2) has mapped two soil types on the site. Complete descriptions of the soil types are presented in Appendix D. In general, the soils consist of sandy loam to gravelly loamy sand. The soils are described as follows:

<u>Type</u>	<u>Description</u>
41	Kettle gravelly, loamy sand, 8 – 40% Slopes
71	Pring coarse sandy loam, 3 – 8% Slopes

The soils have been described to have rapid permeabilities. The soils are described as well suited for use as homesites. Possible hazards with soils erosion are present on the site. The erosion potential can be controlled with vegetation. The soils have been described to have moderate erosion hazards (Reference 2).

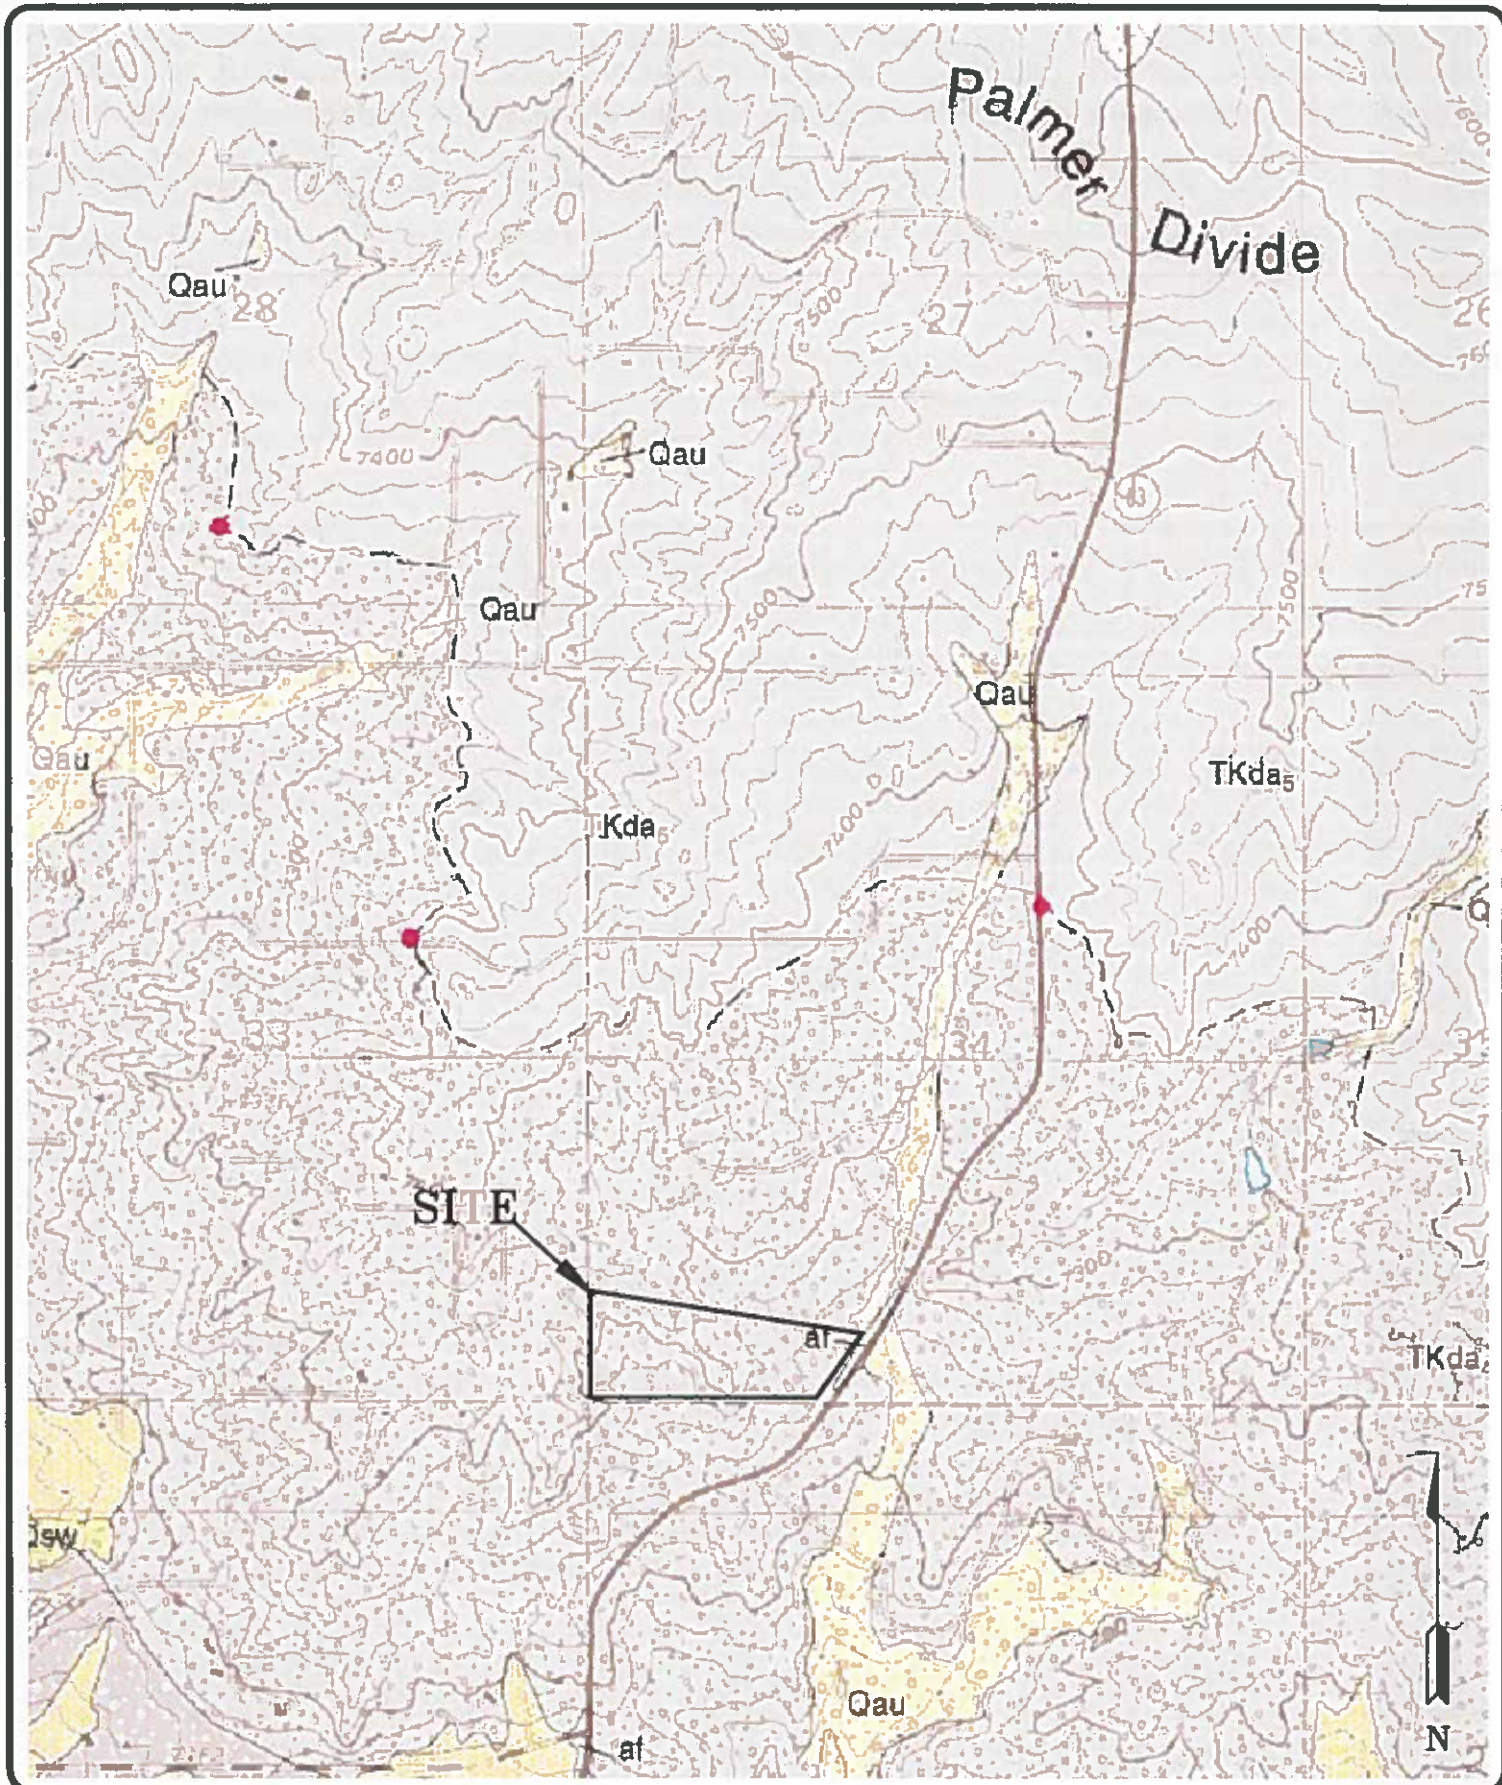
MONUMENT QUADRANGLE GEOLOGIC MAP
JOHNSON SUBDIVISION NO. 1
14502 HIGHWAY 83
EL PASO COUNTY, CO.
FOR: DELROY JOHNSON

The geology of the site was evaluated using the *Geologic Map of the Monument Quadrangle*, by Thorson and Madole in 2003, (Reference 4, Figure 5). The Geology Map for the site is presented in Figure 6. One mappable unit was identified on this site which is described as follows:

Qc/Tkd Colluvium of Quaternary Age overlying Dawson Formation of Tertiary to Cretaceous Age: The materials consist of colluvial or residual soils overlying the bedrock materials on-site. The colluvial soils were deposited by the action of sheetwash and gravity. The residual soils were derived from the in-situ weathering of the bedrock on site. These materials typically consist of silty to clayey sand with potential areas of sandy clays. The bedrock consists of the Dawson Formation. The

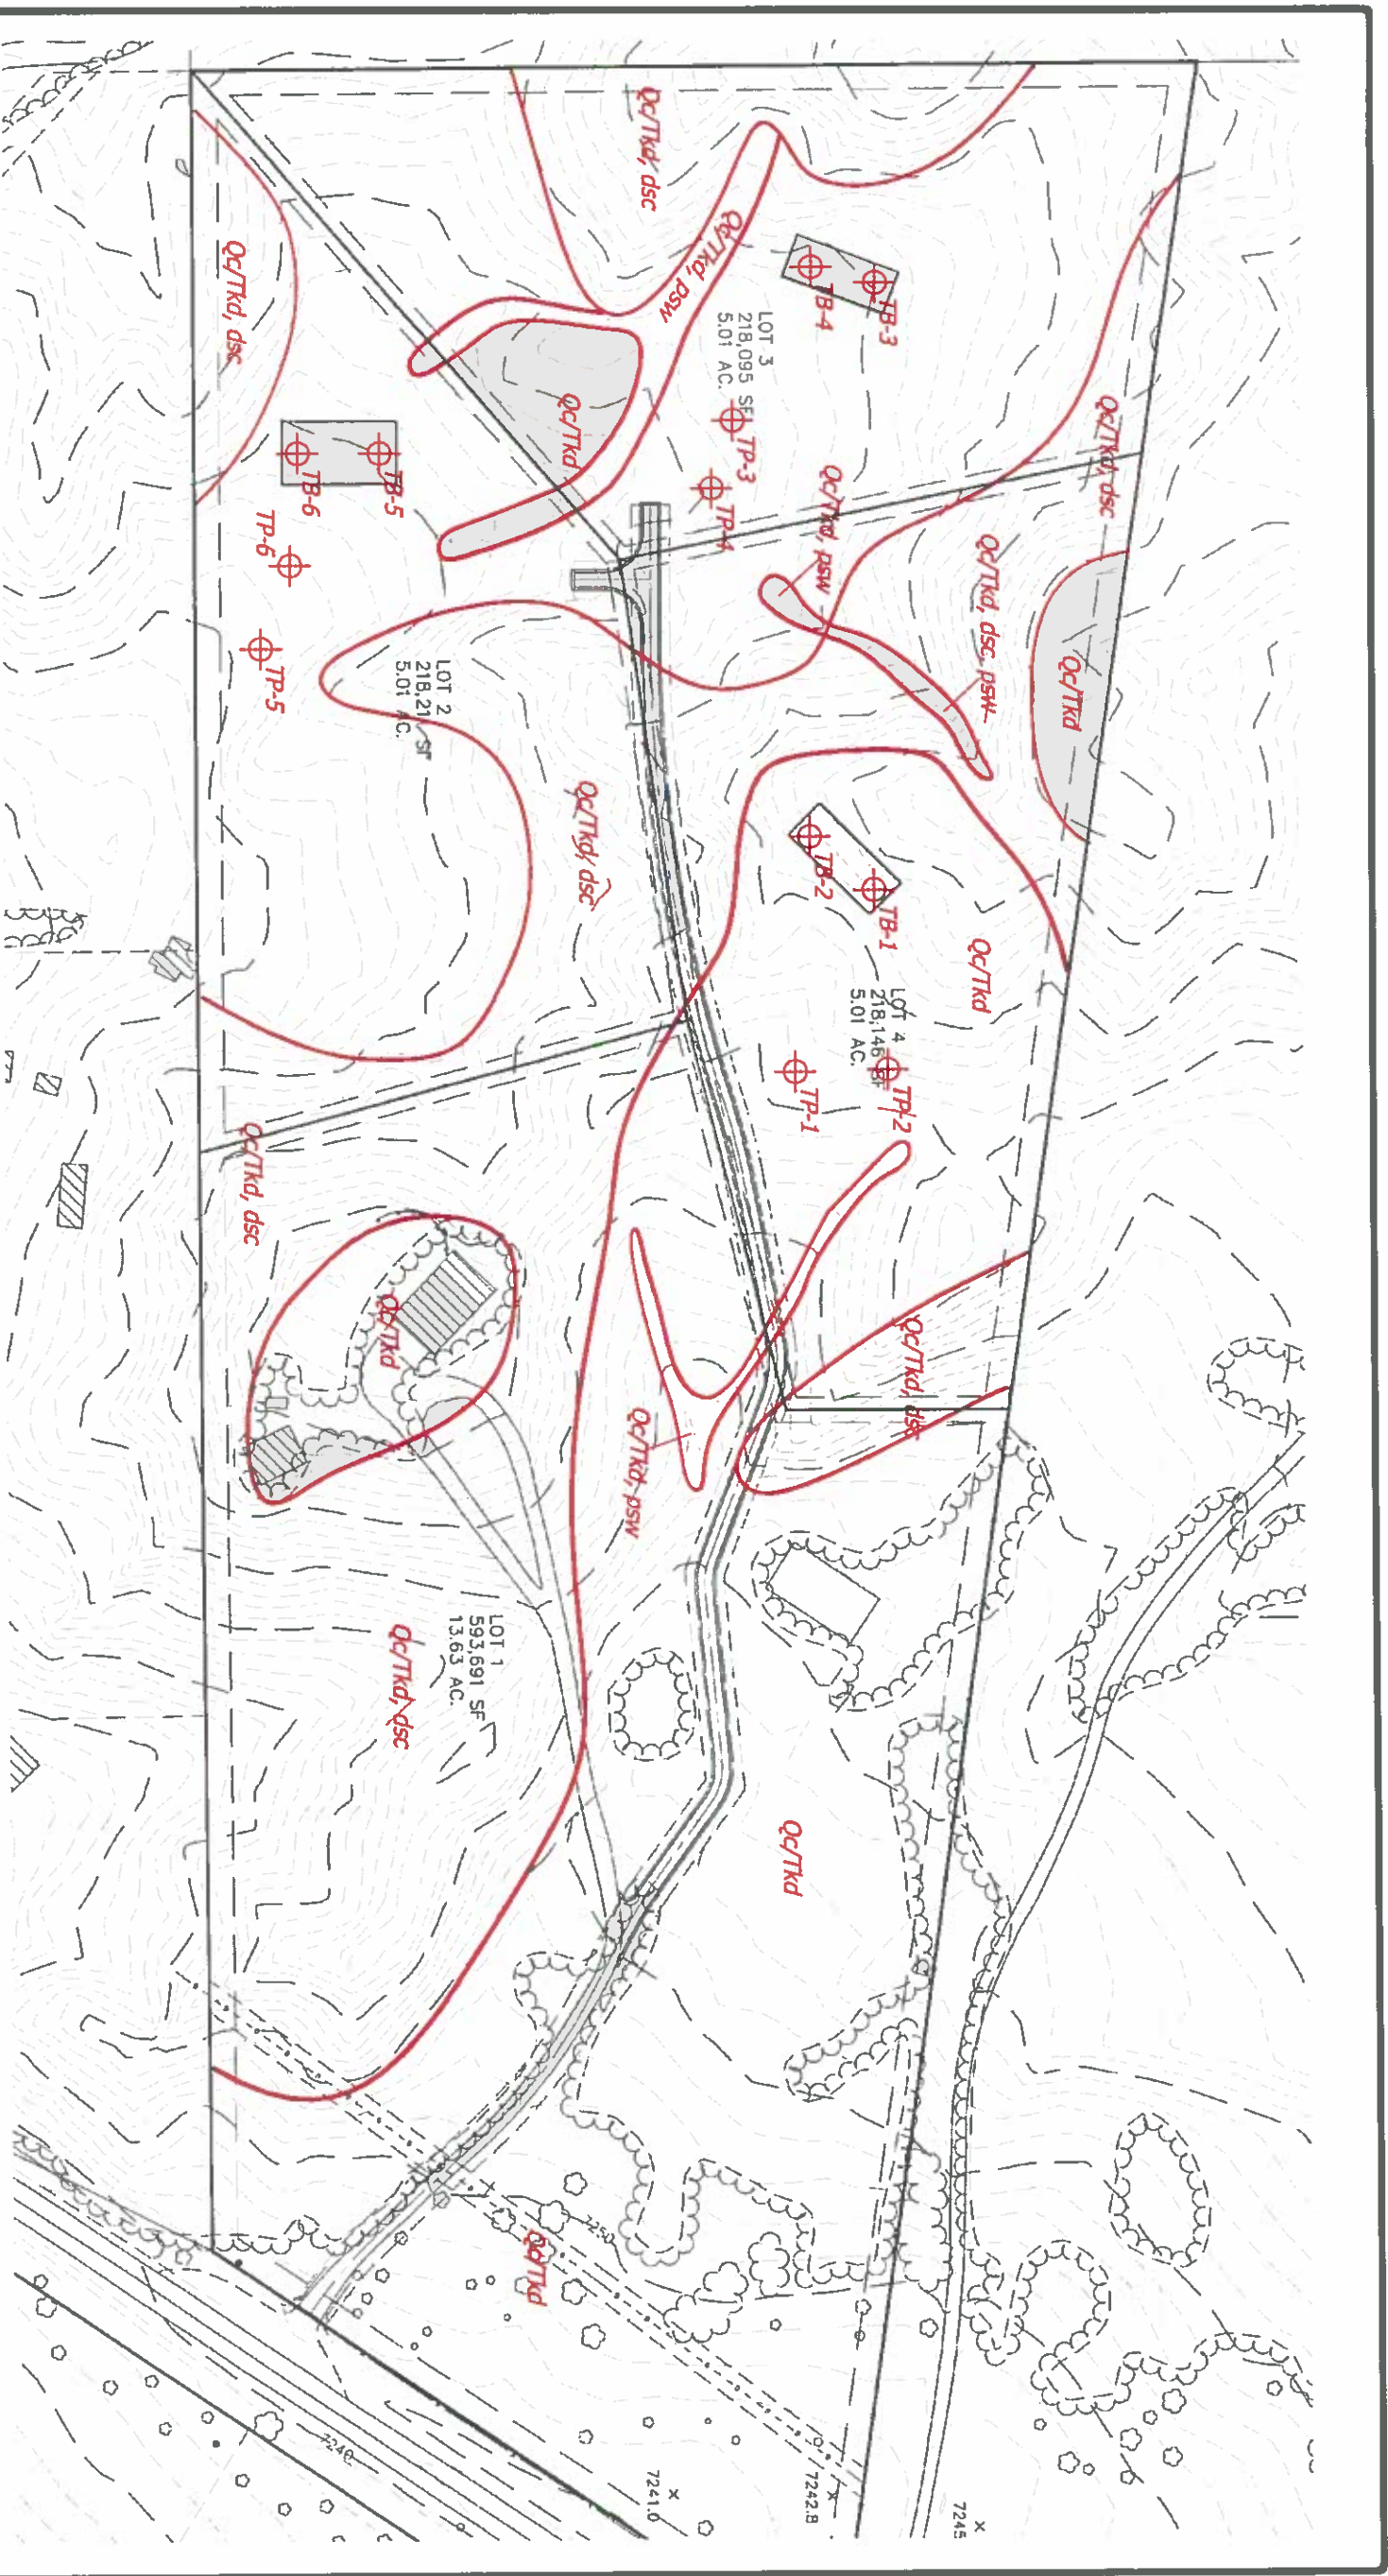
GEOLOGY/ENGINEERING GEOLOGY MAP
JOHNSON SUBDIVISION NO. 1
14502 HIGHWAY 83
EL PASO COUNTY, CO.
FOR: DELROY JOHNSON

Several minor drainage swales exist on the site. No water was observed flowing in the drainage swales at the time of the investigation, however, these areas have the potential for seasonal shallow groundwater. These areas are indicated in the Geology/Engineering Geology Map (Figure 6). Due to the size of the proposed lots these areas can either be avoided or redirected around proposed structures or proposed soil treatment areas. The proposed building areas are not affected by these areas. The site does not lie within any floodplain zones according to the FEMA Map No. 08041CO295G dated December 7, 2018 (Figure 7, Reference 7). Exact locations of floodplain and specific drainage studies are beyond the scope of this report.

The area identified with this hazard includes the steeper slopes along the ridges across the site. In these areas we would anticipate lateral and vertical movement of the near surface soils in the downslope direction. These areas will be avoided by the proposed structures; however, they are acceptable for building sites with the following constraints on construction.

Areas of downslope creep were observed across the site, and are indicated on Figure 6. The areas identified with this hazard includes the steeper slopes along the ridges across the site. In these areas we would anticipate lateral and vertical movement of the near surface soils in the downslope direction. These areas will be avoided by the proposed structures; however, structures may encroach on these areas. In areas of downslope creep, structures should be designed to be as compact and rigid as possible. Foundations may require tie-beams or additional foundation reinforcement in these areas. Foundations should be designed to step up the slopes to avoid deep cuts. Deep cuts should be avoided on all steeper sloping areas of the site. Any retaining walls should be designed for the global slope stability by a qualified professional engineer. This includes cuts made for terracing in backyards.

Mitigation: This type of movement will increase lateral pressures against foundation walls on the uphill side of structures. The design of foundations in these areas should account for this additional pressure. A lateral pressure detail is shown in Figure 8. Where possible in areas of downslope creep, structures should be designed to be as compact and rigid as possible. This will help them better tolerate the vertical and lateral movements to which the foundation system may be subjected with minimal damage. Long, rambling, irregular structures should be avoided in these areas as they are associated with a much greater potential for damaging differential movement. Due to lot size, it is anticipated that the majority of the downslope creep areas can be avoided as building sites. Reinforcement or tie beams in the foundation may be necessary where the structures encroach on the downslope creep area. Any cuts steeper than 3:1 should be retained by walls designed for the sloping conditions.

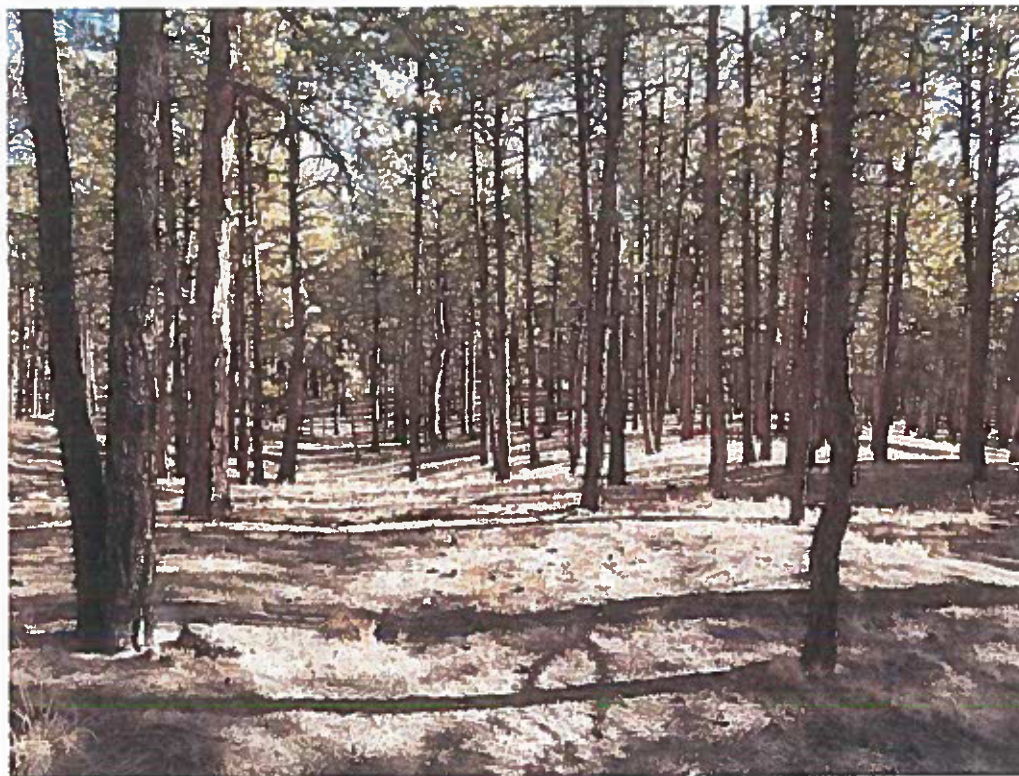
**Looking south along
head of minor drainage
in the southern portion
of the site.**
