**Kumar & Associates, Inc.**  
Geotechnical and Materials Engineers  
and Environmental Scientists

GEOLOGY AND SOILS STUDY  
MOUNTAINS EDGE DEVELOPMENT  
EL PASO COUNTY, COLORADO

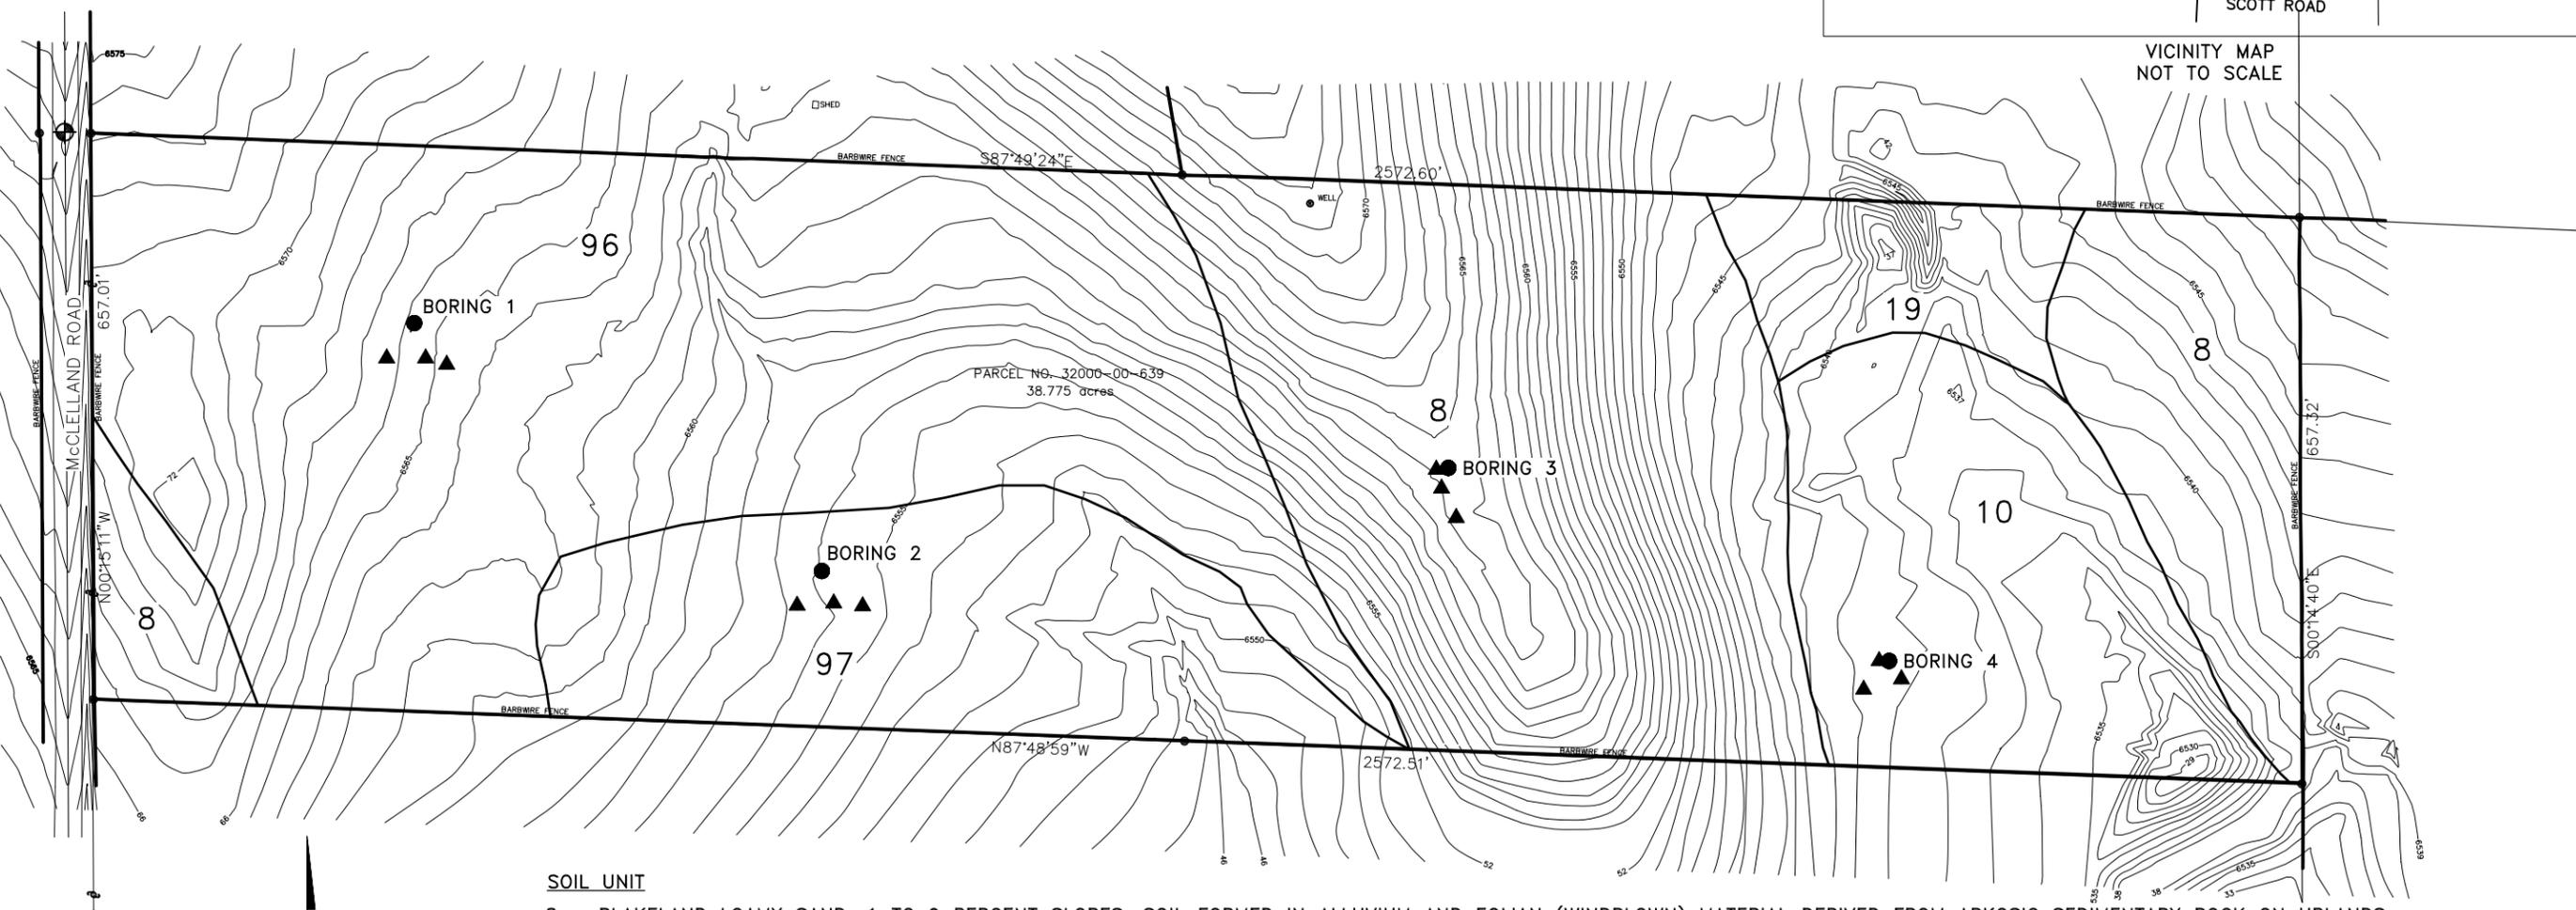
FIG. 1 - SCS SOIL MAP

Soils: The U.S. Soil Conservation Service (SCS)(1981) maps five soil units on the property as reproduced on Fig. 1. The Blakeland loamy sand formed in alluvium and eolian (windblown)

According to the SCS (1981), the hazard of erosion is moderate for the soil units mapped on the site. The SCS (1981) also notes that restrictive features affecting the building of dwellings with or without basements are slight for these soils, with the exception of the Columbine gravelly sand loam which is at risk of flooding. Restrictive features affecting the construction of absorption fields are also reported to be slight, but again, the Columbine gravelly sandy loam is reported to be at risk of flooding.

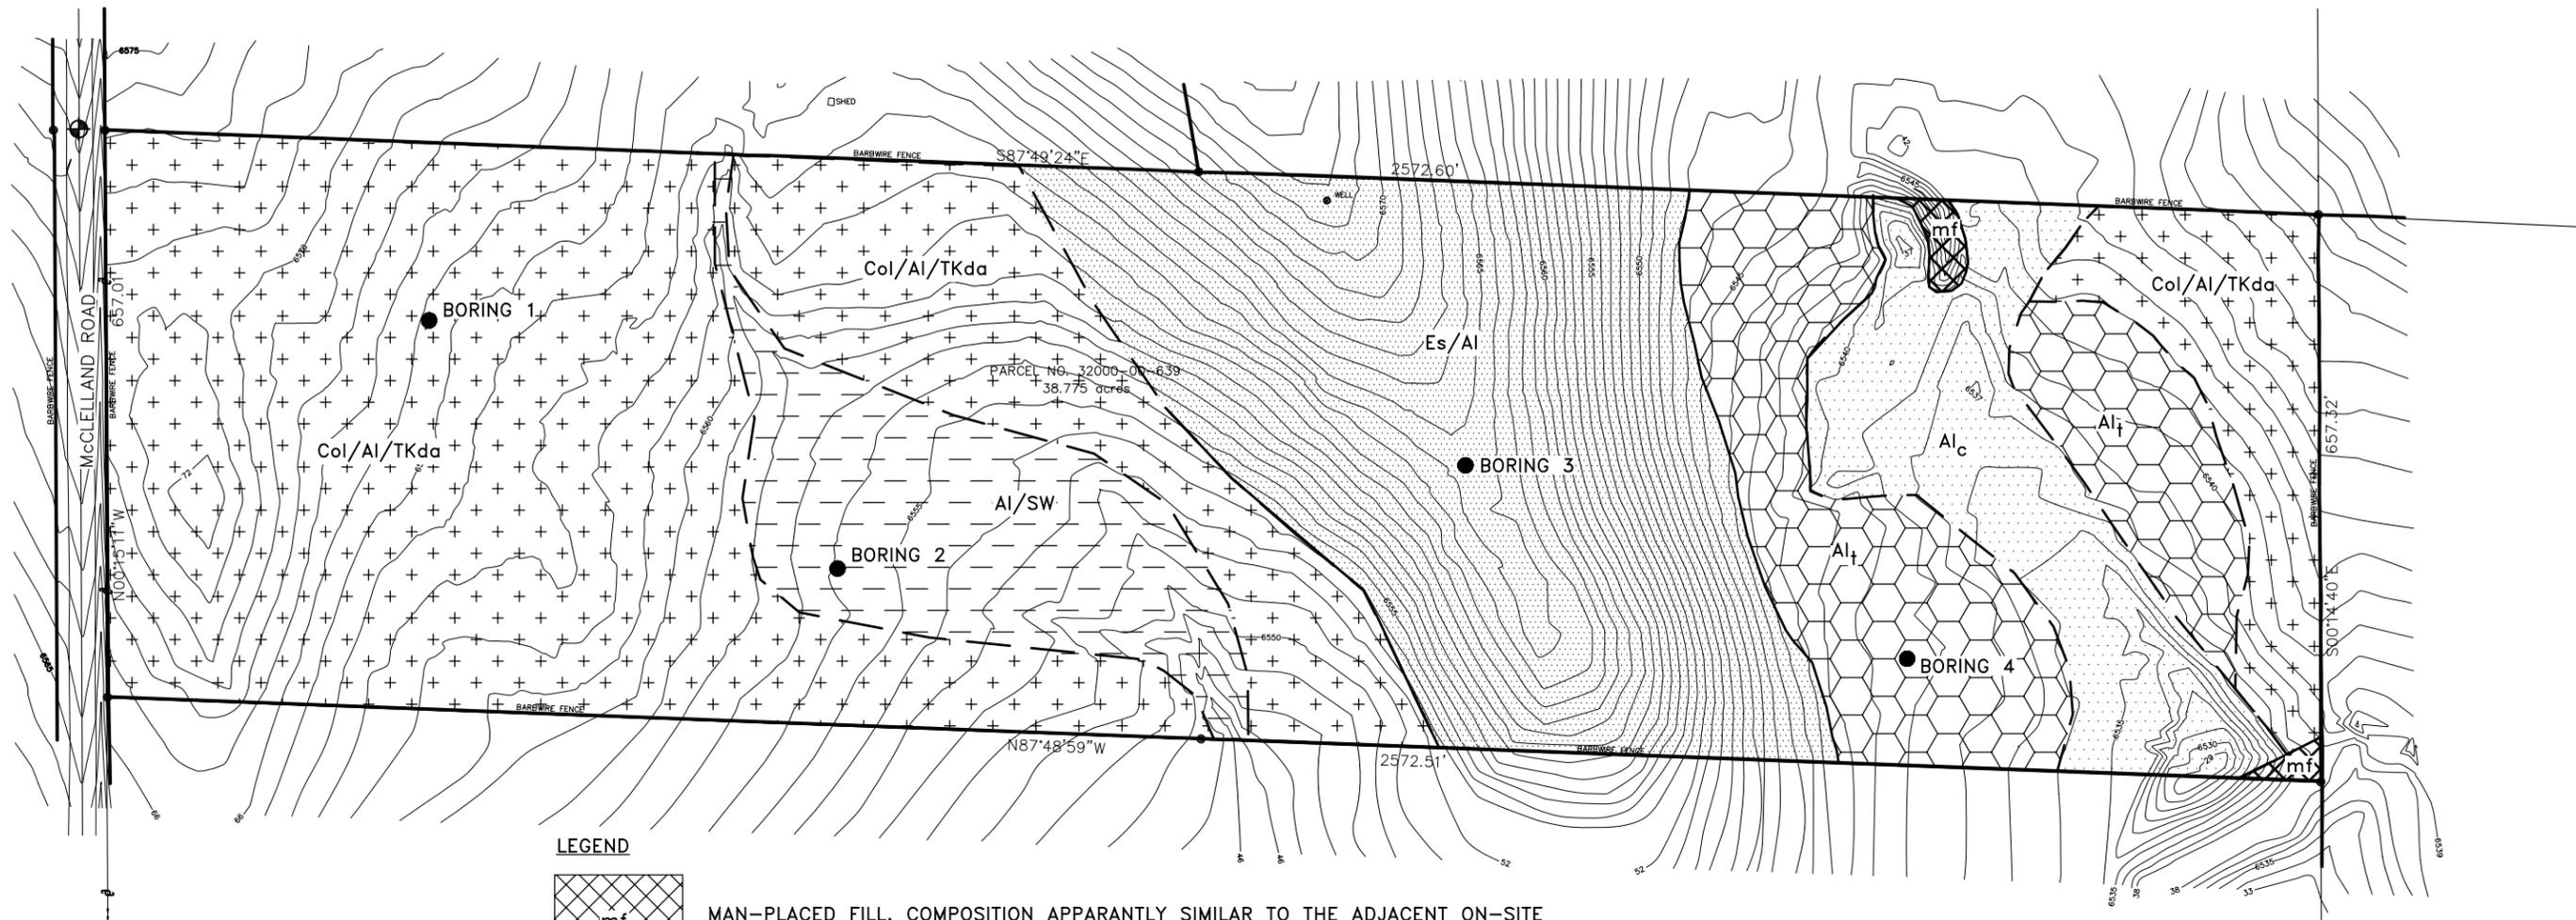
FIG. 2 - SURFICIAL GEOLOGY MAP

Geology: The attached Surficial Geology Map, Fig. 2, depicts the surficial geology at the site. The map is based on a review of published geologic maps and literature, and the results of our field reconnaissance.

Our field reconnaissance indicates man-placed fill consisting of silty sand with occasional gravel is present within a berm (north) and dam (south) constructed in the creek on the eastern side of the property. The exact vertical and lateral extent of this fill was not determined during this study.

The geologic units within the approximate western half and eastern edge of the property consist of colluvium, alluvium and occasional exposed bedrock of the Dawson Formation, map unit Col/Al/TKda. The southeast-trending ridge crossing the middle portion of the property appears to consist of eolian or alluvial terrace deposits that have been incised by the modern

drainages, map unit Es/AI. Alluvial and slopewash deposits were observed along the drainage channel on the western-central portion of the property, map unit AI/SW. Alluvium was also observed within the creek on the eastern side of the property, map unit AIc. Adjacent to the creek are alluvial terrace deposits located approximately 2 to 5 feet above the existing creek bottom, map unit AIr.

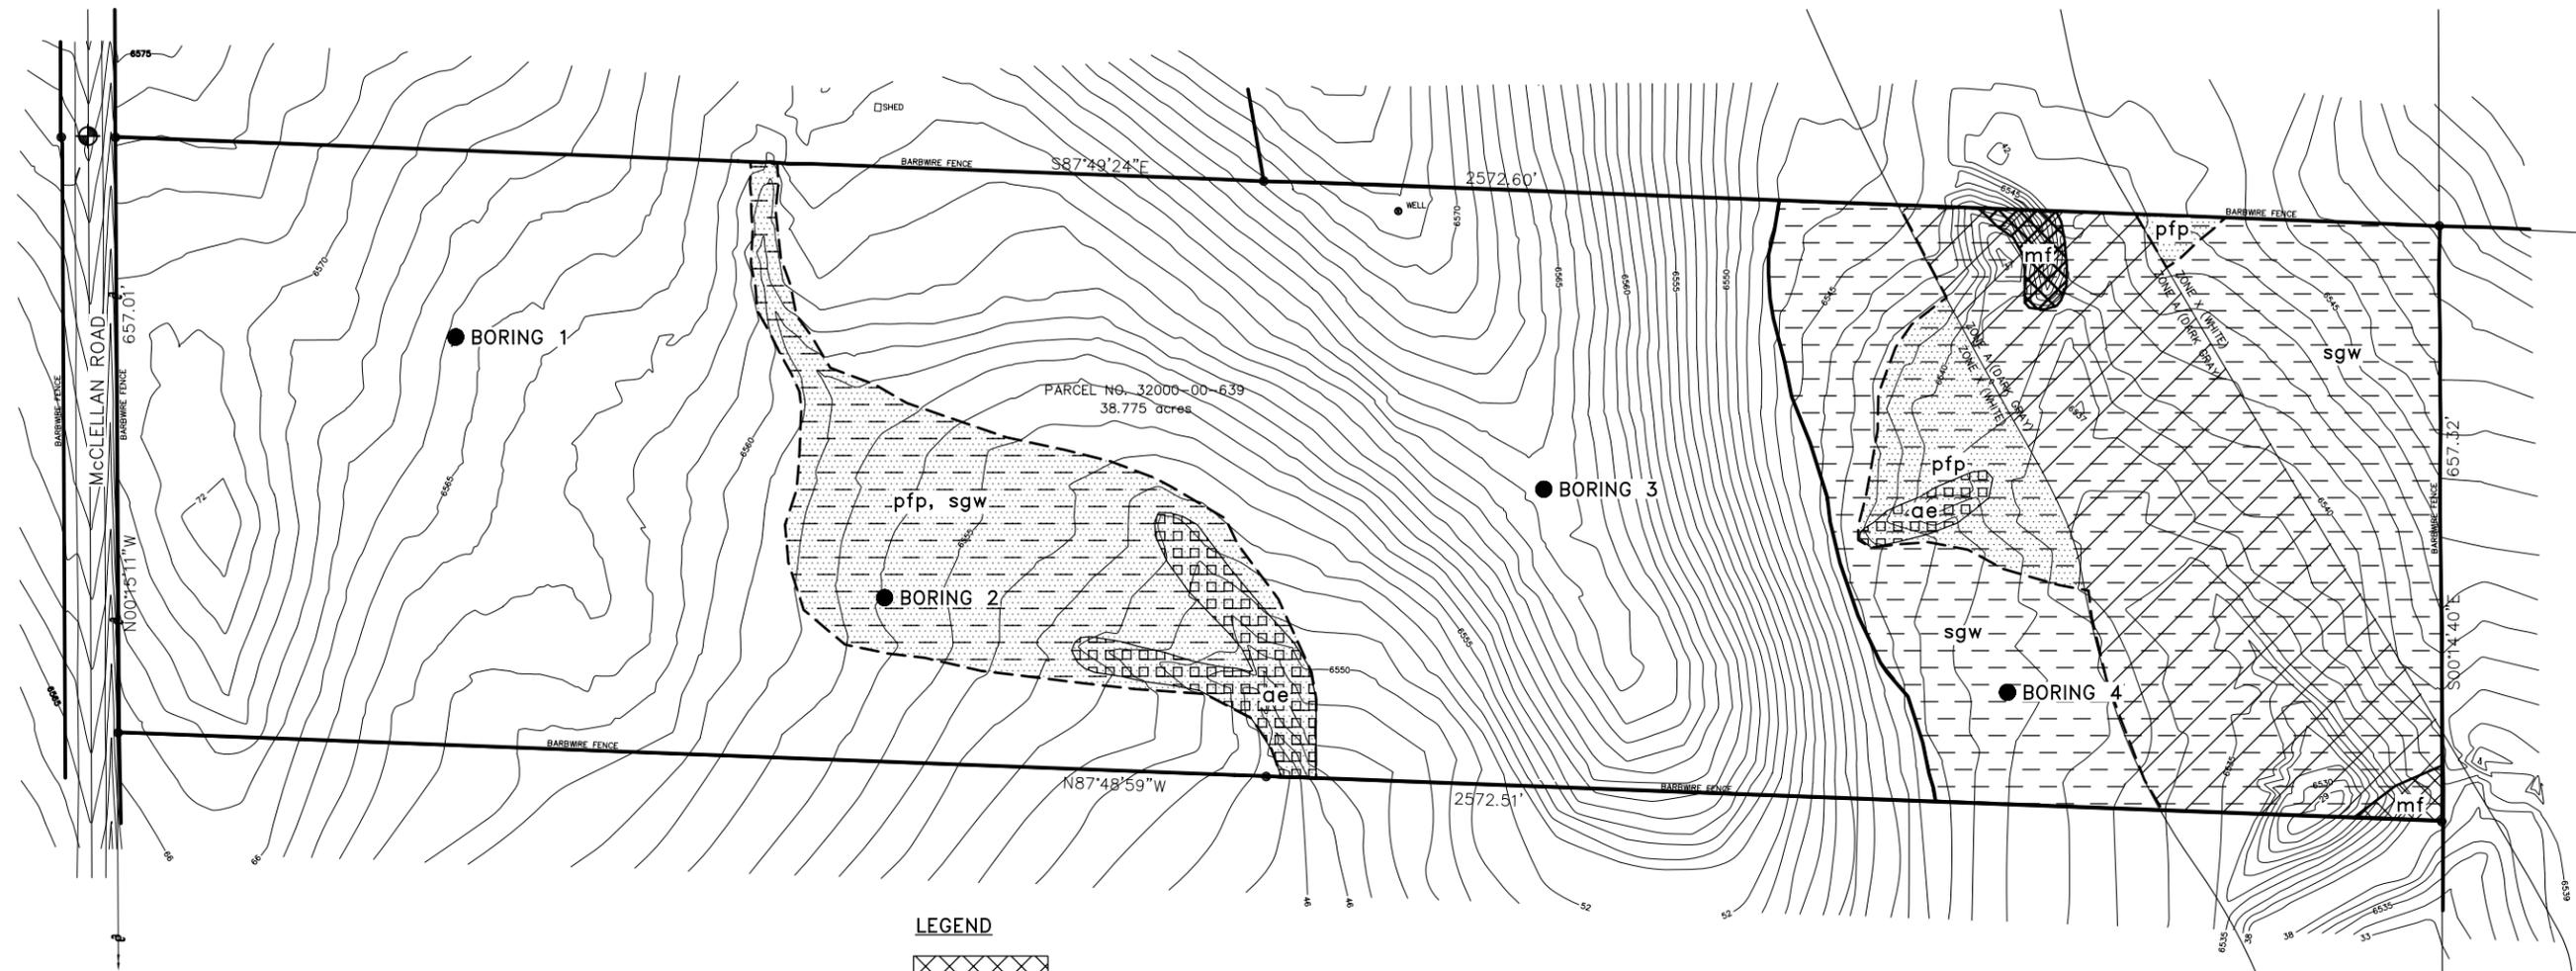
FIG. 3 - GEOLOGIC HAZARD MAP

Flooding: The Federal Emergency Management Agency (1997) "Flood Insurance Rate Map", map number 08041C0375F indicates a portion of the eastern part of the property, is within Zone A, a flood hazard area inundated by the 100-year flood. The general limits of the FEMA 100-year floodplain is shown on Fig. 3 and were provided by LDC, Inc. Based on our field observations, we believe the floodplain may extend beyond the limits suggested by FEMA. The channel morphology of the drainages suggests that in addition to the mapped FEMA floodplain, other areas on the subject site may be prone to flooding. Based on our observations we have mapped potential flood-prone areas, in addition to the FEMA floodplain, on Fig. 3.

Erosion and Sedimentation: We anticipate that erosion of the banks and channel of the creek on the eastern edge of the site may occur during flow events within the creek. Bank or channel erosion is more likely during flood events. The potential for erosion is also present within the gullies on the western half of the site, especially near the southern edge of the property. Sedimentation is a hazard in the channel of the creek and other drainages. Sedimentation within the pond area north of the dam (at the southeast corner of the property) will eventually infill this area. Periodic maintenance may be required to clean out the pond area for it to maintain its function. Areas which are at risk of erosion and sedimentation, as presented herein, are those sites within or adjacent to the areas mapped as flood-prone areas or the Fema 100-year floodplain on Fig. 3.

Potentially Shallow Ground Water: Iron-staining observed in Boring 4 suggests the ground-water elevation in that area has been higher in this area in the past. Based on this, seasonally shallow ground water may be present in the low-lying eastern portion of the property. We anticipate that potentially shallow ground water may also develop within the area mapped as flood prone on the western portion of the site. Areas anticipated to potentially develop shallow ground water are mapped on Fig. 3.

AREAS OF ACCELERATED EROSION AND ADVANCING GULLY HEADS.

Flooding: It appears that the FEMA floodplain map is too general and may not adequately depict the 100-year floodplain on the subject site. A hydrologic study of the property should be performed by a qualified hydrologist or civil engineer to determine the limits of the 100-year floodplain and other flood-prone areas. At this time, we recommend the mapped FEMA 100-year floodplain and the low-lying areas mapped as potentially flood prone be considered no-build areas. It may be feasible to develop building sites within the area mapped as potentially flood prone on the western portion of the property or on the alluvial terraces adjacent to the ephemeral creek if they are determined to be outside the floodplain, or if they can be raised by grading to mitigate the hazards related to flooding and be protected from erosion.

Erosion and Sedimentation: Mitigation measures to protect the development from erosion include armoring the banks of the creek. Another alternative is to allow a buffer between the existing banks and the proposed development. We recommend a buffer or set back of at least 100 feet from the creek be observed, if bank protection is not provided. If erosion of the buffer encroaches on the proposed development, maintenance of the banks or armoring may be required.

Because sedimentation will be limited to within the creek channels and flood prone areas, we recommend that development not occur within these areas. The FEMA floodplain and the other flood-prone areas are presented on Fig. 3

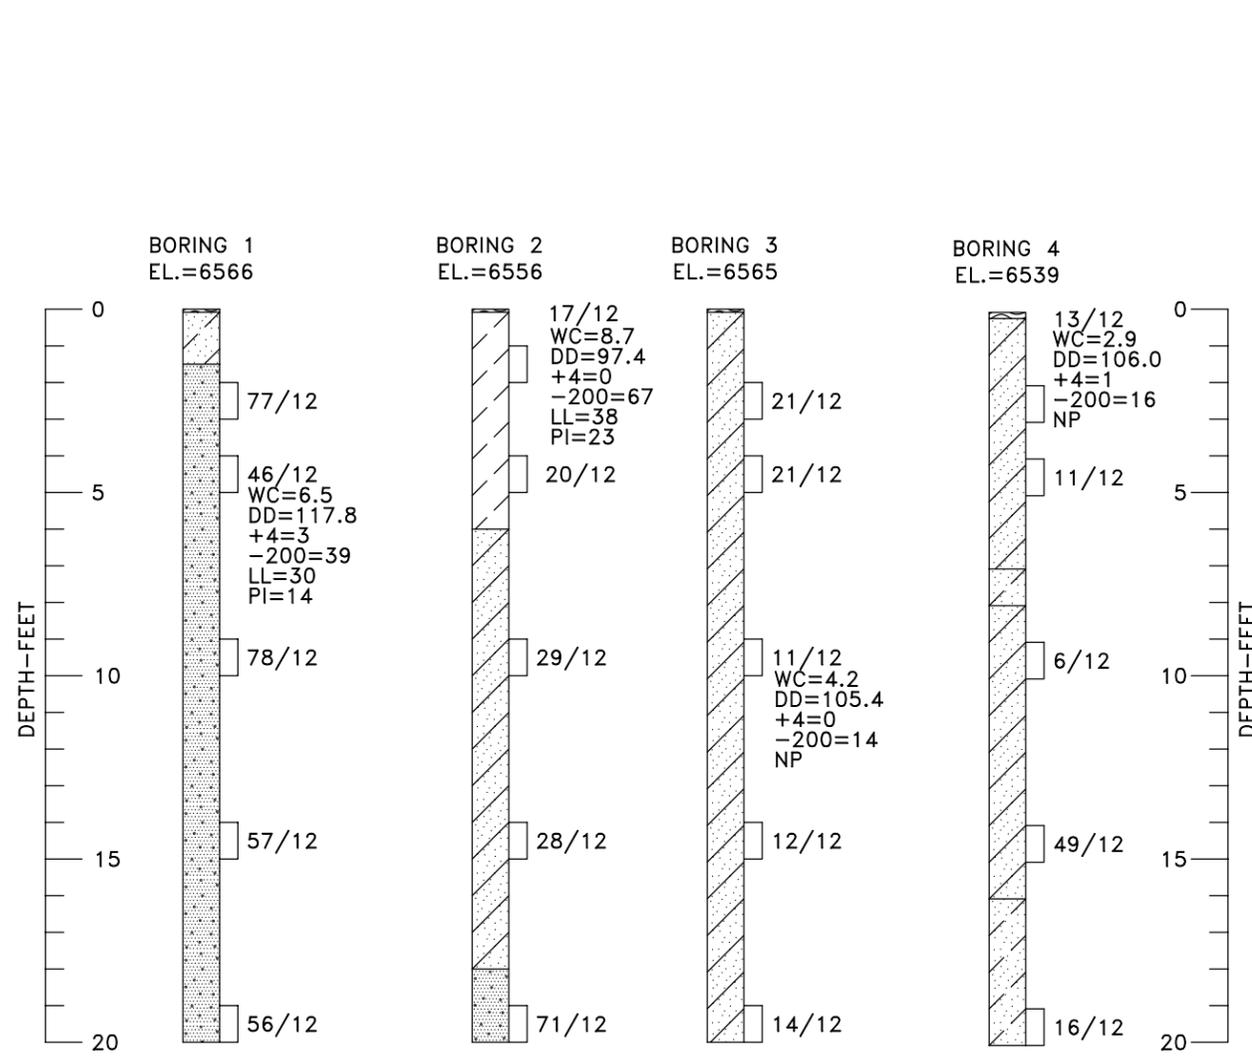
FIG. 4 - LOGS OF EXPLORATORY BORINGS

Beneath a thin layer of topsoil, sandy lean clay was encountered to a depth of approximately 6 feet in Boring 2. Sampler penetration blow counts within the sandy lean clay suggest the clay is very stiff in consistency. A swell-consolidation test performed on a sample of the sandy lean clay indicates the clay consolidated slightly when wetted under a constant 1-ksf load.

Beneath the topsoil in Borings 1, 3 and 4, and the clay soils in Boring 2, the overburden soils generally consisted of silty sand, clayey sand and poorly- to well-graded sand with silt to depths ranging from approximately 1.5 feet in Boring 1 to the maximum depth explored of 20 feet in Borings 3 and 4. Sampler penetration blow counts indicate the silty sand and poorly- to well-graded sand with silt is loose to dense and the clayey sand is very stiff.

Noncemented clayey sandstone bedrock was encountered beneath the overburden soils in Borings 1 and 2 at depths of approximately 1.5 and 18 feet, respectively. The sandstone bedrock extended to the maximum 20-foot depth explored in Boring 1 and 2. Sampler penetration blow counts indicate the sandstone is medium hard to hard.

Ground water was not encountered in the borings at the time of drilling or when checked three days later. Iron staining observed at a depth of approximately 9 feet in Boring 4 suggests ground-water levels have been higher in this area in the past. Fluctuations in the water level may occur with time.
