**Kumar & Associates, Inc.**<sup>®</sup>  
Geotechnical and Materials Engineers  
and Environmental Scientists

GEOLOGIC HAZARDS STUDY  
PROPOSED PIKE SOLAR FARM  
EAST OF BIRDSALL ROAD  
SOUTHEAST OF FOUNTAIN, COLORADO

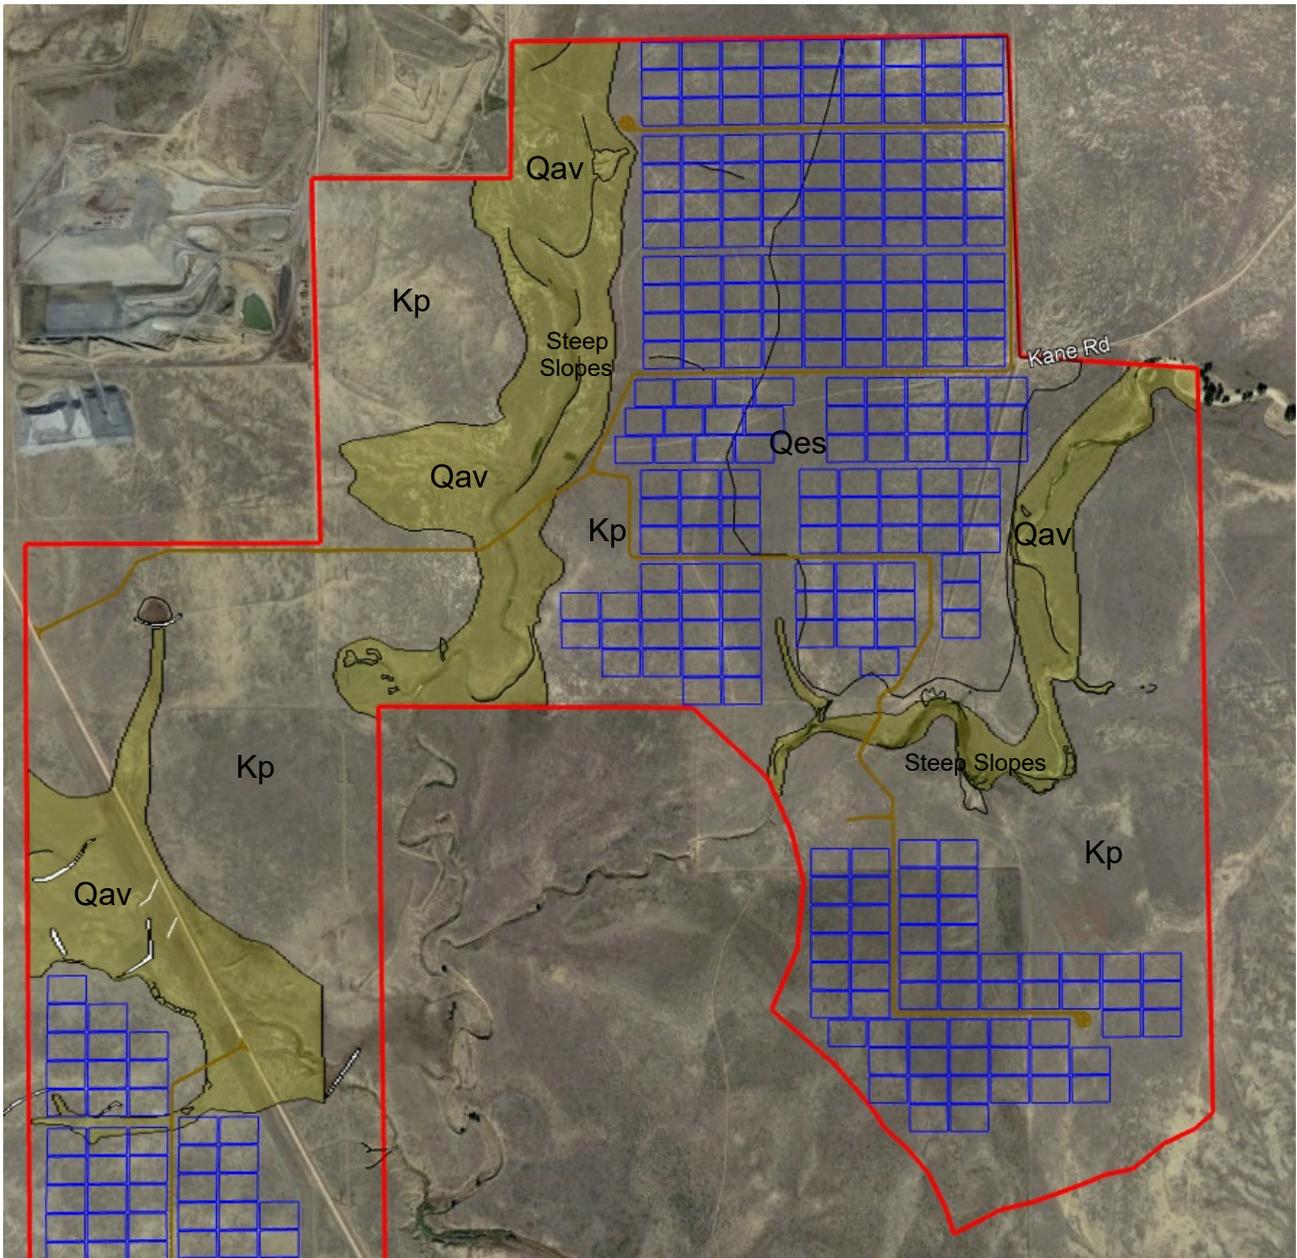
Erosion is a prominent geologic process occurring on the subject site. Erosional Features are shown on Figure 2B through 2D, indicated as black lines and polygons. Erosional scour and headward erosion were observed across much of the subject site and were very common in the vicinity of drainages and the ephemeral waterways. Many of the erosional features are associated with slopes greater than 30 percent. Slopes varied on a location-to-location basis, however, many slopes on erosional surfaces were found to be near vertical. The progression of these erosional features is anticipated to continue if not mitigated by site grading, landscaping or other means. If site development concentrates surface water flow over these features, accelerated erosion should be expected and the project civil engineer should evaluate possible methods to mitigate the potential for erosion.

Erosional features should be protected from further accelerated erosion. It may be feasible for accelerated erosion to be mitigated by re-grading the slopes to 3:1 (horizontal to vertical) or flatter, and revegetating or otherwise protecting the new slopes from erosion. These areas may cause concentrated surface flow over erosional features and through the subject site. If this is the case, concentrated surface flows should be collected or diverted away from development areas. Kumar and Associates, Inc. understands that proposed site grading will mitigate the majority of the observed erosional features within the vicinity of development. Recommendations from the Site Grading and Surface Drainage section below should be followed to reduce impacts resulting from concentrated surface flow over erosional features.

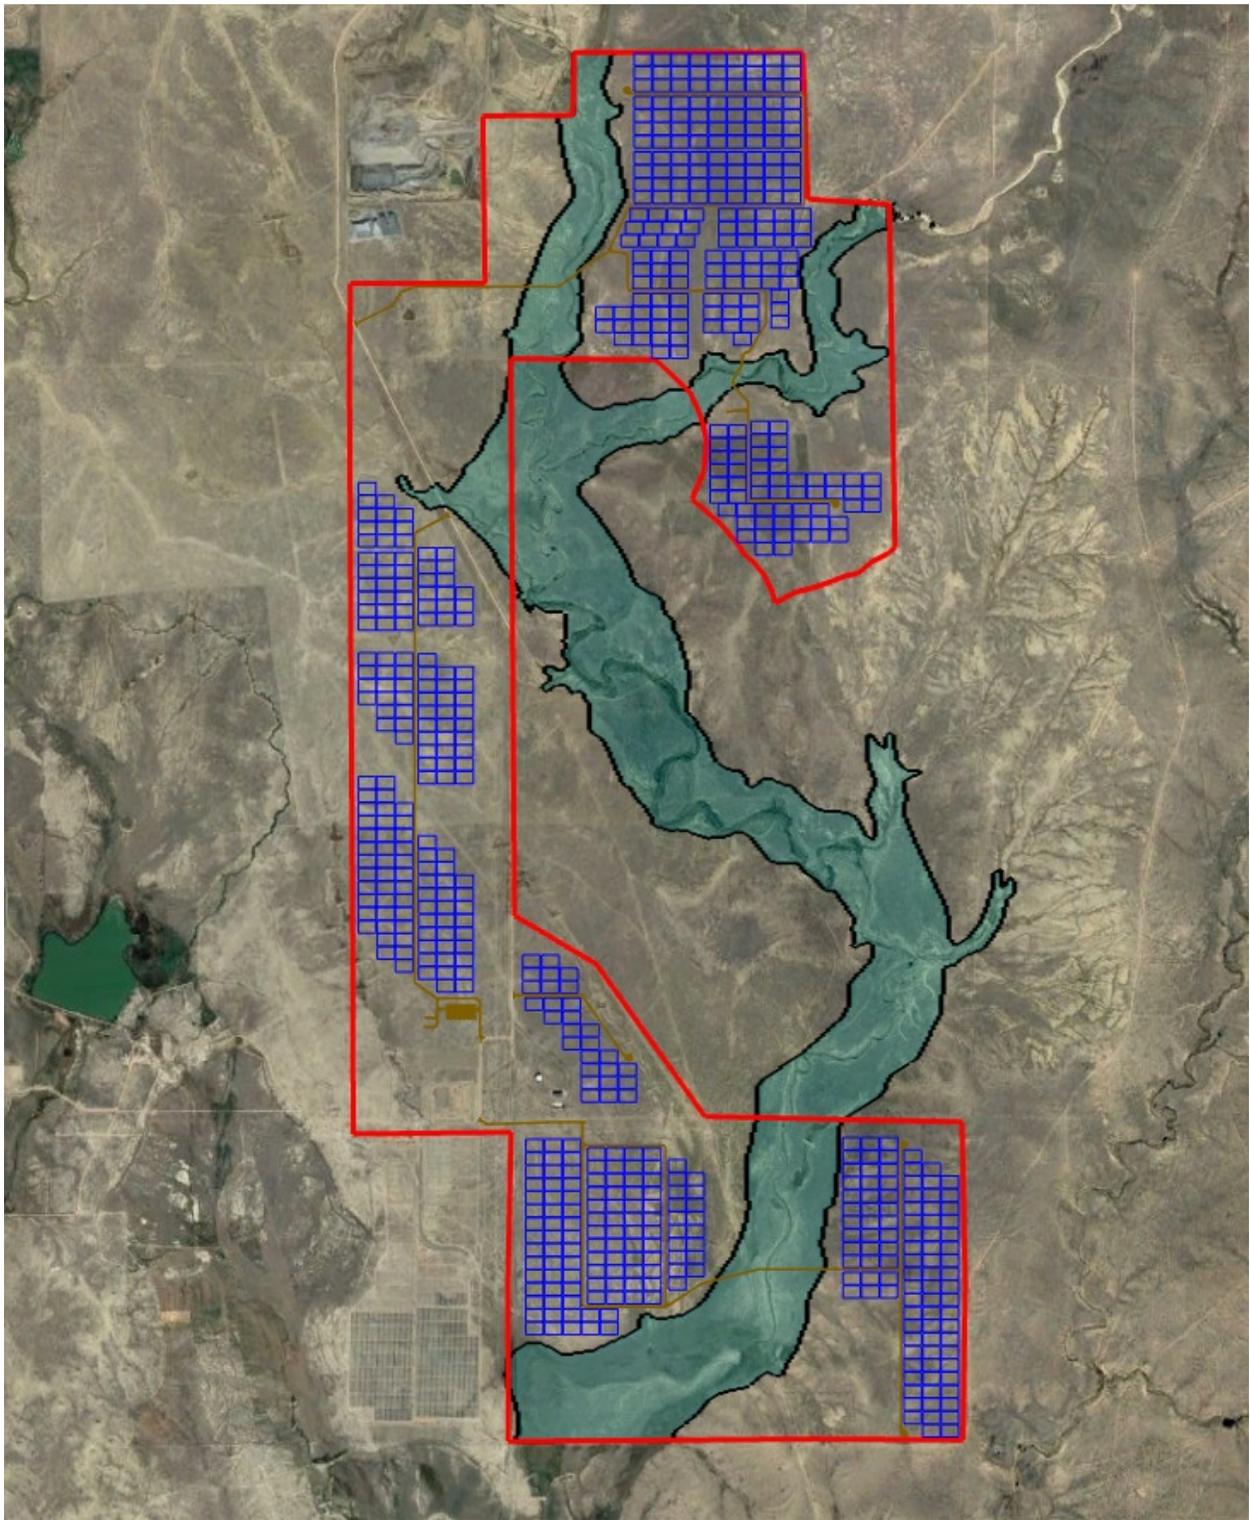
According to the "Flood Insurance Rate Map" (FIRM), map numbers 08041C0967G, 08041C0970G, 08041C1000G, 08041C1160G, and 08041C1180G produced by the Federal Emergency Management Agency (FEMA, 2018), the subject site is located in both unshaded regions of Zone X and shaded regions of Zone A. Unshaded regions of Zone X have been identified as areas of minimal flood hazard. Shaded regions of Zone A are designated as a Special Flood Hazard Area. These shaded regions of Zone A represent areas that are subject to inundation by the 1% annual chance flood, also known as the 100-year flood. The majority of the site is located within unshaded regions of Zone X, however, Special Flood Hazard Areas associated with Williams Creek and a handful of unnamed tributaries traverse the site in several locations, generally flowing from north to south. These Special Flood Hazard Areas are indicated on Figure 4. Floodplain migration can occur over time as a result of man-induced change, erosional processes or other natural factors. See the Potential Flooding and Site Grading and Surface Drainage sections in Development Considerations below for further discussion. No flood modeling was performed as a part of this study.

SPECIAL FLOOD HAZARD AREAS: Subject to inundation by the 1% annual chance flood (100-year flood).

Special flood hazard areas have been identified on the subject site. These flood hazard areas also have the potential to migrate from their current location. As such, we recommend that a floodplain buffer be considered in the development design. In areas with less elevation change between proposed development and the floodplain, a buffer of 50 feet would reduce the risk from potential flooding, while a buffer of 25' in areas of increased elevation separation between development and the floodplain should be sufficient. We recommend that site grading and surface drainage features are incorporated into the site design to reduce the potential for flooding. Design features such as rip-rap or other erosional armor may decrease the risk of floodplain migration as well. See the Site Grading and Surface Drainage section below for further discussion. No flood modelling was performed as a part of this study.
