**SOIL, GEOLOGY AND GEOLOGIC HAZARD STUDY  
7020 WYOMING LANE  
TAX SCHEDULE NO. 53080-00-105  
EL PASO COUNTY, COLORADO**

**Phoenix Holdings**  
4900 O'Hear Avenue, Suite 100  
North Charleston, SC 29405

June 25, 2021

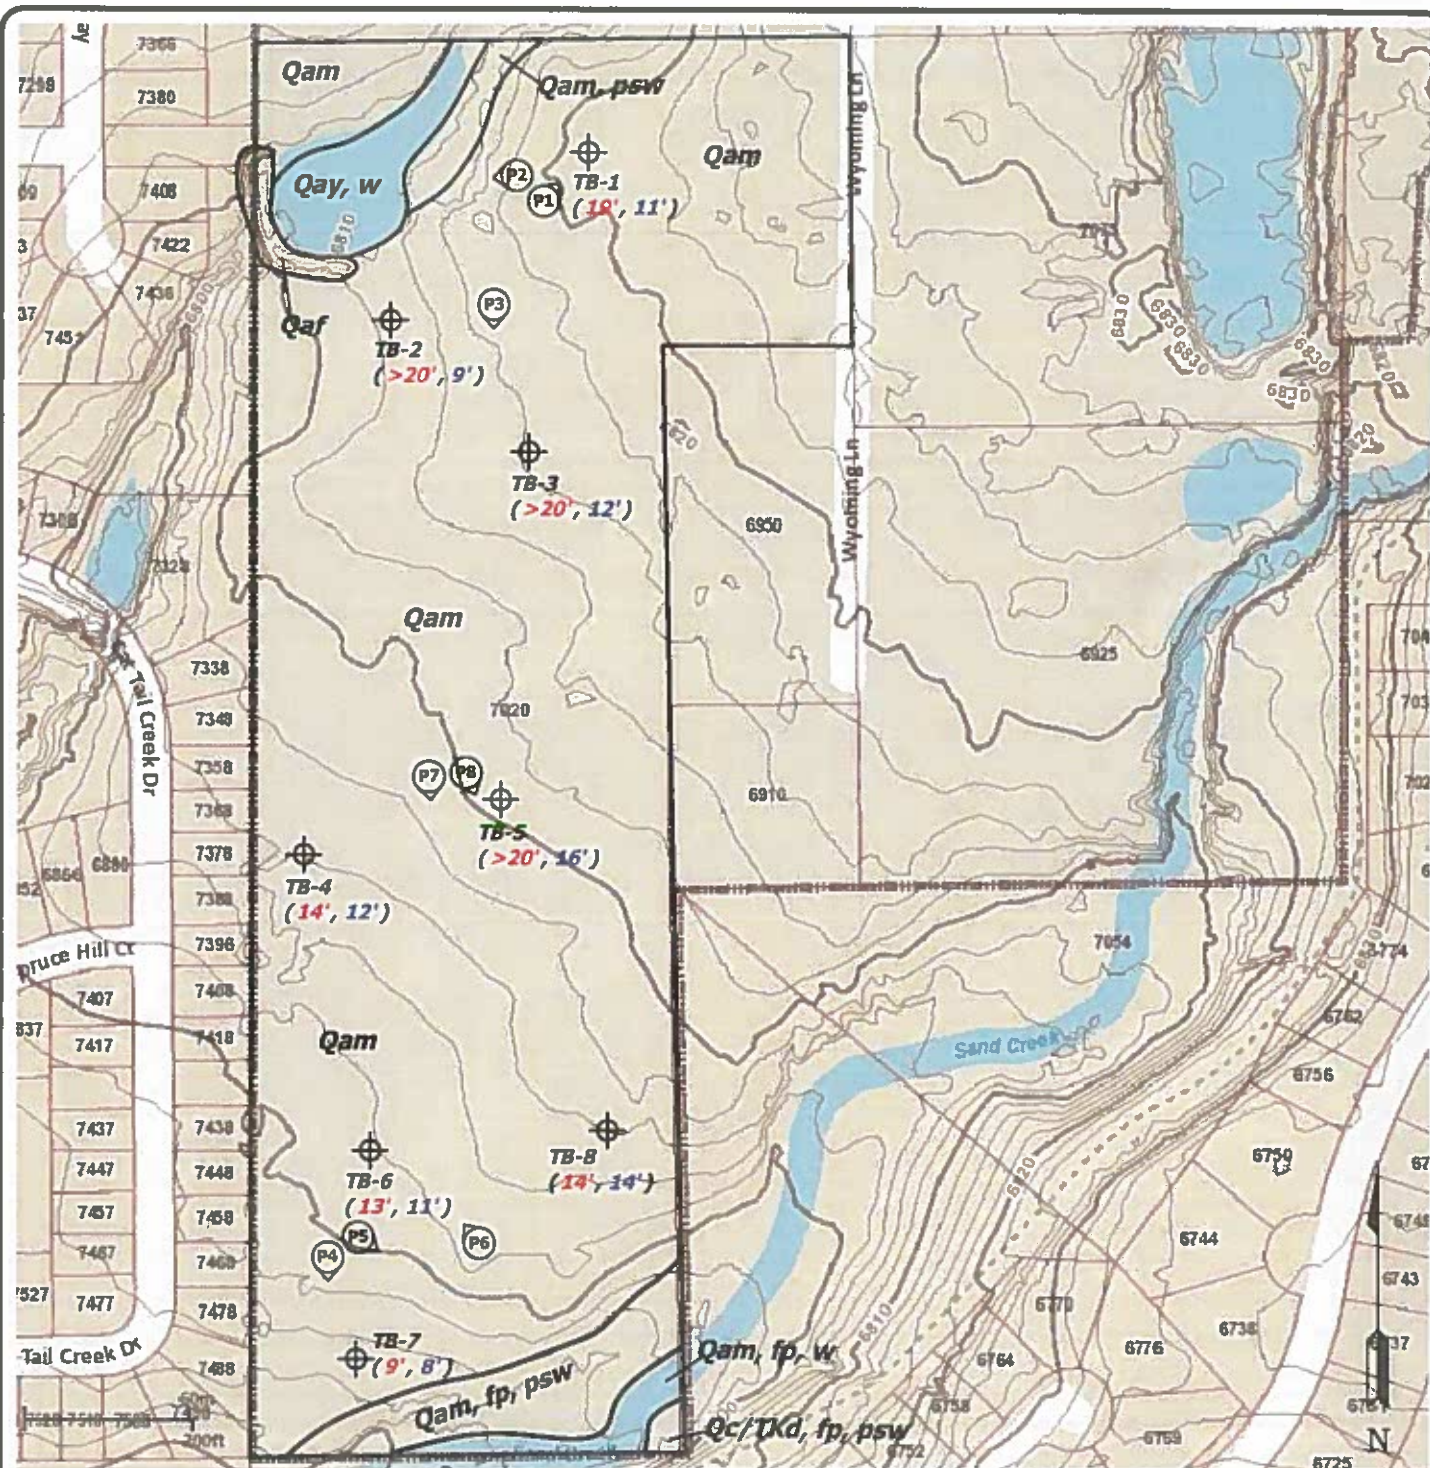
FIG NO.:  
6

As mentioned previously, detailed mapping has been performed on this site to produce an Engineering Geology Map (Figure 6). This map shows the location of various geologic conditions of which the developers and planners should be cognizant during the planning, design and construction stages of the project. The hazards identified on this site include artificial fill, loose soils, potentially seasonal shallow groundwater areas, and areas of flowing and ponded water. The following hazards have been addressed as a part of this investigation:

Areas of artificial fill were observed on the site. The majority of the fill is associated with earthen dams and erosion berms. The earthen dams lie within areas designated as open space or easements and will be avoided by construction. The majority of the erosion berms are shallow and may be penetrated by foundations or will likely be removed during site grading. Should any uncontrolled fill be encountered beneath foundations, removal and recompaction at 95 percent of its maximum Modified Proctor Dry Density, ASTM D-1557 will be required.

Groundwater was encountered in five of the test borings at depths ranging from 8 to 16 feet. Areas within the drainages on-site have been identified as seasonal and potentially seasonal shallow groundwater. Only minor areas with water flowing in the drainages were noted at the time of this investigation, however, an area of ponded water was observed in the northwestern portion of the site. Sand Creek in the southern portion of the has been mapped within floodplain zones according to the FEMA Map No. 08041CO535G, Figure 7 (Reference 9). Exact floodplain location and drainage studies are beyond the scope of this report. Groundwater areas are discussed as follows:

These are areas where there is standing water observed in drainages or ponded water behind earthen dams. The majority of these areas lie within the drainages designated as open space and will be avoided by construction. Where construction is proposed, the following mitigation is recommended:

Mitigation: The pond is located behind an earthen dam in the northwestern portion of the site and can be avoided by the proposed development. All soft and organic soils should be removed prior to fill placement. Any drainage into these areas should be rerouted in a non-erosive manner where it does not create areas of ponded water around proposed structures. The same mitigation techniques for the seasonal shallow groundwater areas are recommended for these areas as well.

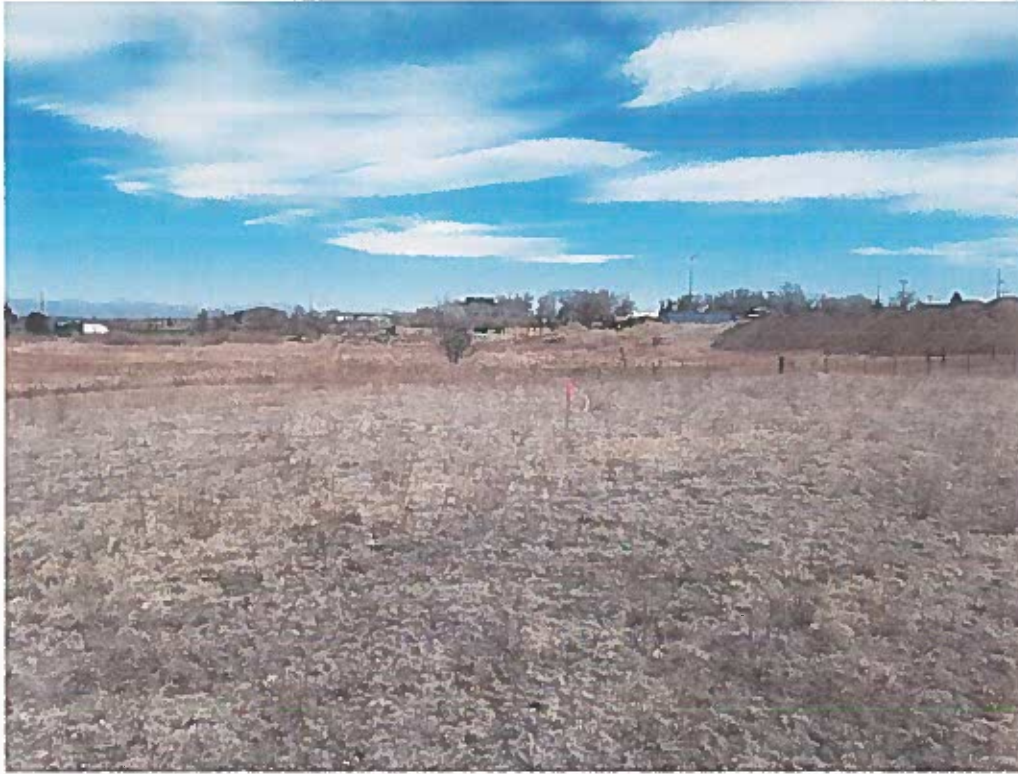
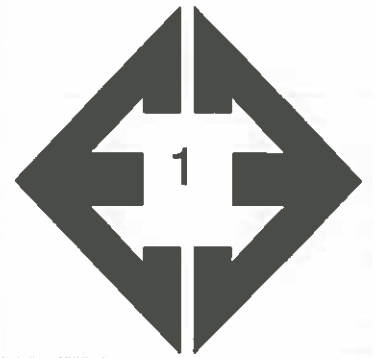
**Looking northeast  
from northern portion  
of the site.**

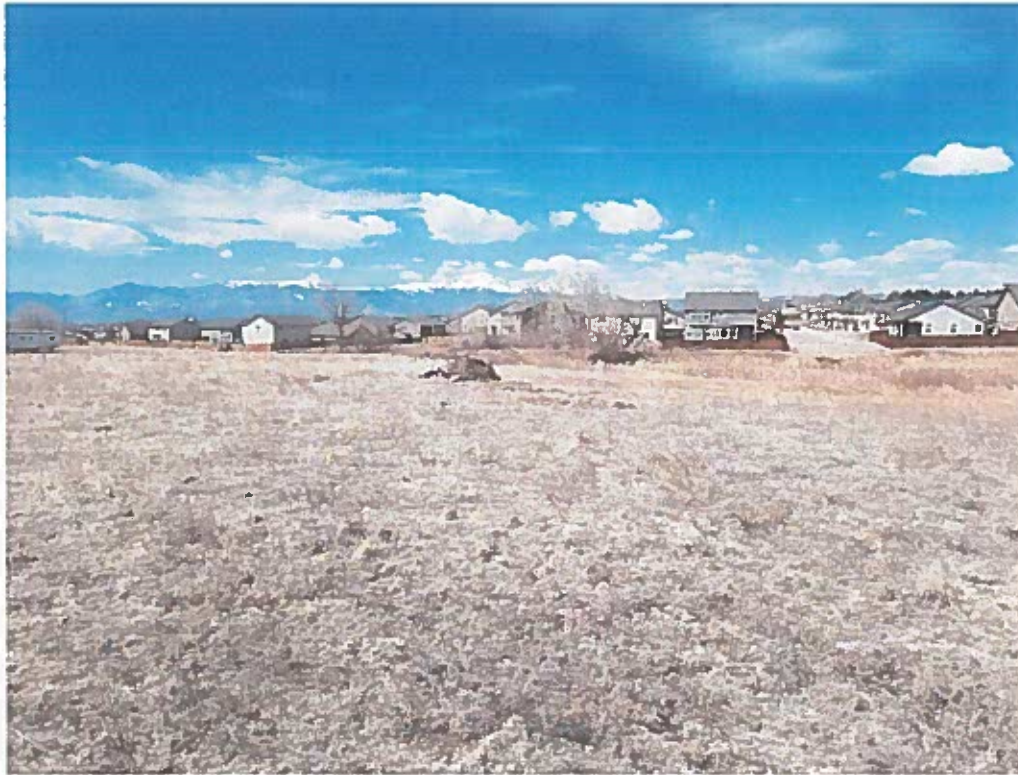
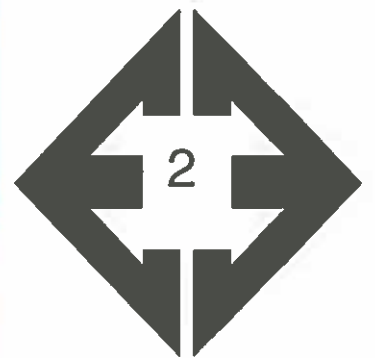
**Looking west from the  
northern portion of the  
site.**

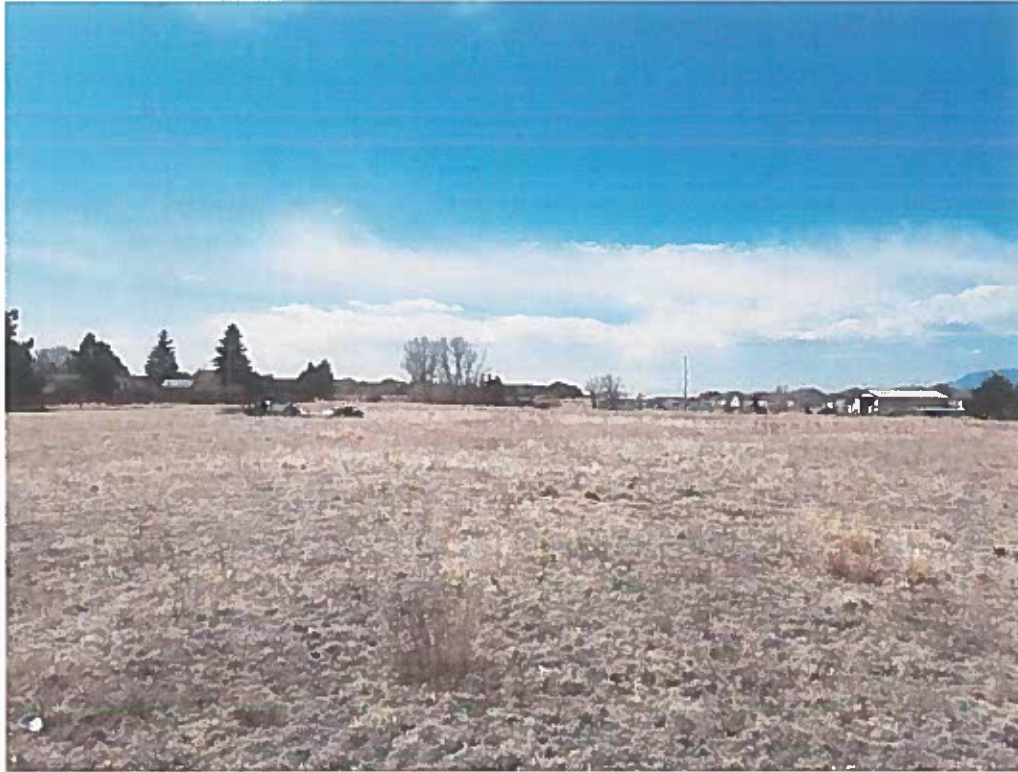
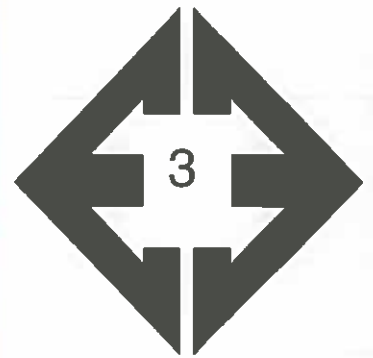
**Looking south from  
northern portion of the  
site.**

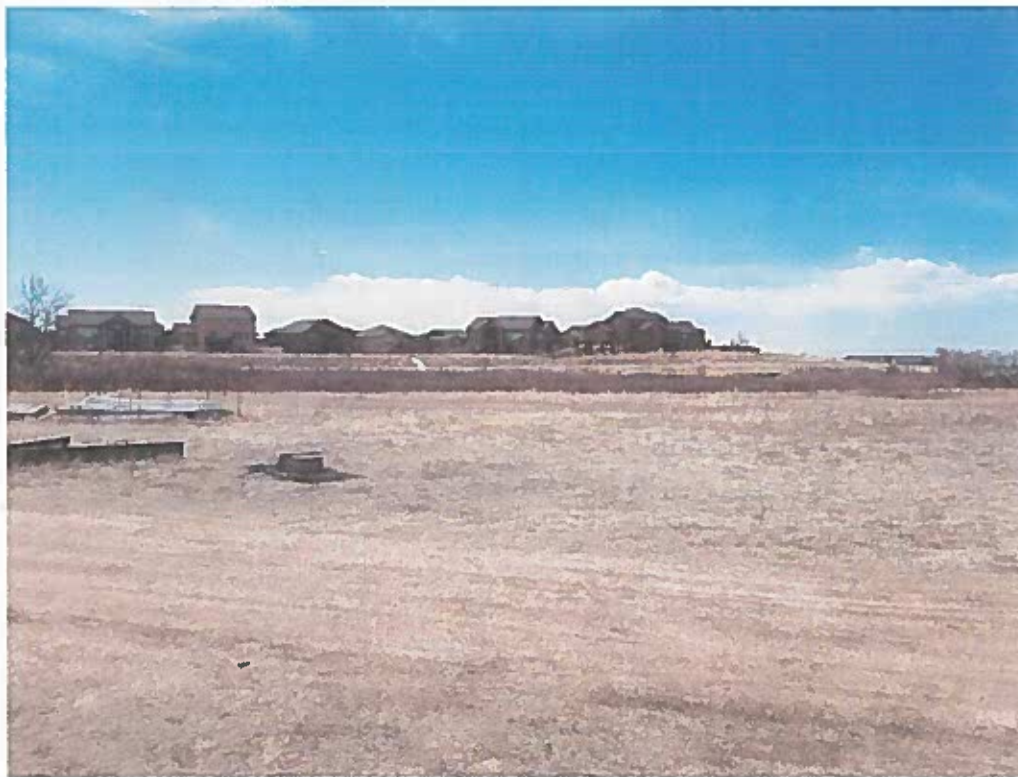
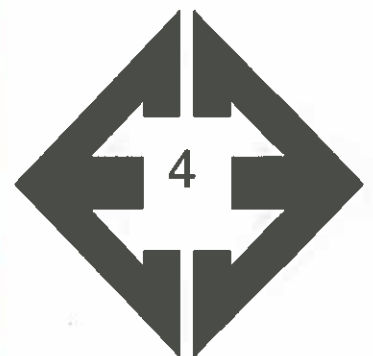
**Looking south from  
the southwestern  
portion of the site.**

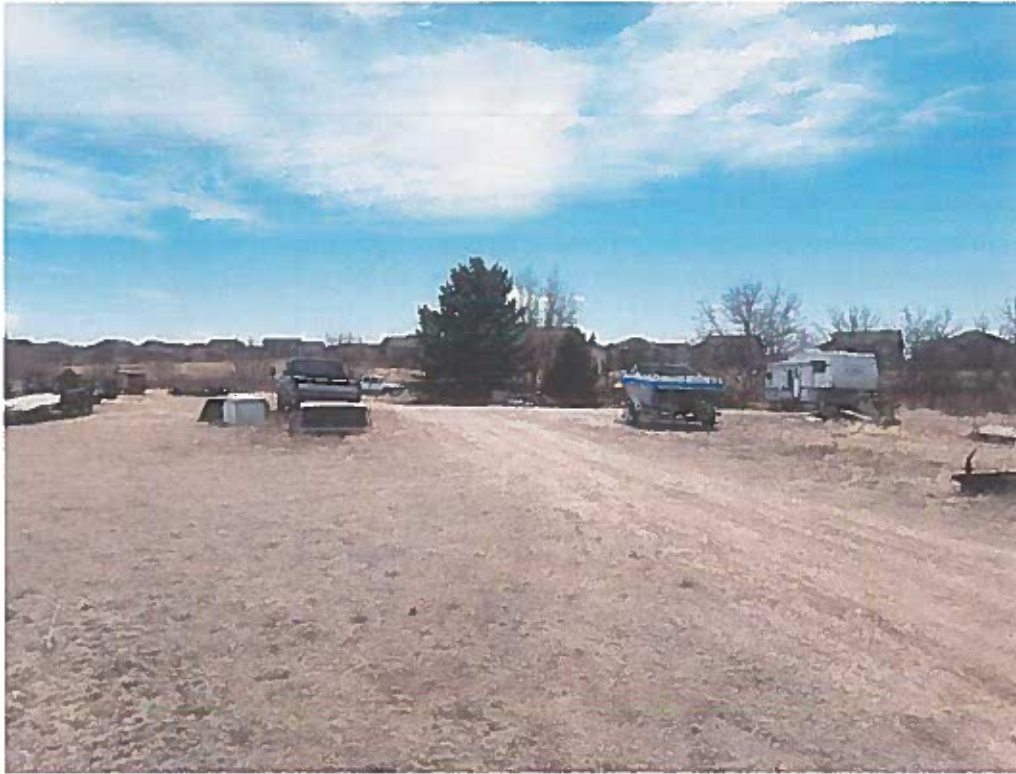
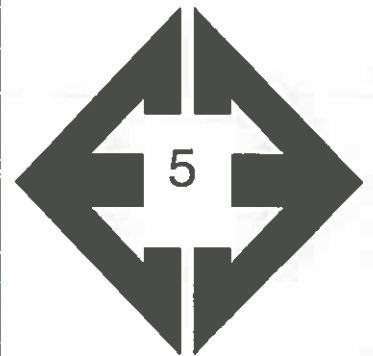
**Looking southeast  
from the southwestern  
portion of the site.**

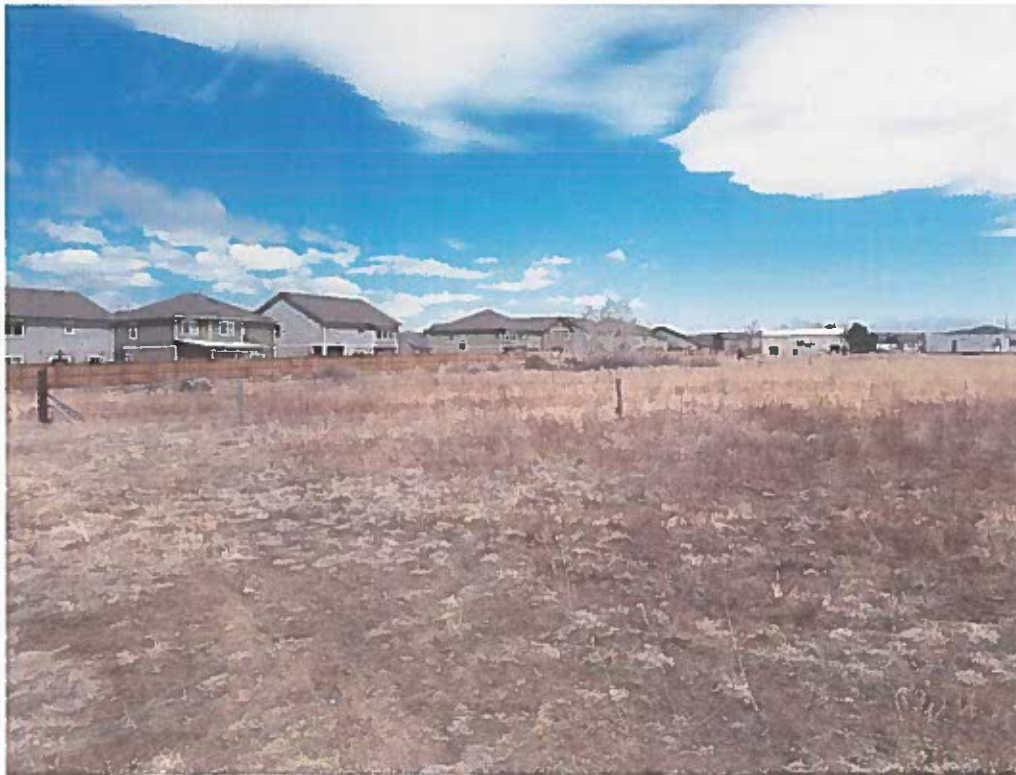
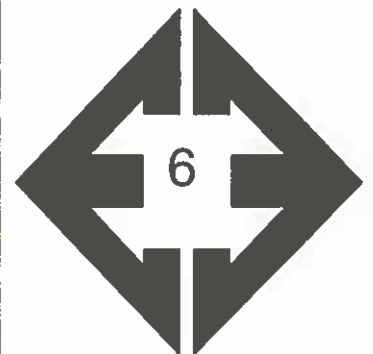
**Looking northwest  
from the southern  
portion of the site.**

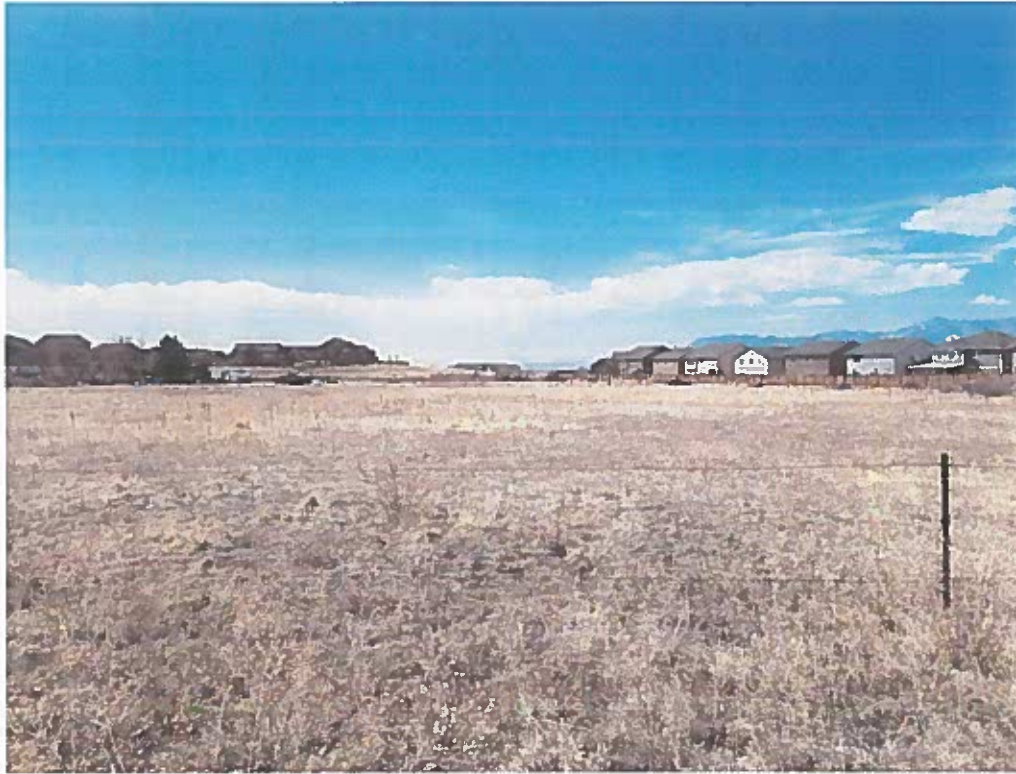
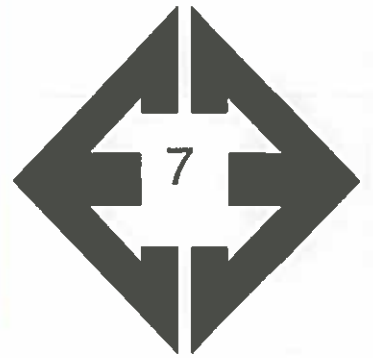
**Looking south from  
the central portion of  
the site.**

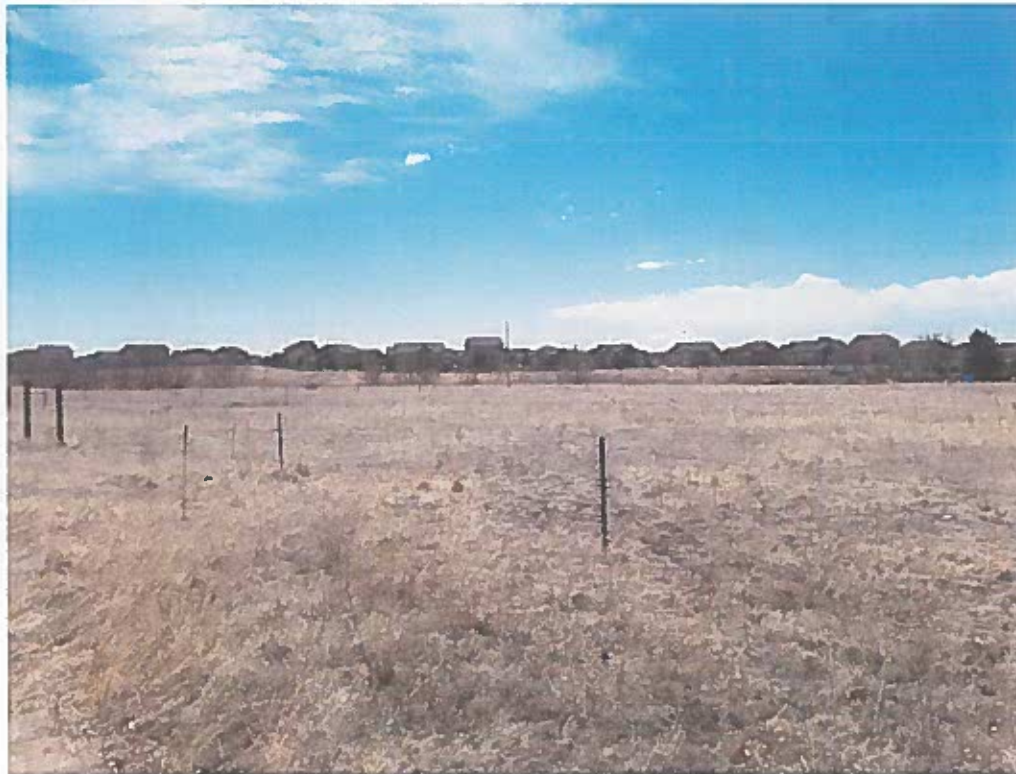
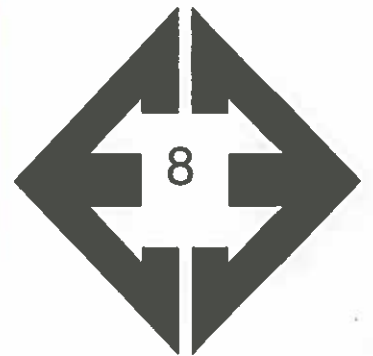
**Looking southeast  
from the central  
portion of the site.**
