EL PASO COUNTY CONSTRUCTION STORMWATER SITE INSPECTION REPORT

Facility Name: Sterling Ranch Filing No.2	Permittee: SR Land LLC
Date of Inspection: 07/27/2022	Weather Conditions: Partly Cloudy
Permit Number: ESQ2137	Disturbed Acreage: 211.16 acres
Phase of Construction: Active	Site Qualified Stormwater Manager: Chaz Collins
Inspector Name: Molly Galloway	Site Contact Info: 719-492-3880

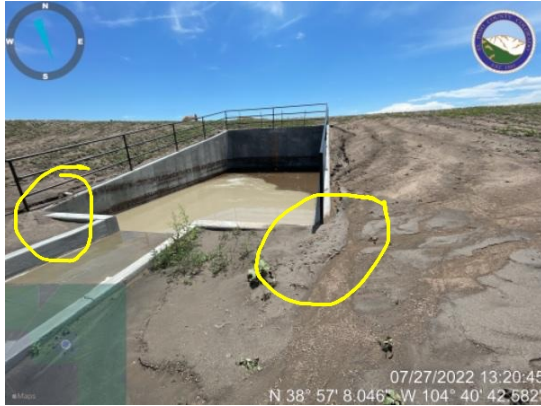
Implement control measures to prevent sediment from entering water quality pond 5 at outlet structure.

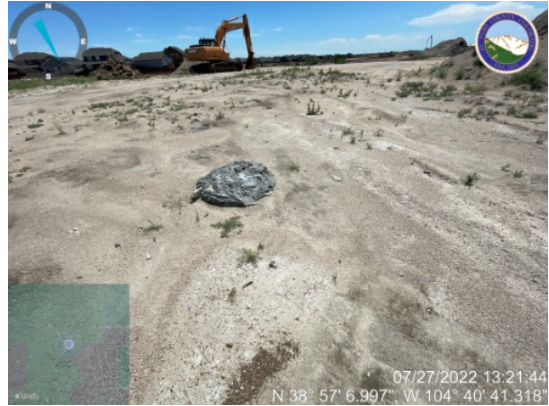
Properly dispose of cured concrete and implement CWO near pond 5.

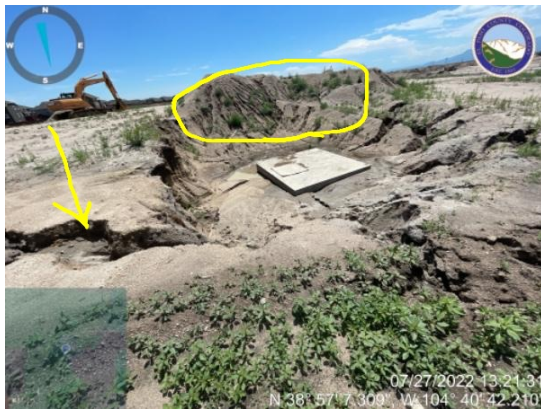
Address gully formation and unprotected stockpile at Box up gradient of WQ pond 5.

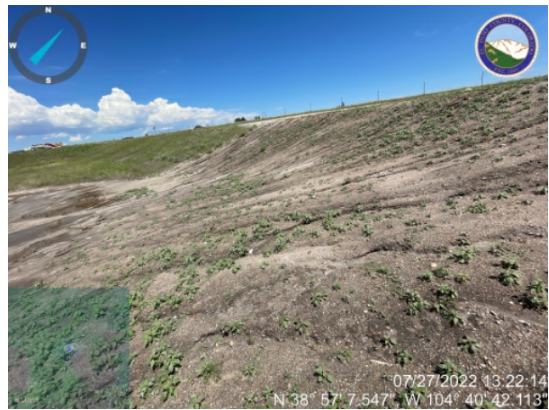
Extend ECB stabilization matting to encourage vegetative establishment along embankment at WQ pond 5.

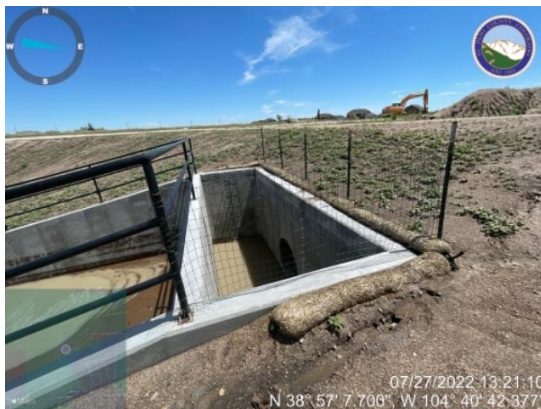
Ensure straw wattle control measure is staked down as per detail at WQ pond 5.

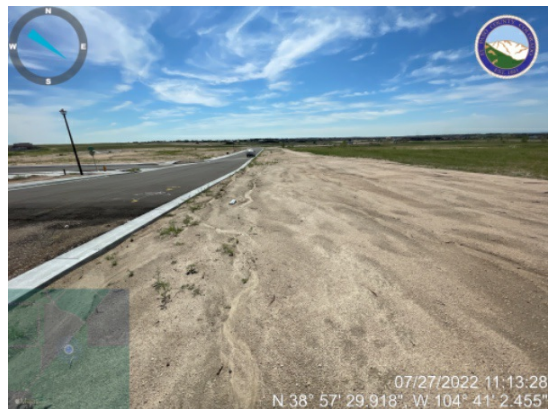
Implement control measure along Alzada Drive as per plan.

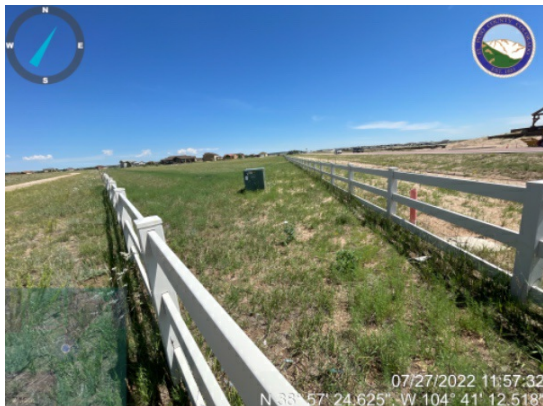
Install WQ pond 4 and associated structures as per approved plans.

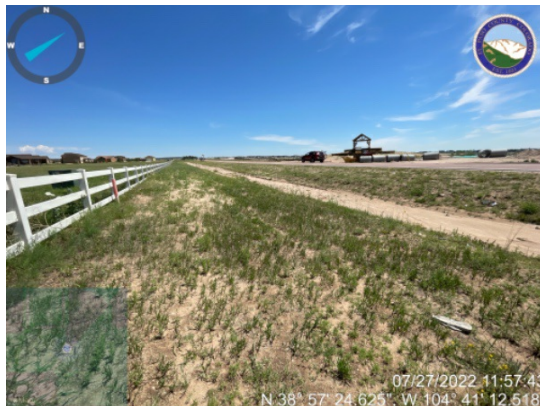
Implement Northeast rock check dams to pond 4 as per approved plans.
