July 25, 2019
Revised December 15, 2019

ENTECH
ENGINEERING, INC.

Re: Soil, Geology, Geologic Hazard and Wastewater Study
8190 Poco Road
Parcel No. 52280-00-001
Colorado Springs, Colorado

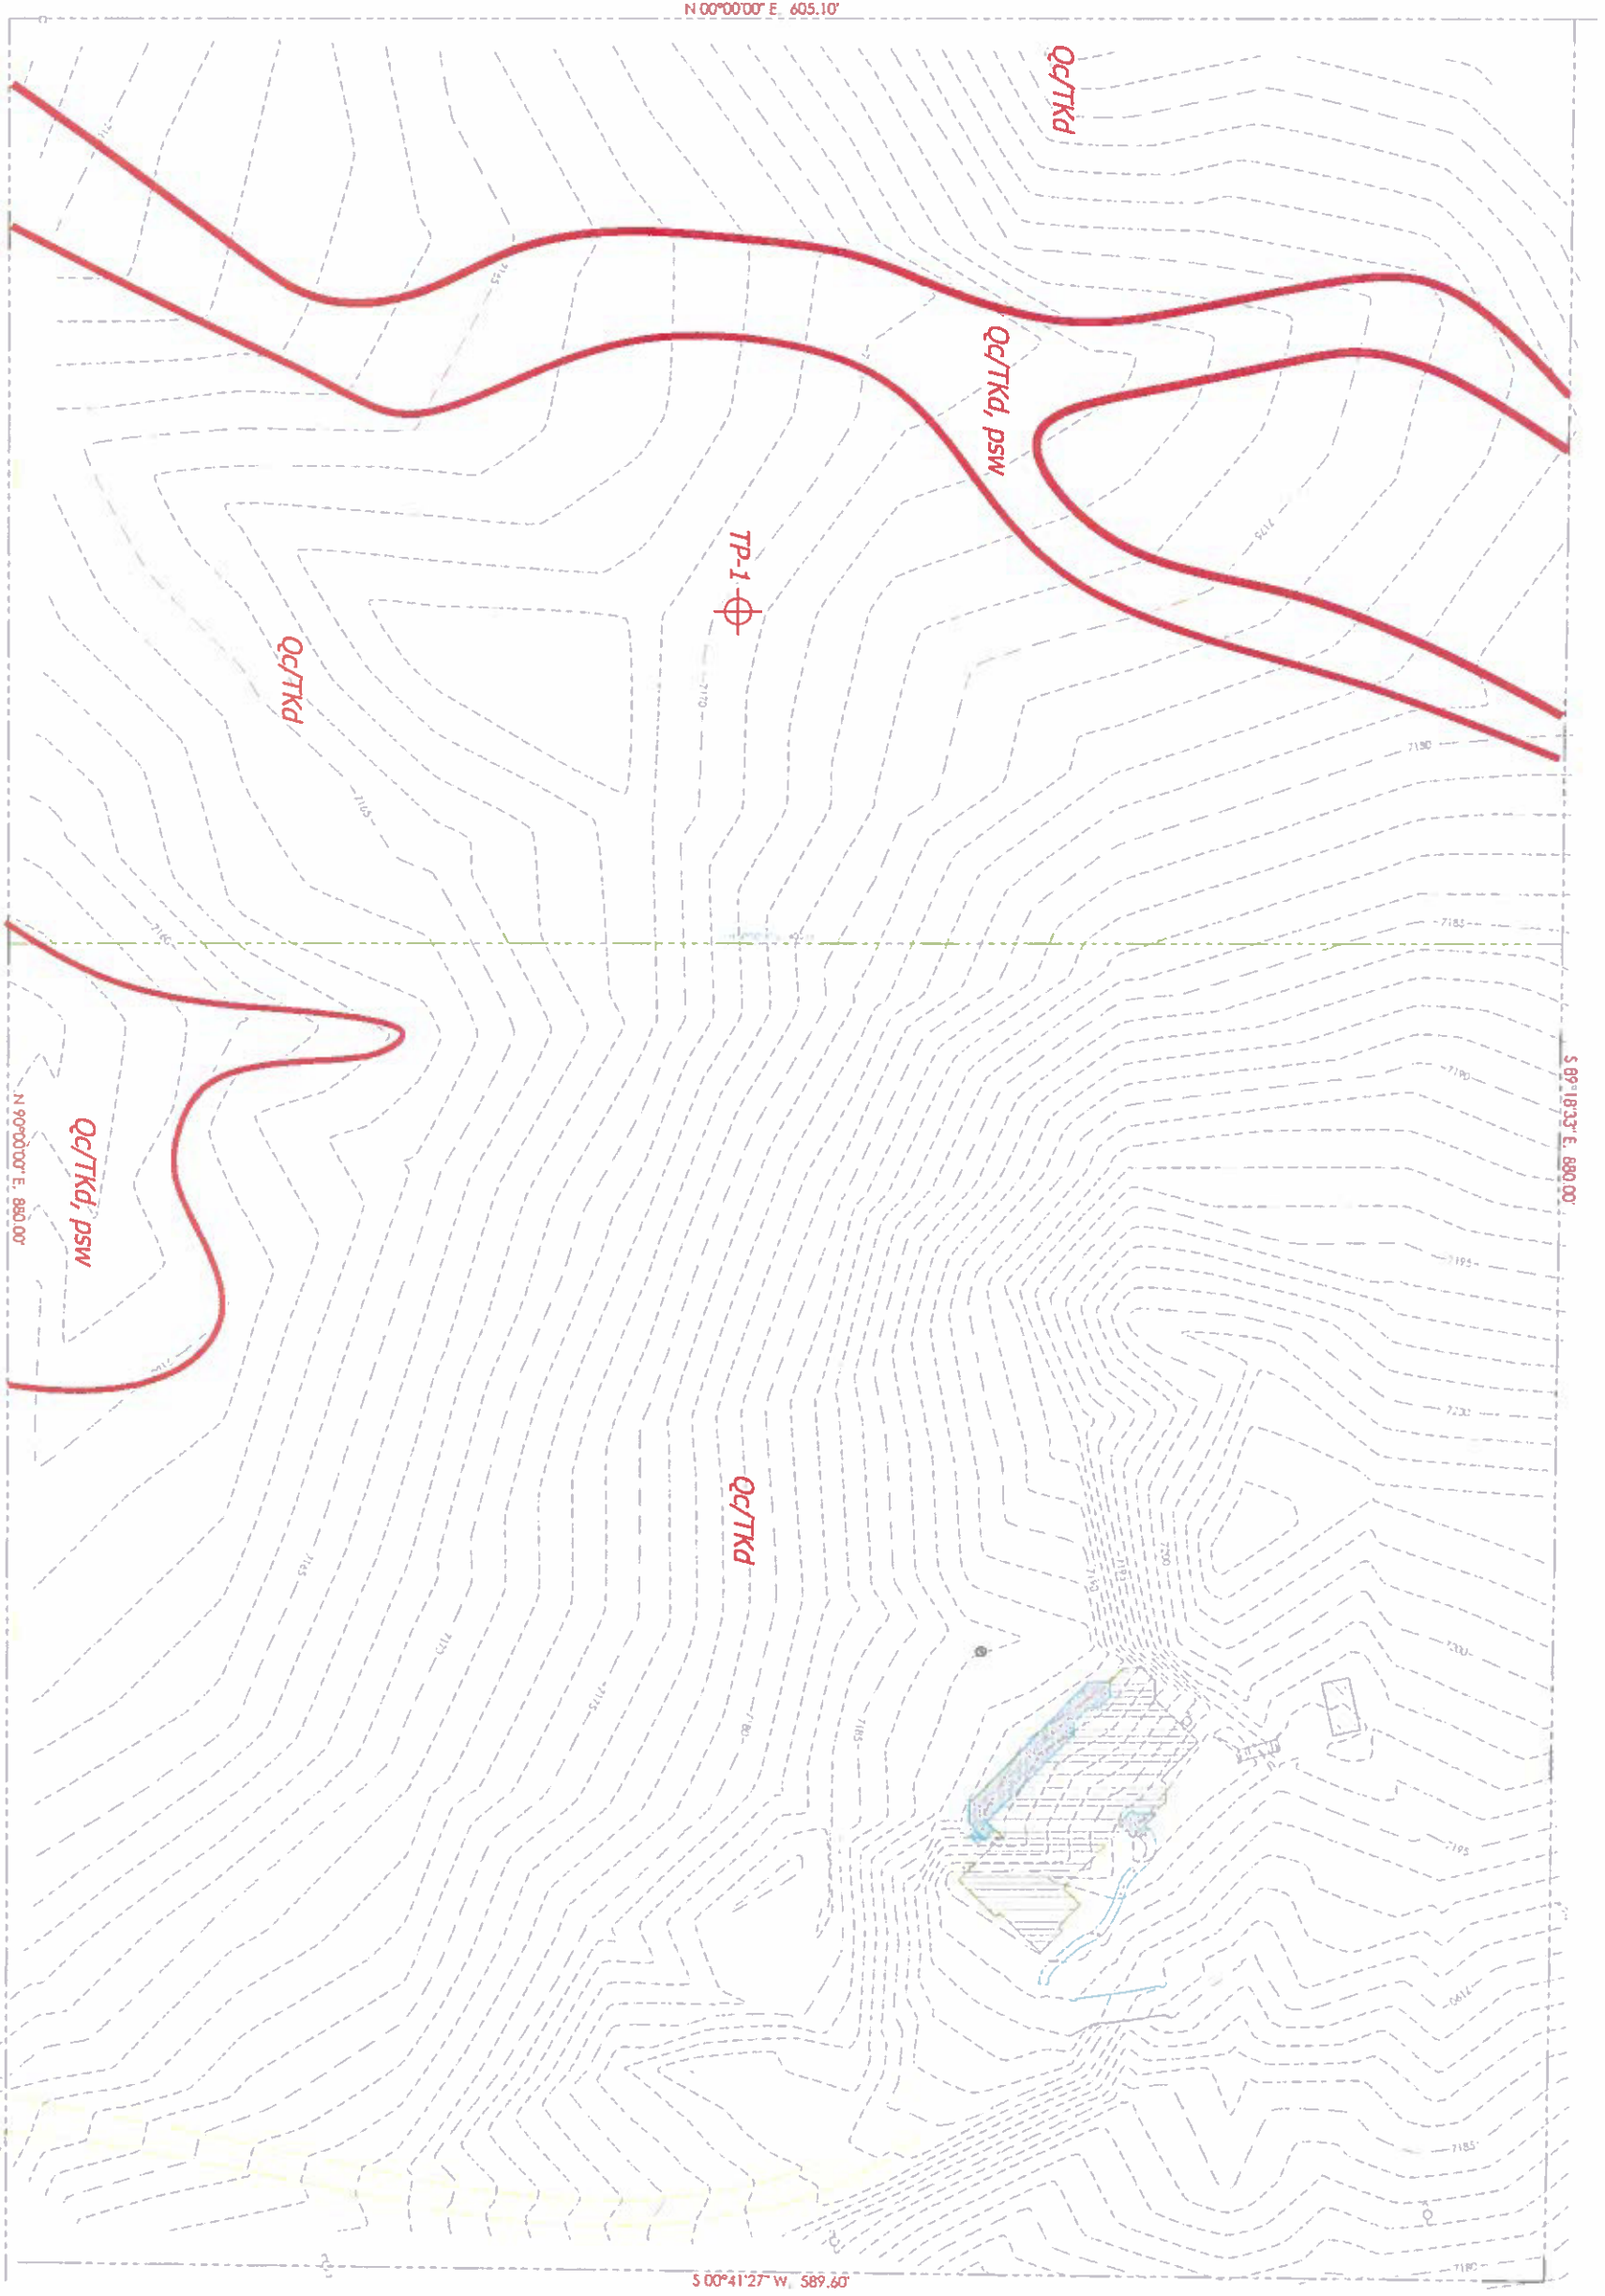
GEOLOGY/ENGINEERING GEOLOGY MAP
8190 POCO ROAD
COLORADO SPRINGS, CO.
FOR: JIM MARTENS

The site is not mapped within any floodplains according to the FEMA Map No. 08041CO535G, dated December 7, 2018 (Figure 7, Reference 7). Areas of potentially seasonal shallow groundwater were observed on the site (Figure 6). In these areas, we would anticipate the potential for periodically high subsurface moisture conditions and frost heave potential. These areas lie within low-lying areas and along the minor drainage in the western portion of the site. Water was not observed in any of the drainages at the time of our site investigation. These areas can likely be avoided or properly mitigated by development. The potential exists for high

Areas of potentially shallow groundwater were observed on the site (Figure 6). In these areas, we would anticipate the potential for periodically high subsurface moisture conditions and frost heave potential. These areas lie within low-lying areas and along the minor drainage in the western portion of the site. These areas can likely be avoided or properly mitigated by development. The potential exists for high groundwater levels during high moisture periods and should structures encroach on these areas. A subsurface perimeter drain is recommended should structures encroach on this area. Typical drain details are presented in Figure 8. Septic systems are not recommended in these areas due to the potential for shallow groundwater. Any grading in these areas should be done to direct surface flow around construction to avoid areas of ponded water. All organic material should be completely removed prior to any fill placement. Specific drainage studies are beyond the scope of this report. The site is not mapped within any floodplains according to the FEMA Map No. 80841C0535G (Figure 7, Reference 7).

Mitigation: Foundations must have a minimum 30-inch depth for frost protection. In areas where high subsurface moisture conditions are anticipated periodically, subsurface perimeter drains are recommended to help prevent the intrusion of water into areas below grade. Typical drain details are presented in Figure 8. Any grading in these areas should be done to direct surface flow around construction to avoid areas of ponded water. All organic material would be completely removed prior to any fill placement. Specific drainage studies are beyond the scope of this report.

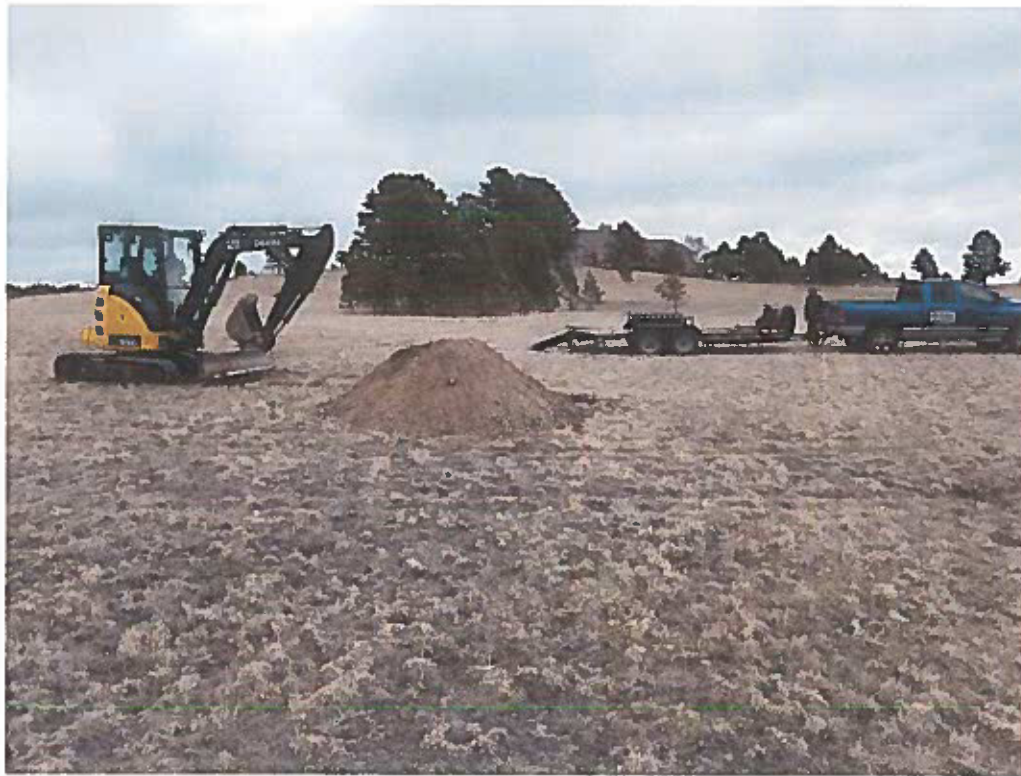
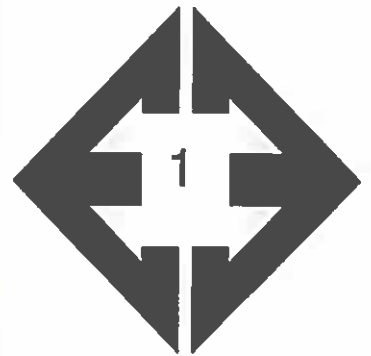
**Looking east from the
western portion of the
site.**

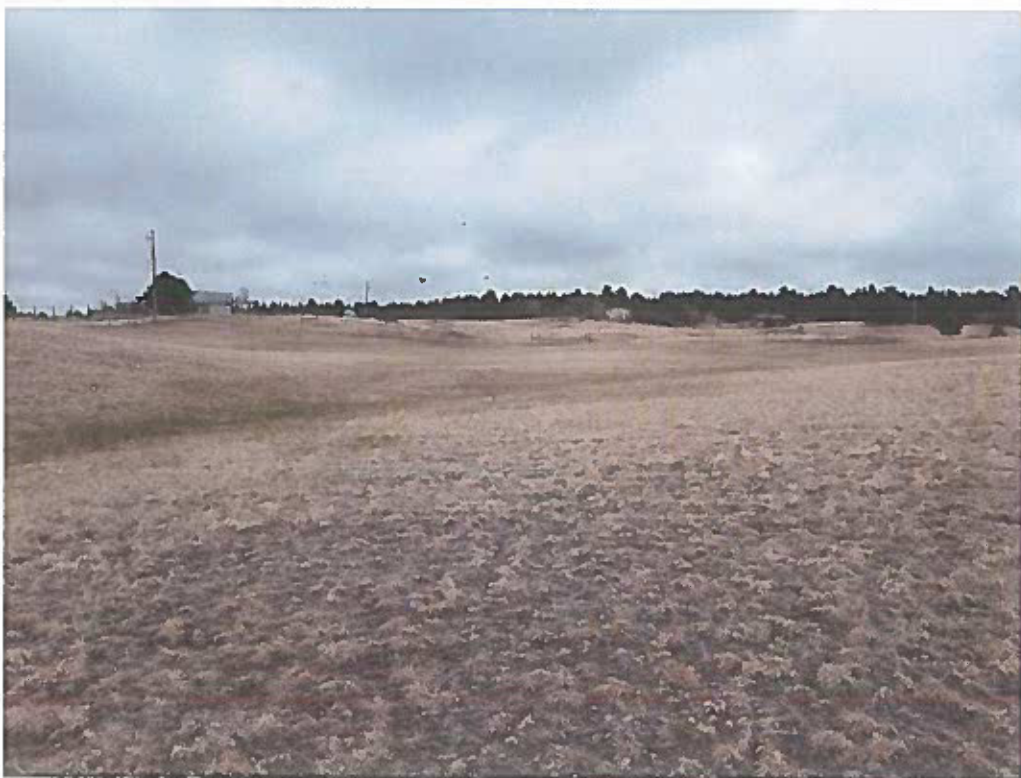
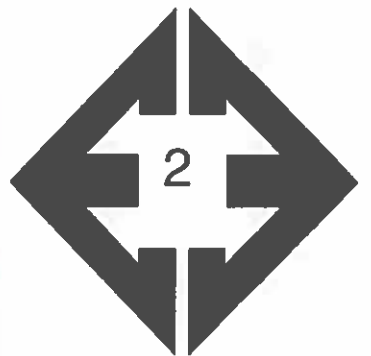
**Looking north from the
western portion of the
site.**

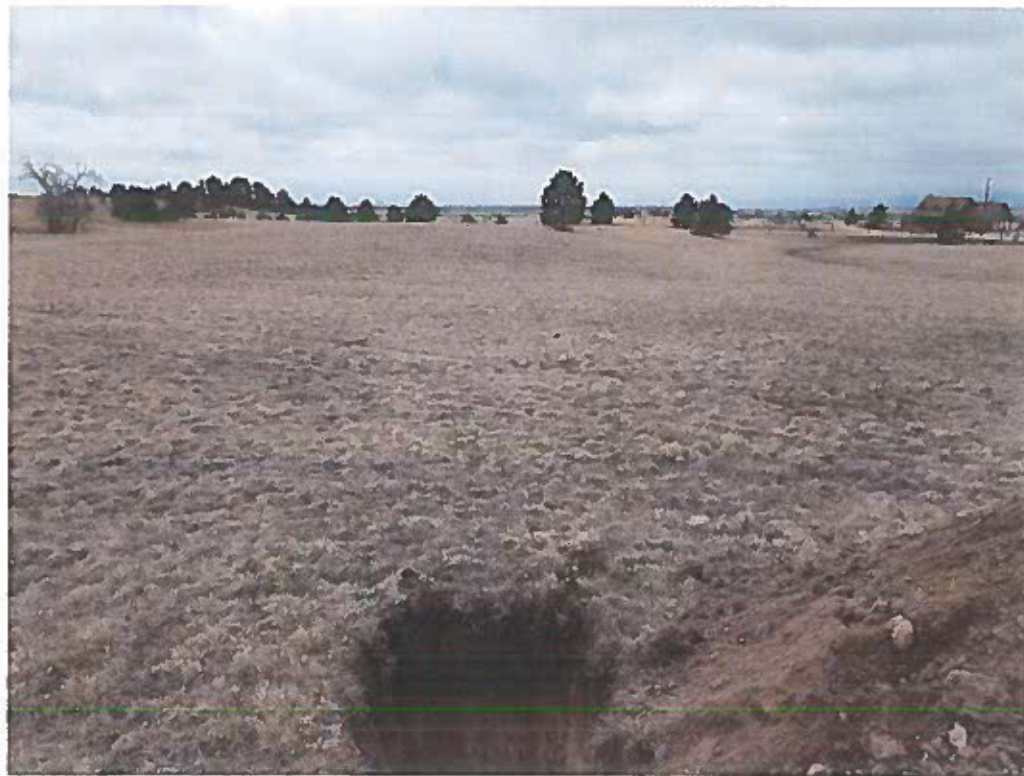
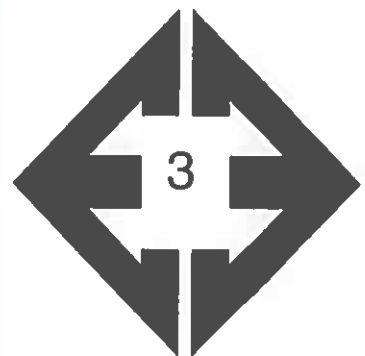
**Looking south from
the western portion of
the site.**

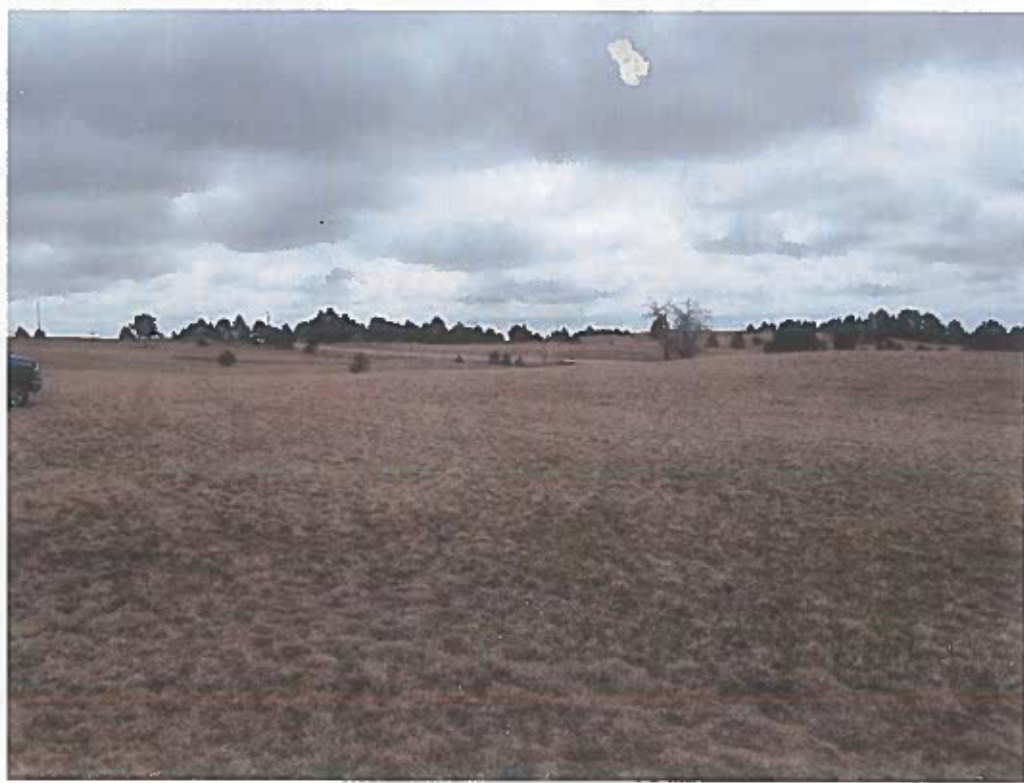
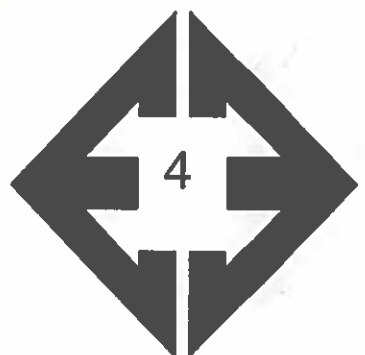
**Looking southeast
from the western
portion of the site.**
