ENTECH
ENGINEERING, INC.

Re: Soil, Geology, Geologic Hazard
8190 Poco Road
Parcel No. 52280-00-001
Colorado Springs, Colorado

Jim Martens
Soils, Geology, Geologic Hazard and Wastewater Study
8190 Poco Road
Parcel No. 52280-00-001
Colorado Springs, Colorado

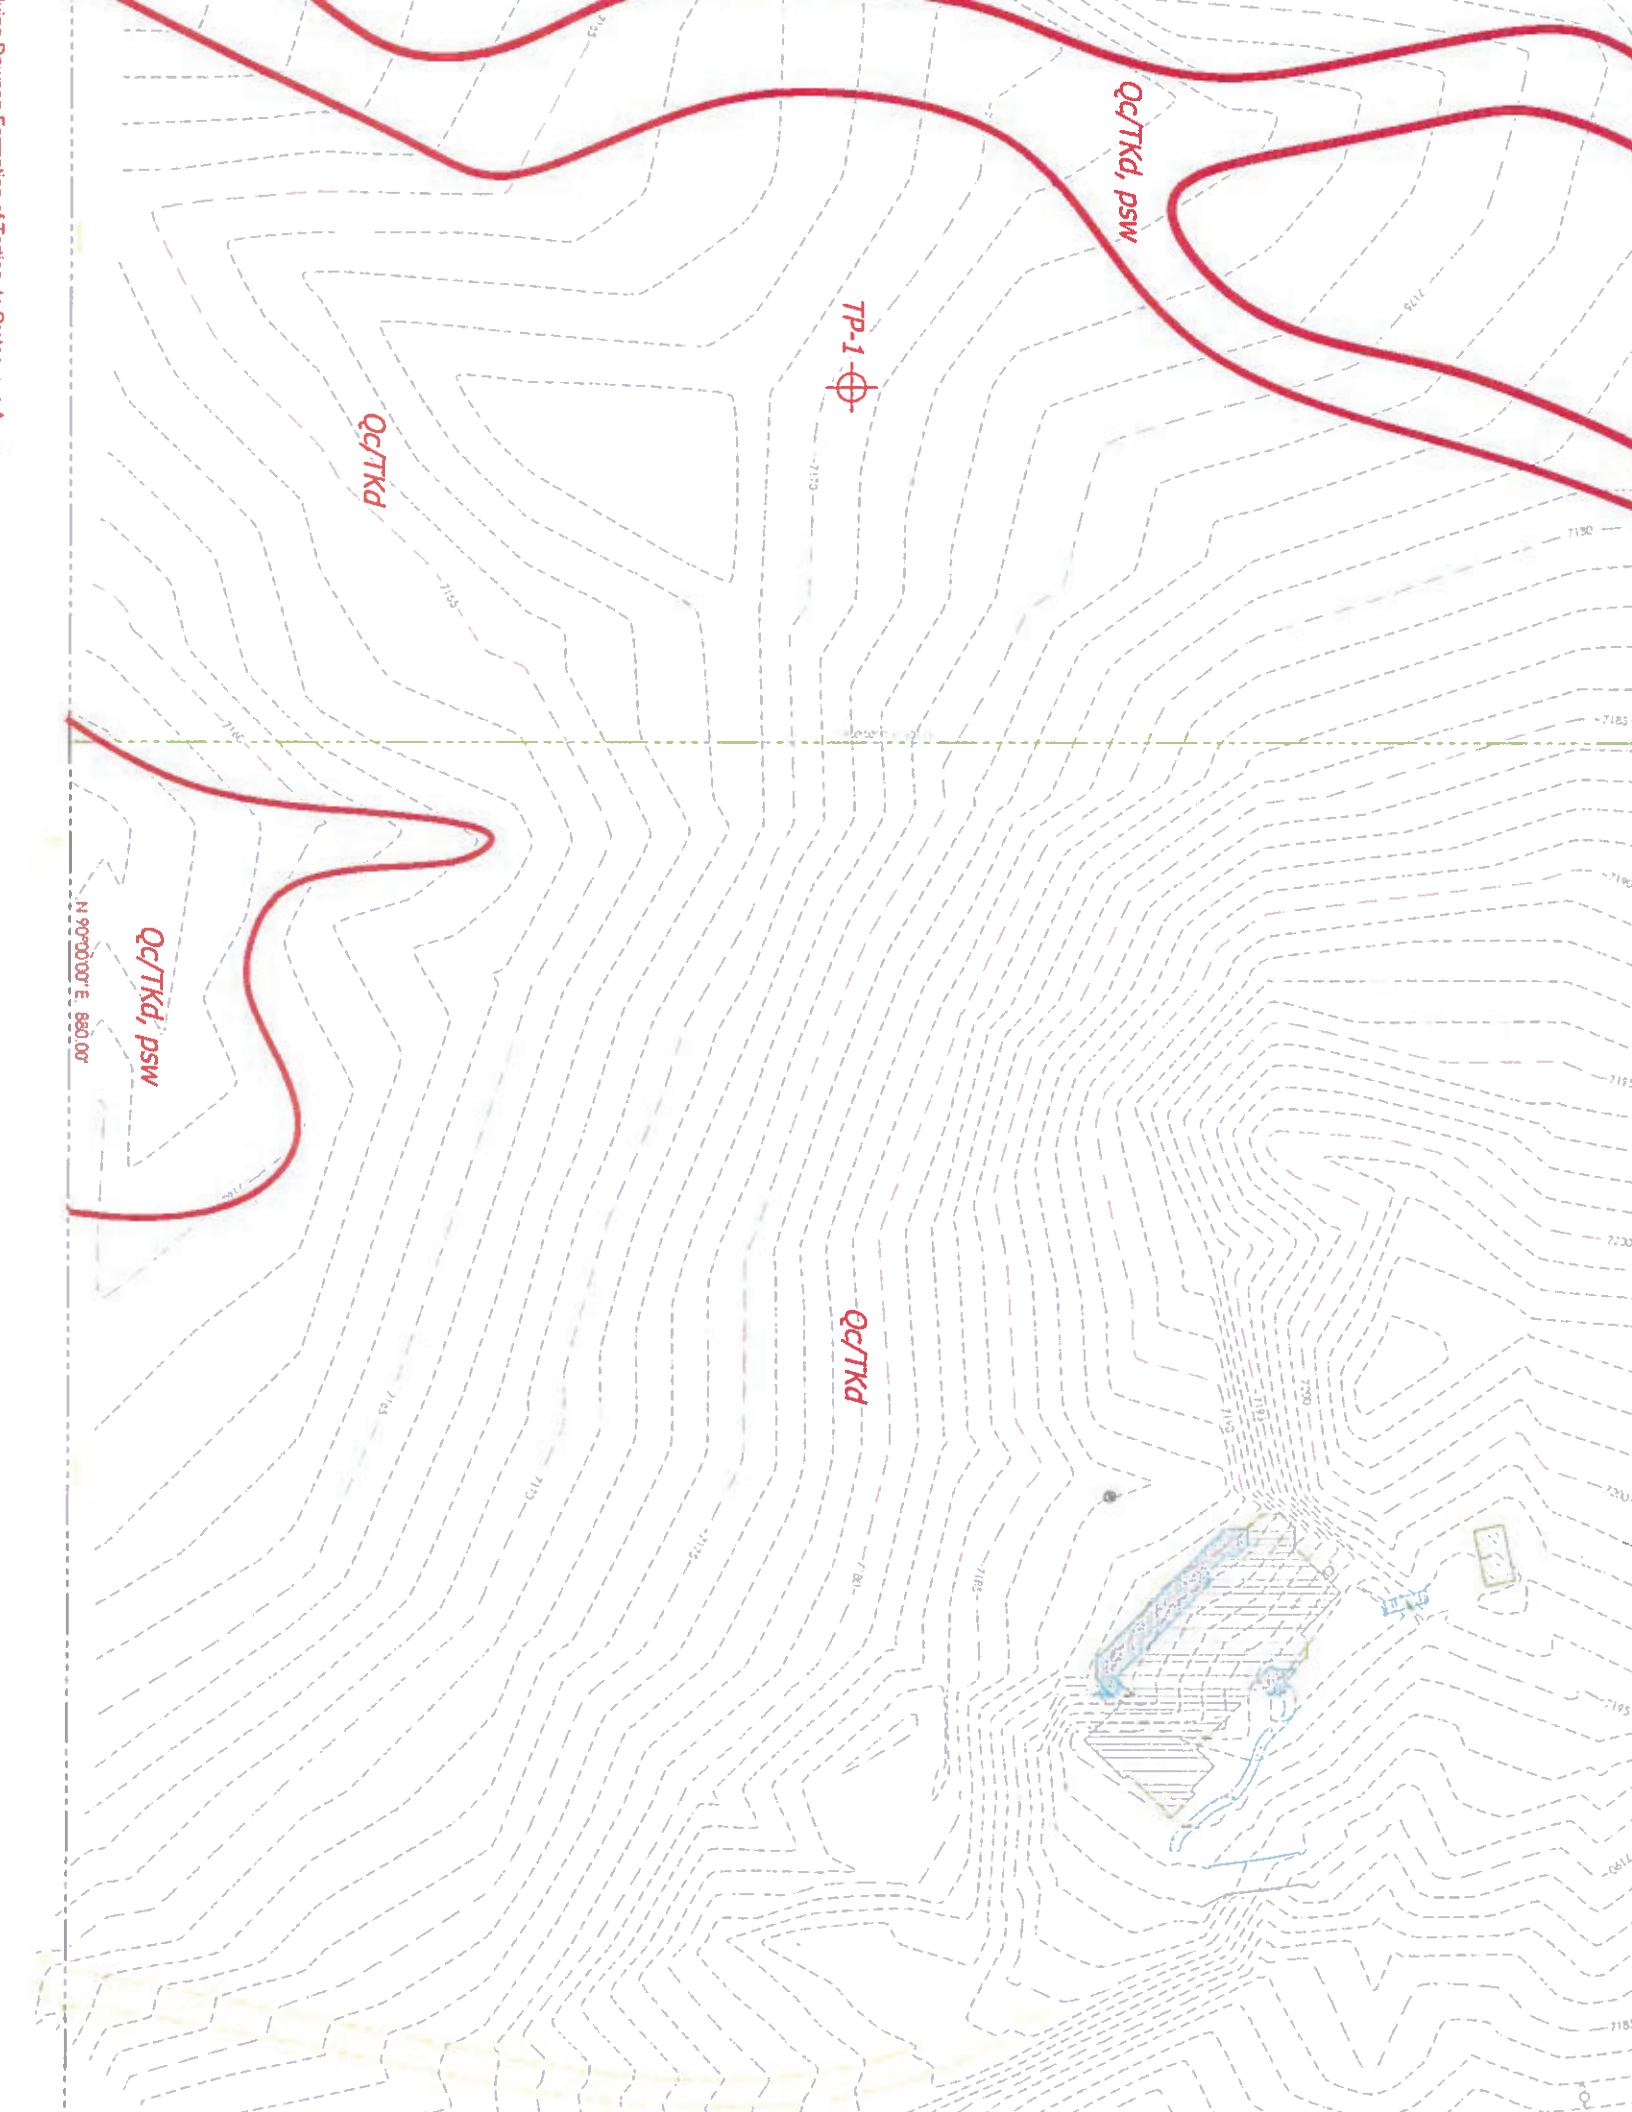
The site is not mapped within any floodplains according to the FEMA Map No. 08041CO535G, dated December 7, 2018 (Figure 7, Reference 7). Areas of potentially seasonal shallow groundwater were observed on the site (Figure 6). In these areas, we would anticipate the potential for periodically high subsurface moisture conditions and frost heave potential. These areas lie within low-lying areas and along the minor drainage in the western portion of the site. Water was not observed in any of the drainages at the time of our site investigation. These areas can likely be avoided or properly mitigated by development. The potential exists for high

Areas of potentially shallow groundwater were observed on the site (Figure 6). In these areas, we would anticipate the potential for periodically high subsurface moisture conditions and frost heave potential. These areas lie within low-lying areas and along the minor drainage in the western portion of the site. These areas can likely be avoided or properly mitigated by development. The potential exists for high groundwater levels during high moisture periods and should structures encroach on these areas. A subsurface perimeter drain is recommended should structures encroach on this area. Typical drain details are presented in Figure 8. Septic systems are not recommended in these areas due to the potential for shallow groundwater. Any grading in these areas should be done to direct surface flow around construction to avoid areas of ponded water. All organic material should be completely removed prior to any fill placement. Specific drainage studies are beyond the scope of this report. The site is not mapped within any floodplains according to the FEMA Map No. 80841C0535G (Figure 7, Reference 7).

Mitigation: Foundations must have a minimum 30-inch depth for frost protection. In areas where high subsurface moisture conditions are anticipated periodically, subsurface perimeter drains are recommended to help prevent the intrusion of water into areas below grade. Typical drain details are presented in Figure 8. Any grading in these areas should be done to direct surface flow around construction to avoid areas of ponded water. All organic material would be completely removed prior to any fill placement. Specific drainage studies are beyond the scope of this report.

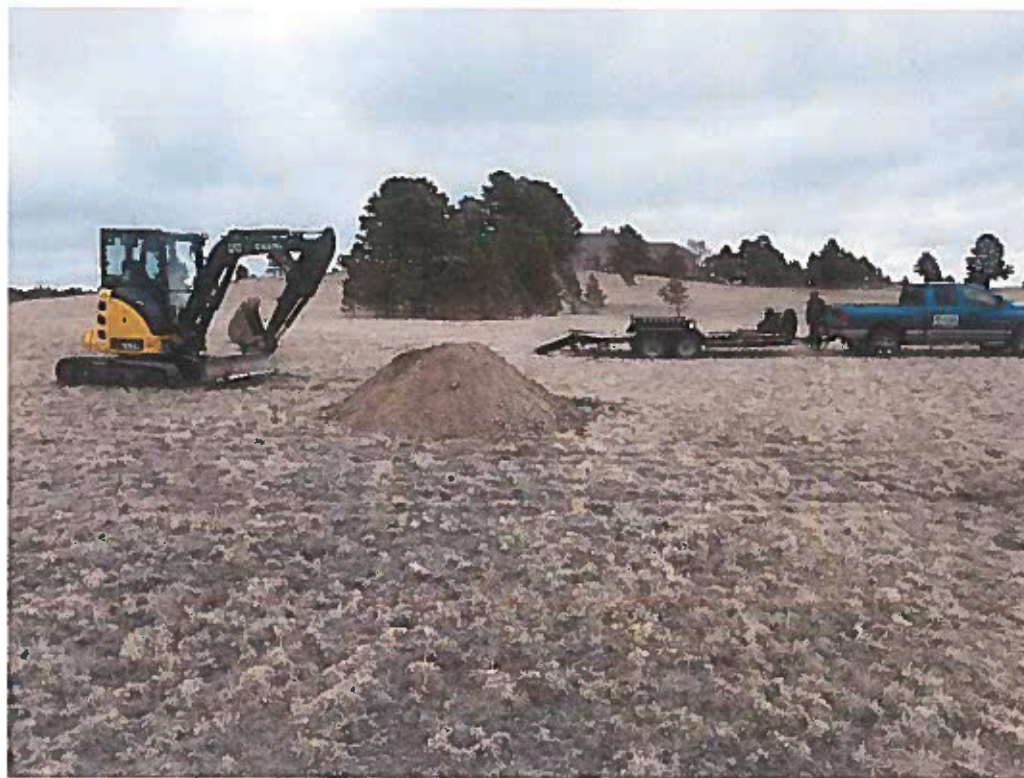
**Looking east from the
western portion of the
site.**

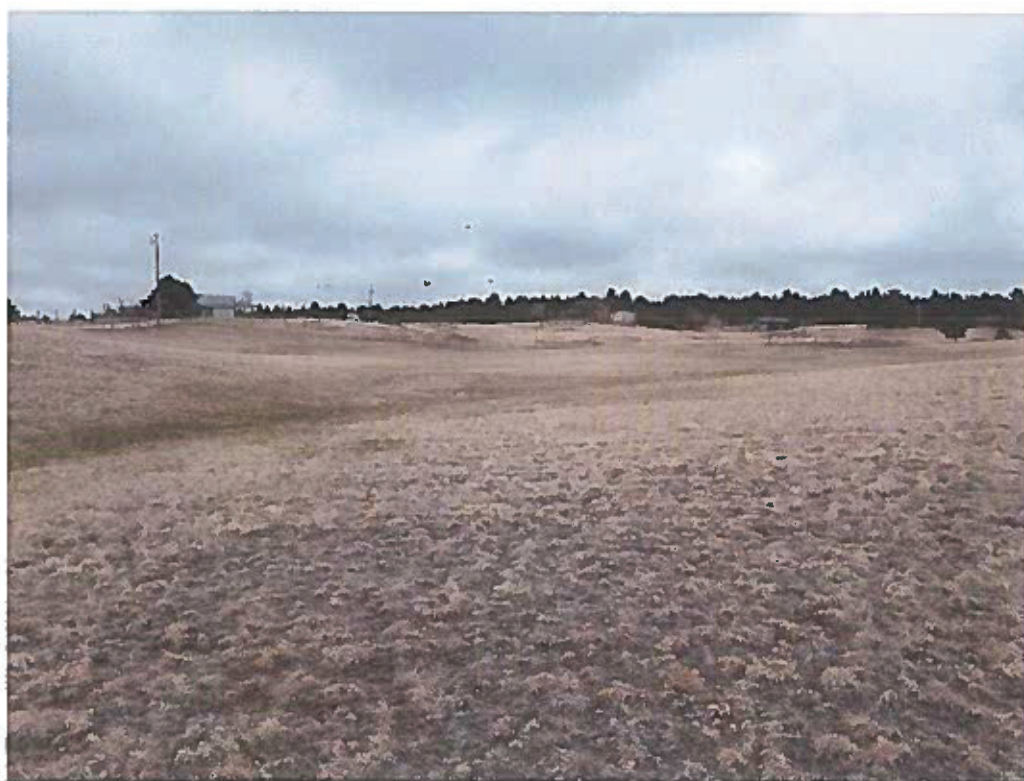
**Looking north from the
western portion of the
site.**

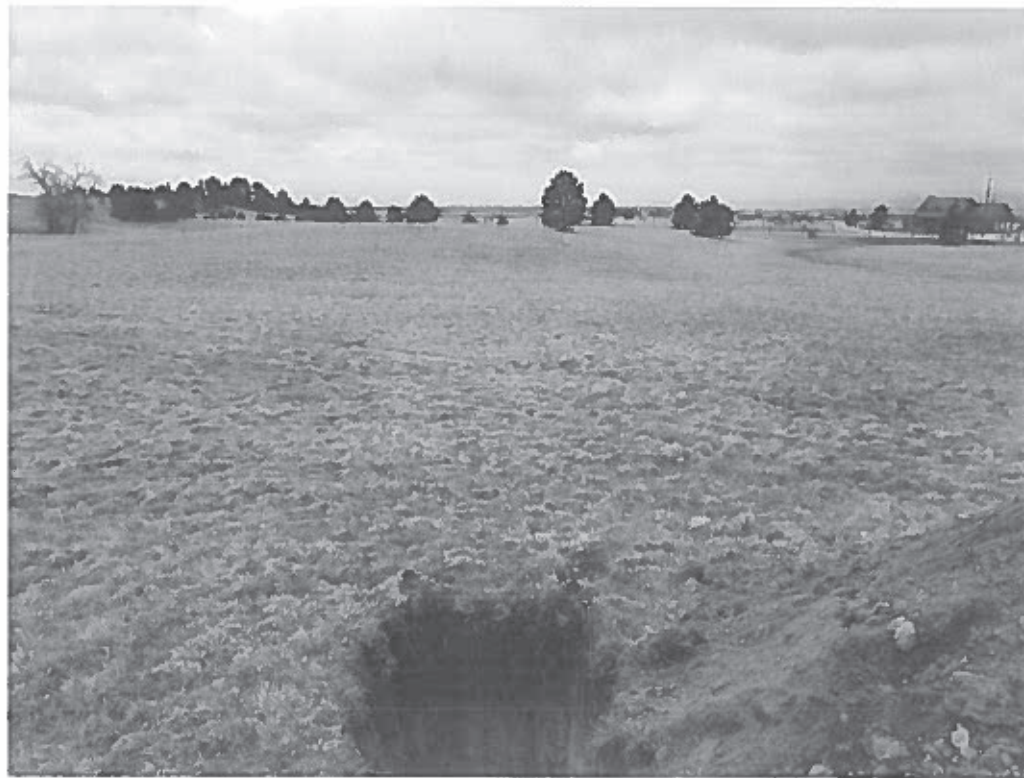
**Looking south from
the western portion of
the site.**

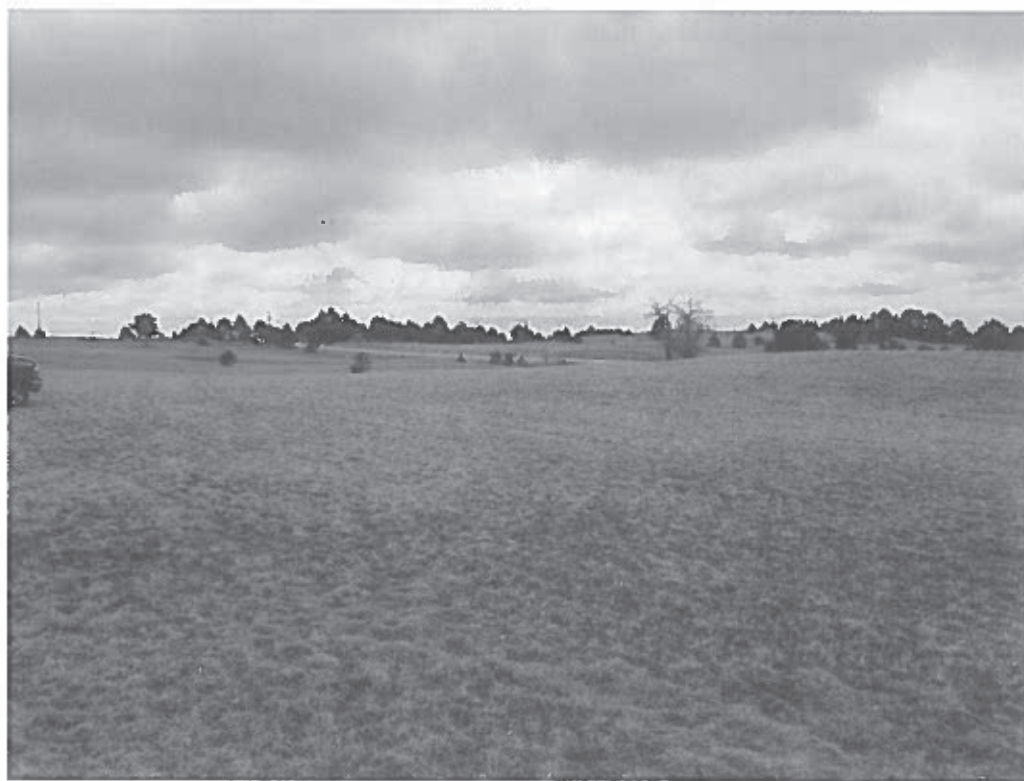
**Looking southeast
from the western
portion of the site.**
