Preliminary Acceptance Punchlist
El Paso County – Department of Public Works - Stormwater Section

Project Name:	Cloverleaf Filing 2
EDARP Filing Number(s):	SF2123, CON2216
ESQCP Number:	ESQ2133
Attendees:	DPW SW: Molly Layshock, Ben Jones DPW Development Services: Brad Walters, Spencer Pirzadeh Developer: Joe Desjardin, Connie Miller, Charlie Williams
Date of Walk-Thru:	07/13/2023
Walk-Thru Number:	1st

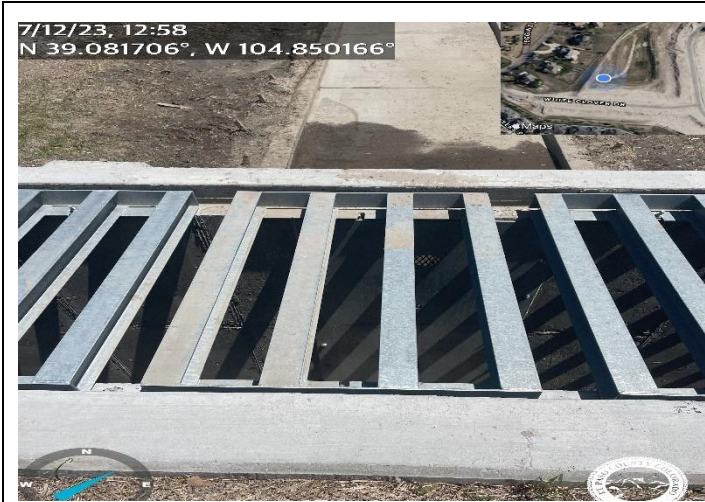
- Bolt missing above at trash-rack (Photo 1).
- Check dimensions of spillway and install/construct per plan or ask engineer to confirm that as-built condition is acceptable. Because plan calls for 45ft bottom width but as-built condition appears to be no more than 20ft wide.

Photo 1: Pond P2 missing bolt above 42" RCP above trash-rack.

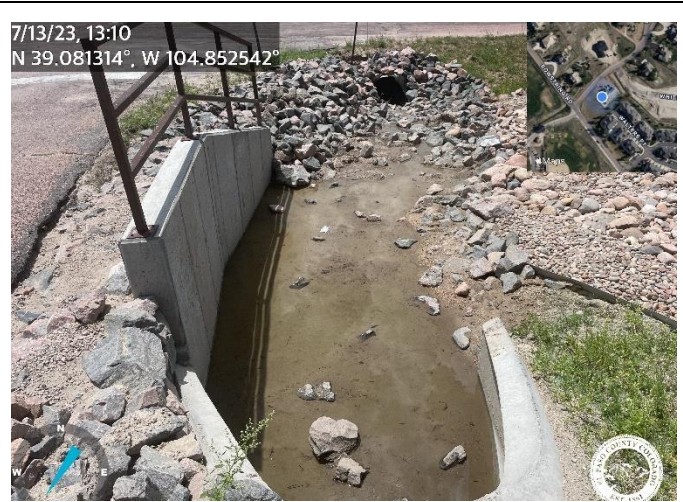
- Install riprap apron at Leggins Way as per outlet structure detail on sheet 7 and 23 of 28 (Photo 2).
- Check elevations of spillway crest and pond embankment. Does not appear to be a 1ft difference from spillway crest to top of pond embankments.

Photo 2: Install riprap apron at Leggins Way outfall of pond P4.

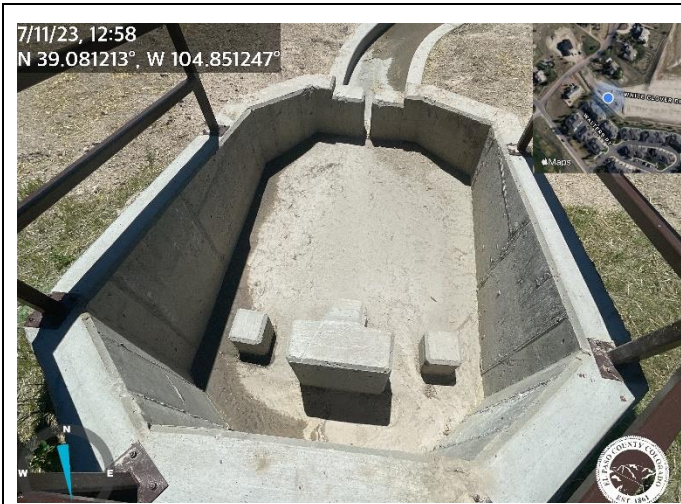
- Missing Secondary Baffle Blocks on forebay. Only 2 secondary baffle blocks are installed and approved plans show 6. Submit as-builts to show that this is acceptable. See Forebay Plan View detail on Sheet 22 of 28. (Photo 3)

Photo 3: Pond 4 Forebay is missing 4 secondary baffle blocks. Submit as-builts to show that this is acceptable.

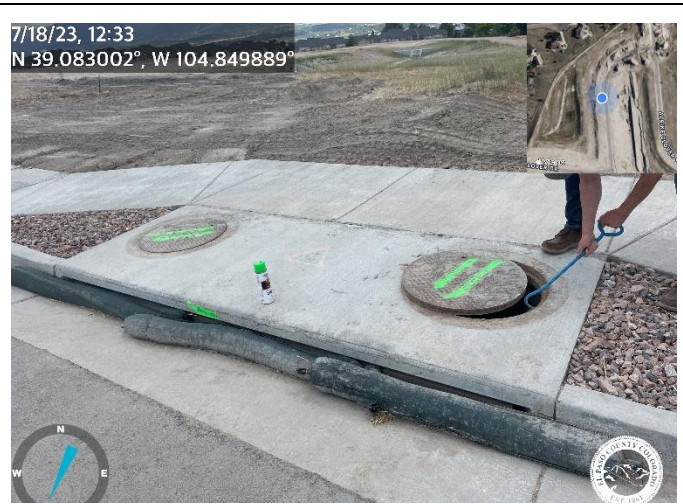
- Clean out inlet painted with green (Photo 4)

Photo 4: Remove forms and clean out above inlet painted with green strips.
