ENTECH
ENGINEERING, INC.

Re: Soils and Geology Study
10650 Black Forest Road
Parcel No. 52190-00-101
El Paso County, Colorado
Entech Job No. 221371

Taher Nabulsi
Soils and Geology Study
10650 Black Forest Road
Parcel No. 52190-00-101
El Paso County, Colorado
Entech Job No. 221371

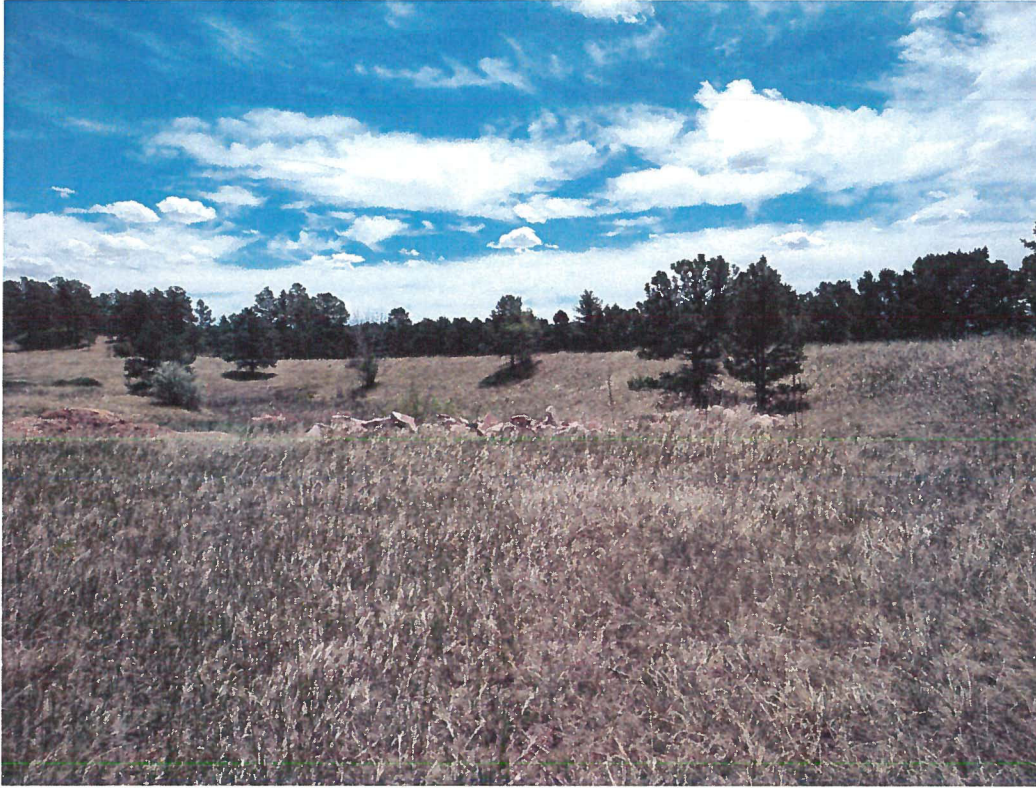
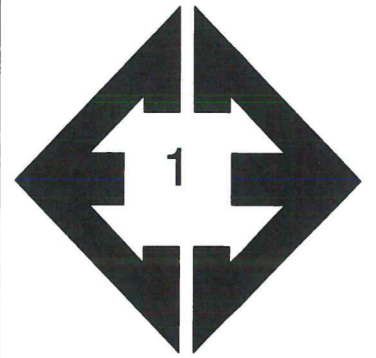
Looking east from the northwest side of the pond.

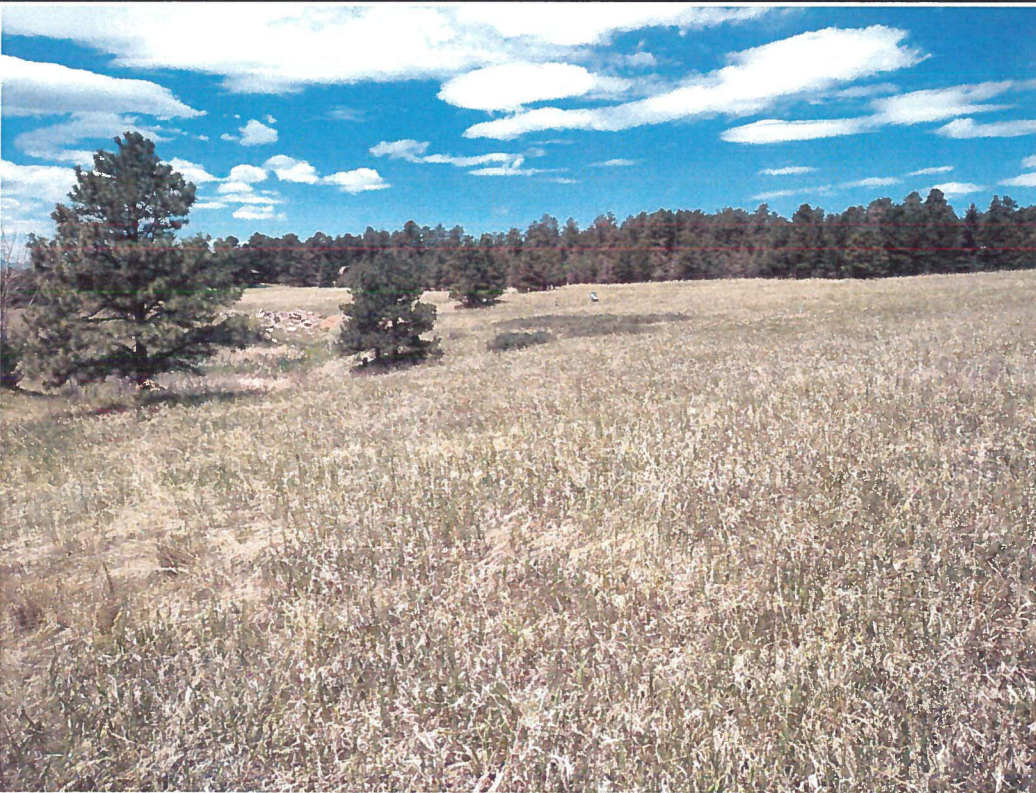
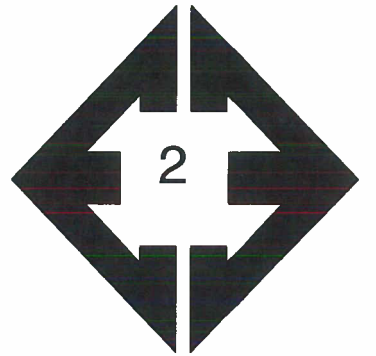
Looking northwest from the southeast corner of the site.

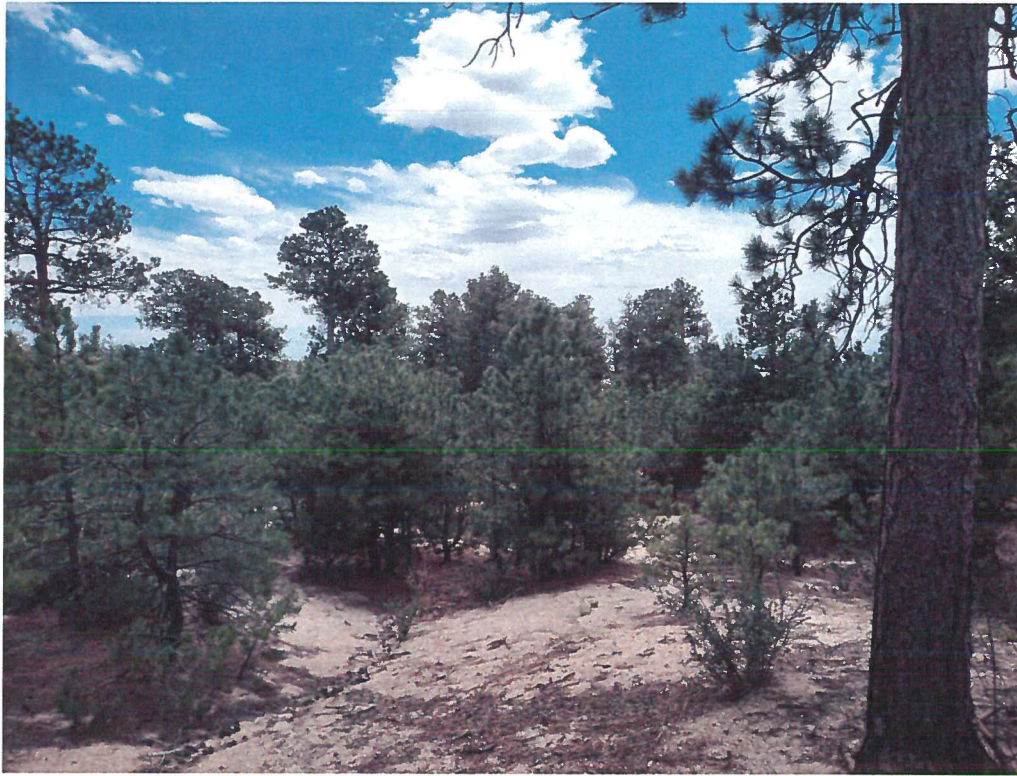
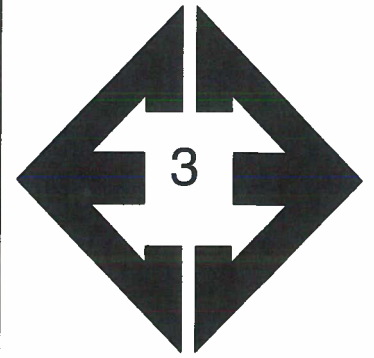
**Looking southeast
from the northwest
corner of the site.**

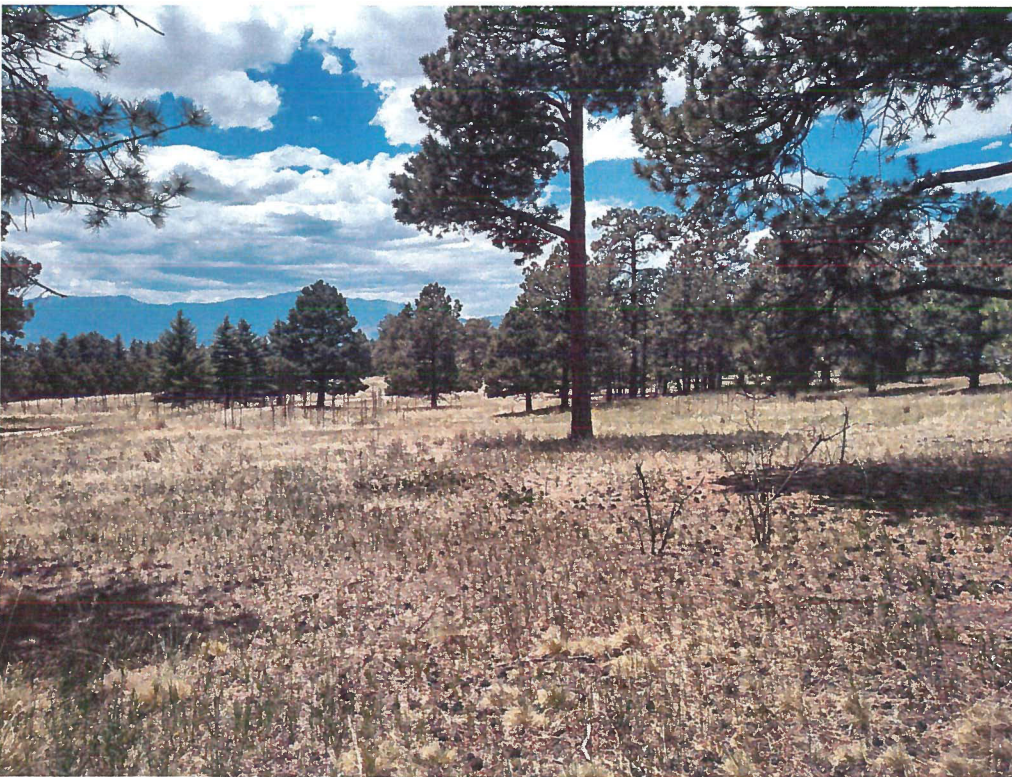
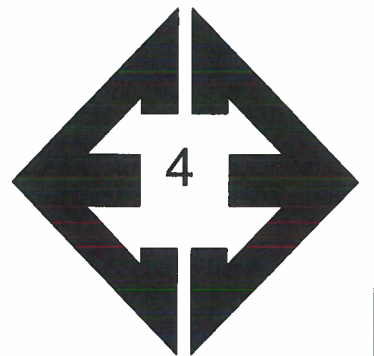
**Looking southwest
from the central
portion of the east
property line of the
site.**

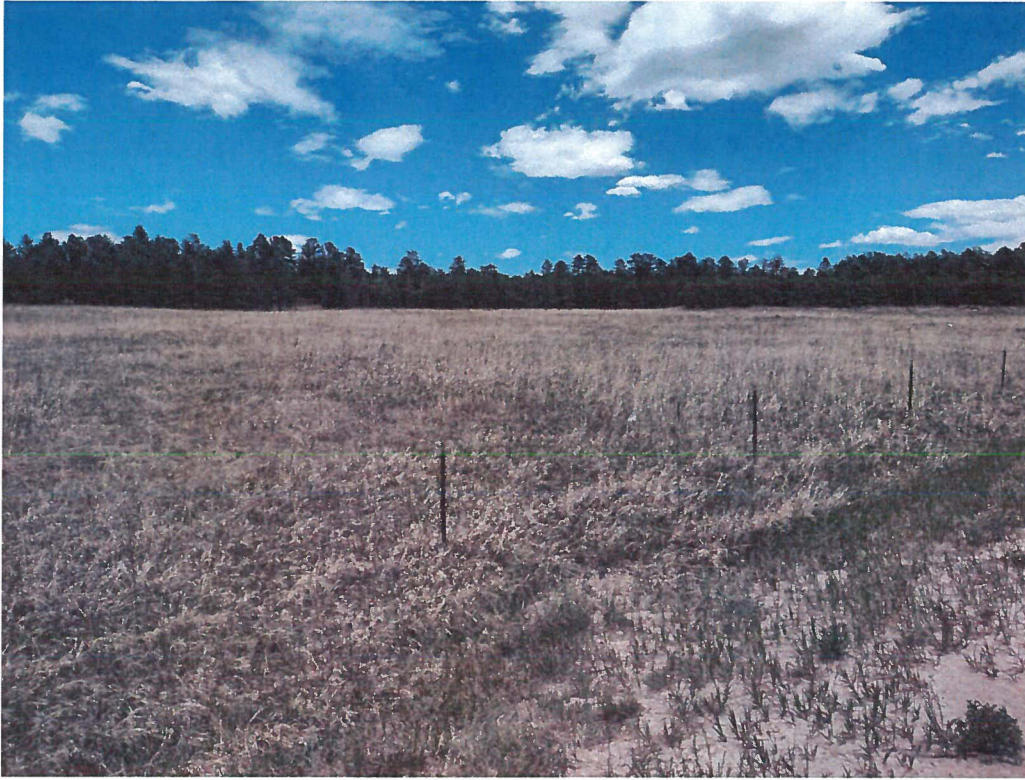
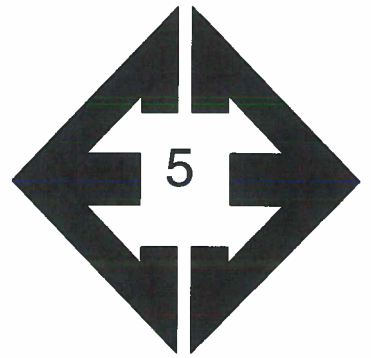
**Looking northeast
from the southwest
portion of the site**

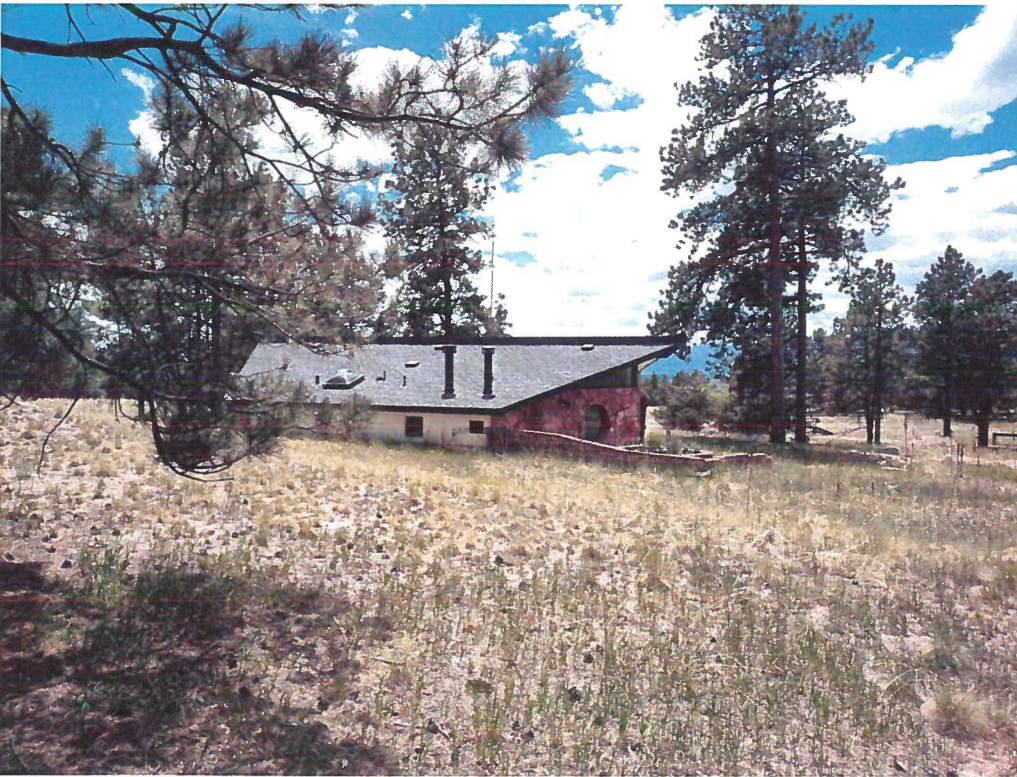
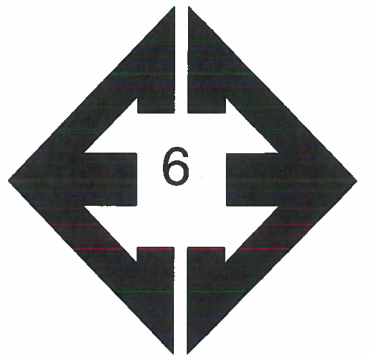
**Looking south at the
existing residence
from the northeast
portion of the site.**

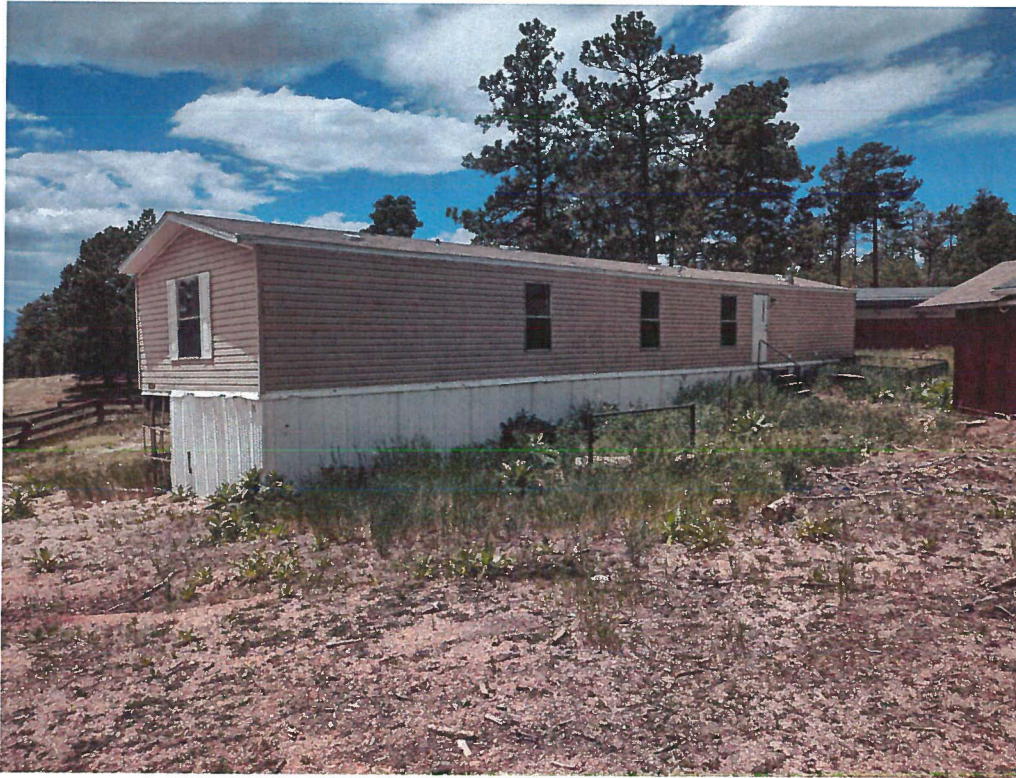
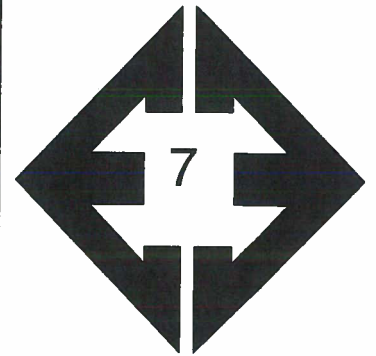
Looking east at existing modular home from the center of the proposed Lot 1.

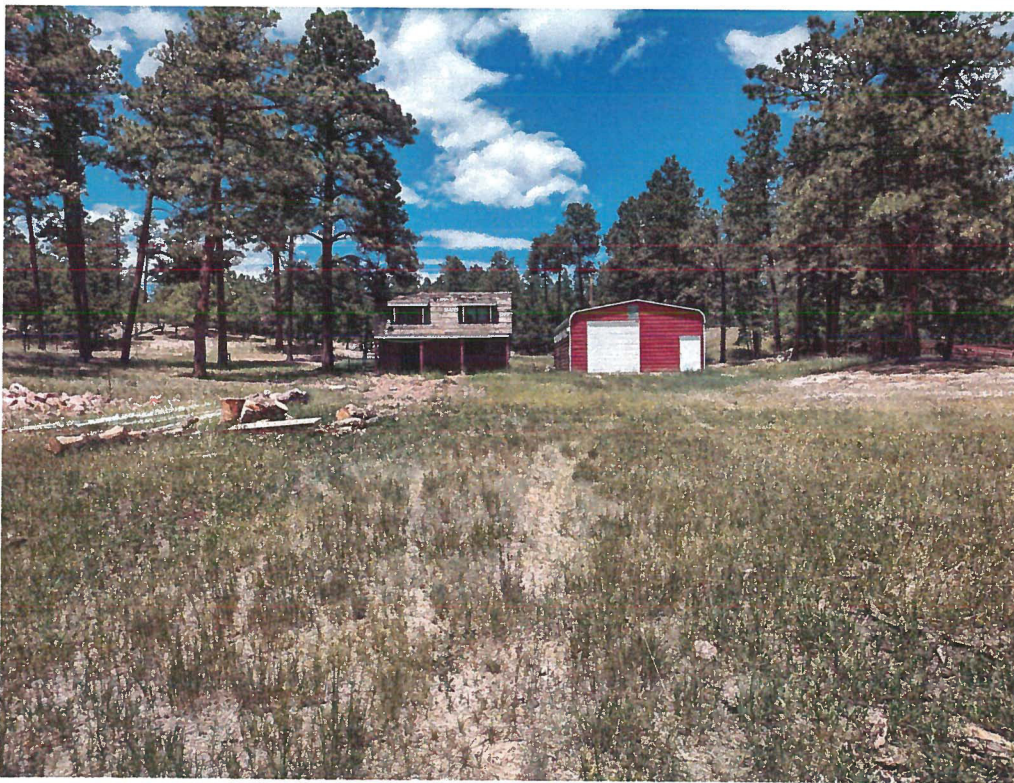
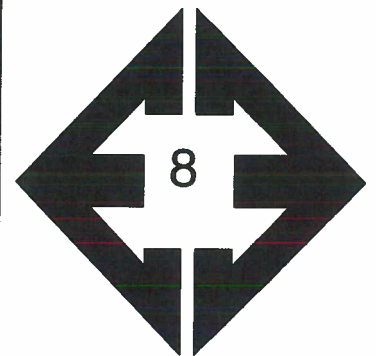
Looking north at existing storage structures from the center of the proposed Lot 1.

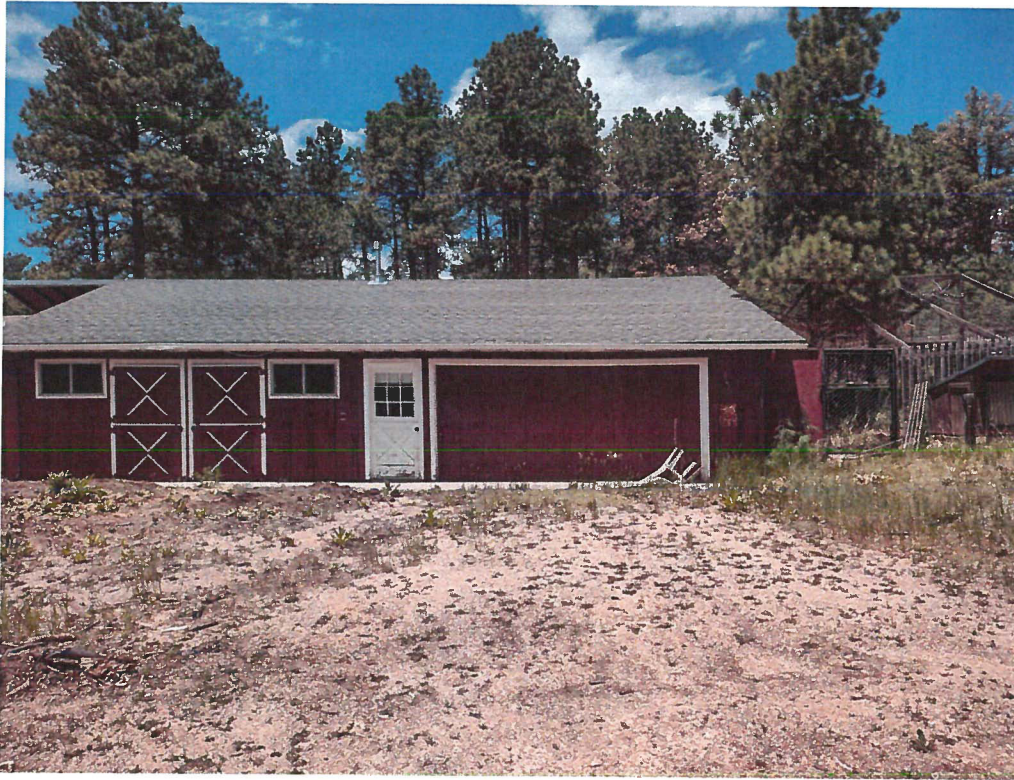
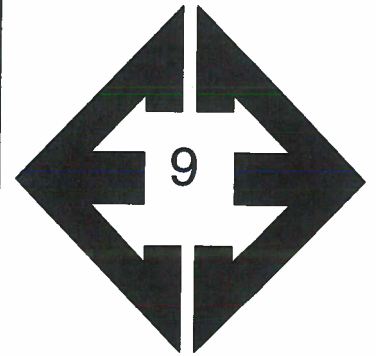
**Looking northwest at
an existing structure
from the center of the
proposed Lot 1.**

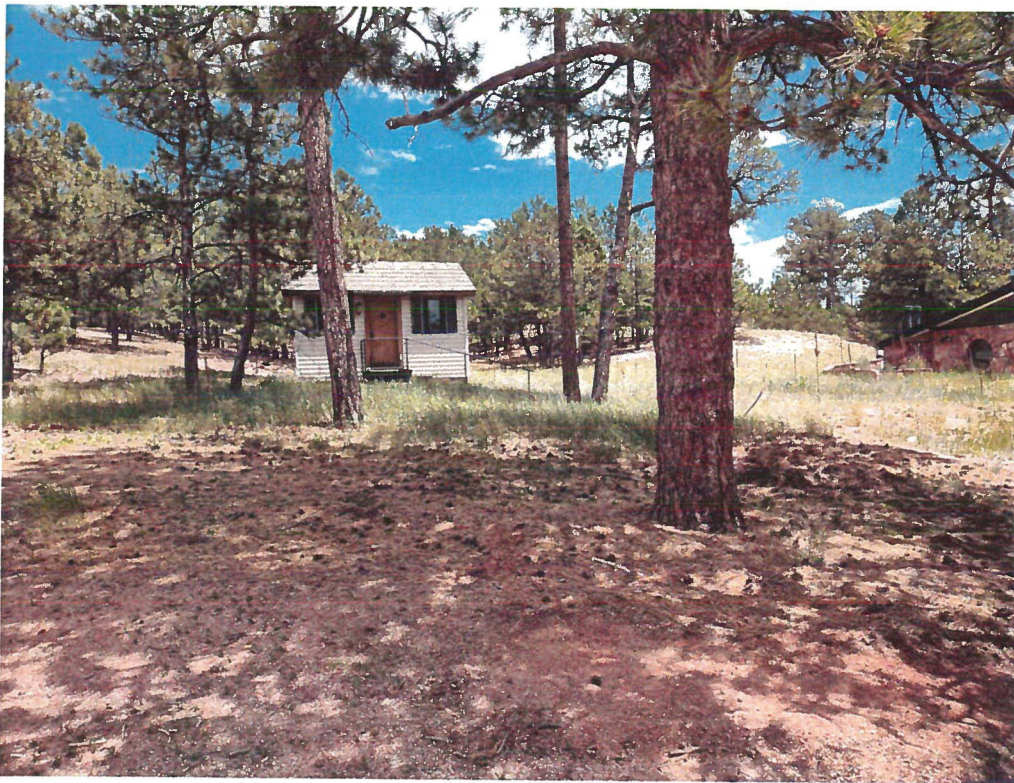
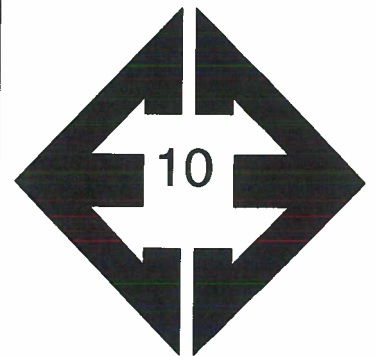
**Looking northwest at
an existing structure
from the center of the
proposed Lot 1.**
