Final Acceptance (FA) – Punchlist from EPC Stormwater

Project Name:	Legacy Church
PCD Filing Number:	CON2027
ESQCP #:	ESQ2020
Attendees:	DPW: Natasha Grimaldo, Ben Jones, and Joshua Augustenborg PCD: N/A Developer: Tyler Horner
Date of Walk-Thru:	11/15/2022
Walk-Thru #:	First Walk

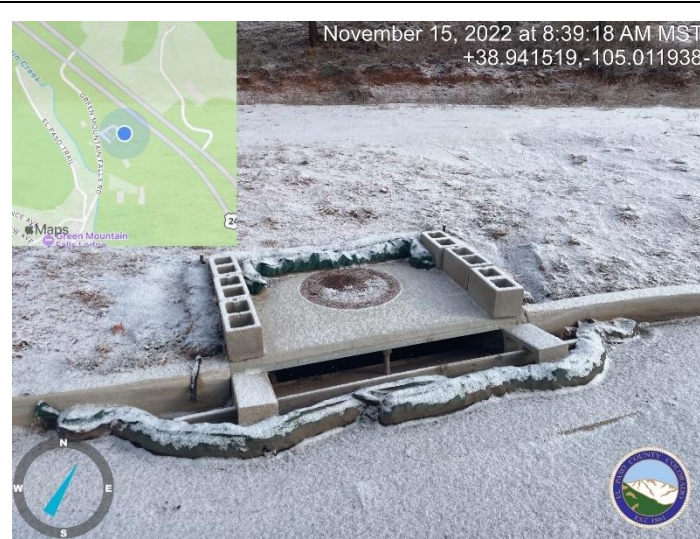
Photo 1: Remove inlet protection, as well as the 2x4 forms inside the inlet at STA 0+07.50.

- Remove inlet protection
- Remove wood forms inside the inlet.

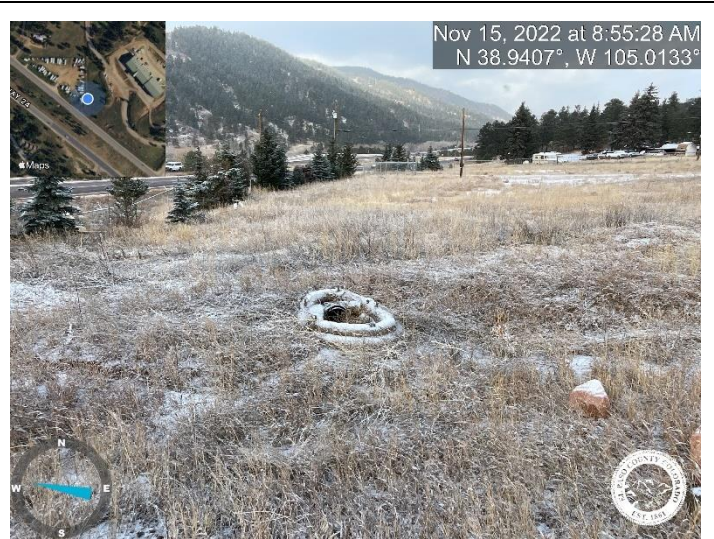
Photo 2: Remove all temporary control measures throughout site. Photo depicts straw wattle near STA 2+22.54.

- Remove all temporary control measures from the site including silt fence, rock socks, and wattles.

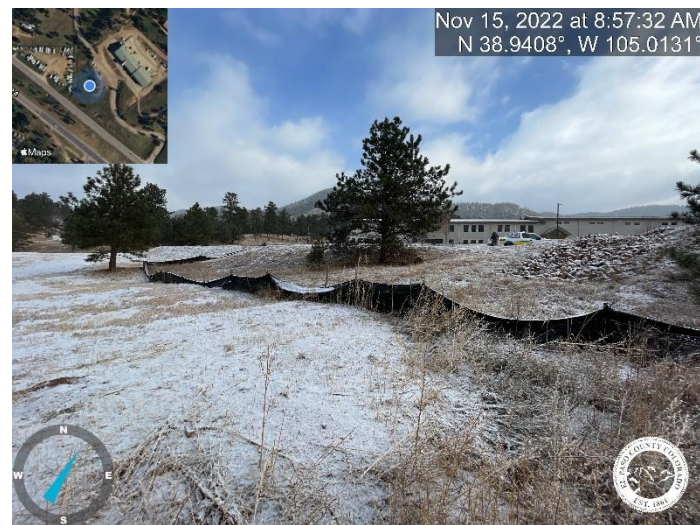
Photo 3: Remove all temporary control measures throughout site. Photo depicts silt fence below the west detention pond.

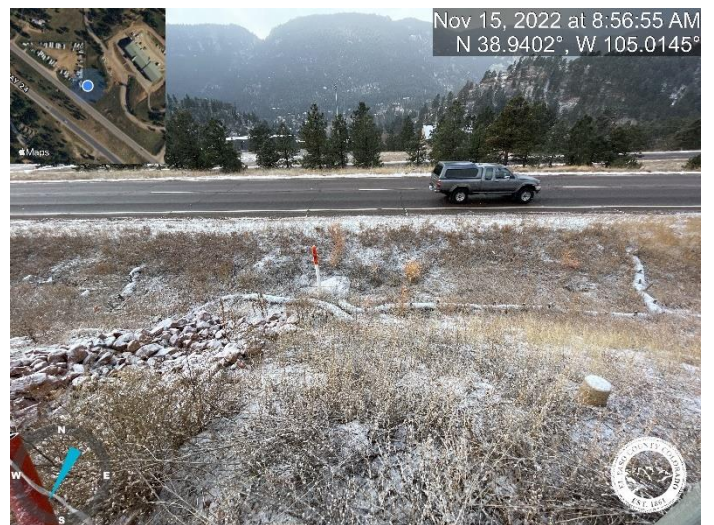
Photo 4: Install check dams as depicted on sheet C2.2 of the Erosion Control Plans located below station STA 2+70.10. Ensure that temporary straw wattles are removed from location as well.

- Install check dams as depicted on sheet C2.2 of the Erosion Control Plans.

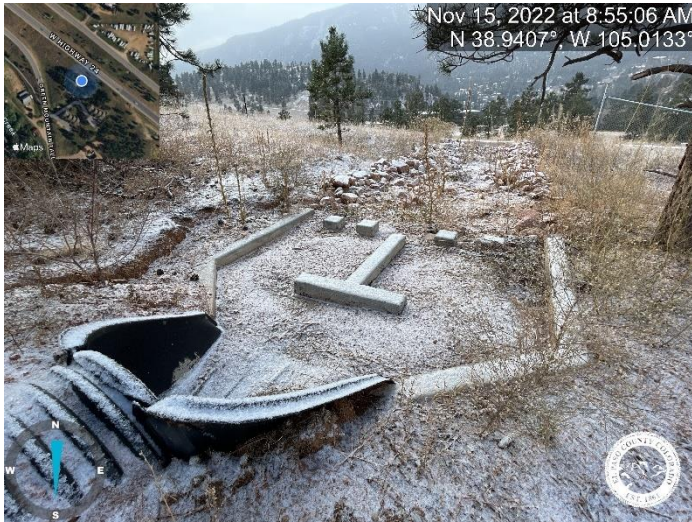
Photo 5: Remove sediment and debris from the forebay and riprap at STA 2+70.10

- Remove sediment and debris from the forebay and riprap.

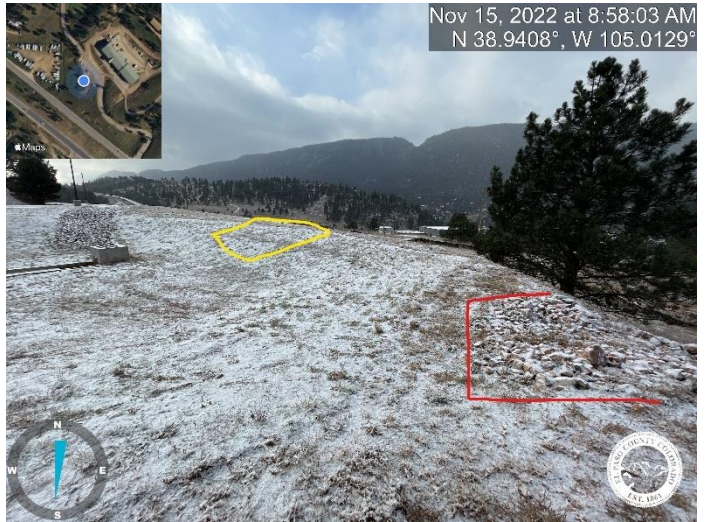
Photo 6: West detention pond; Emergency overflow path was not installed at proper location. Yellow box indicates the approximate location provided on Sheet C2.9 of the Erosion Control Plans, and the red box indicated the current installed location.

- Install the emergency overflow path at proper location. Location provided on Sheet C2.9 of the Erosion Control Plans.
- Emergency overflow path is not installed per detail. Provided detail on Sheet C2.9 shows that the path should measure 18’ at the base.
- Raise pond bottom to top of trickle channel curb with a 3% slope towards trickle channel for positive drainage.

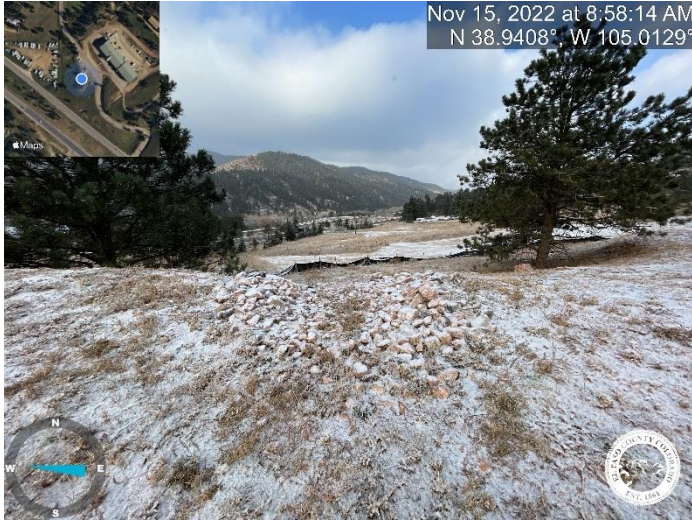
Photo 7: West detention pond; Emergency overflow path is not installed per detail. Provided detail on Sheet C2.9 shows that the path should measure 18' at the base.

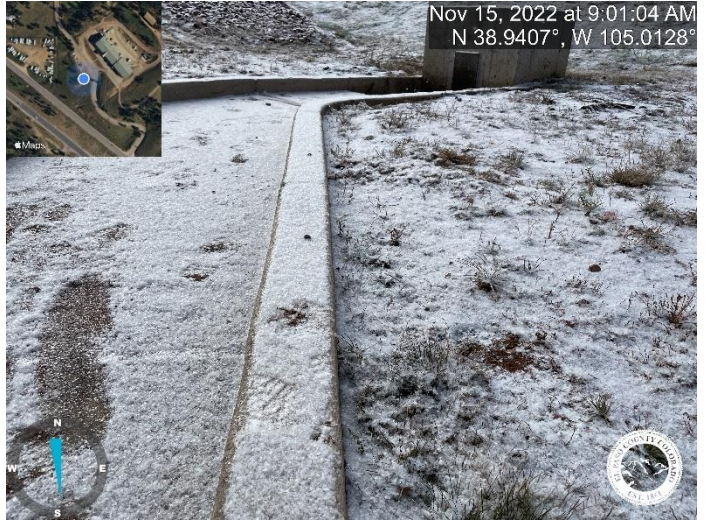
Photo 8: West extended detention pond; Raise pond bottom to top of trickle channel curb with a 3% slope towards trickle channel for positive drainage.

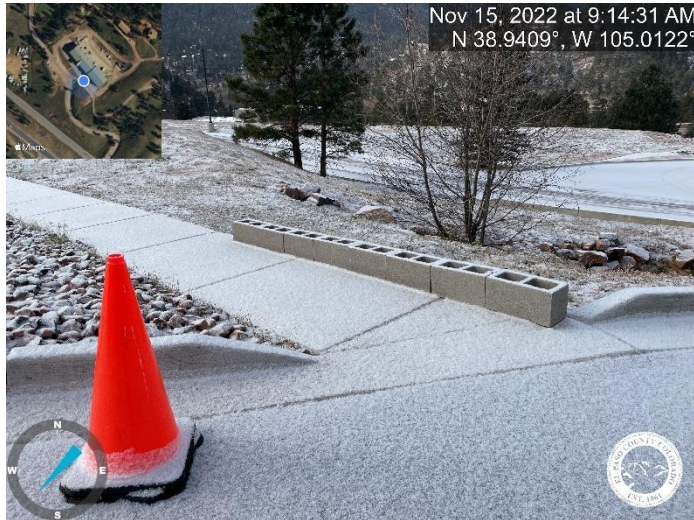
Photo 9: East detention pond; Remove temporary cinderblocks and replace with a permanent control measure (e.g., cement curb)

- Remove temporary cinderblocks along the concrete rundown and replace with a permanent control measure (e.g., cement curb).
- Remove curb to allow access to the gravel maintenance road as depicted on C2.9 of the Erosion Control Plans.
- Address erosion behind cinderblocks above STA 1+26.61.
- Pond outlet at STA 1+26.61. Remove sediment and debris to allow for positive drainage.
- Emergency overflow path is not installed per detail. Provided detail on Sheet C2.9 shows that the path should measure 18’ at the base.

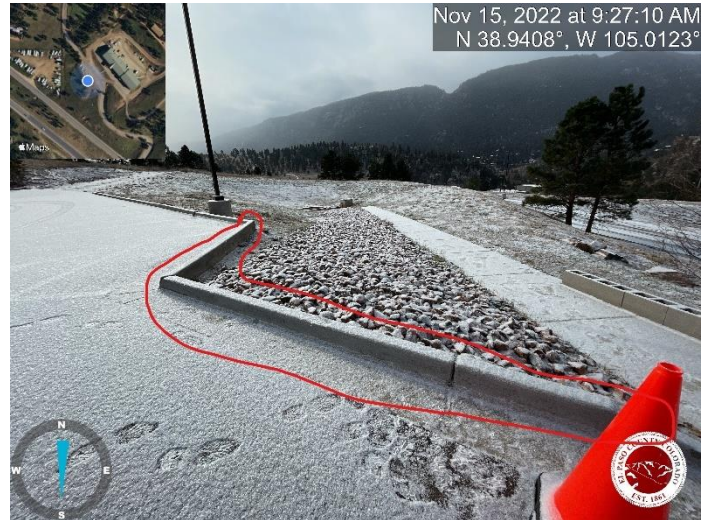
Photo 10: East detention pond; Remove curb to allow access to the gravel maintenance road as depicted on C2.9 of the Erosion Control Plans.

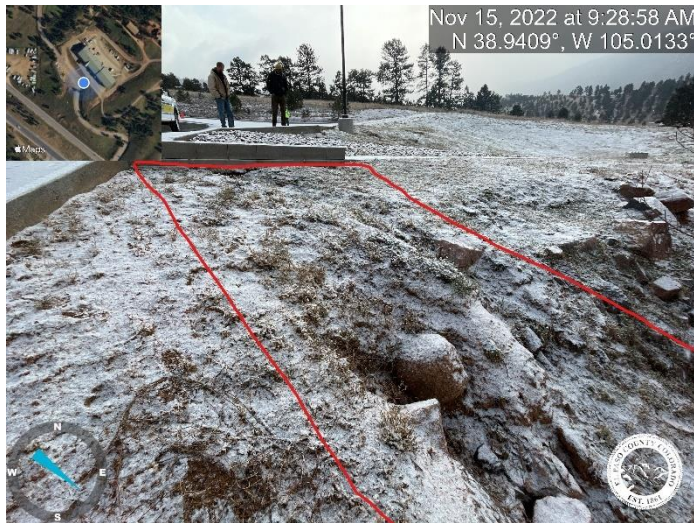
Photo 11: East detention pond; Address erosion behind cinderblocks above STA 1+26.61.

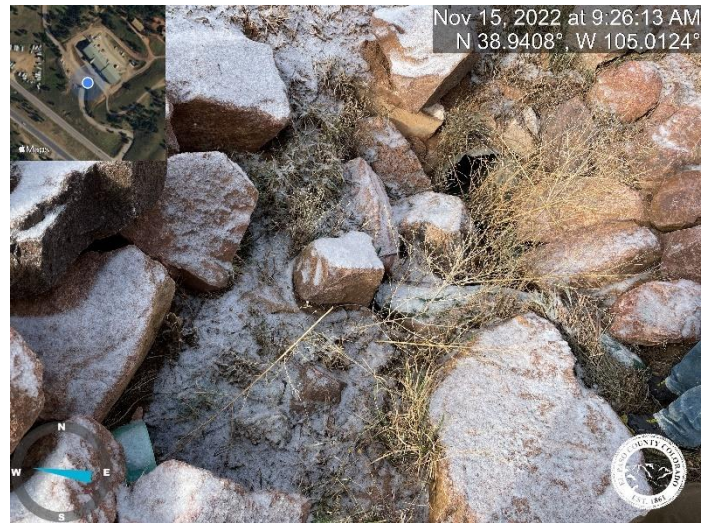
Photo 12: East detention pond outlet at STA 1+26.61. Remove sediment and debris to allow for positive drainage.

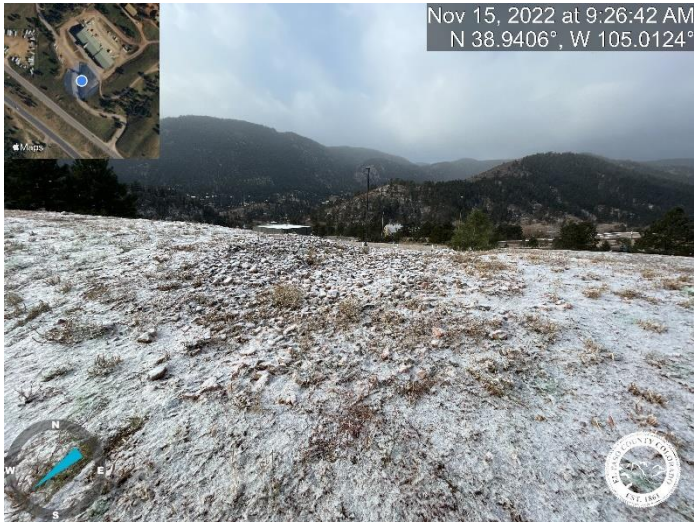
Photo 13: East detention pond; Emergency overflow path is not installed per detail. Provided detail on Sheet C2.9 shows that the path should measure 18' at the base.

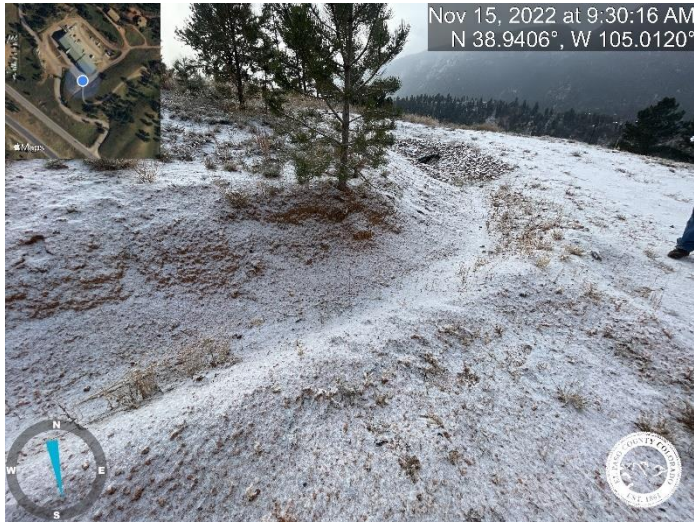
Photo 14: Fine grade ditch to promote positive drainage near STA 0+20.

- Fine grade ditch to promote positive drainage.
