Geologic Hazards Study

**Peaks Recovery Center
Colorado Springs, Colorado**

August 30, 2019
Terracon Project No. 23195078

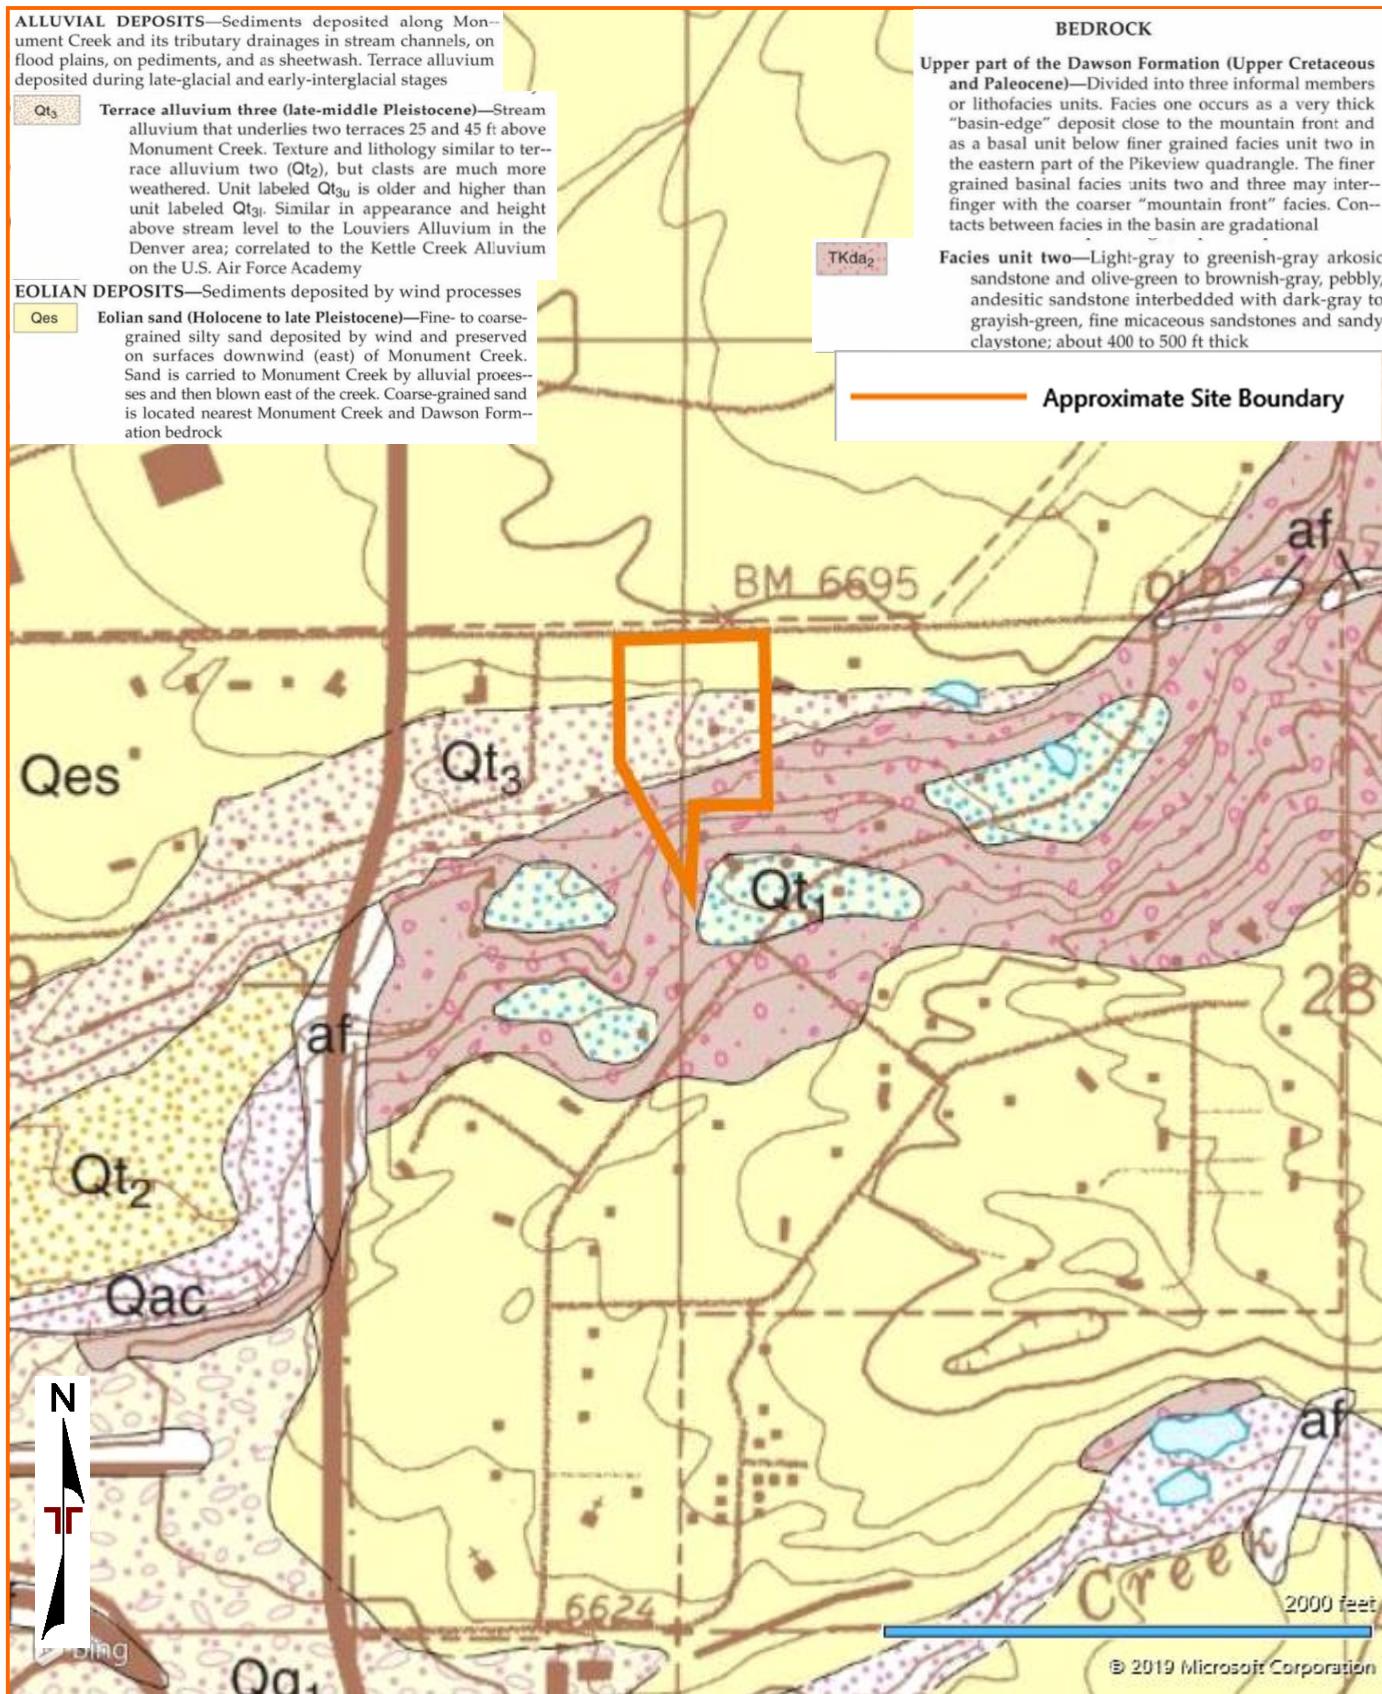
SITE GEOLOGIC MAP

Surficial geologic conditions at the site, as mapped by the Colorado Geological Survey (CGS) (¹Carroll, C.J. et al.), consists of eolian deposits of the Holocene to late Pleistocene age, terrace alluvium of late-middle Pleistocene age, and sedimentary bedrock of the Dawson Formation (Upper Cretaceous and Paleocene).

Eolian deposits are typically described as fine- to coarse-grained silty sand deposited by wind. Eolian deposits can present a risk for hydro-collapse.

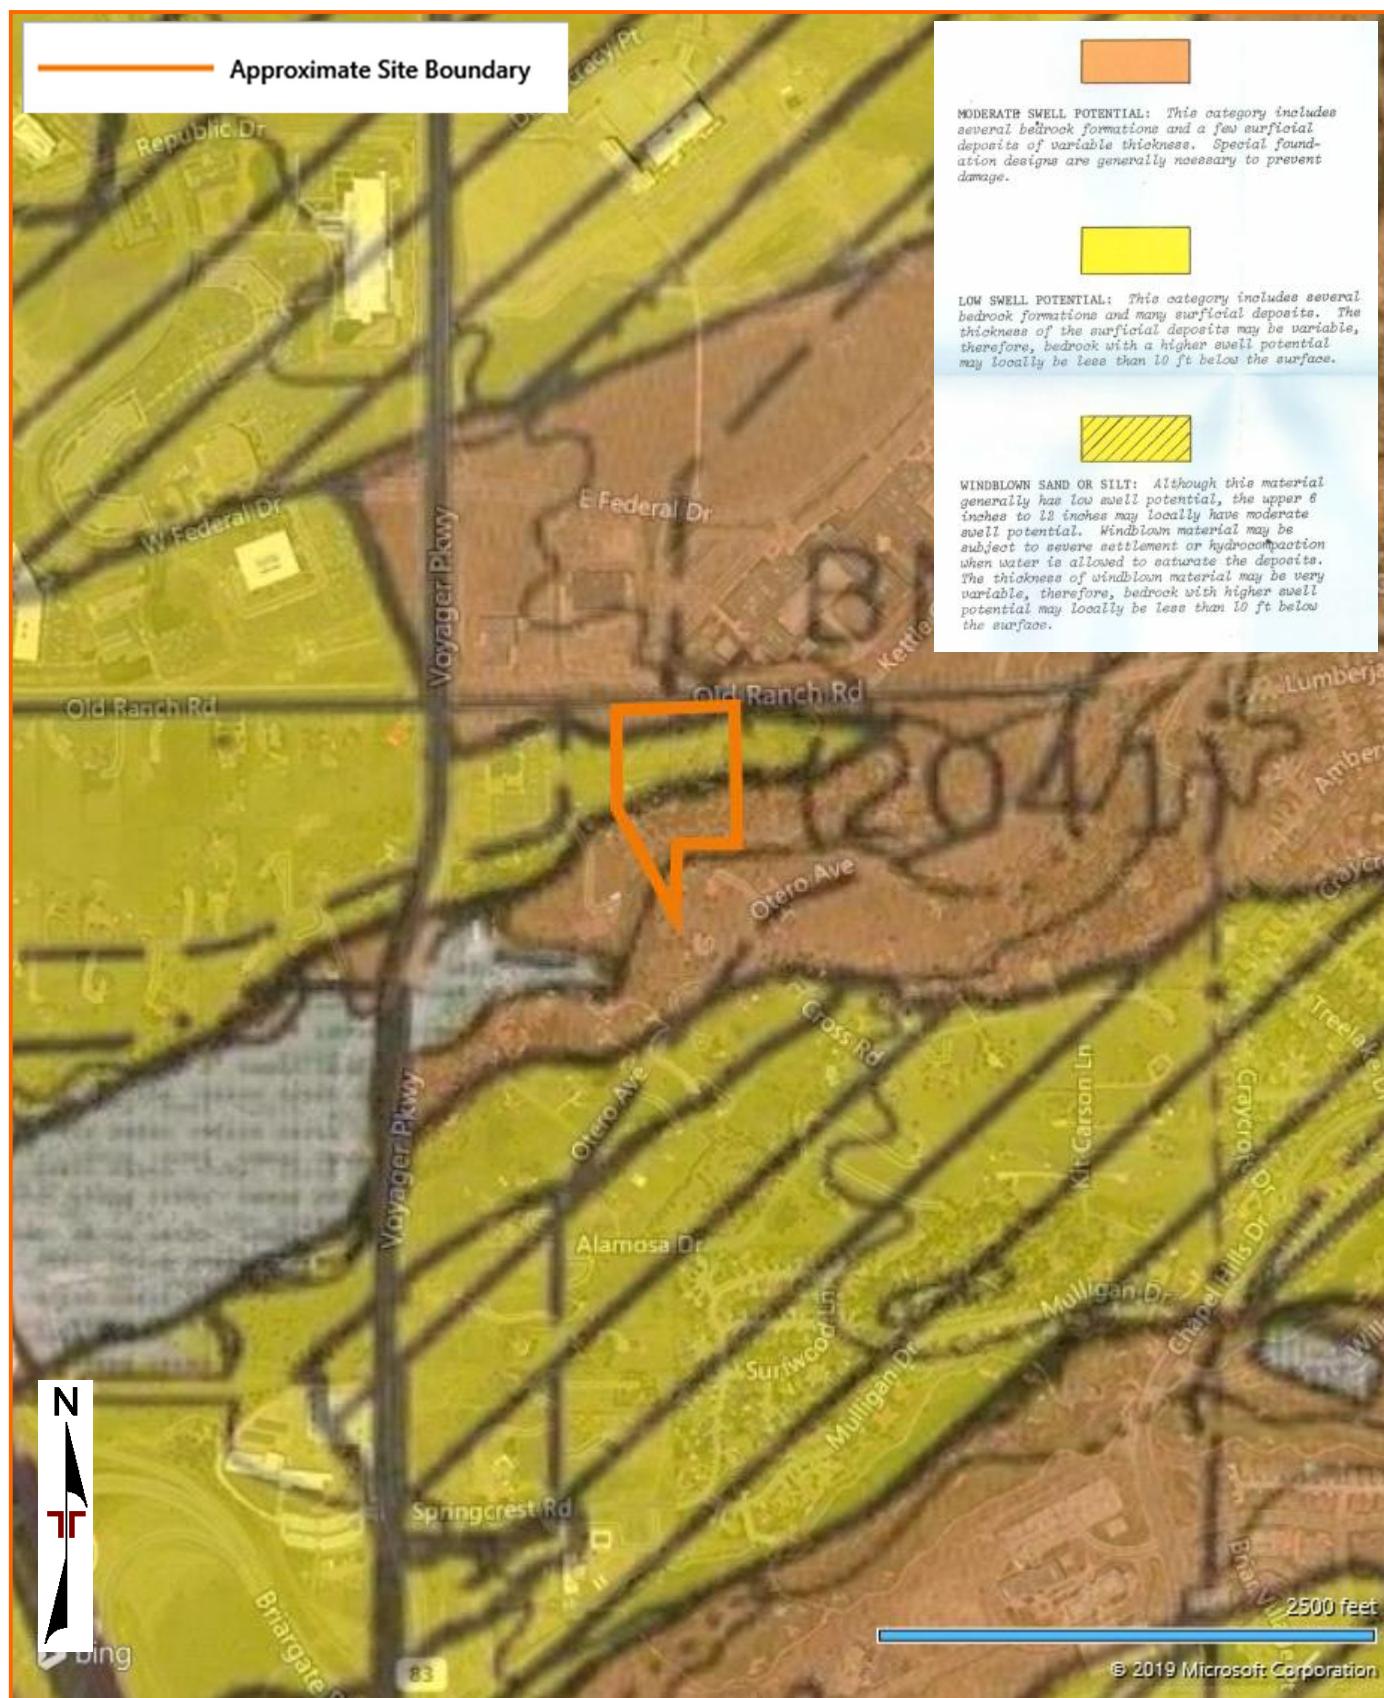
SITE POTENTIALLY SWELLING SOILS AND ROCK MAP

Mapping completed by the Colorado Geological Survey (Carroll, C.J., and Crawford, T.A, 2000; Hart, 1973-1974), indicates the site is in an area associated with low to moderate swell potential.

A full-scale geotechnical study should be performed prior to the proposed development at the site, and provide mitigation options for expansive soils and bedrock, if encountered. Expansive soils and bedrock can likely be mitigated using remedial grading activities or deep foundations and a structural floor.

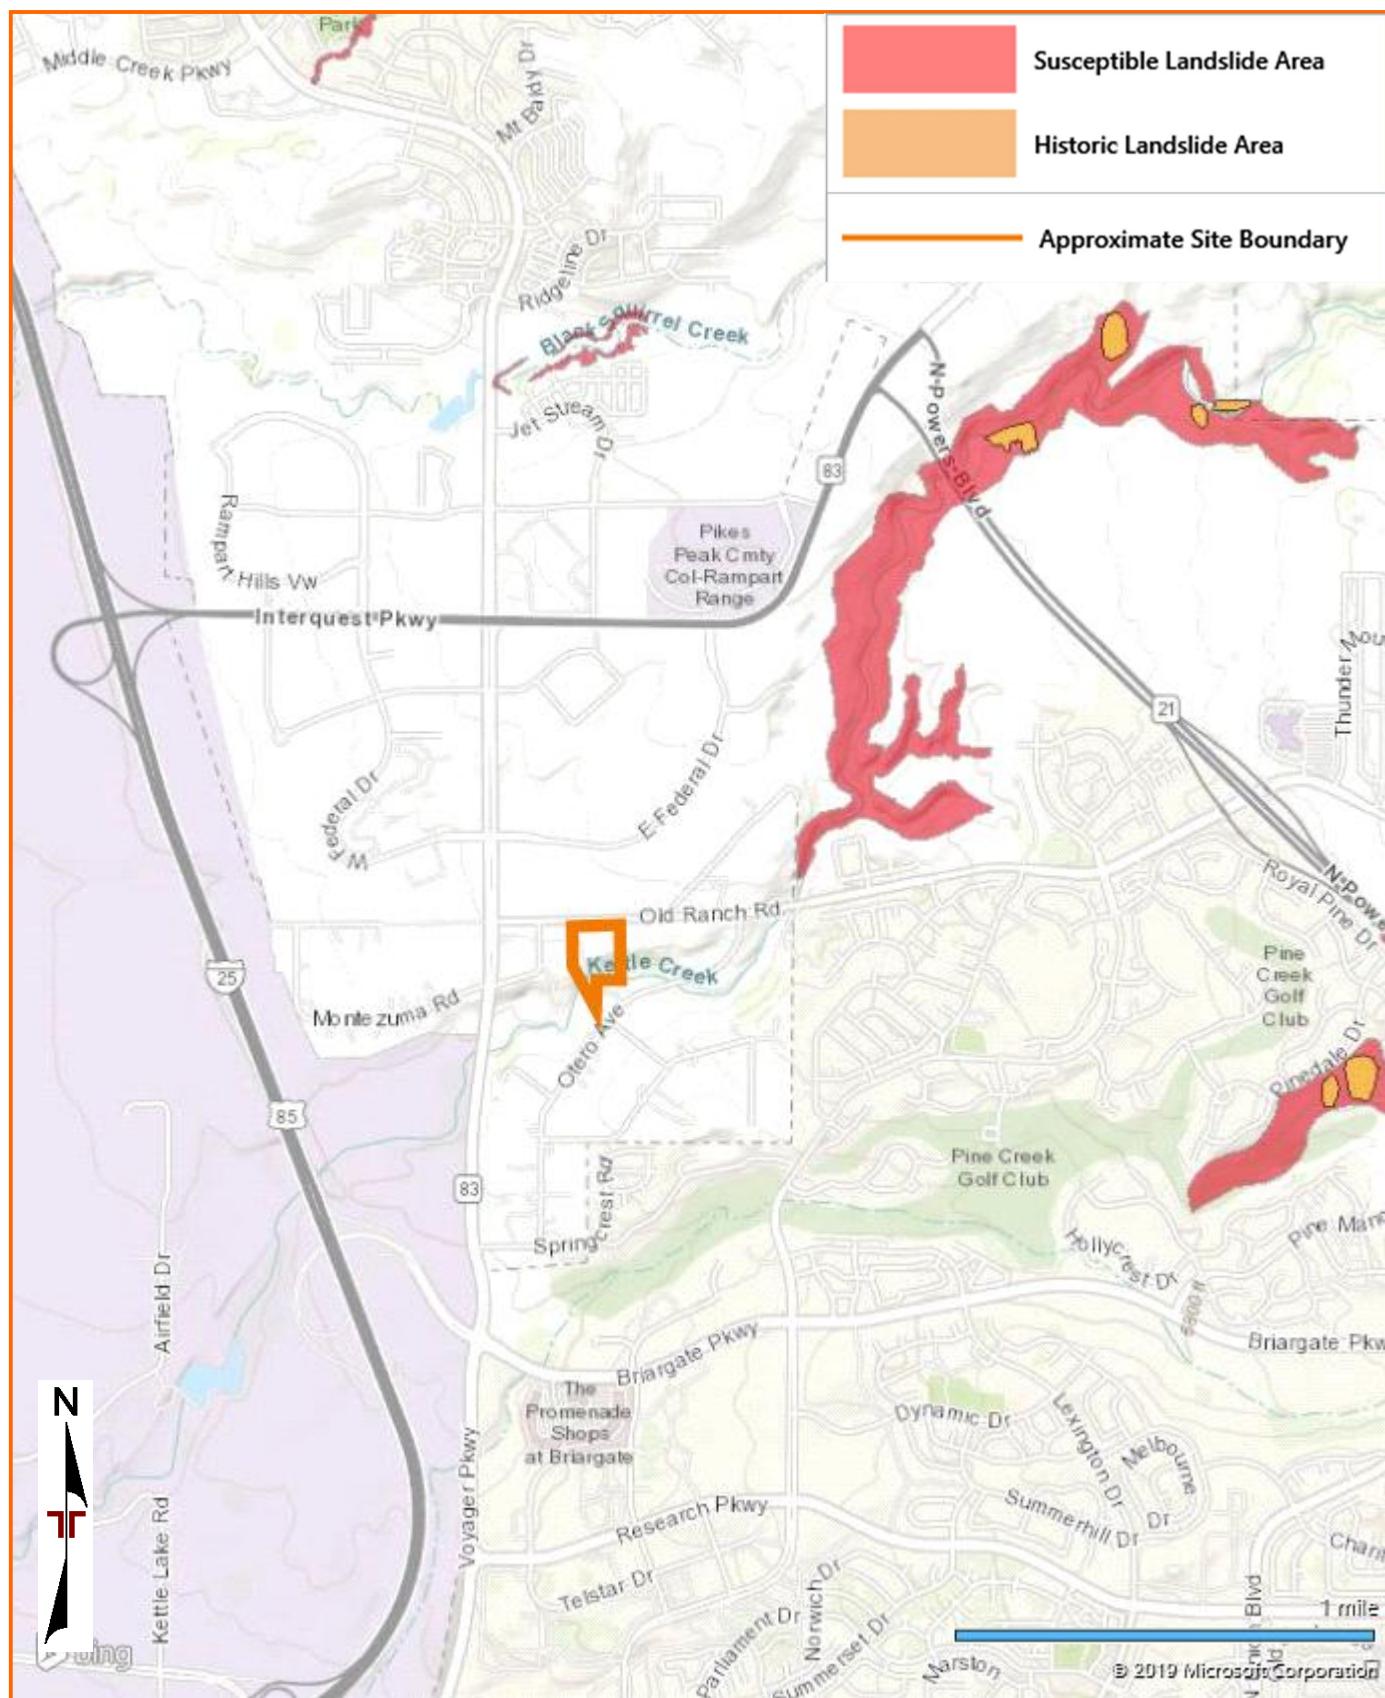
LANDSLIDE SUSCEPTIBLE AREAS MAP

Surficial geologic conditions at the site, as mapped by the Colorado Geological Survey (CGS) website (Colorado Springs Landslide Susceptibility; CGS MS-42), indicates that evidence of landslide susceptibility has not been observed at the site.

Relatively steep slopes with gradients between 1:1 to 3:1 (horizontal:vertical) and up to approximately 60 feet in height were observed along the southern portion of the site associated with the Kettle Creek drainage. It appears that these slopes are native soils. Based on the relatively steep gradients it is our opinion that the slopes could have the potential to become unstable, depending on the subsurface conditions of the slopes. During our site visit however, we did not observe indications of slope instability at the site such as pistol-butting of trees, surficial sloughing of soils, etc.

It is our understanding that planned building area are greater than 100 feet from the crest of the 3:1 slopes. Therefore, it is our opinion that the risk for potential unstable slopes to impact the development is considered very low. Should planned building areas be considered south of the existing residential structures, Terracon should be contacted for additional evaluation with respect to slope stability.

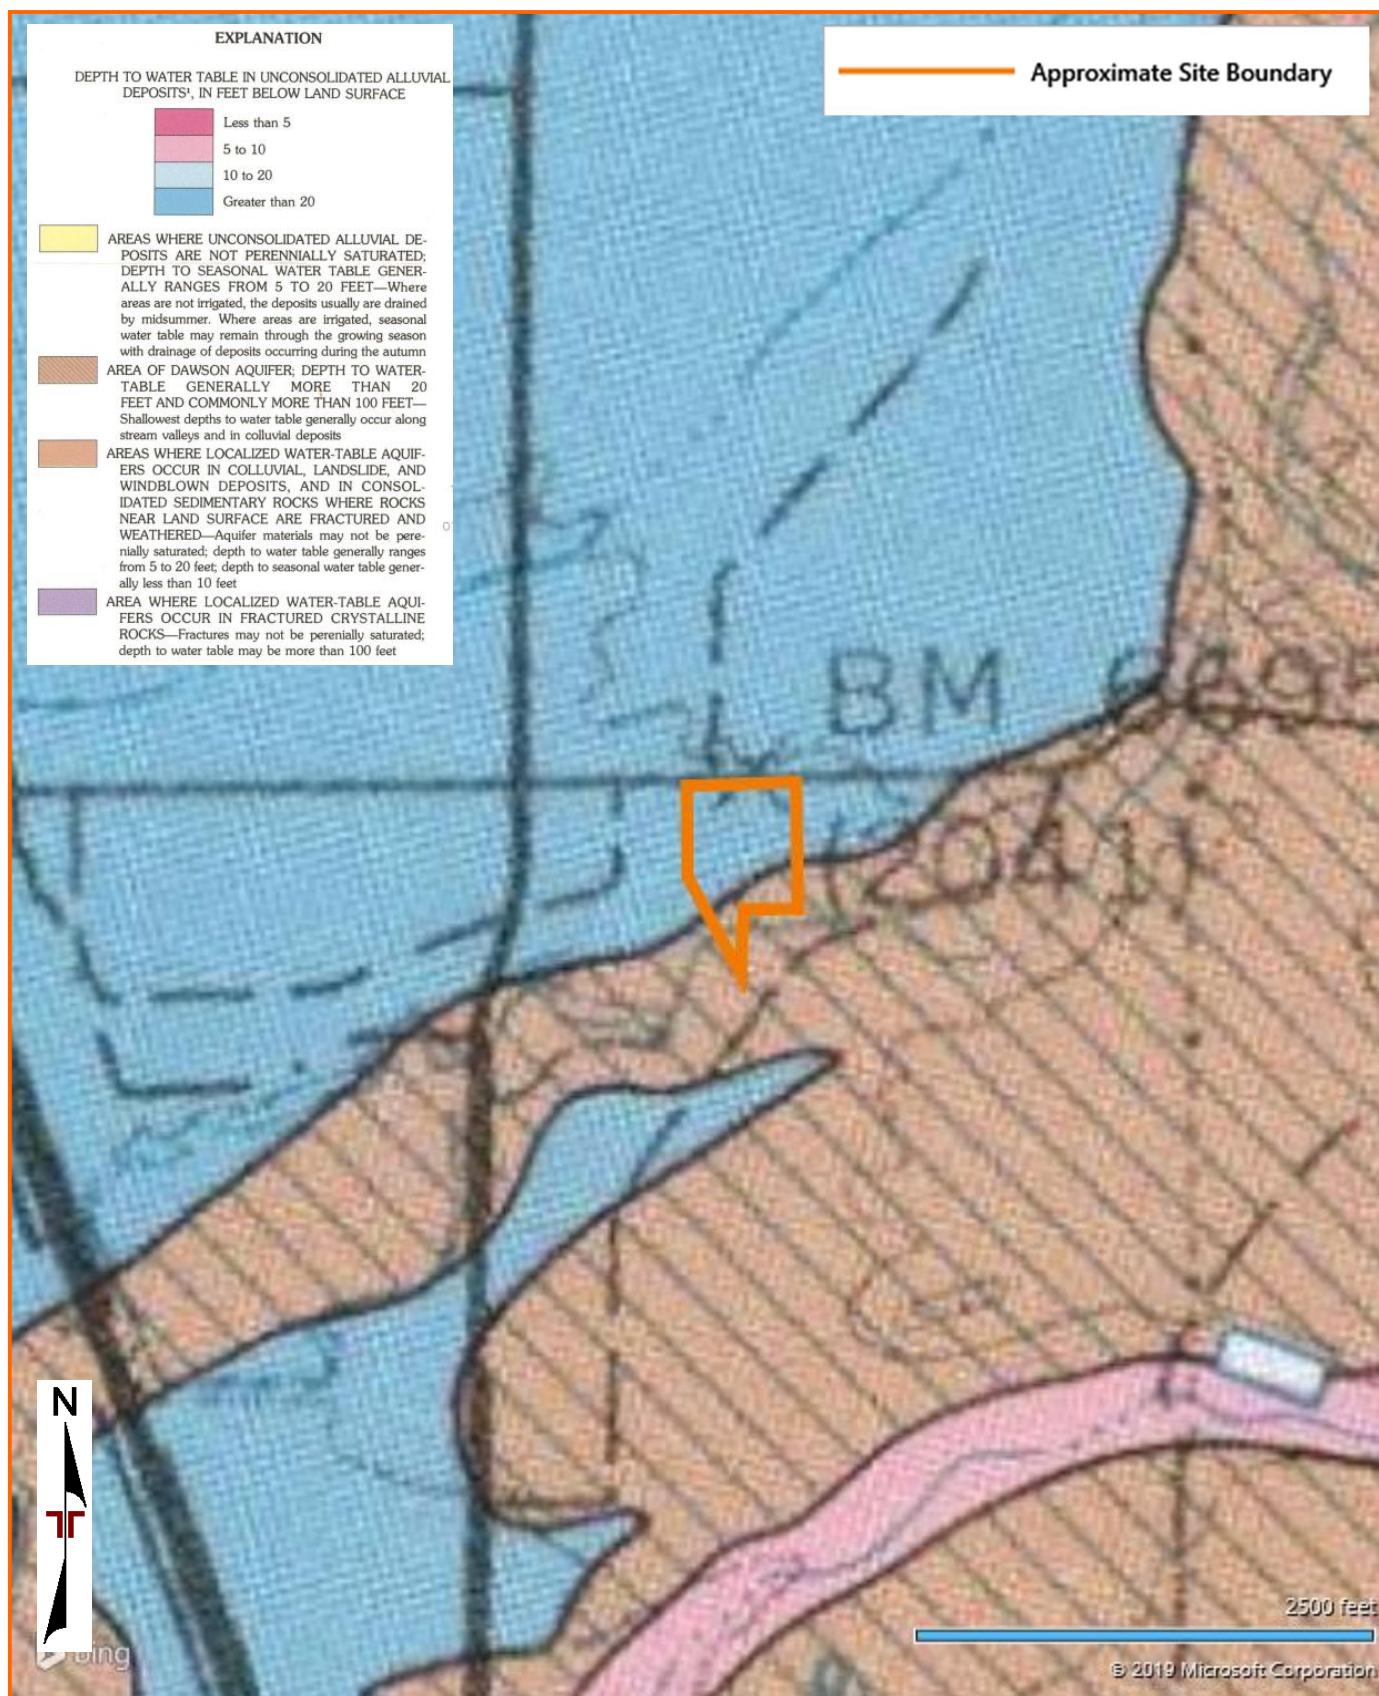
DEPTH TO WATER TABLE MAP

Shallow groundwater was not mapped at the site based upon review of the USGS Depth to Water Table in the Colorado Springs – Castle Rock Area (²Hillier and Hutchinson). The site is mapped within an area of groundwater greater than 20 feet below land surface.

Shallow groundwater may exist along the southern portion of the site near Kettle Creek, however we understand development of this site is not currently planned for this area.

Based on our understanding of the proposed project and the reviewed data, it is our opinion that the potential for shallow water to impact the proposed development is considered low. It is also our opinion that a perimeter drainage system around the proposed building is not necessary based on there not being any below grade areas planned for the development.

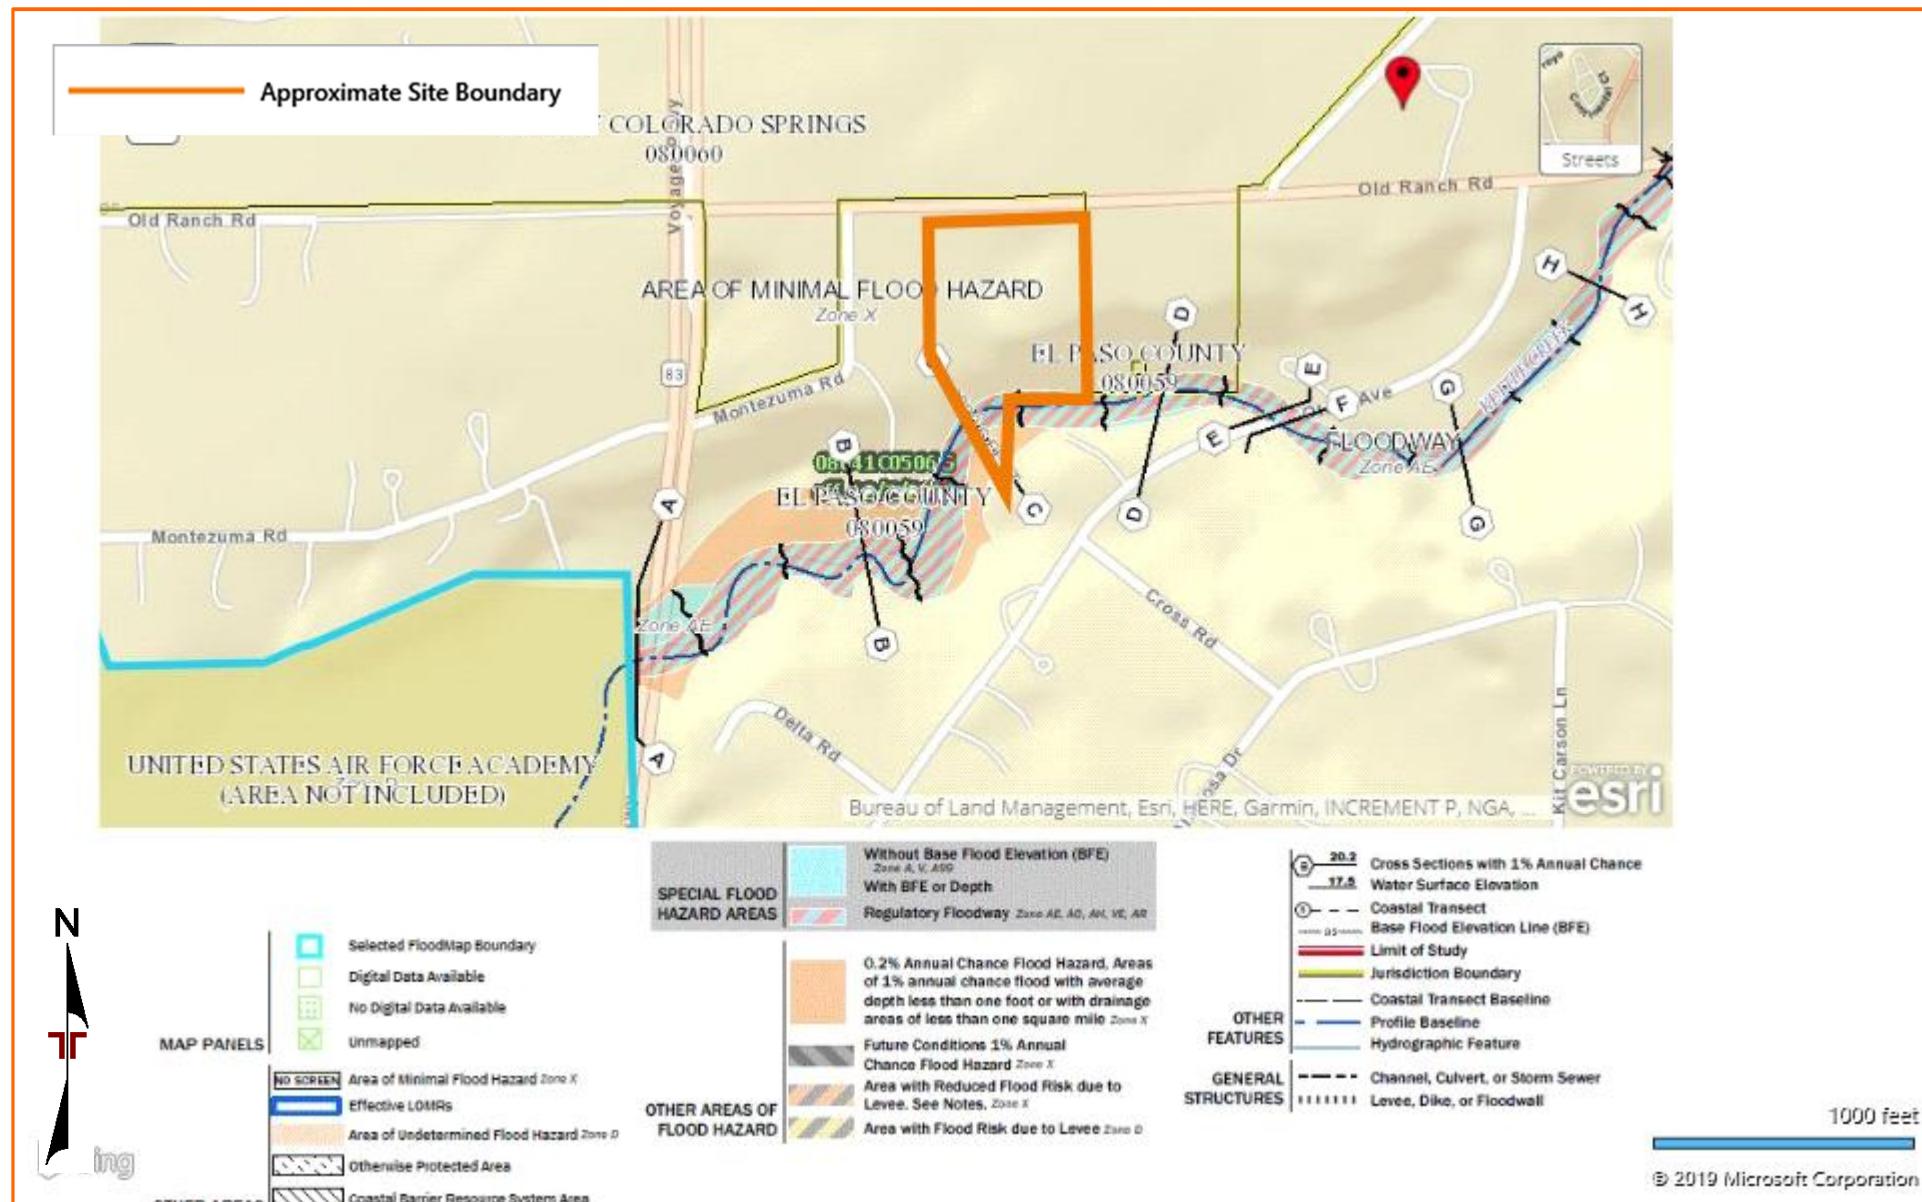
FEMA FLOOD PRONE AREAS MAP

Based on a review of the Federal Emergency Management Agency (FEMA) Special Flood Hazard Areas Inundated by 100-year Flood Map, the areas within the Kettle Creek drainage at the subject property are shown to be within Zone ‘AE’ and Zone ‘X’, which are defined as “Special Flood Hazard Areas Inundated by 100-year Flood” and ‘areas between the limits of the 500-year flood’, respectively. The reported elevation profile of the 100-year flood extends from about 6,621 feet to 6,627 feet along the Kettle Creek drainage in the southern portion of the site. Information provided to us indicates that proposed development at the site is outside the 100-year flood and 500-year flood plains. Therefore, it is our opinion that there is a very low risk for flood prone areas to impact the proposed development.
