Preliminary Acceptance Punchlist
El Paso County – Department of Public Works - Stormwater Section

Project Name:	Solace of Colorado Springs Channel Improvement
EDARP Filing Number(s):	CON2165, SF2032
ESQCP Number:	ESQ2142
Attendees:	DPW Stormwater: Natasha Grimaldo DPW Development Services: Brad Walters and David Parkerson Developer: Kelsey York and Manmit Jadav
Date of Walk-Thru:	01/31/2024
Walk-Thru Number:	1 st

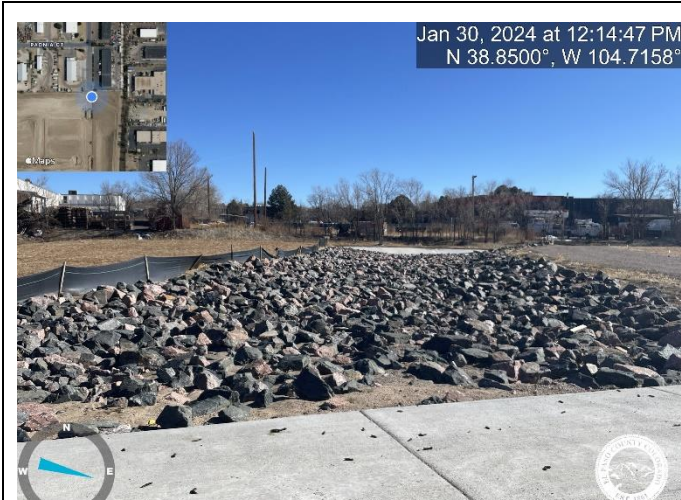
- The Paonia Street Emergency Overflow design calls for 24” deep Type M Soil Riprap. Reference Sheets 4 and 10, Overflow Channel Section B-B of the Channel Improvement Plans. Reference Photo 1.

Photo 1: Overflow channel: Plans call for 24" deep Type M Soil Riprap. Reference sheet 4 of the channel Improvement plans.

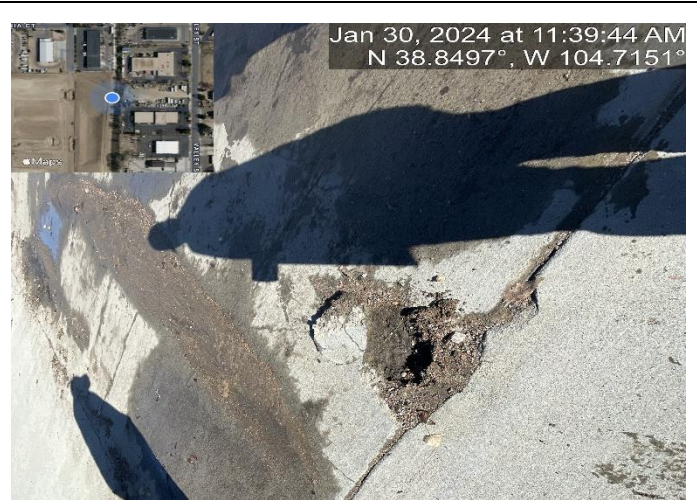
Photo 2: Approximately STA 14+05: Repair chipped concrete.

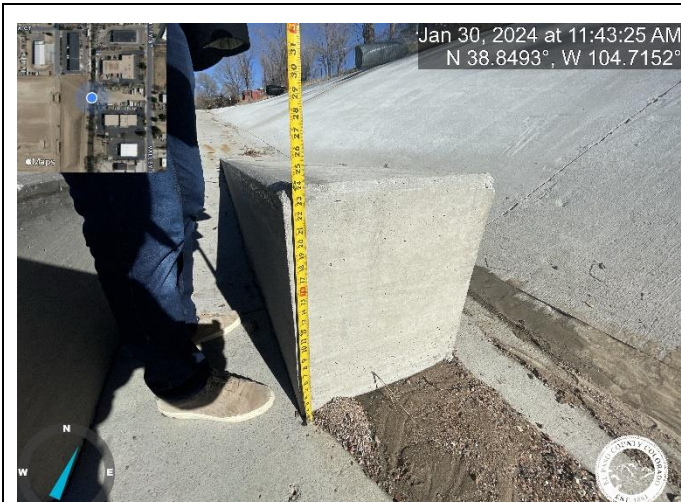
Photo 3: Concrete Baffle Blocks deviate from approved design. Plans call for a height of 1.68'. Reference deviation on the As-builts.

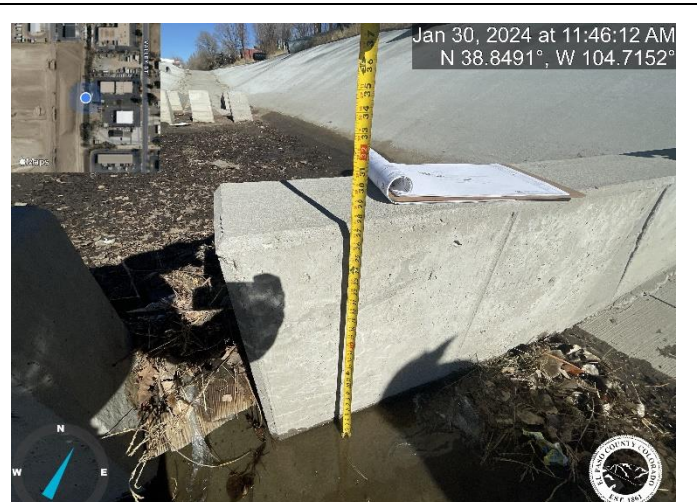
Photo 4: Concrete Sill Wall at STA 13+05 deviates from approved design. Plans call for a height of 2.25'. Reference deviation on the As-builts.

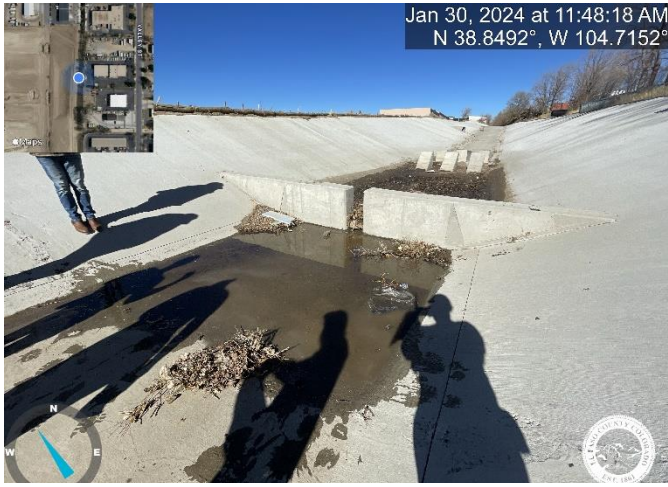
Photo 5: Approximately STA 13+00: Low spot is causing water accumulation. Adjust grade to match the approved 1% slope to promote positive drainage.

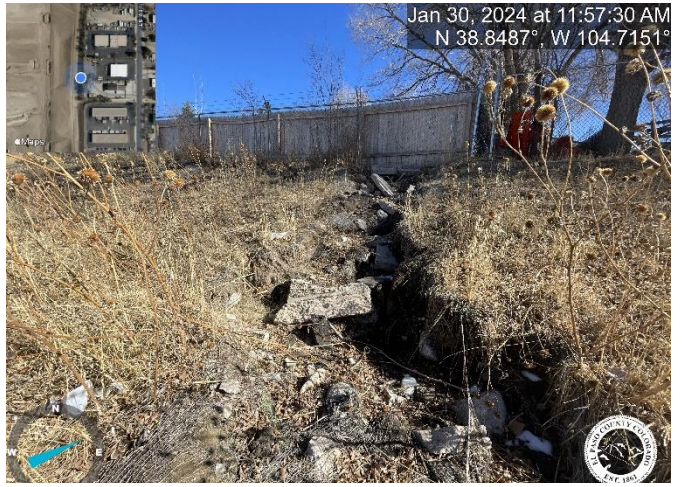
Photo 6: Approximately STA 11+00: Fine grade rill erosion along slope and stabilize.

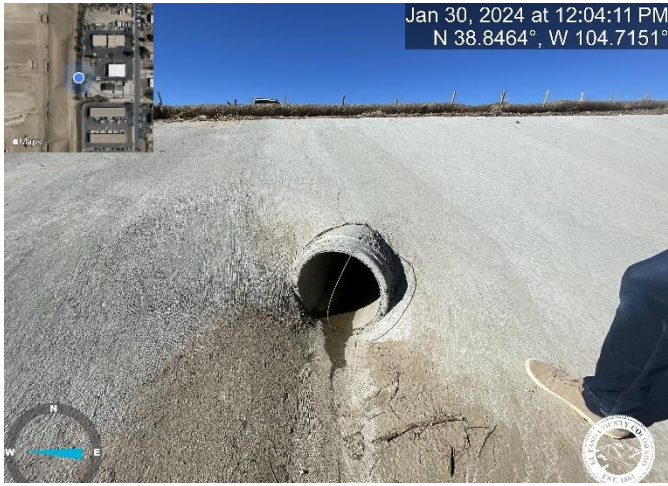
Photo 7: Ponds A and B: Plans call for a flared end section at outlet pipe from the ponds. Reference deviation on the As-builts.
