**Preliminary Acceptance Punchlist**  
**El Paso County – Department of Public Works - Stormwater Section**

Project Name:	Solace of Colorado Springs
EDARP Filing Number(s):	CON2165, SF2032
ESQCP Number:	ESQ2142
Attendees:	<b>DPW Stormwater:</b> Natasha Grimaldo <b>DPW Development Services:</b> Brad Walters and David Parkerson <b>Developer:</b> Kelsey York and Manmit Jadav
Date of Walk-Thru:	01/31/2024
Walk-Thru Number:	1 <sup>st</sup>

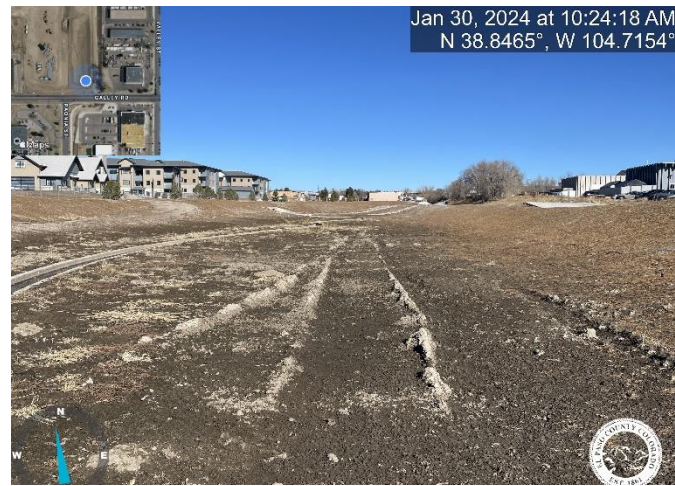
Photo 1: Pond B: Fine grade Pond bottom to match the approved grade.

- Fine grade Pond bottom to match the approved grade. Reference Photo 1.
- Grade Pond bottom to be flush with the top of the trickle channel curb with a 3% slope towards trickle channel for positive drainage. Reference Photo 2.
- Fine grade rill erosion around Forebays B1 and B2 and stabilize/vegetate. Reference Photos 3 and 8.
- Remove exposed rebar from Forebay B1 and B2. Reference Photo 4 and 10.
- Remove exposed wire from Forebay B2. Reference Photo 5.

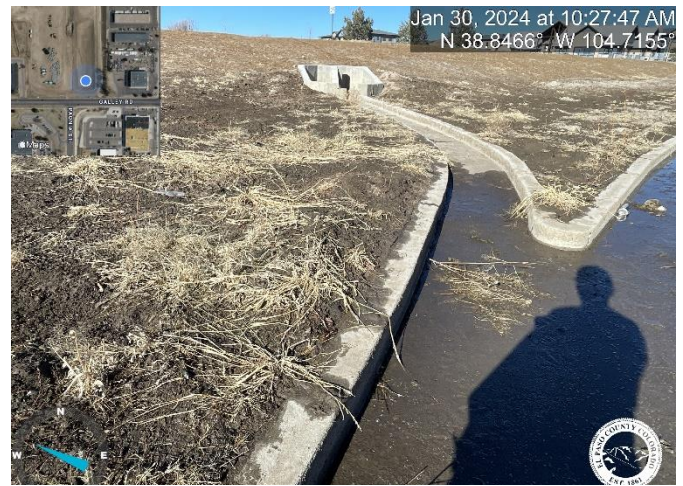
Photo 2: Pond B: Grade Pond bottom to be flush with the top of the trickle channel curb with a 3% slope towards trickle channel for positive drainage.

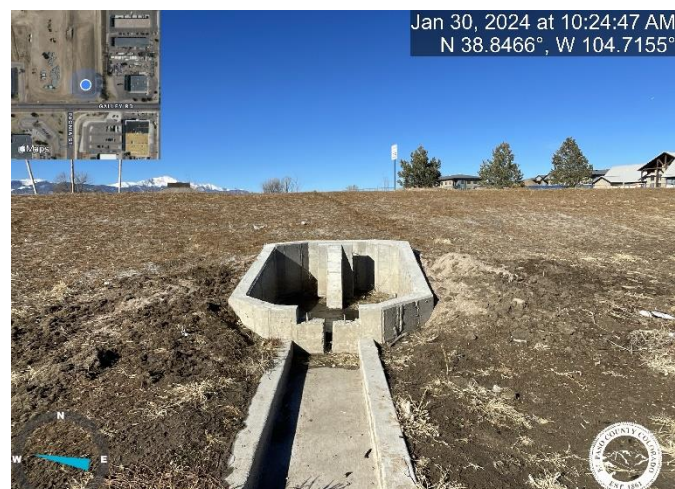
Photo 3: Pond B: Fine grade rill erosion around forebay B2 and stabilize.

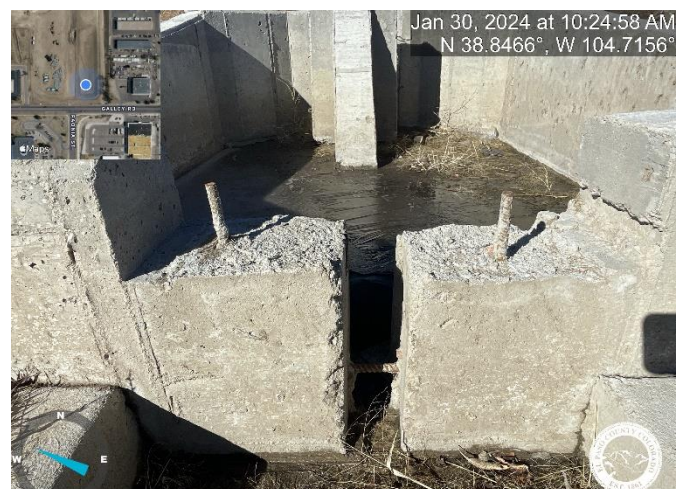
Photo 4: Pond B: Remove exposed rebar from forebay B2.

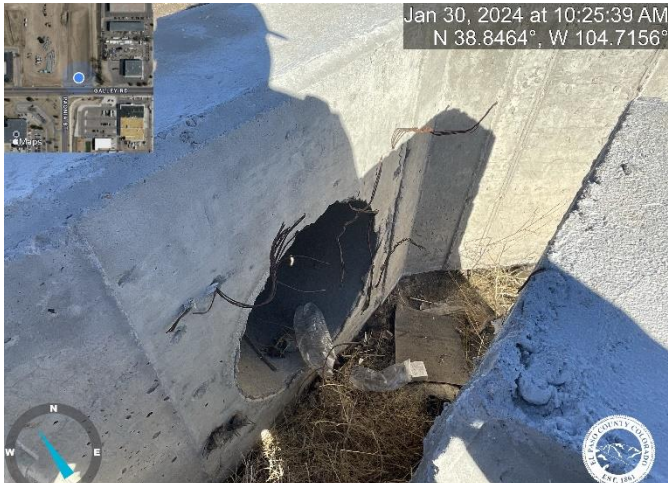
Photo 5: Pond B: Remove exposed wire from forebay B2.

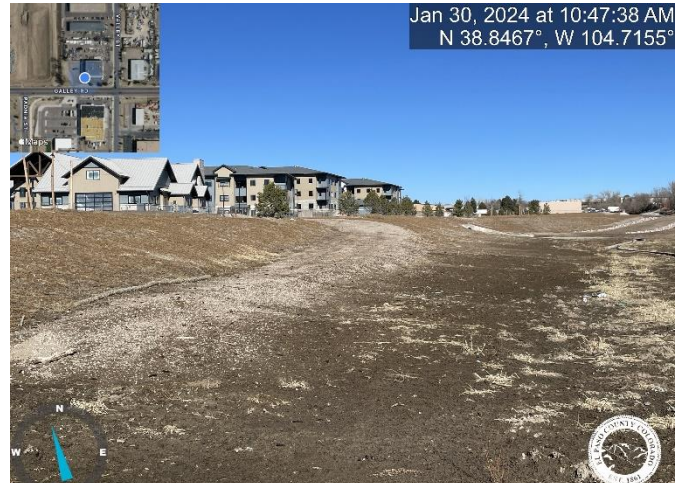
Photo 6: Pond B: Maintenance access should be flush with the grade at a 2% slope. Maintenance access road should be 15' in width. Reference Sheet 22 of the Construction Drawings.

- Maintenance access should be flush with the grade at a 2% slope. Maintenance access road should be 15' in width. Reference Sheet 22 of the Construction Drawings. Reference Photo 6.

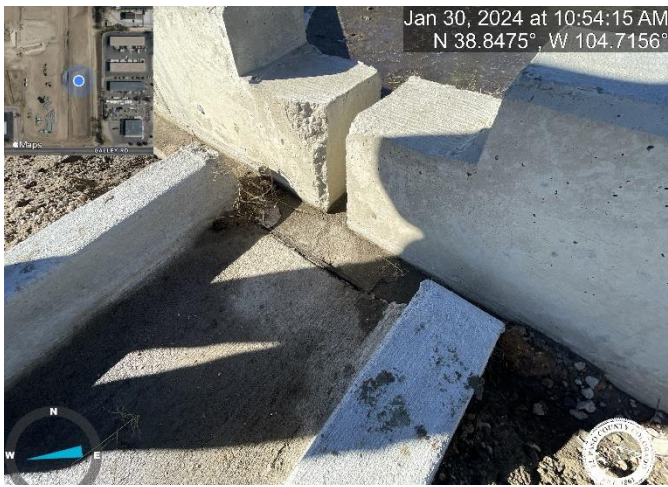
Photo 7: Pond B: Extend trickle channel to be flush with forebay B1.

- Extend trickle channel to be flush with Forebay B1. Reference Photo 7.
- Confirm installation of 8" class 6 aggregate base course or 12" class 6 aggregate base course. Reference Sheet 22 of the Construction Drawings. Reference Photo 9.

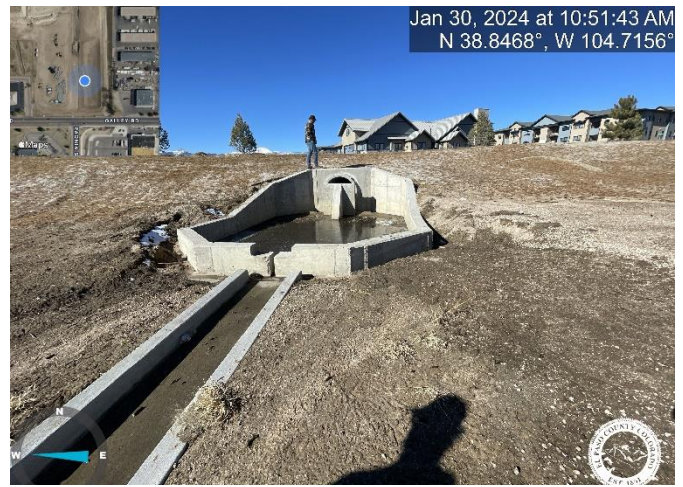
Photo 8: Pond B: Fine grade rill erosion around forebay B1 and stabilize.

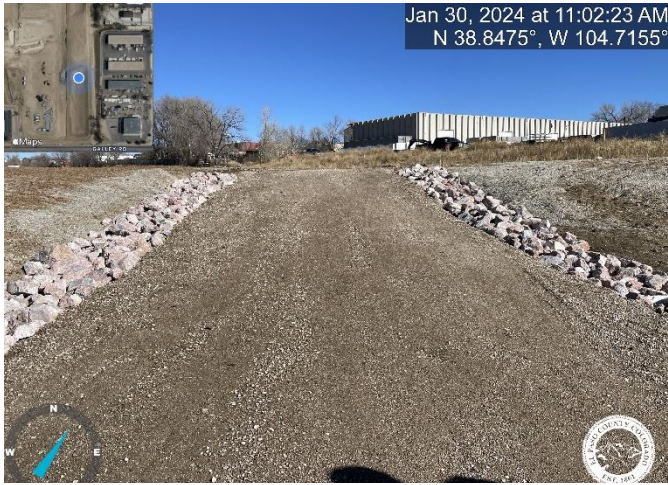
Photo 9: Pond B: Confirm installation of 8" class 6 aggregate base course or 12" class 6 aggregate base course. Reference Sheet 22 of the Construction Drawings.

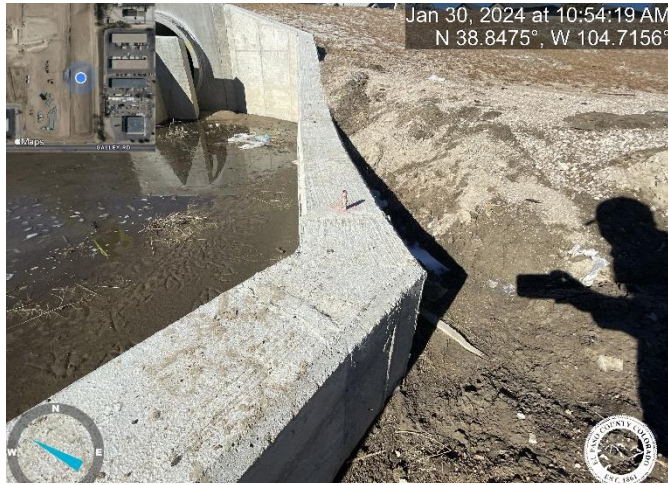
Photo 10: Remove exposed rebar from forebay B1.

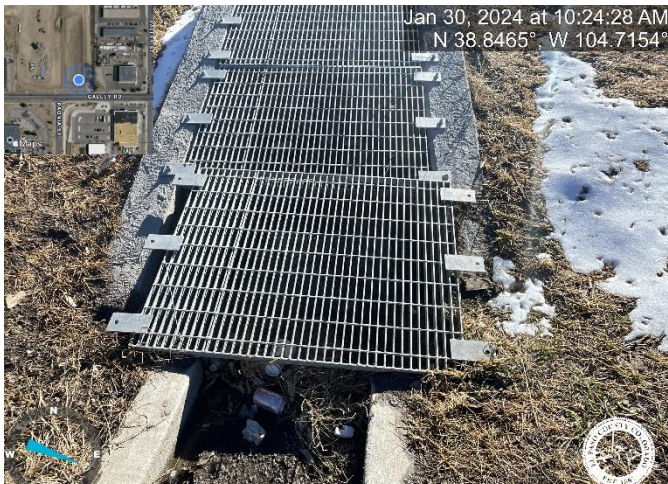
Photo 11: Pond B: Failure to install properly sized trash racks. Reference Sheet 23 of the Construction Drawings.

- Failure to install properly sized trash racks. Reference Trash Screen Detail on Sheet 23 of the Construction Drawings. Reference Photo 11.
- Micropool is not holding water to the invert of the bottom hole on the orifice plate. This indicated that the orifice plate does not have a watertight seal. Confirm installation of gasket between the orifice plate and concrete structure. Reference Photo 12.

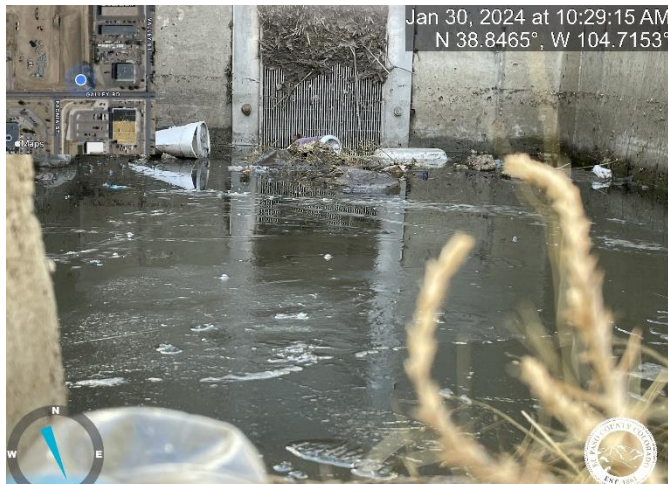
Photo 12: Pond B: Micropool is not holding water to the invert of the bottom hole on the orifice plate. This indicated that the orifice plate does not have a watertight seal.

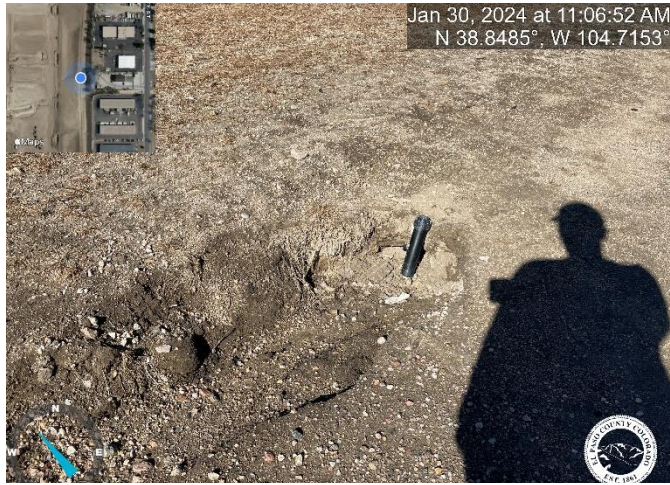
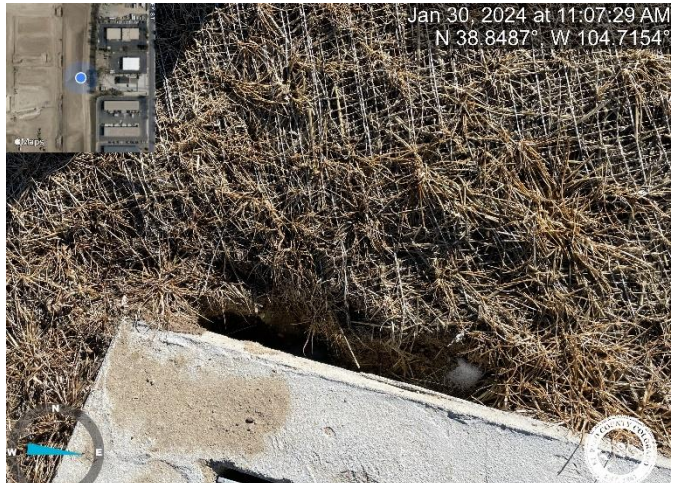
Photo 13: Pond A: Fine grade rill erosion behind the outlet structure and stabilize.

Photo 14: Pond A: Fine grade rill erosion behind the outlet structure and stabilize.

- Fine grade rill erosion behind the outlet structure and stabilize. Reference Photo 13 and 14.
- Micropool is not holding water to the invert of the bottom hole on the orifice plate. This indicated that the orifice plate does not have a watertight seal. Confirm installation of gasket between the orifice plate and concrete structure. Reference Photo 15.

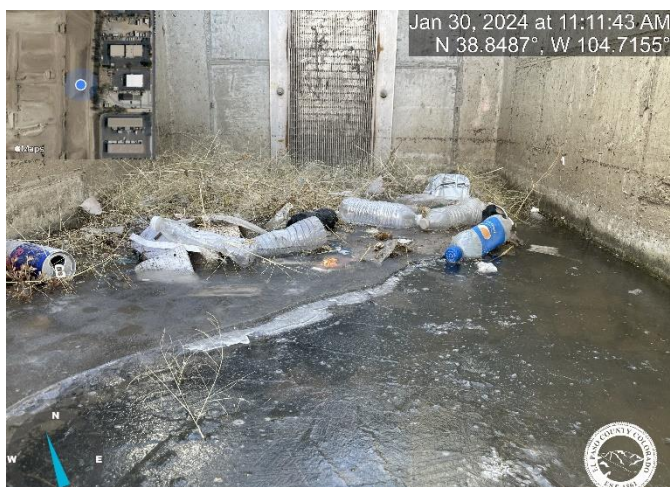
Photo 15: Pond A: Micropool is not holding water to the invert of the bottom hole on the orifice plate. This indicated that the orifice plate does not have a watertight seal.

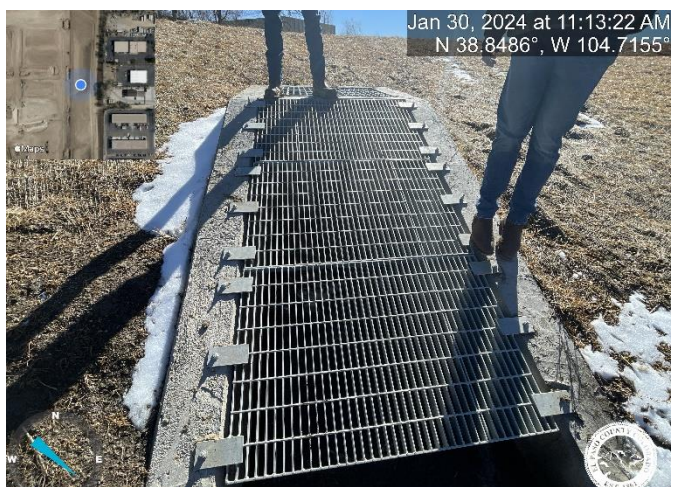
Photo 16: Pond A: Failure to install properly sized trash racks. Reference Sheet 19 of the Construction Drawings.

- Clean out sediment and debris from outlet structure and trickle channel.
- Failure to install properly sized trash racks. Reference Trash Screen Detail on Sheet 19 of the Construction Drawings. Reference Photo 16.

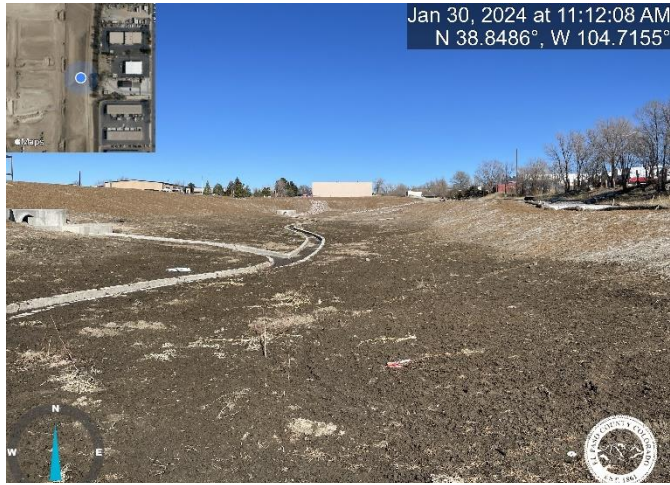
Photo17: Pond A: Fine grade Pond bottom to match the approved grade.

- Fine grade Pond bottom to match the approved grade. Reference Photo 17.
- Grade Pond bottom to be flush with the top of the trickle channel curb with a 3% slope towards trickle channel for positive drainage. Reference Photo 18.

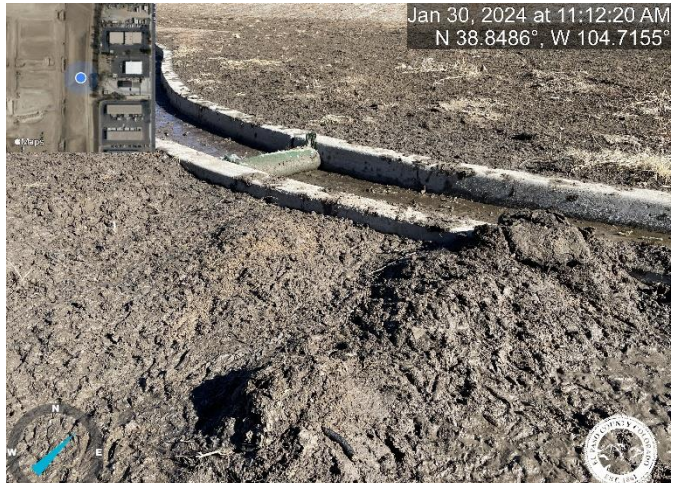
Photo 18: Pond A: Grade Pond bottom to be flush with the top of the trickle channel curb with a 3% slope towards trickle channel for positive drainage.

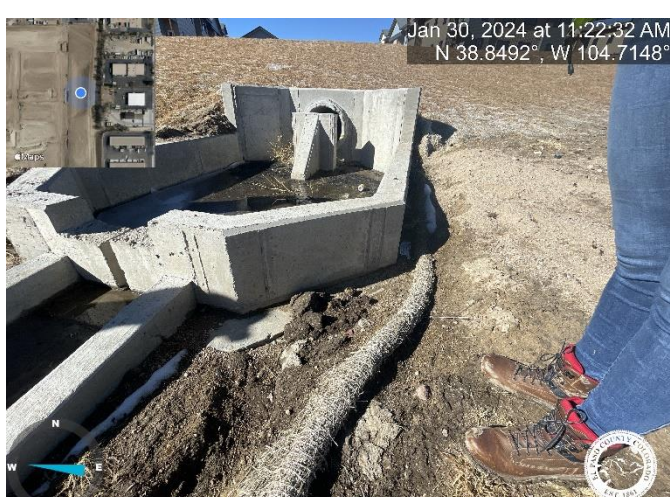
Photo 19: Pond A: Fine grade rill erosion around forebay and stabilize.

- Fine grade rill erosion around Forebays A1 and A2 and stabilize/vegetate.
- Raise grade to be flush with the Emergency Overflow Spillway. Reference Photo 21.

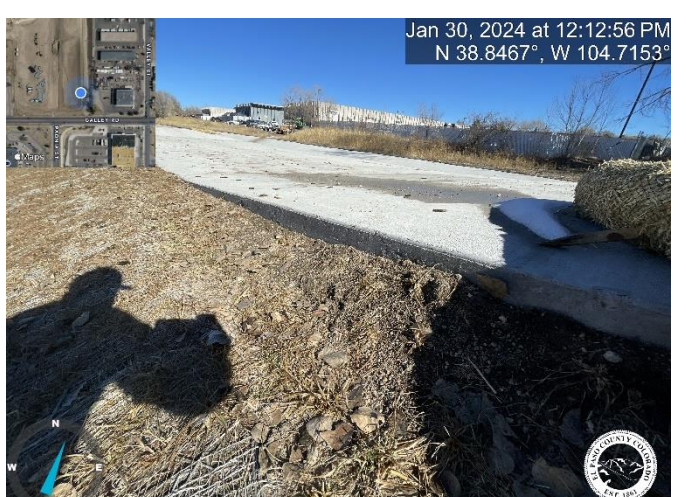
Photo 20: Pond B: Raise grade to be flush with the Emergency Overflow Spillway.

- Clean out sediment and debris from outlet structure and trickle channel.
- Raise grade to be flush with the Emergency Overflow Spillway. Reference Photo 20.

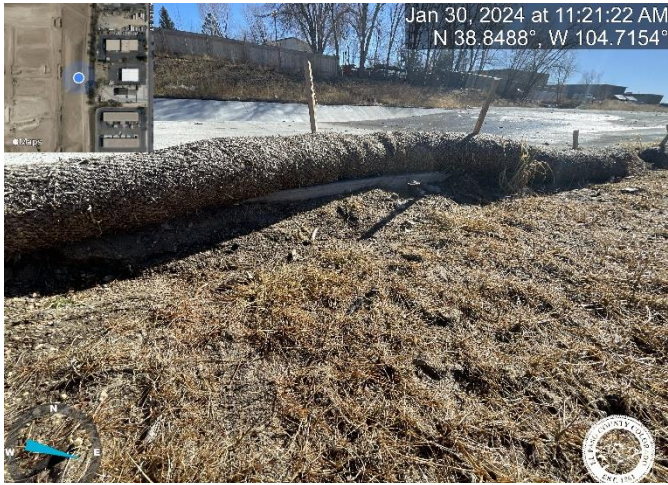
Photo 21: Pond A: Raise grade to be flush with the Emergency Overflow Spillway.

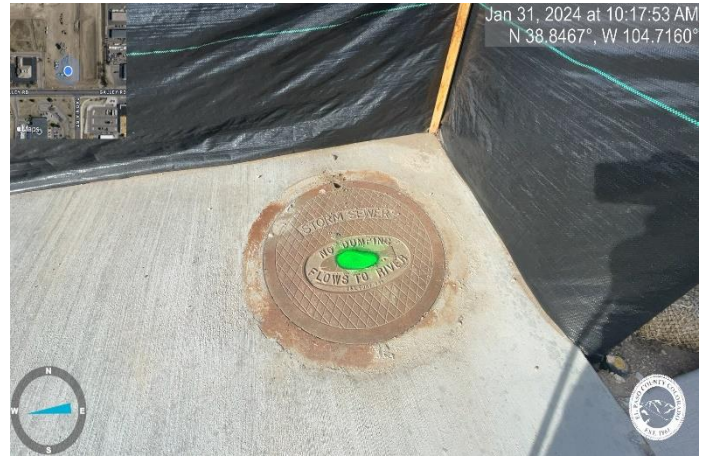
Photo 22: Inlets that need to be cleaned of sediment and debris are marked with green paint on manhole lid (photo is an example of marked inlet).

- STA 12+65.01: Install manhole lid. Reference Photo 24.
- STA 12+12.45: Install manhole lid. Reference Photo 25.
- Inlets that need to be cleaned of sediment and debris are marked with green paint on manhole lid
- Area drain inlets that need to be cleaned of sediment and debris are marked with green paint on the grate Reference Photos 22, 23, and 26.

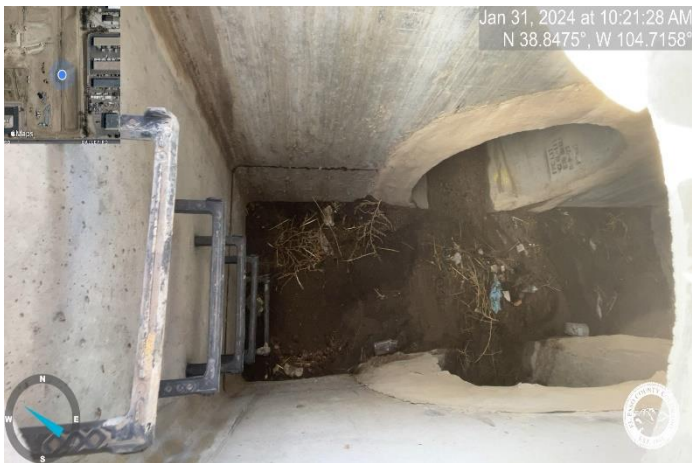
Photo 23: Example of inlet that needs to be cleaned.

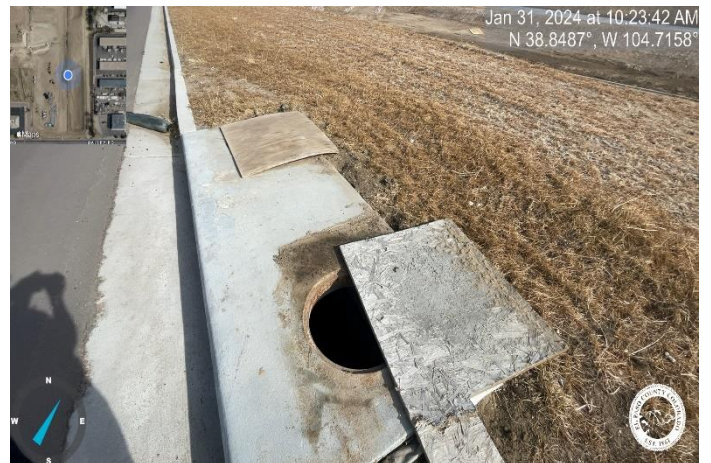
Photo 24: Inlet at STA 12+65.01: Install manhole lid.

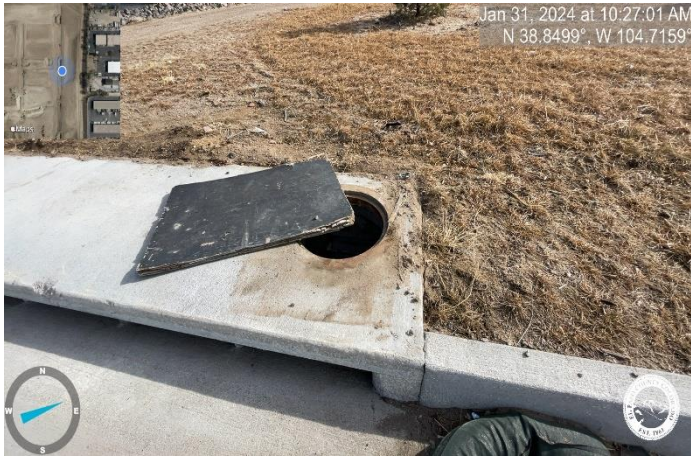
Photo 25: Inlet at STA 12+12.45: Install manhole lid.

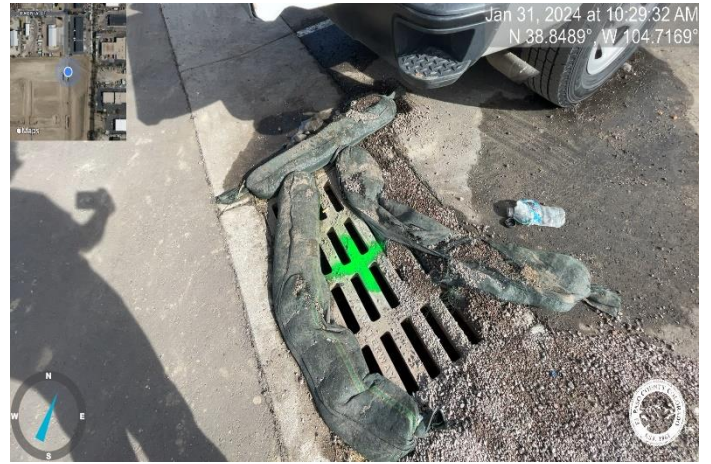
Photo 26: Area drain inlets that need to be cleaned of sediment and debris are marked with green paint on the grate (photo is an example of marked inlet).
