**SOIL, GEOLOGY, AND GEOLOGIC HAZARD STUDY
EAGLEVIEW SUBDIVISION
ARROYA LANE & RAYOR ROAD
PARCEL NO. 52260-00-001 & 52260-00-002
EL PASO COUNTY, COLORADO**

November 19, 2021
Revised August 22, 2022

Entech Job No. 212684
AAprojects/2021/212684 countysoil/geo

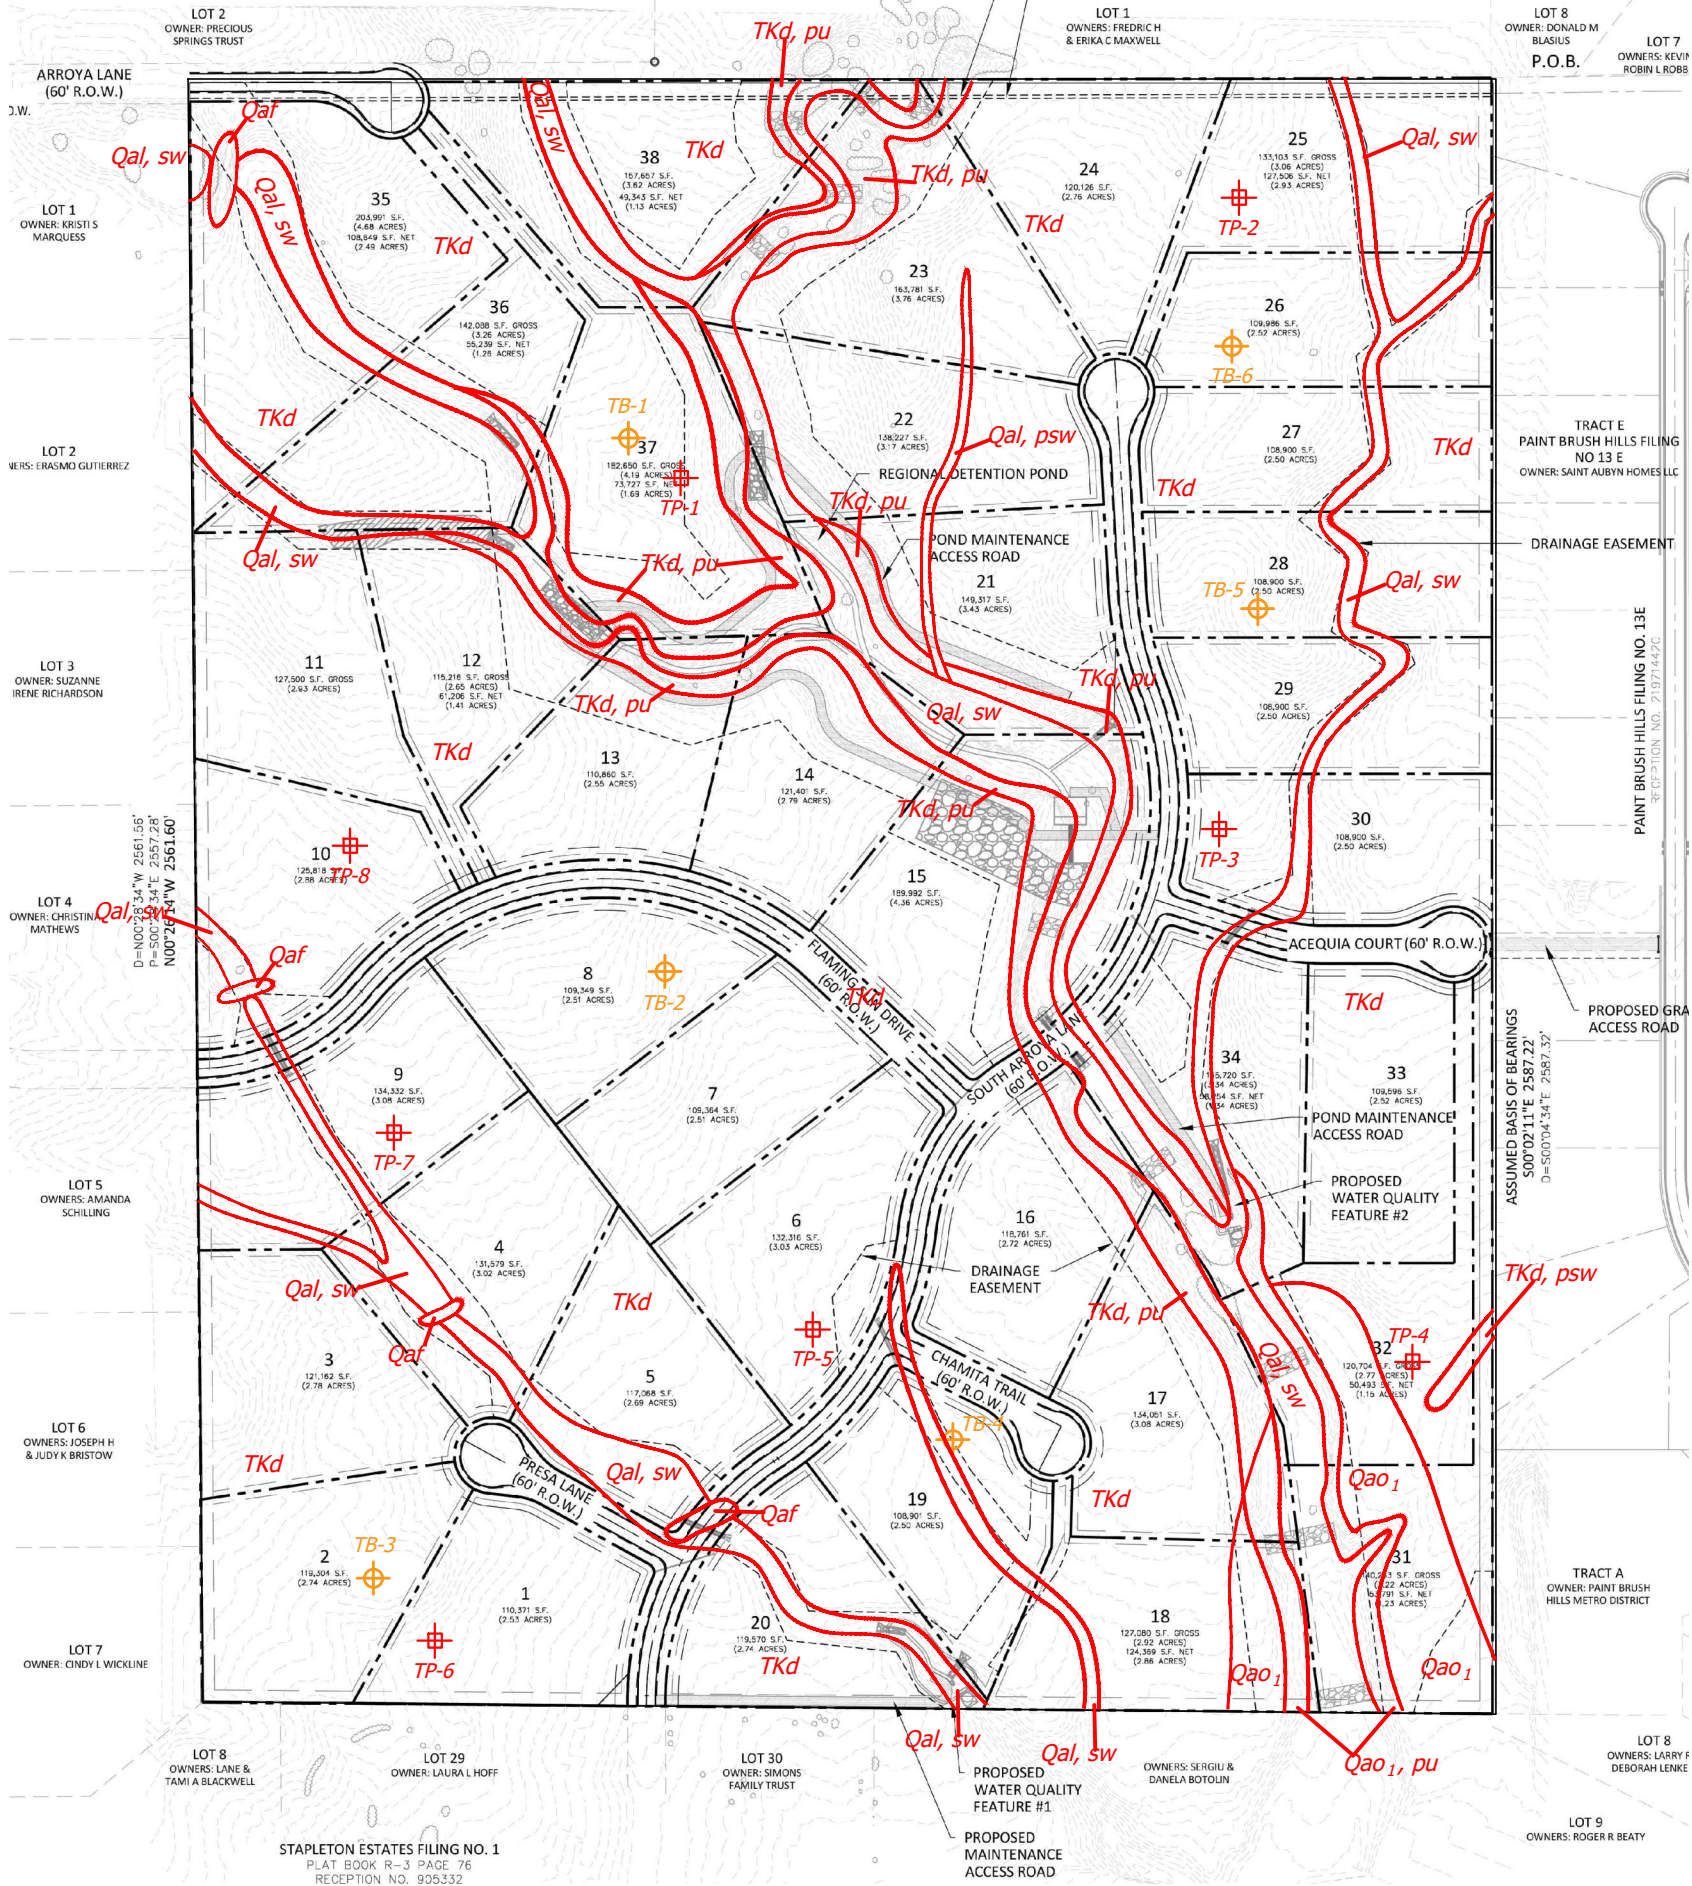
DRAWN
L.L.
CHECKED
L.L.
DATE
8/22/22
SCALE
AS SHOWN
JOB NO.
212684
FIGURE NO.
6

As mentioned previously, detailed mapping has been performed on this site to produce a Geology/Engineering Geology Map (Figure 6). This map shows the location of various geologic conditions of which the developers should be cognizant during the planning, design and construction stages of the project. These hazards and the recommended mitigation techniques are as follows:

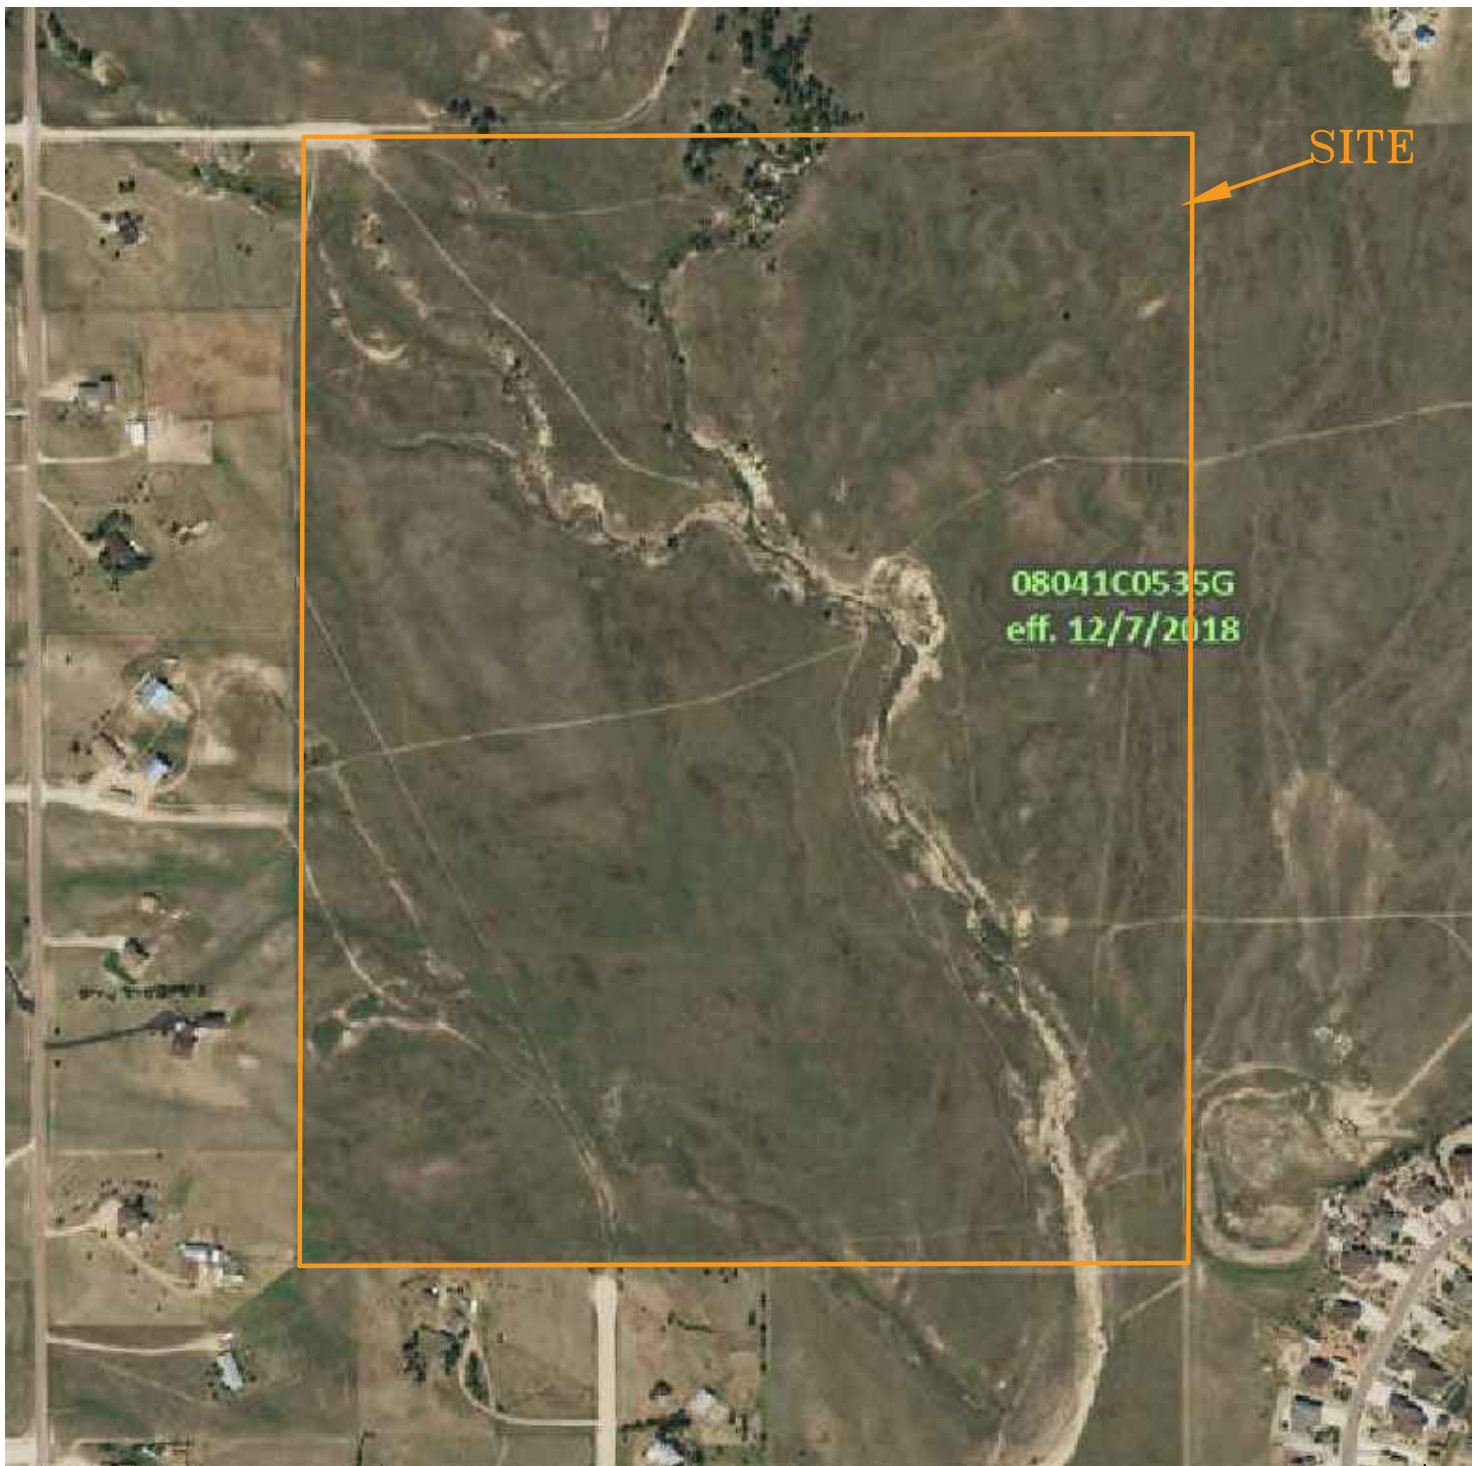
JOB NO.:
212684
FIG NO.:
7

Areas of seasonal shallow groundwater and potentially seasonal shallow groundwater were encountered on site. The site is not mapped in a floodplain zone (Figure 7, Reference 7). Areas of seasonal and potentially seasonal shallow groundwater were observed across the site. In these areas, we would anticipate the potential for periodically high subsurface moisture conditions and frost heave potential. These areas lie within low-lying areas along the drainage in the central portion of the subdivision and in the low-lying areas and minor drainages across the site. Water was not observed in any of the minor drainages at the time of our site investigation. Due to the size of the lots and the proposed development, the majority of these areas can be avoided by construction on the lots. Regrading can also mitigate some minor drainage swales on some of the lots. Structures should not block drainages. Any site grading should be done in such a manner as to not create areas of ponded water around structures or septic fields. Finished floor levels must be a minimum of one foot above the floodplain level. Septic fields should not be located in drainage areas due to the potential for periodic high groundwater conditions. Specific floodplain locations and drainage studies are beyond the scope of this report.

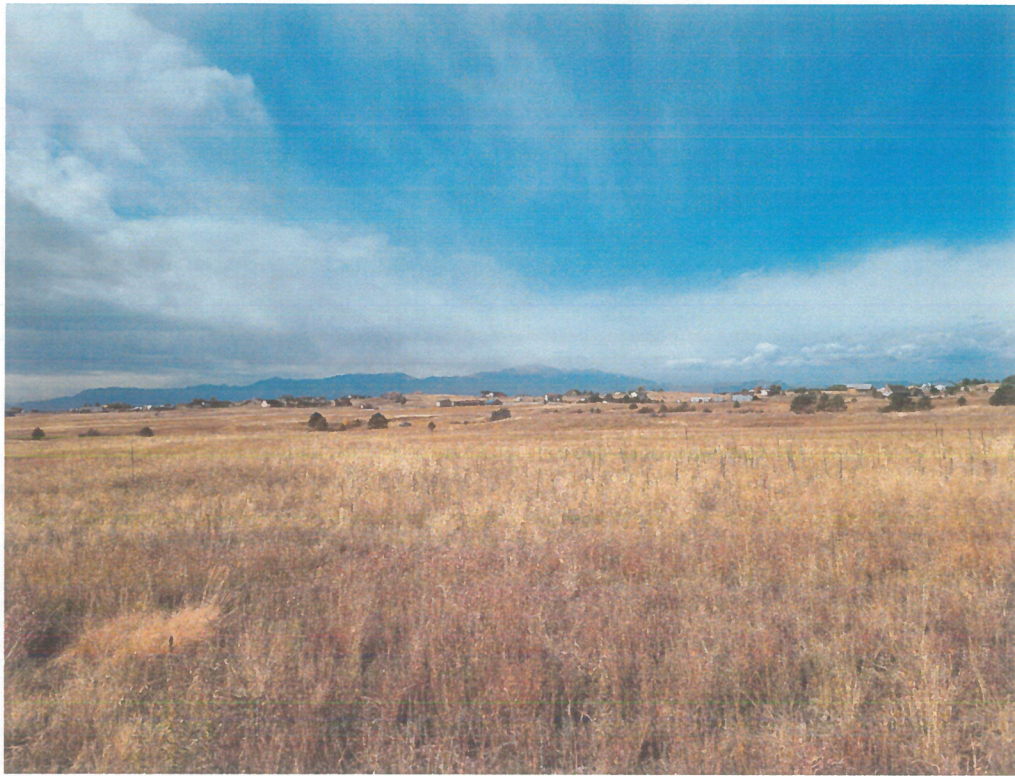
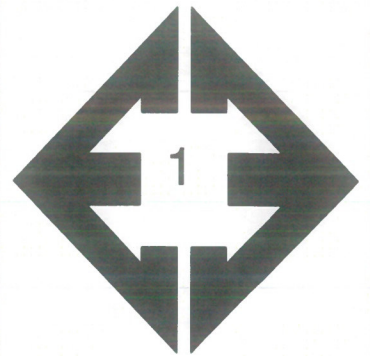
Looking west from the northeastern portion of the site.

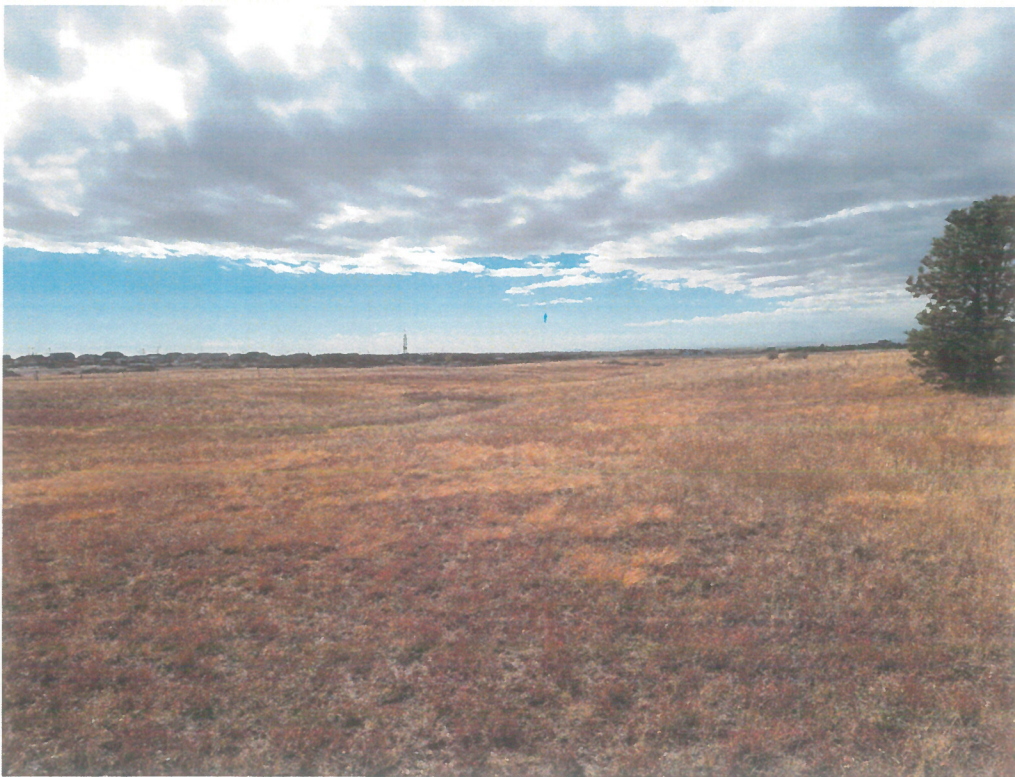
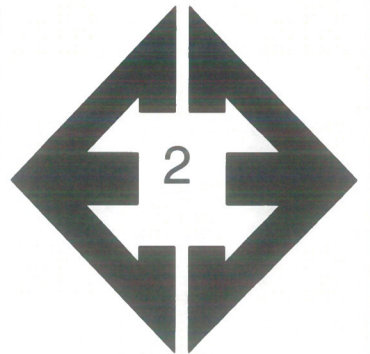
Looking south from northeastern portion of the site.

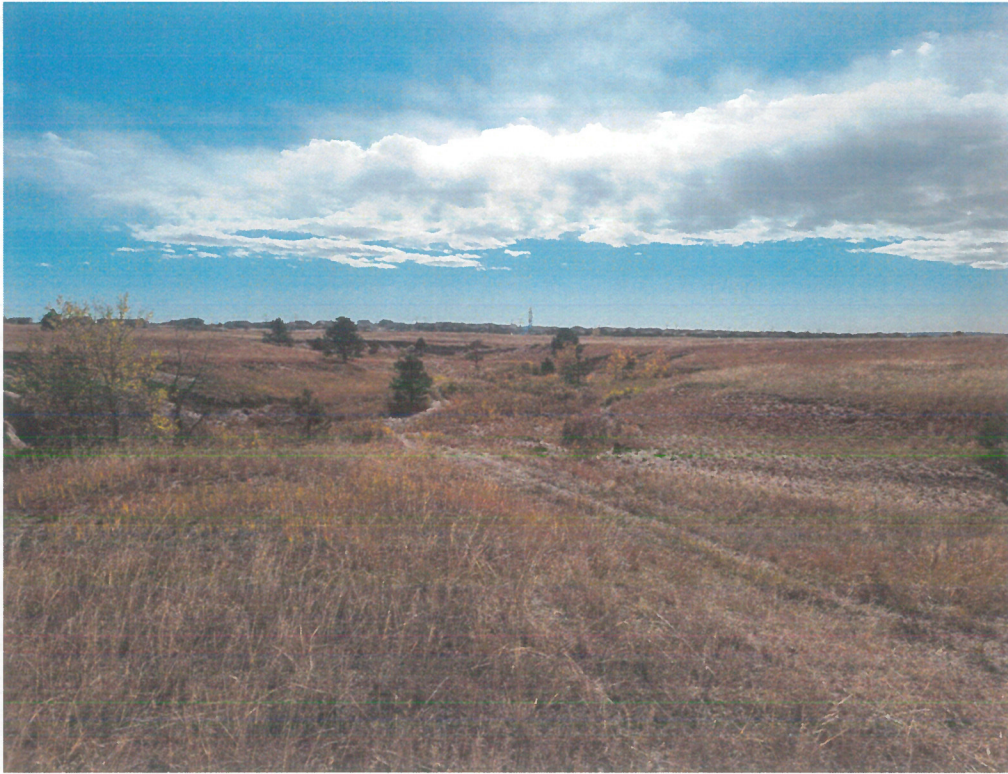
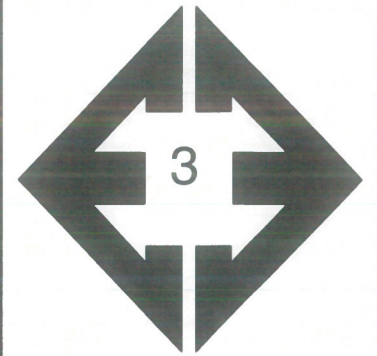
**Looking southeast
from the north-central
portion of the site.**

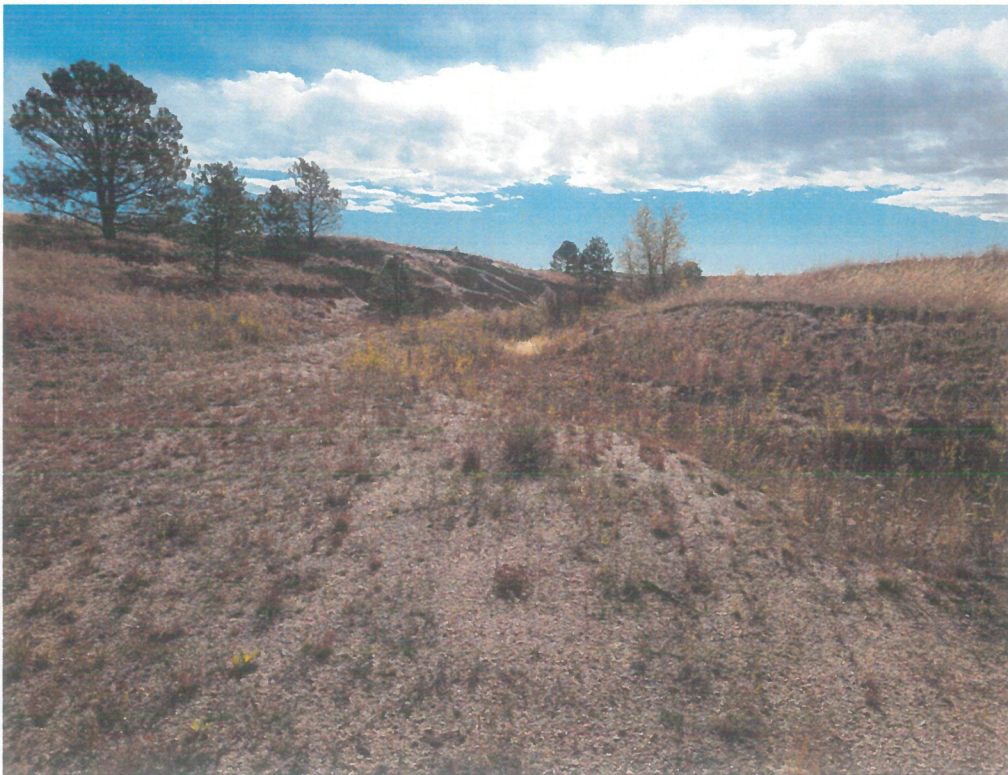
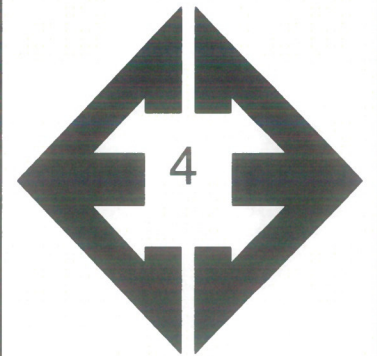
**Looking southeast
along drainage with
potentially unstable
slopes.**

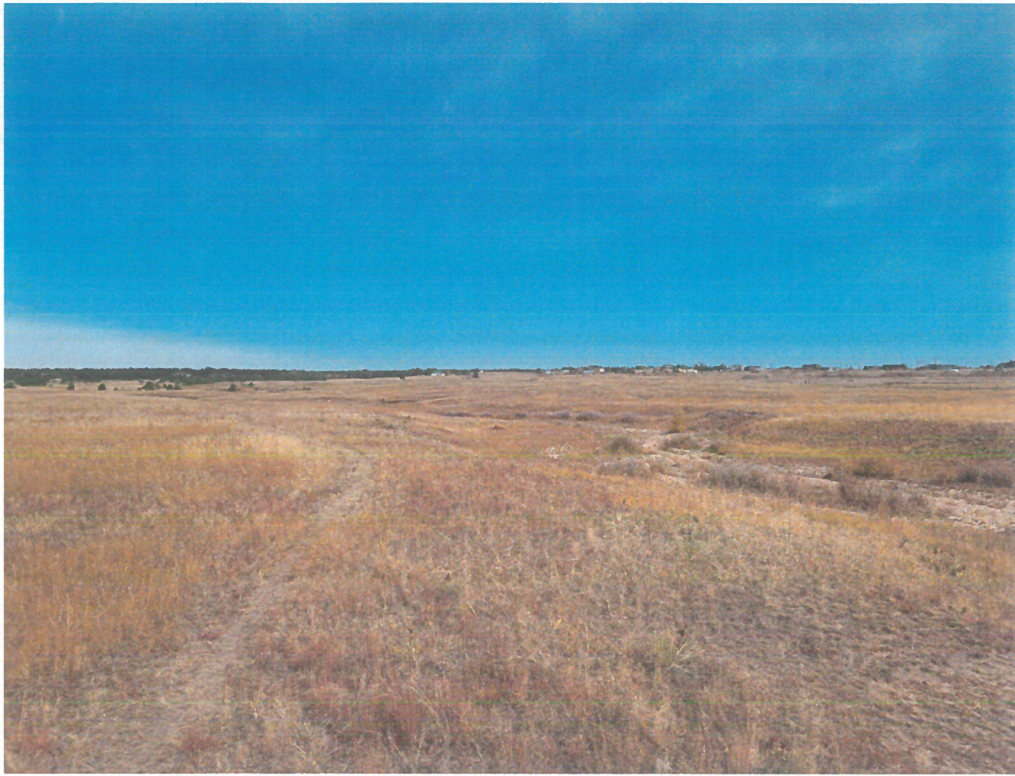
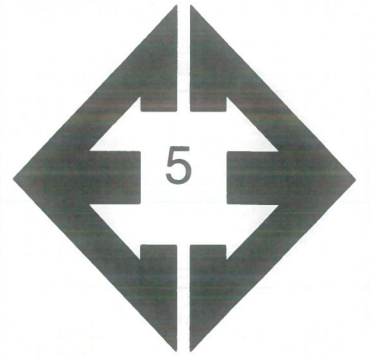
Looking north from the southeastern portion of the site.

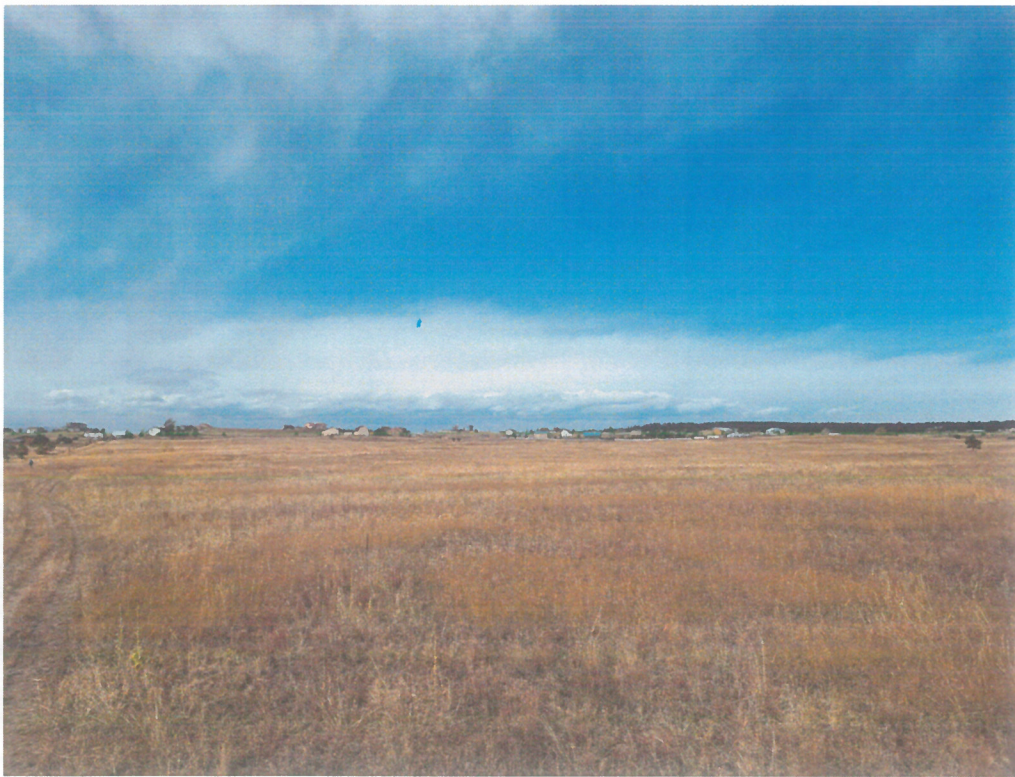
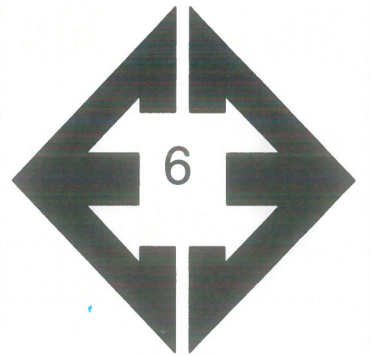
Looking west from the southeastern portion of the site.

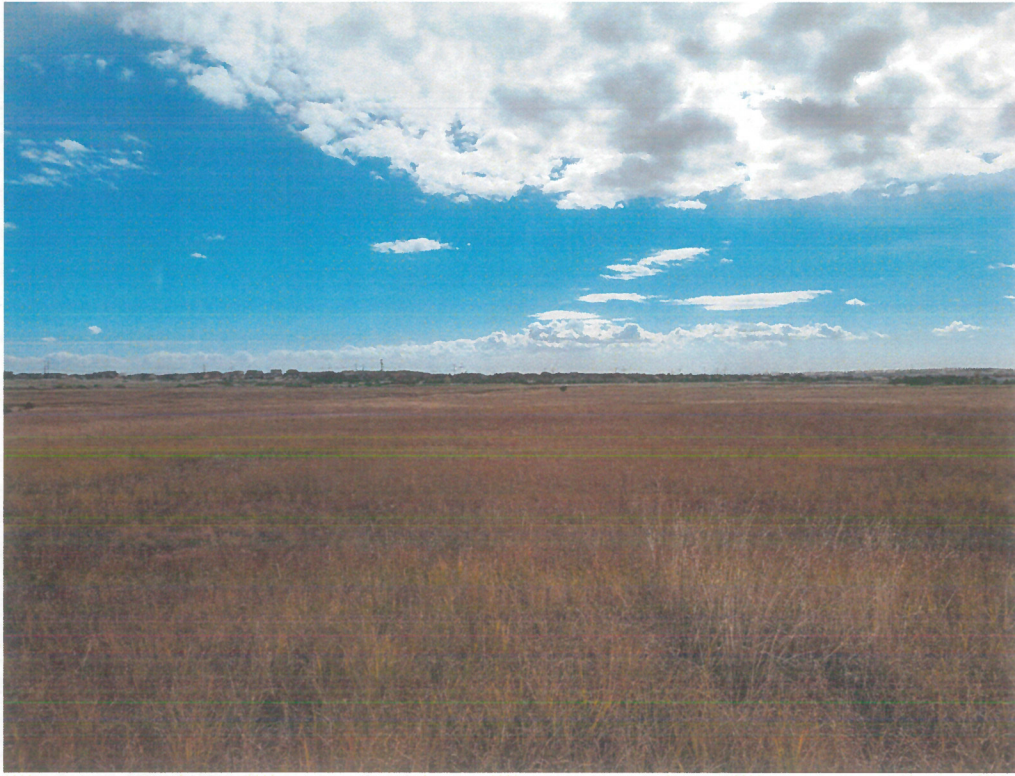
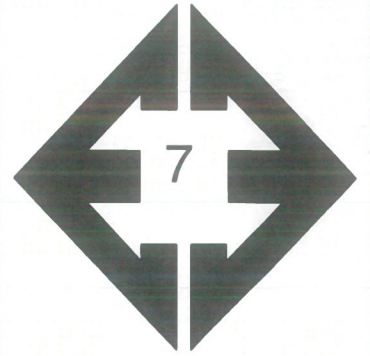
**Looking east from the
west-central portion of
the site.**

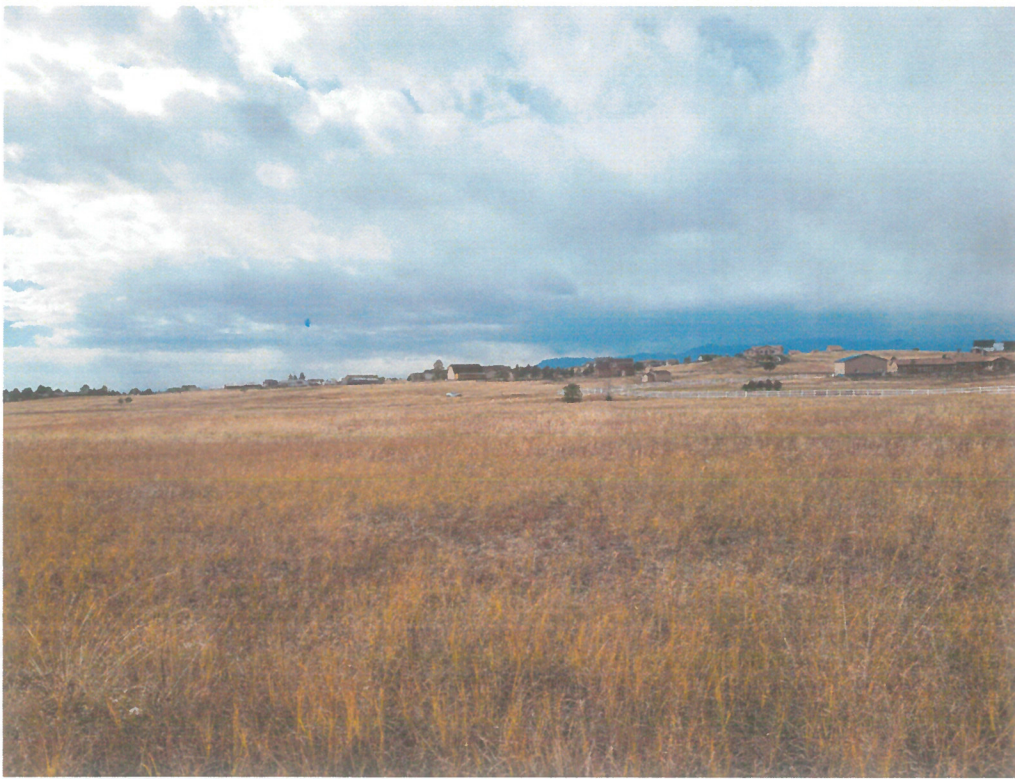
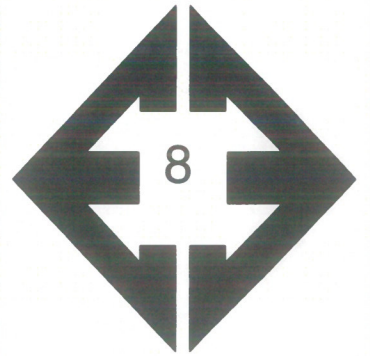
**Looking south from
the western portion of
the site.**
