**SOILS AND GEOLOGY STUDY  
OVERLOOK AT HOMESTEAD – FILING NO. 1  
ELBERT ROAD  
EL PASO COUNTY, COLORADO**

**PT Overlook, LLC**  
1864 Woodmoor Drive, Suite 100  
Monument, Colorado 80132

June 7, 2024  
Revised November 13, 2024

**PCD No. SF2425**

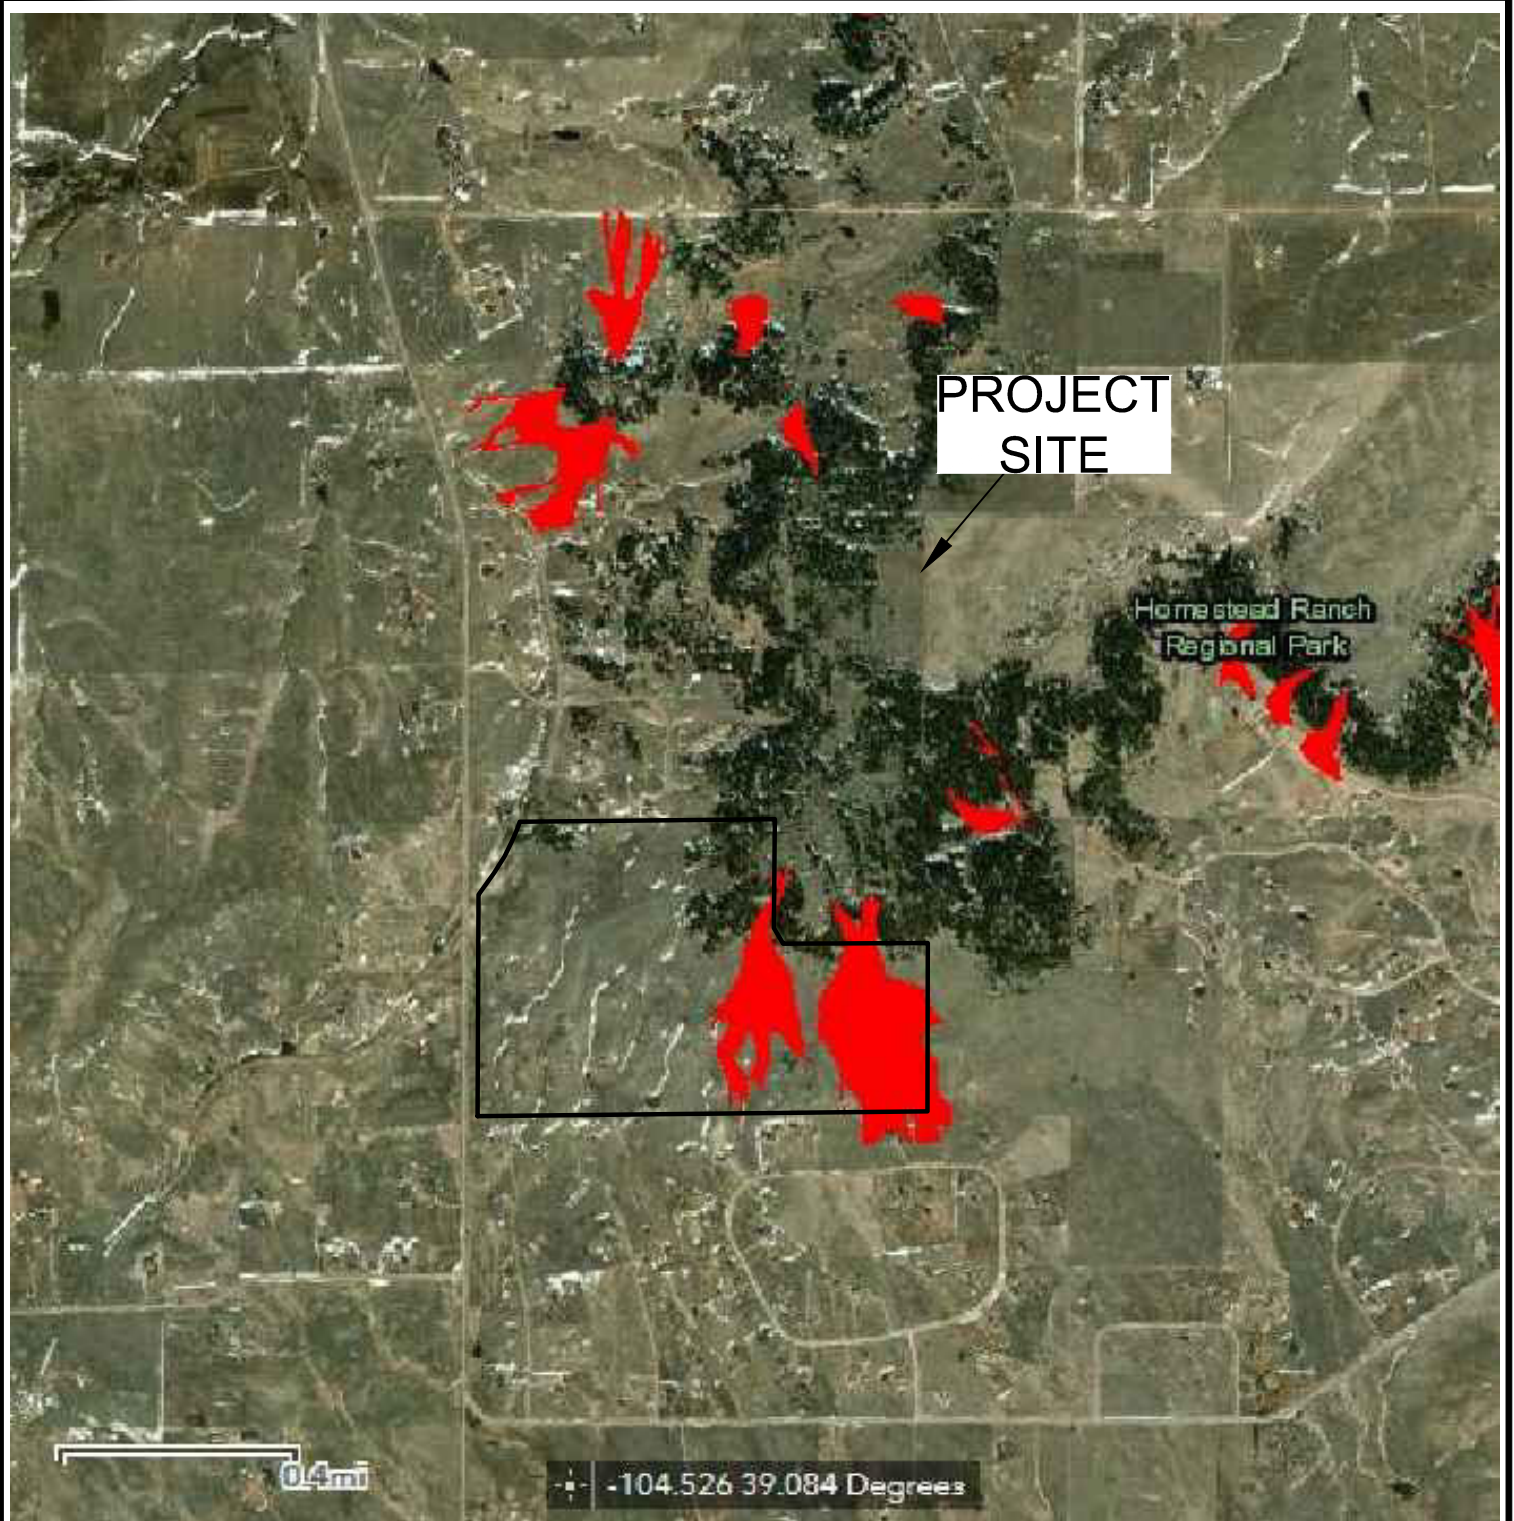
## DEBRIS FLOW SUSCEPTIBILITY MAP

The site is mapped within an area susceptible to debris flows according to the *Debris Flow Susceptibility Map of El Paso County, Colorado*, by McCoy, Morgan, and Berry (Reference 14, Figure 9). Based on site observations, recent minor debris fans/erosion were observed on the site along minor drainages originating off of the mesa in the southeastern portion of the site. Due to the material type and steepness of the slopes, the potential for significant erosion and sediment laden flows originating along the heads of these drainages in the southeastern portion of the site following significant precipitation events exist. Any site grading should direct surface flows around the structures in a non-erosive manor. Drainage culverts and other drainage infrastructure should be adequately sized for the potential sediment laden flows. Lots 11 – 23 are located within the area indicated as Debris Flow Susceptible (Figure 9).

The site is mapped within an area susceptible to debris flows according to the *Debris Flow Susceptibility Map of El Paso County, Colorado*, by McCoy, Morgan, and Berry (Reference 14, Figure 8). Based on site observations, recent minor debris fans/erosion were observed on the site along minor drainages originating off of the mesa in the southeastern portion of the site. Due to the material type and steepness of the slopes, the potential for significant erosion and sediment laden flows originating along the heads of these drainages in the southeastern portion of the of the site following significant precipitation events exist. Any site grading should direct surface flows around the structures in a non-erosive manor. Drainage culverts and other drainage infrastructure should be adequately sized for the potential sediment laden flows. Lots 11 – 23 are located within the area indicated as Debris Flow Susceptible, Figure 9.

Mitigation: Channel armoring consisting of riprap and/or other forms of erosion protection should be utilized in areas of concentrated flows to include permanent channel armoring to prevent accelerated erosion, creating unstable conditions. Building sites in these areas can be elevated lowering the effect of potential for sediment laden flows, and grading improvements diverting surface flows around the foundations are recommended for these affected lots. Any diversion swales should be created up gradient of the structures and should have permanent channel armoring. Riprap sizing should be based off potential flow velocities. The erosion protection must utilize proper fabric/grid grading to prevent piping and undermining. Erosion control measures and riprap sizing should be determined by a qualified professional.

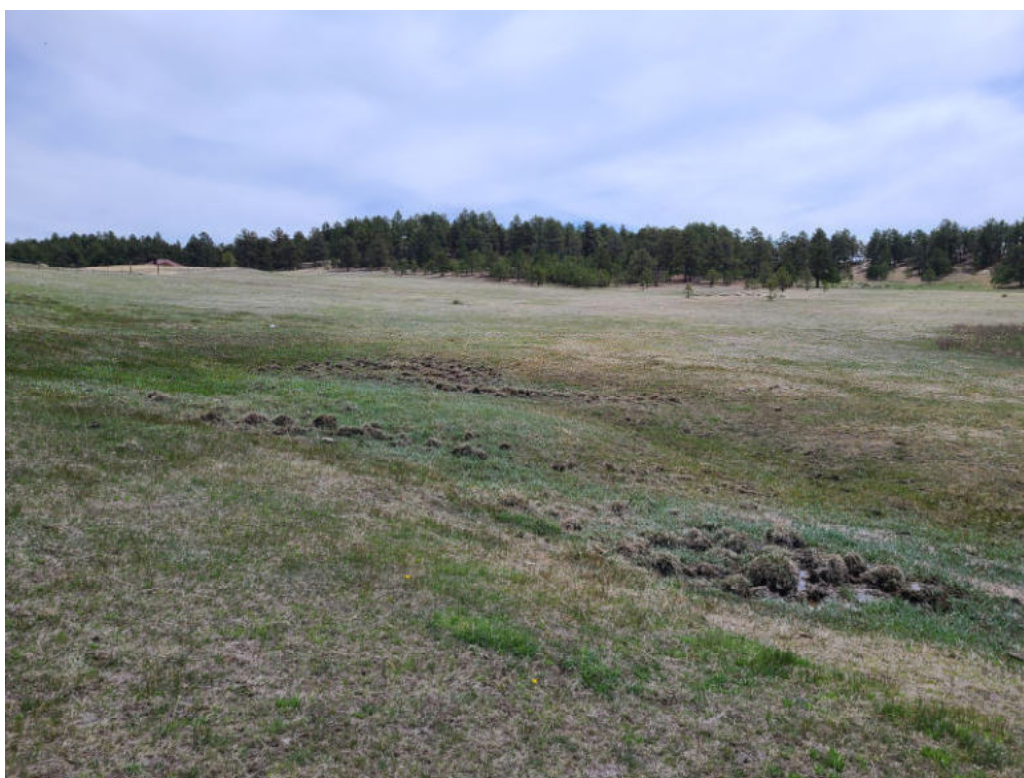
**Looking east towards  
spring in the area of  
Lots 47 and 55.**

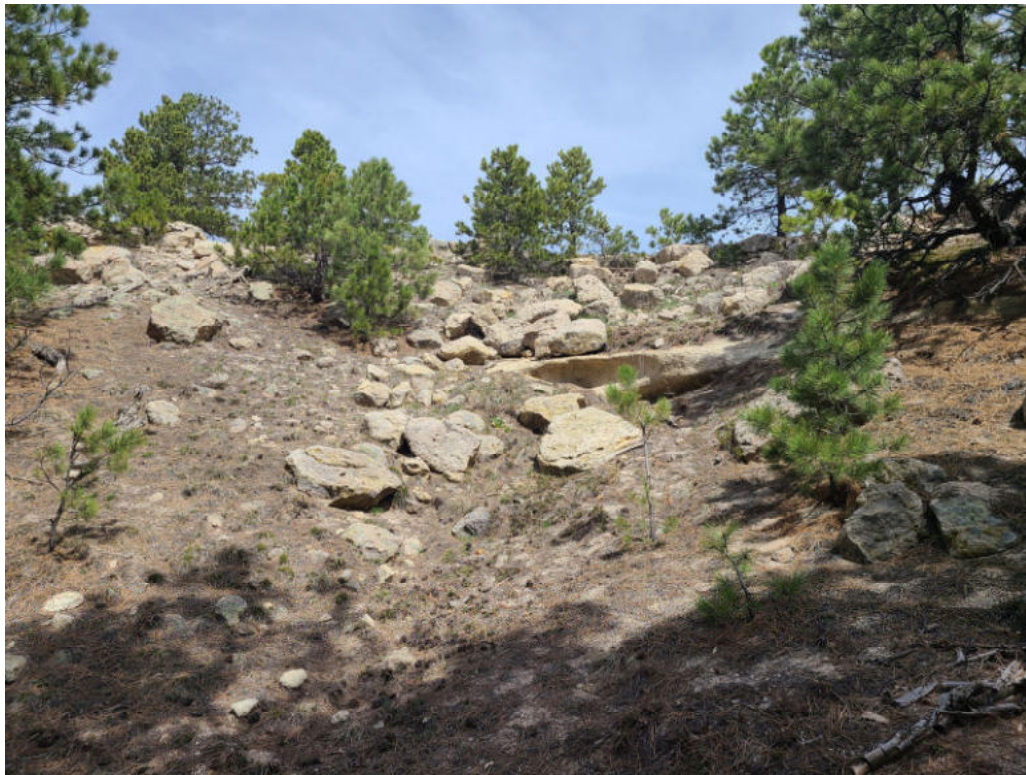
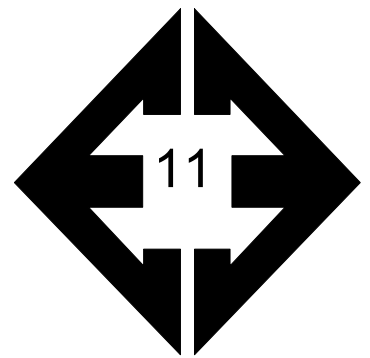
**Looking towards cliff  
in the southeastern  
portion of the site.**

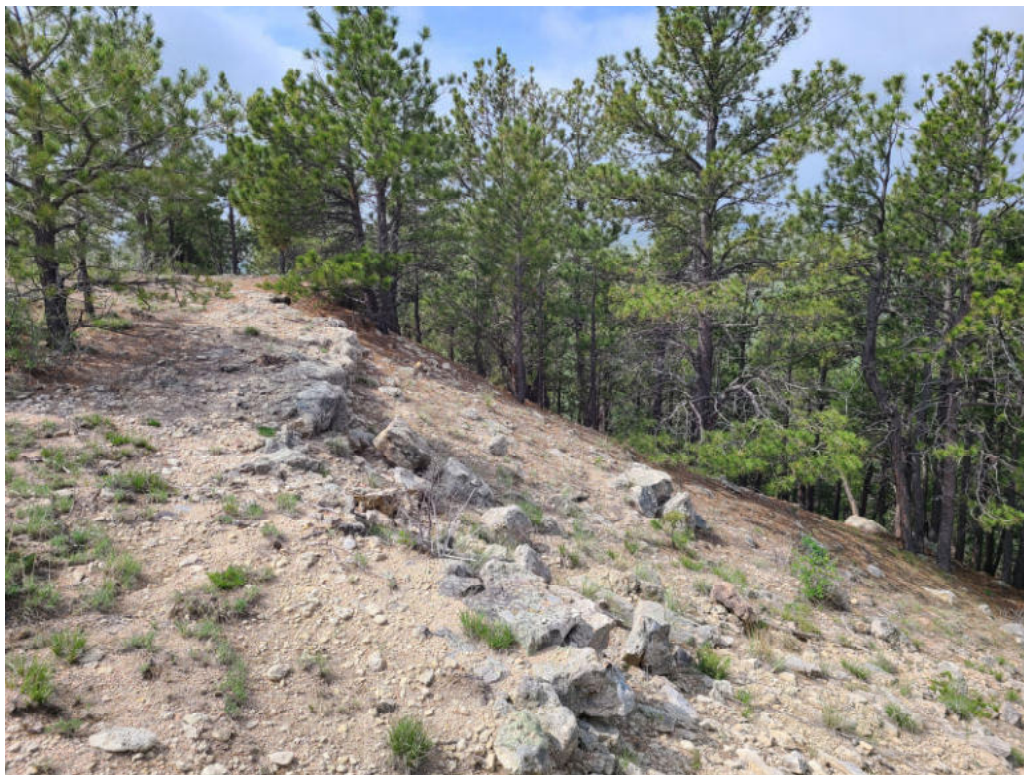
**Looking south along  
steep slope in the area  
of Lot 20.**

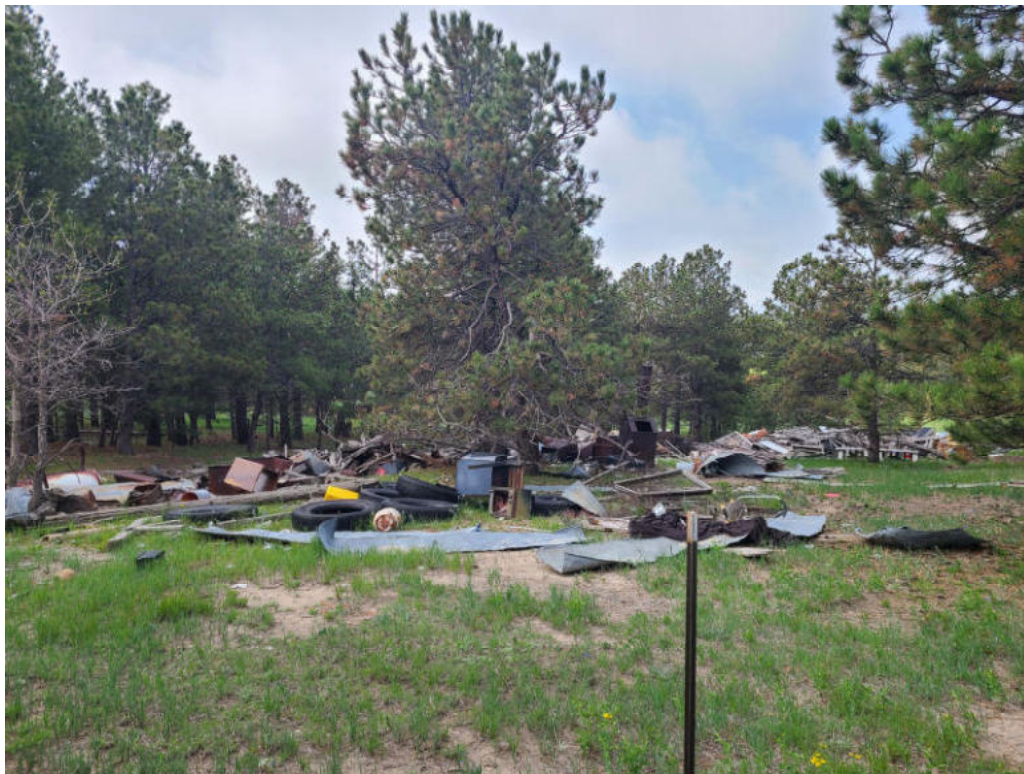
**Looking southwest  
toward trash pile on  
Lot 12.**

Mitigation: The fill on this site is considered uncontrolled for construction purposes. Any uncontrolled fill encountered beneath foundations will require removal and recompaction at a minimum of 95% of its maximum Modified Proctor Dry Density, ASTM D-1557.

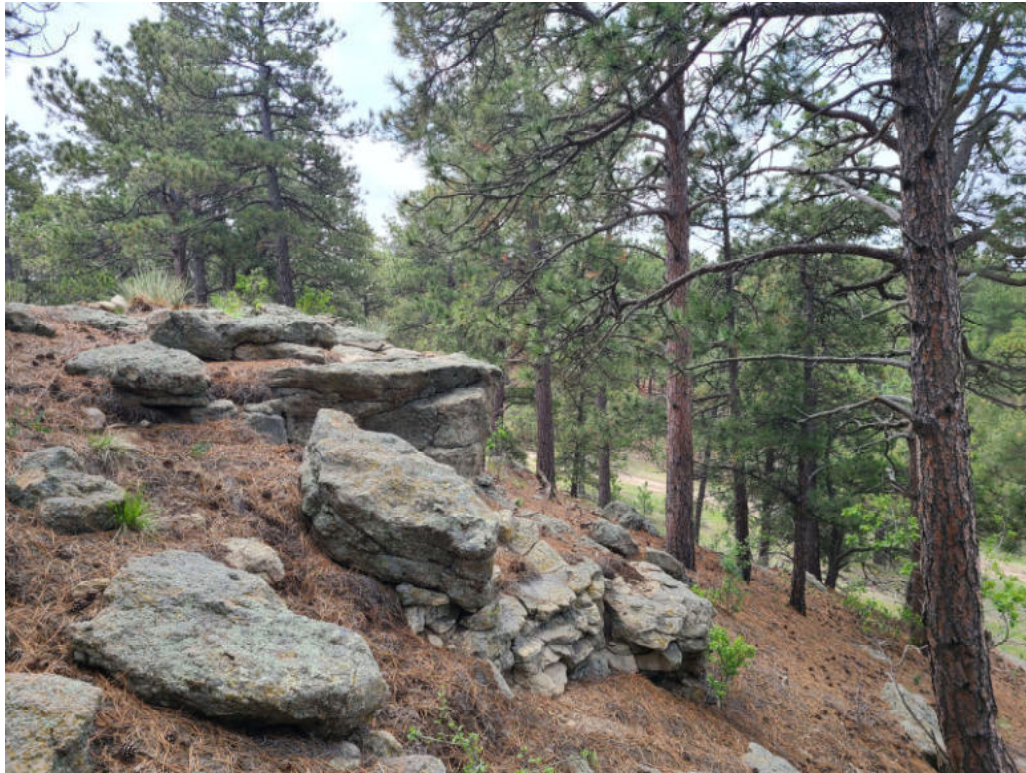
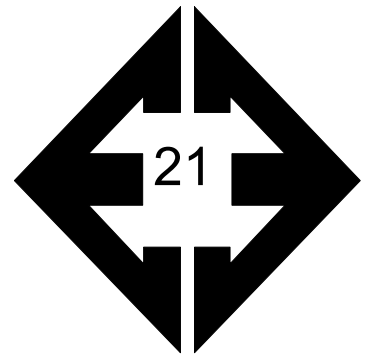
**Looking southwest  
along cliff and slope  
northern portion of the  
site.**
