**Preliminary Acceptance Punchlist**  
**El Paso County – Department of Public Works - Stormwater Section**

Project Name:	Lorson East F4
EDARP Filing Number(s):	SF198, CON1991
ESQCP Number:	ESQ1814
Attendees:	DPW SW: Natasha Grimaldo, Ben Jones, and Glen Reese DPW Development Services: N/A Developer: Did not attend
Date of Walk-Thru:	11-06-2023
Walk-Thru Number:	4 <sup>th</sup>

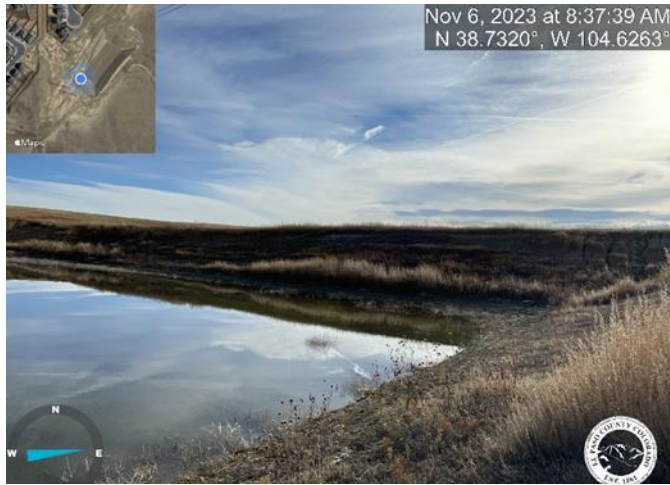
Photo 1: Implement missing AEC perimeter coconut fibernet or equivalent along the east perimeter slope. Reference sheet C5.2 of the Final Grading and Erosion Control Plans.

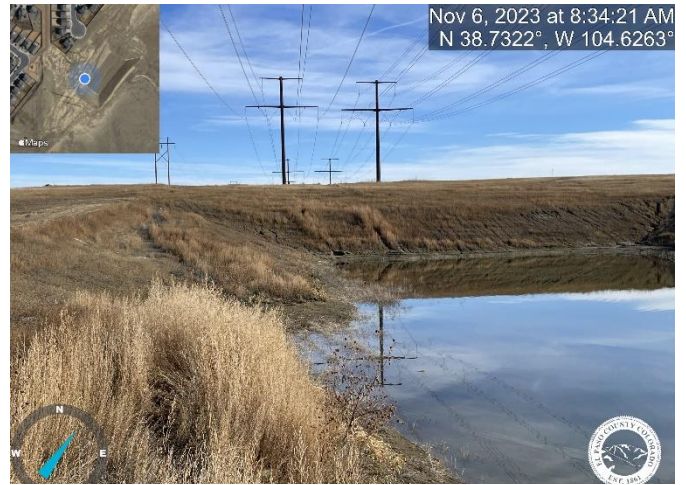
Photo 2: Implement missing Gravel Access Road. Reference sheet C5.2 of the Final Grading and Erosion Control Plans.

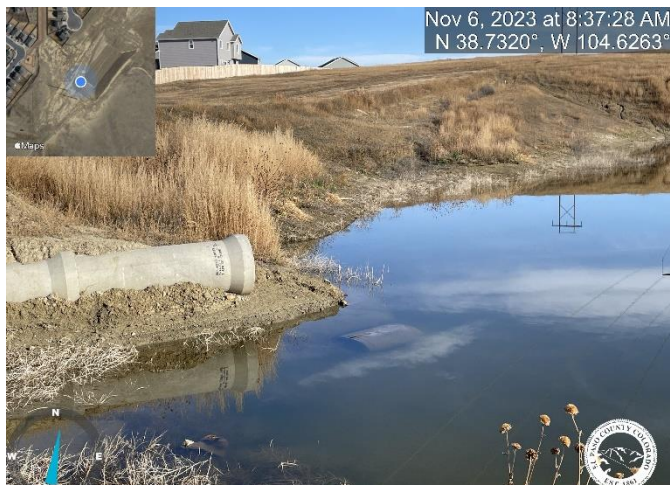
Photo 3: Implement missing 12" high riprap check dam with fabric and riprap pad at outlet pipe. Reference sheet C5.2 of the Final Grading and Erosion Control Plans.

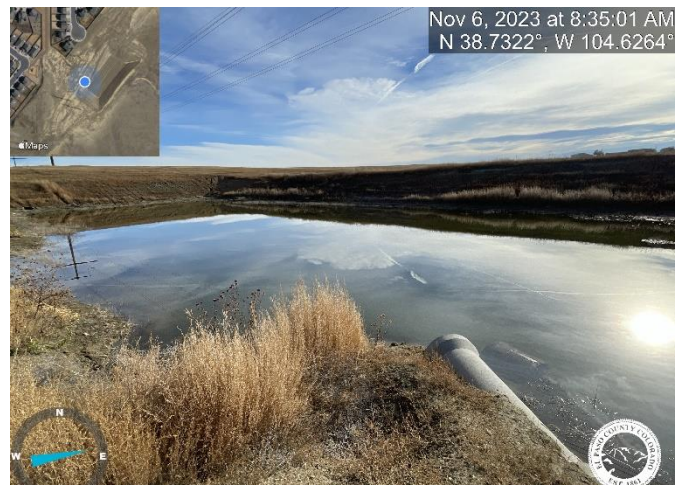
Photo 4: Implement missing low flow channel. Reference sheet C5.2 of the Final Grading and Erosion Control Plans.

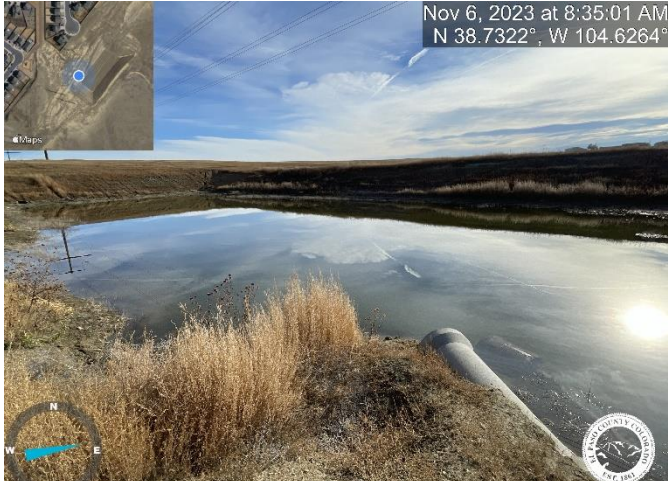
Photo 5: Water retention within pond. Fill pond bottom to be at approved grade to allow for positive drainage.

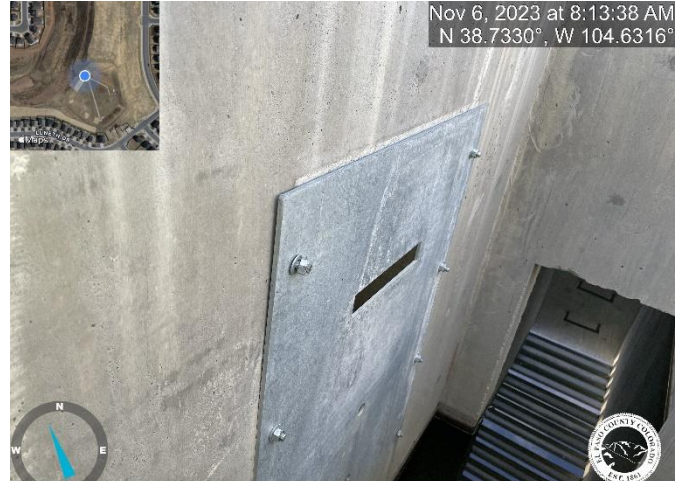
Photo 6: Confirm caulk bead around orifice plate.

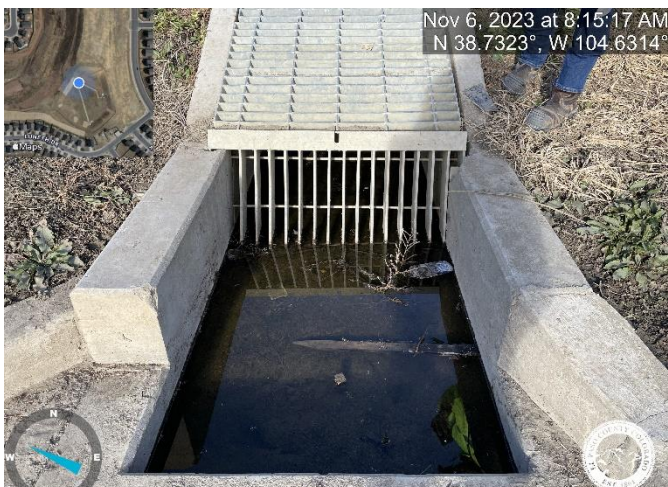
Photo 7: Remove sediment and debris from outlet structure micropool.

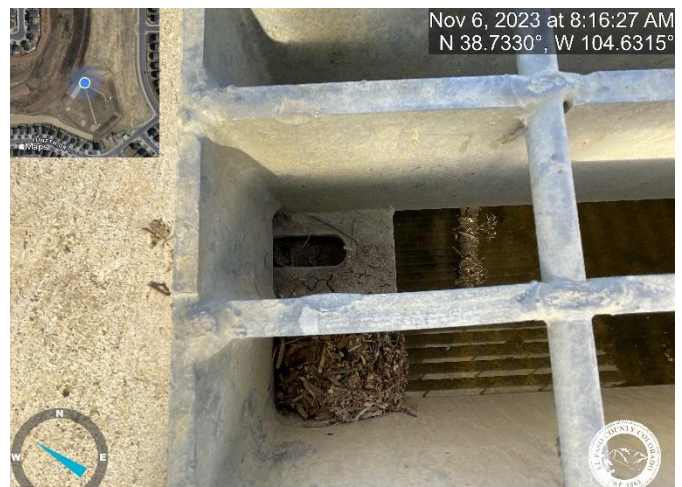
Photo 8: Implement missing bolts on outlet structure top grates.

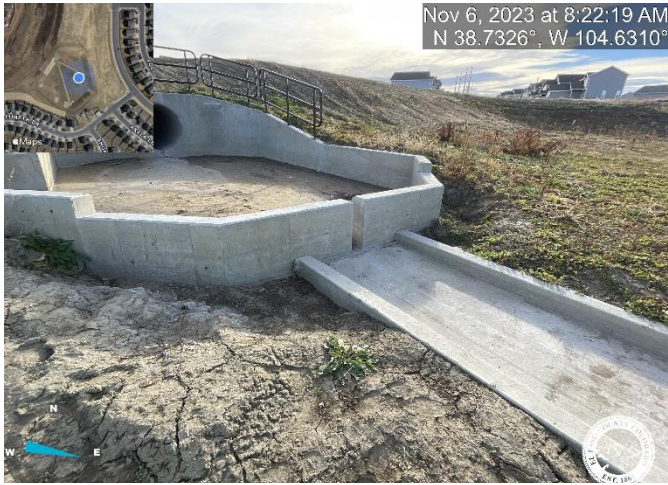
Photo 9: Confirm installation of 24" thick soil riprap at east forebay. Reference sheet C9.1 of the Construction Plans.

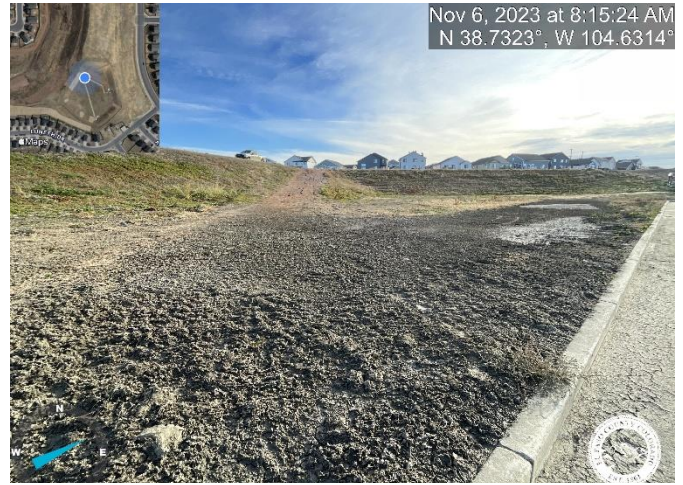
Photo 10: Remove excess sediment from maintenance access road within pond bottom and reestablish road base along trickle channel. Access road should consist of 12" thick class 6 aggregate. Reference sheet C9.1 of the Construction Plans.

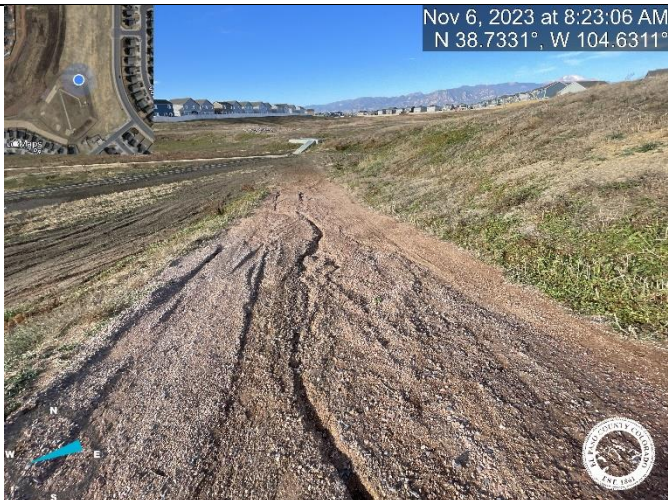
Photo 11: Repair rilling along maintenance access road. Rilling could worsen and will be required to be repaired at Final Acceptance.

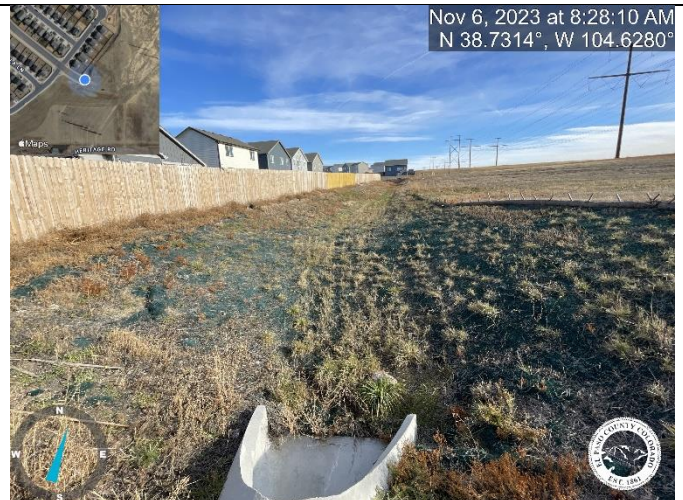
Photo 12: Swale 67b (east end of Trappe): Implement missing check dam (SD-3-62) or justify change within As-builts. Reference sheet C4.4 of the Final Grading and Erosion Control Plans.

- Check dams with Substation Swale 2 and Swale 67b.
- Riprap pad at mouth of RCP inlet pipe within Substation Swale 2.

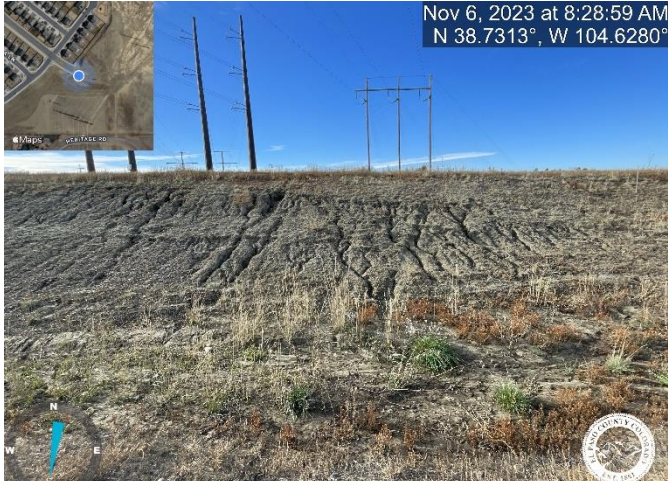
Photo 13: Swale 67a (east end of Trappe): Repair minor rilling and stabilize slope adjacent to area drain.

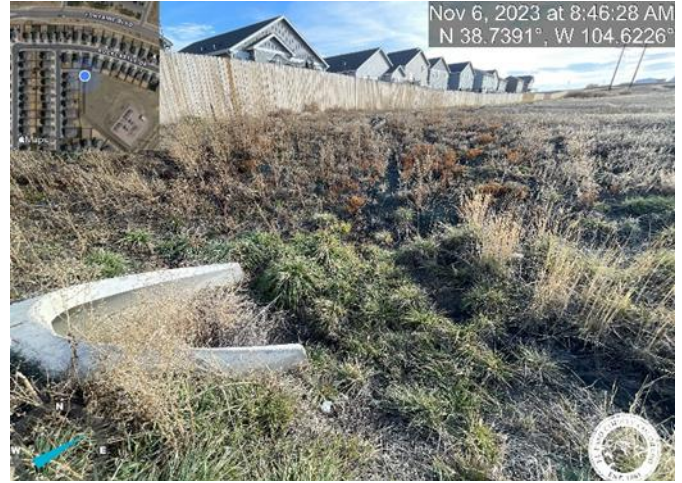
Photo 14: Substation Swale 2: Implement missing 9" D50 riprap 18" thick on fabric at RCP inlet or justify change in As-builts. Reference sheet C7.1 of the Construction Plans.

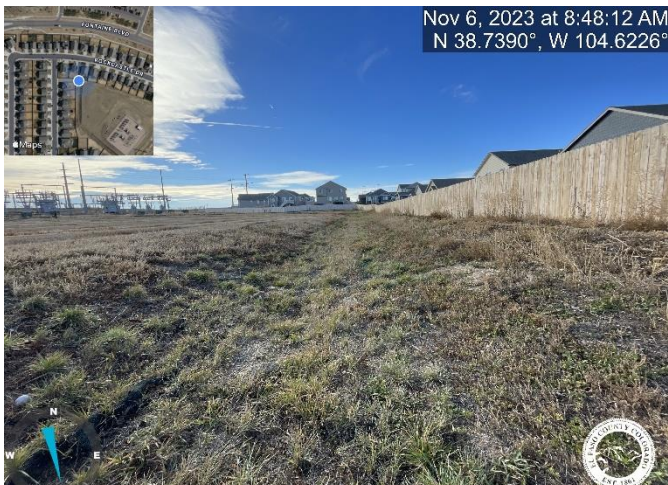
Photo 15: Substation Swale 2: Implement missing check dams (SD-3-62) or justify change within As-builts. Reference sheet C4.1 of the Final Grading and Erosion Control Plans

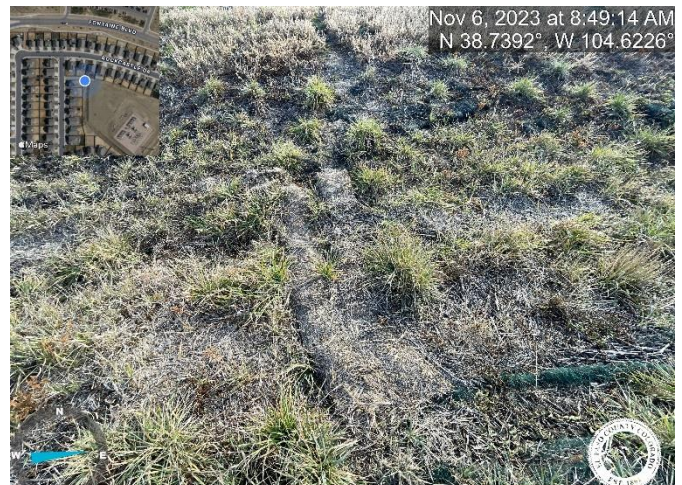
Photo 16: Substation Swale 2: Remove temporary control measures from swale.

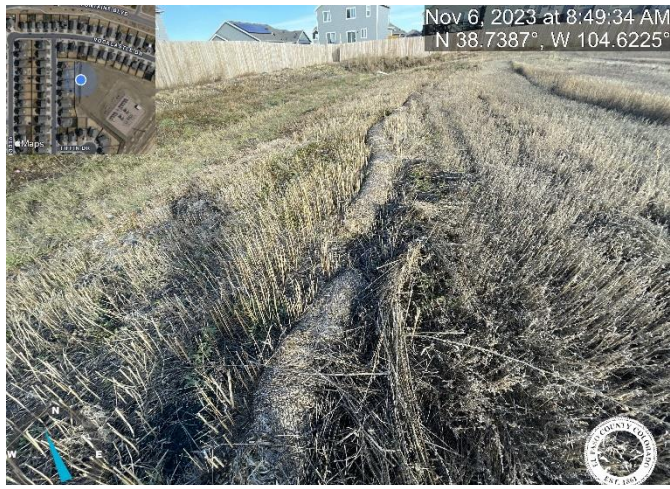
Photo 17: Substation Swale 2: Remove temporary control measures from swale.
