GEOLOGIC HAZARD STUDY

**The Ridge at Spring Creek, Filing No. 1
Colorado Springs, Colorado**

JOB NO. 197354

October 14, 2024

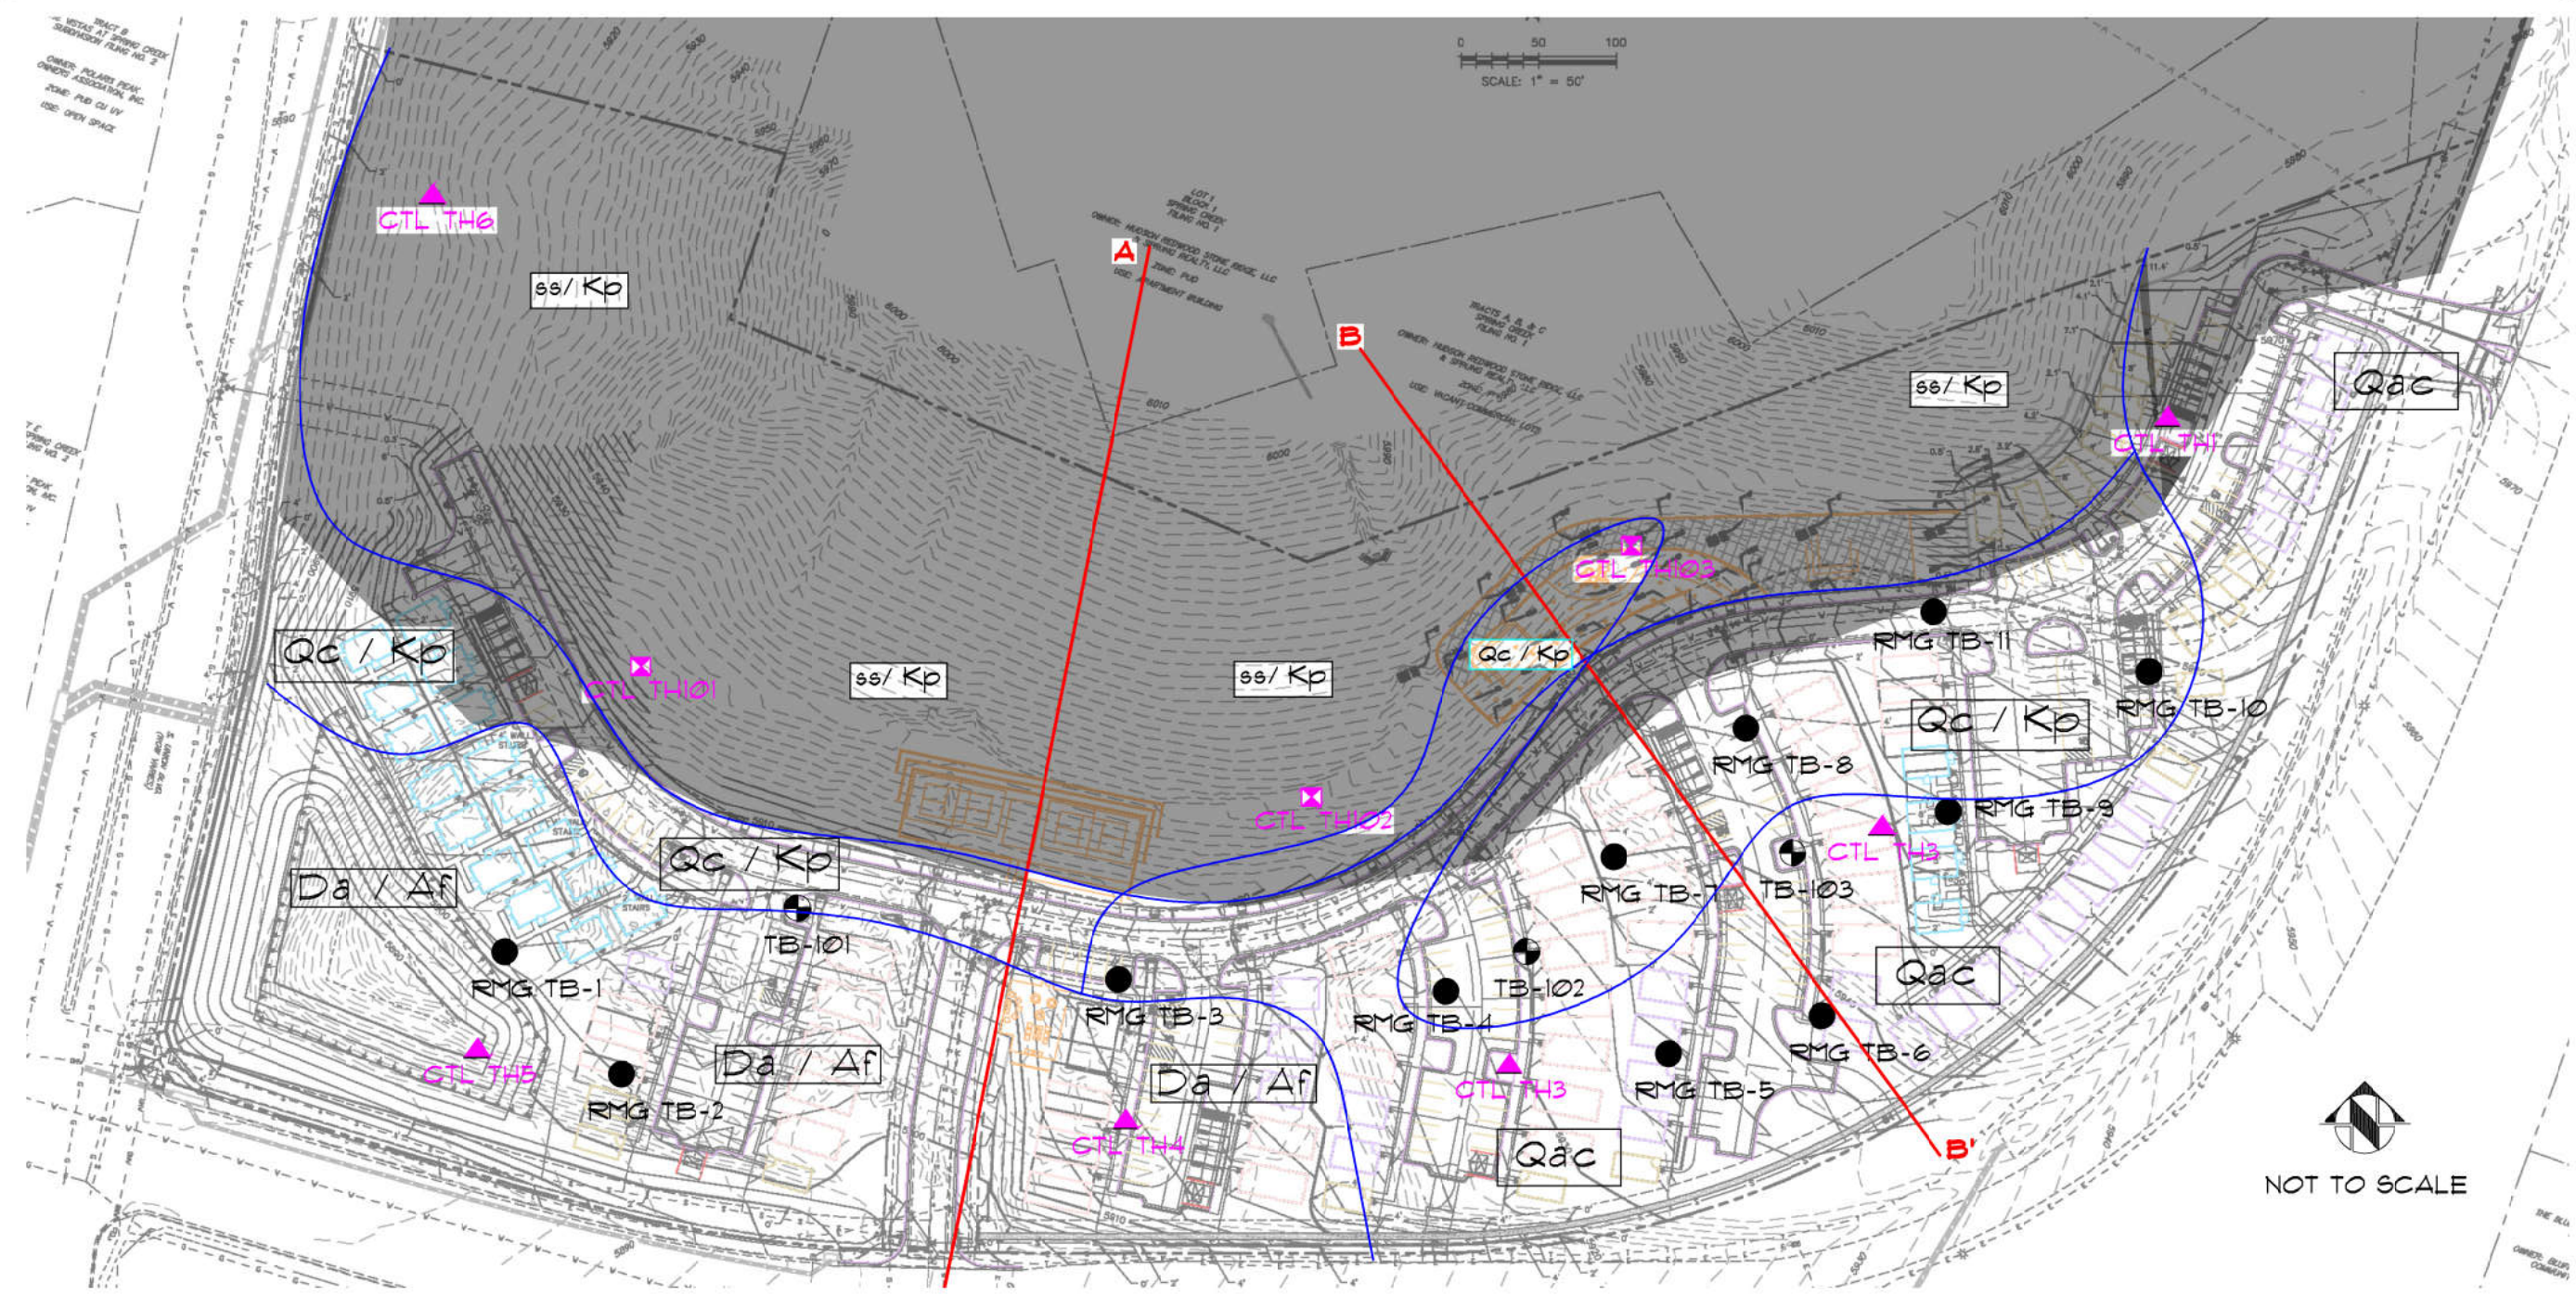
SHEET No.
FIG-10

The majority of the site lies within the Colorado Springs Landslide Susceptibility Zone, as mapped in the electronic (online) version, prepared by the CGS. Evidence of unstable slopes (tension cracks) was not observed around or on the property. The northern part of the site has slopes up to 2:1 (horizontal:vertical) that flatten to the south and west. RMG performed several slope stability analyses as part of our investigation and obtained Factors of Safety (FOS) ranging from 1.65 to 1.93 where obtained for the slope sections selected. The slope stability analyses included two slope sections (A and B) utilizing a variety of parameters and moisture conditions (sensitivity analysis). The results of the slope analysis are presented in Section 7.0. The slope sections are presented on the Engineering and Geology Map, Figure 10.
