## EL PASO COUNTY CONSTRUCTION STORMWATER SITE INSPECTION REPORT

| Facility Name: Matika Subdivision F1 | Permittee: Jordan Savage |
| Date of Inspection: 09/21/2021 | Weather Conditions: Partly Cloudy |
| Permit Number: ESR2134 | Disturbed Acreage: 3.6/42.26 |

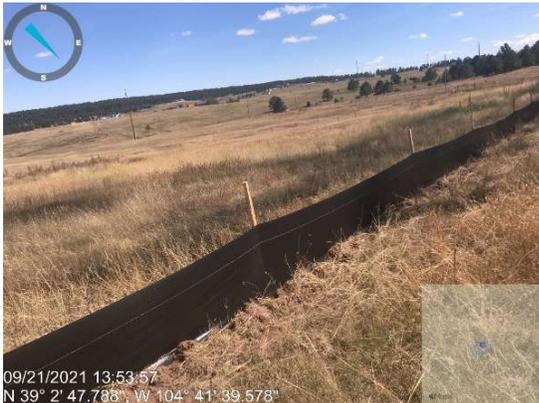
Silt fence initial control measure implemented as per GEC plans.

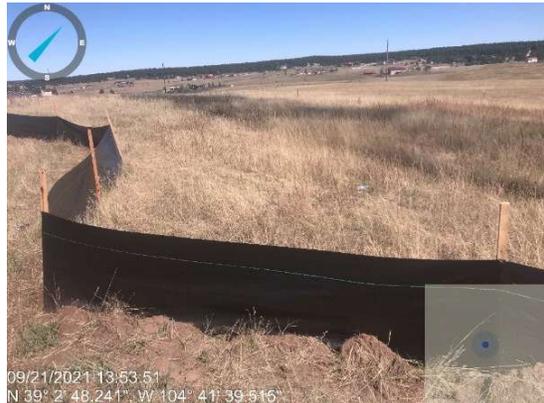
Silt fence initial control measure implemented as per plans.

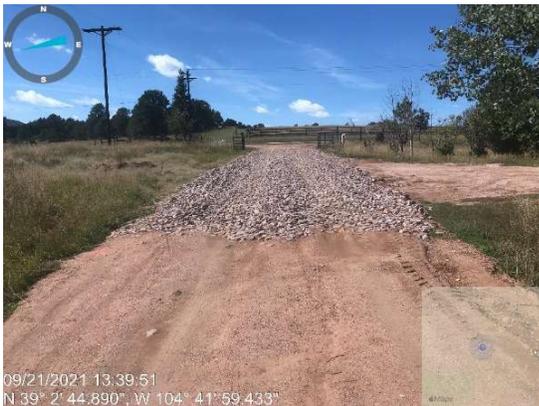
| | YES/NO | If "YES" describe discharge or potential for discharge below. Document related maintenance, inadequate control measures and corrective actions <b>Inadequate Control Measures Requiring Corrective Action</b> form: |
|--|---|---|
| Locations where vehicles exit the site | No | VTC adequate. |

VTC implemented at site entrance.

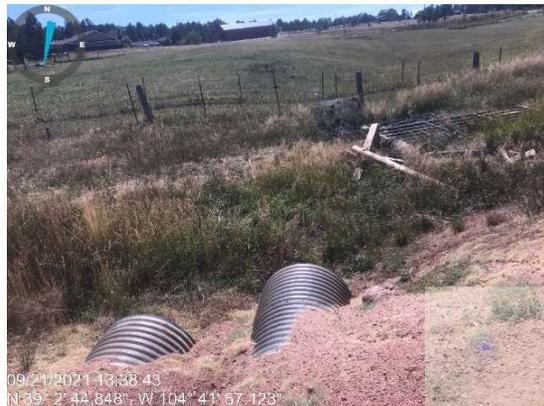
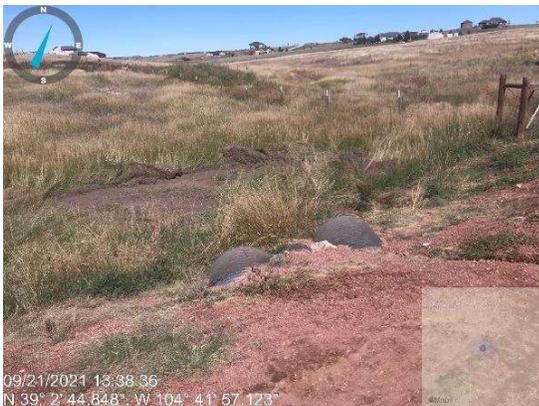
| | YES/NO | If "YES" describe discharge or potential for discharge below. Document related maintenance, inadequate control measures and corrective actions <b>Inadequate Control Measures Requiring Corrective Action</b> form: |
|--|---|---|
| Locations where stormwater has the potential to discharge offsite | Yes | Stormwater has the potential to discharge offsite where control measures are missing, which is the drainage where rock check dams are not installed. Please see photos for more details. |

Failure to implement rock check dams as per plans in drainage swale.

| Location | Missing Control Measure | Description of Corrective Action |
|---|---|--|
| Along drainage way | Failure to implement rock check dams as per plans | Implement rock check dams as per plans. Rock check dams are initial control measures as per plans. |

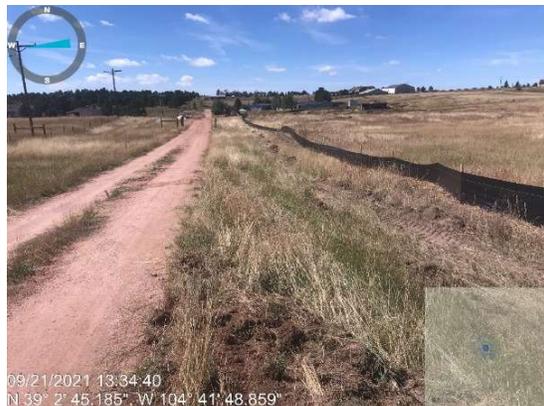
Silt fence initial control measure implemented as per plans.
