**SOIL, GEOLOGY, & GEOLOGIC HAZARD STUDY  
JAYNES PROPERTY  
POCO ROAD AND VOLLMER ROAD  
EL PASO COUNTY, COLORADO**

**Elite Properties of America, Inc.**  
2138 Flying Horse Club Drive  
Colorado Springs, Colorado 80921

April 5, 2022

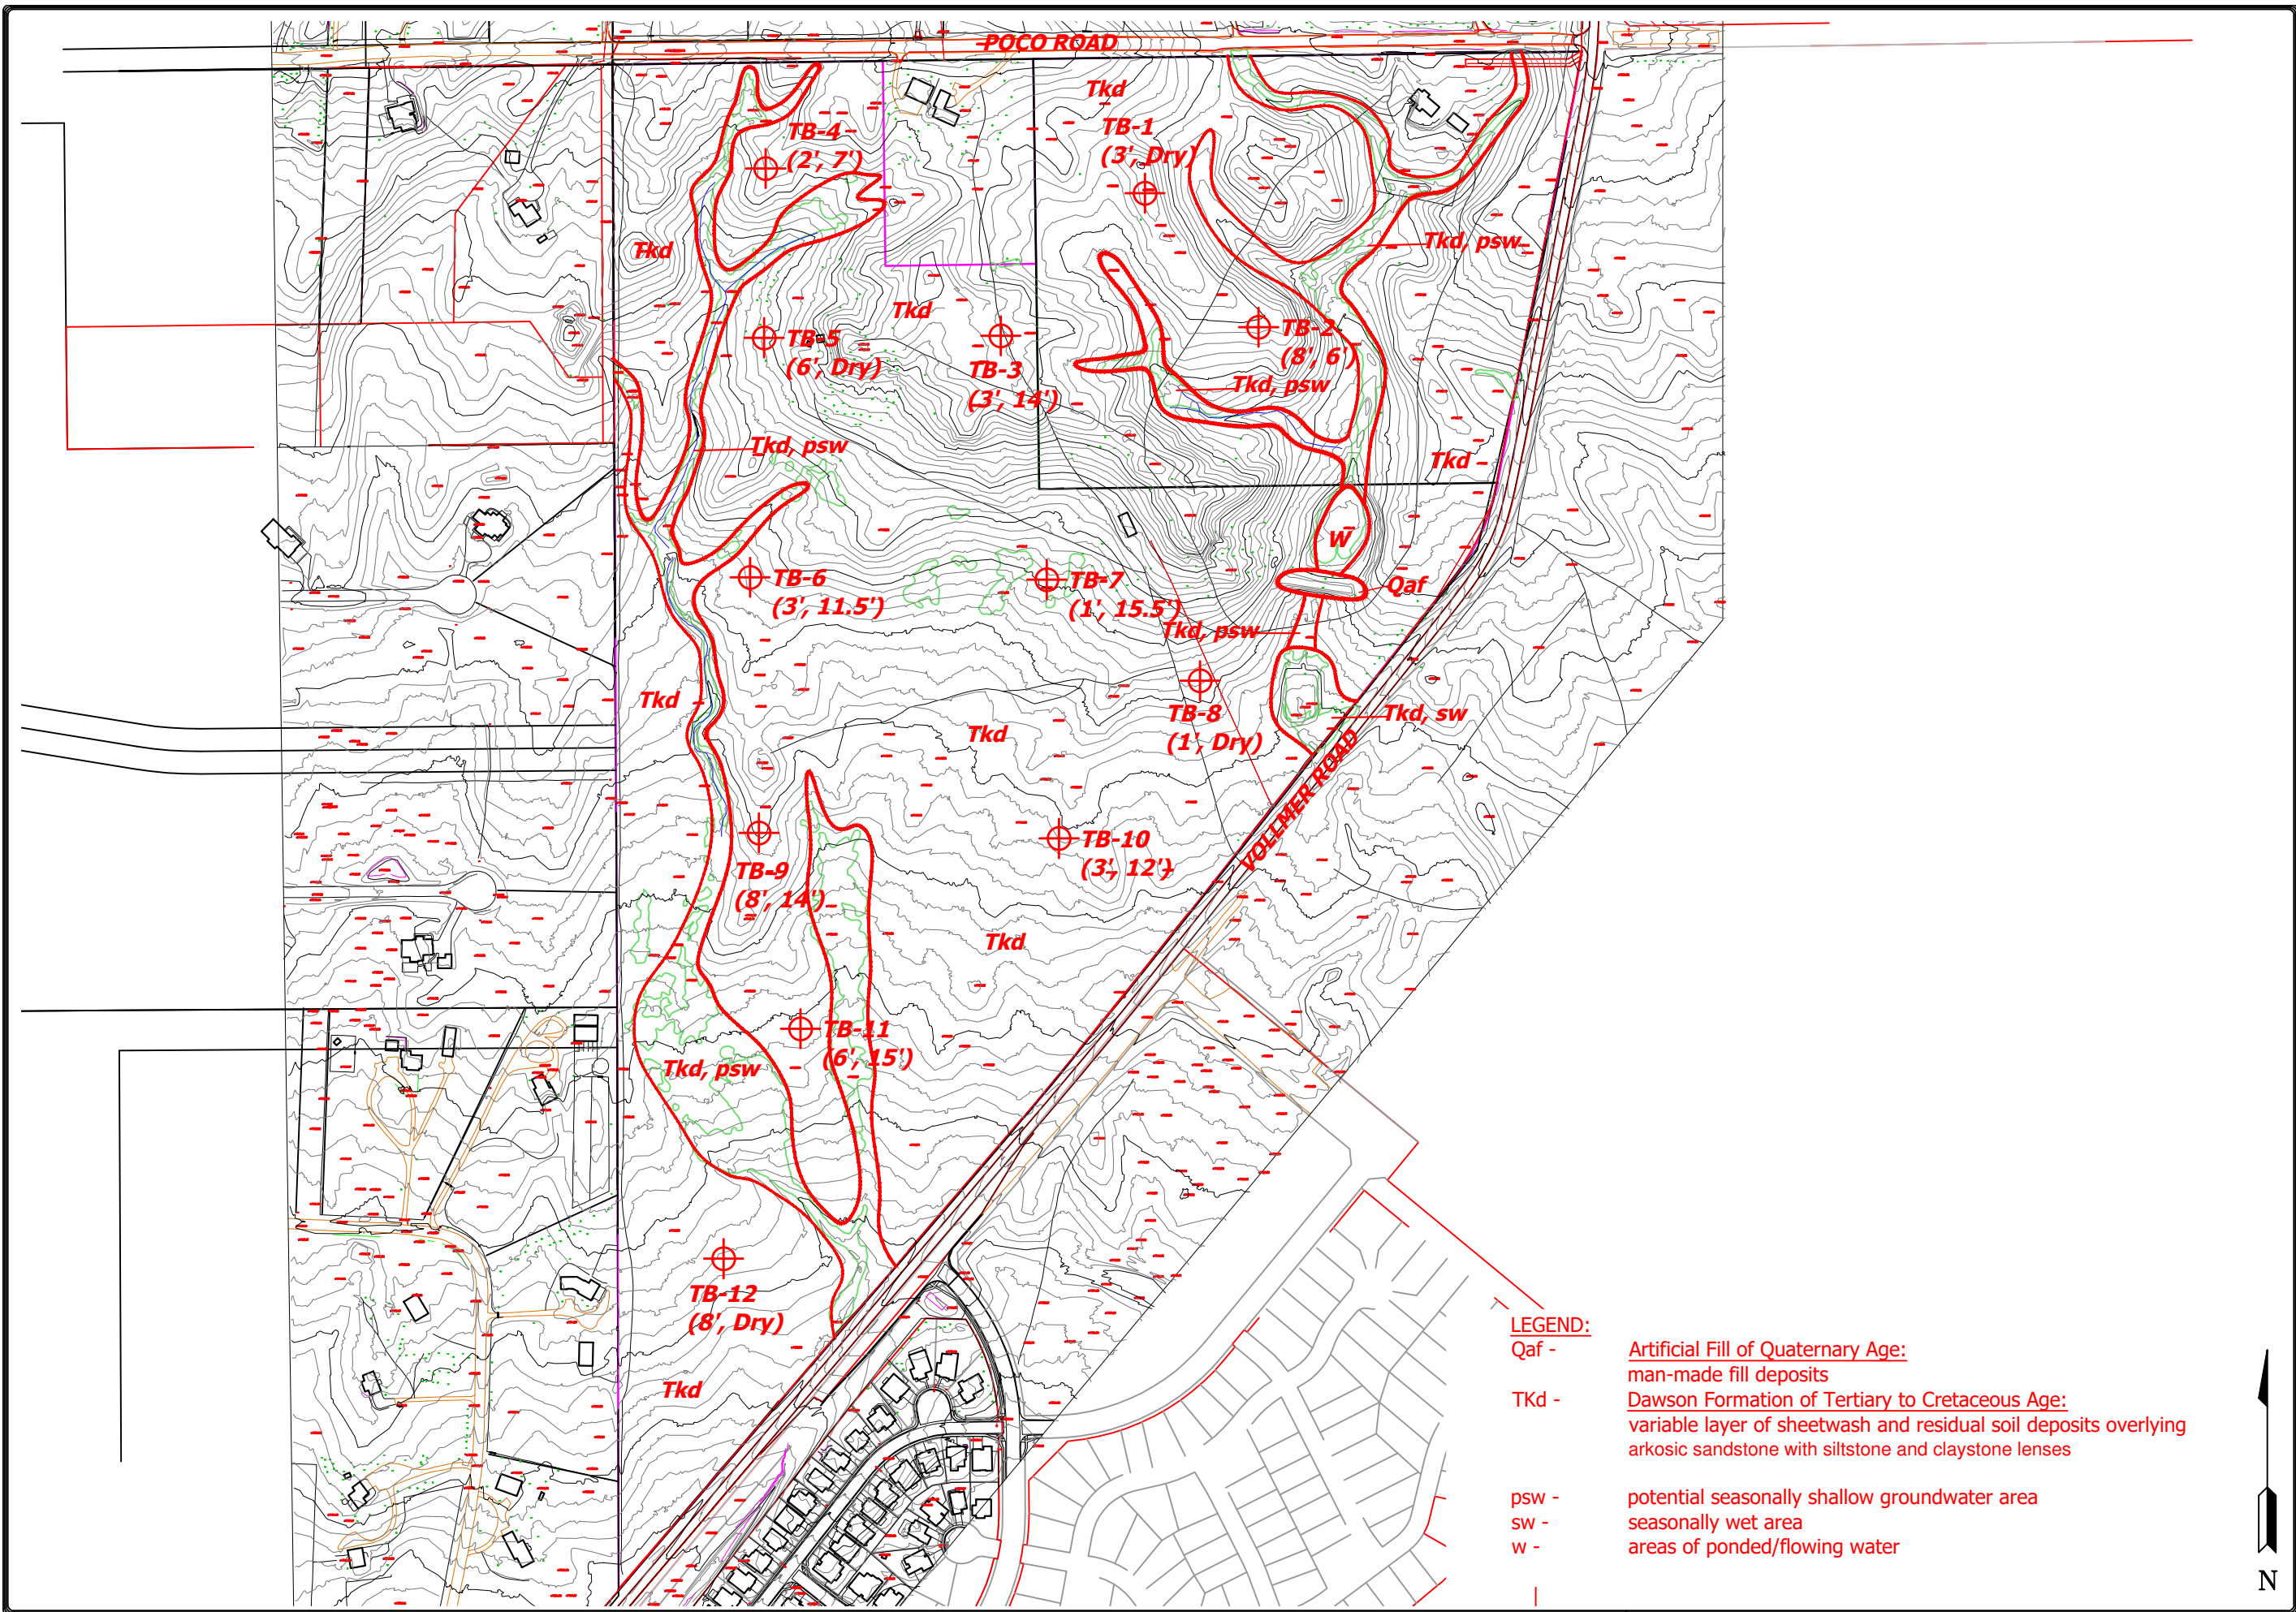
As mentioned previously, detailed mapping has been performed on this site to produce an Engineering Geology Map Figure 7. This map shows the location of various geologic conditions of which the developers should be cognizant during the planning, design and construction stages of the project. These hazards and the recommended mitigation techniques are as follows:

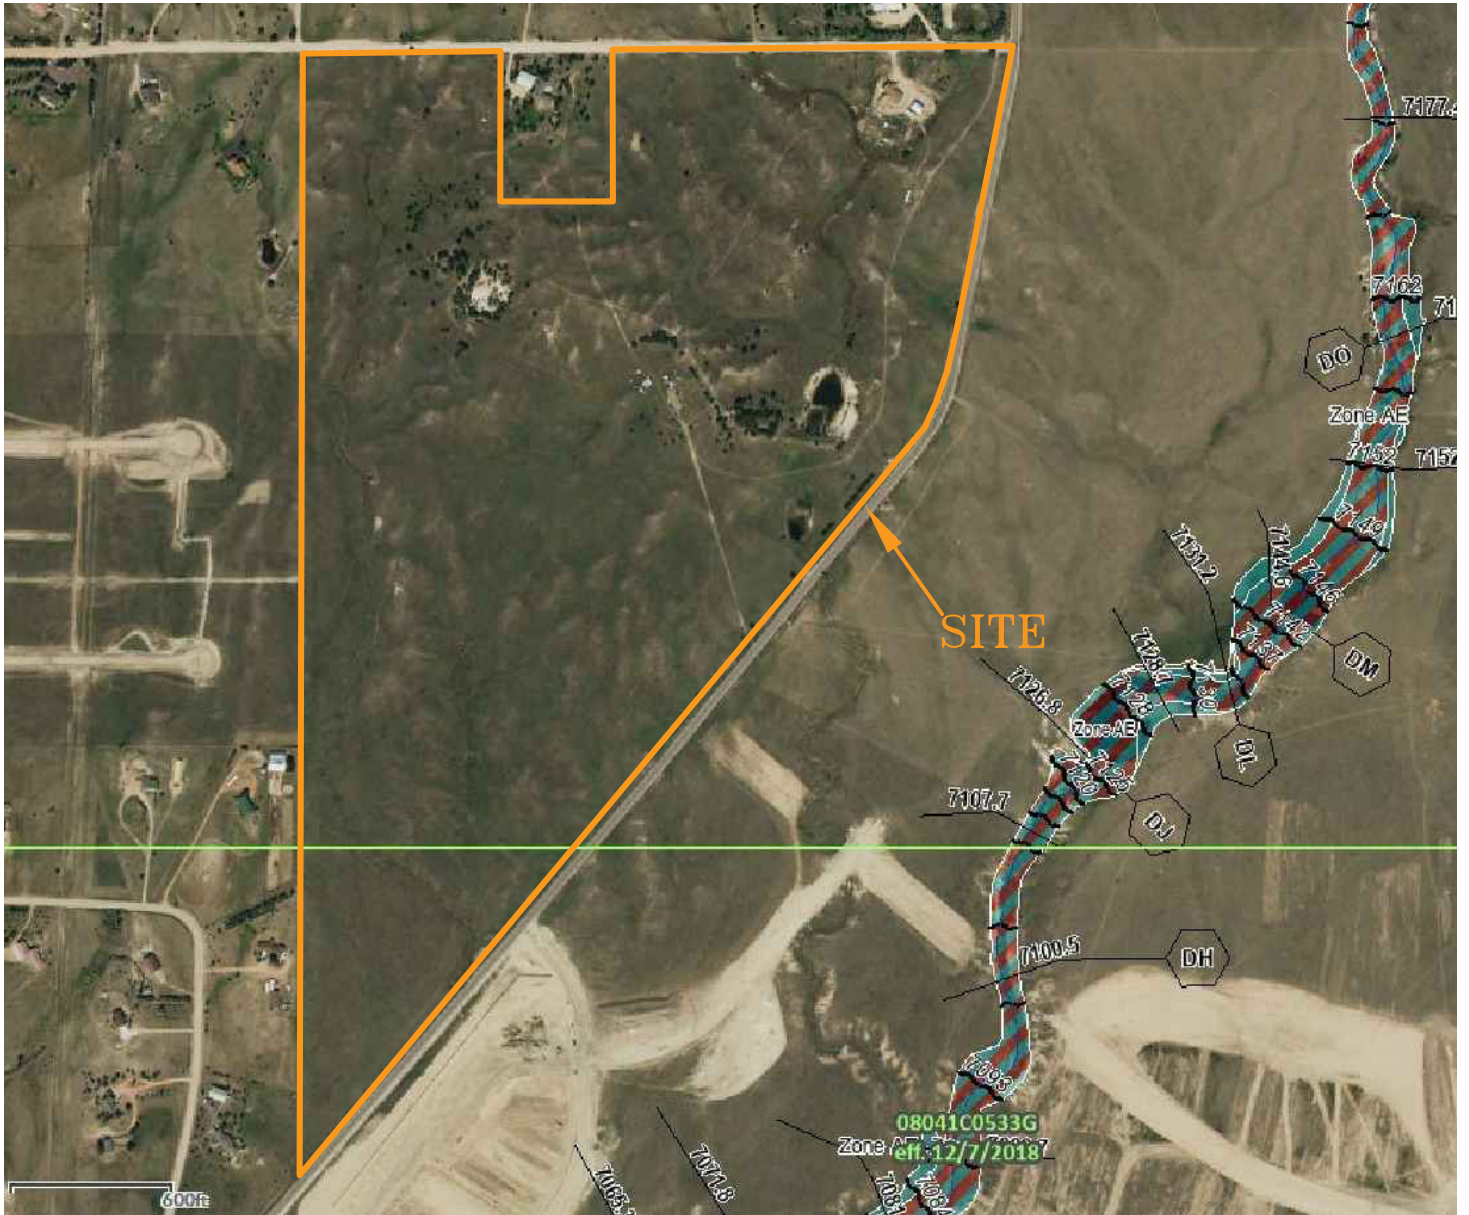
FIG NO.:  
8

Two drainages exist in the eastern and western portions of the site that have been identified as areas of seasonally wet and/or seasonally high groundwater areas. Water was observed in the pond located in the eastern portion of the site. Water was not observed in the drainage areas on the site. The site is not mapped within floodplain zones according to the FEMA Map Nos. 08041CO533G and 08041CO535G, Figure 8 (Reference 8). These areas are discussed as follows:

Mitigation: Foundations must have a minimum 30-inch depth for frost protection. In areas where high subsurface moisture conditions are anticipated periodically, subsurface perimeter drains are recommended to help prevent the intrusion of water into areas below grade. Typical drain details are presented in Figures 9 through 11. Any grading in these areas should be done to direct surface flow around construction to avoid areas of ponded water. Structures should not block drainages. All organic material should be completely removed prior to any fill placement. Finished floor levels must be located a minimum of one foot above floodplain levels.

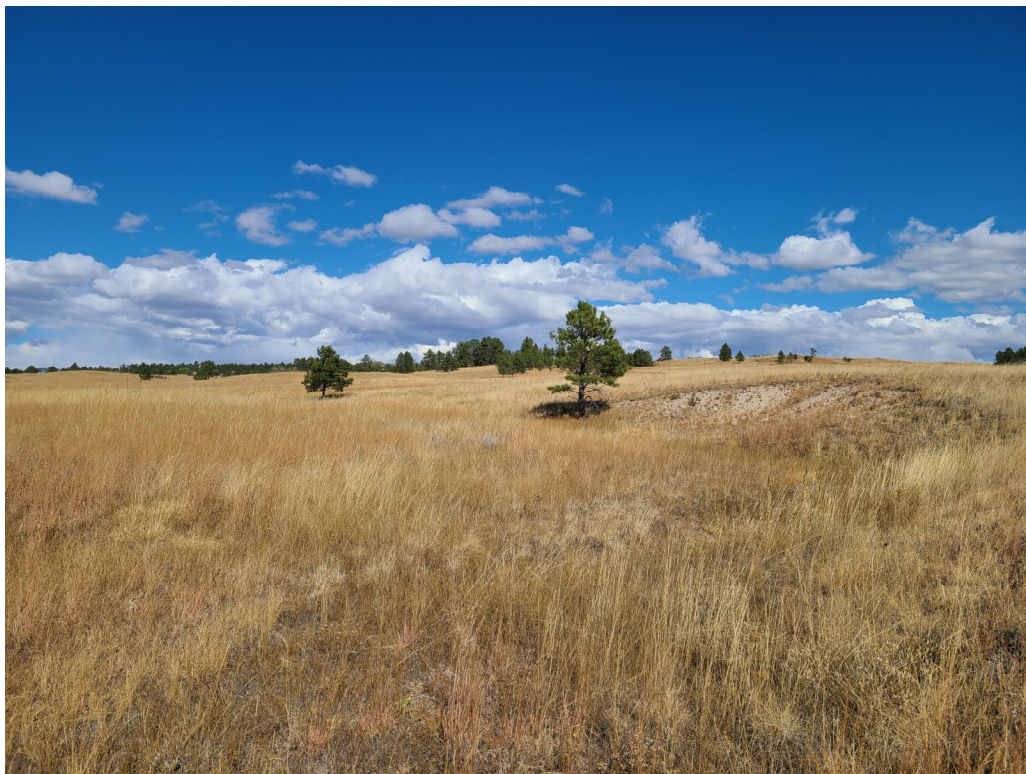
**Looking north along  
drainage in the  
southwestern portion  
of the site.**

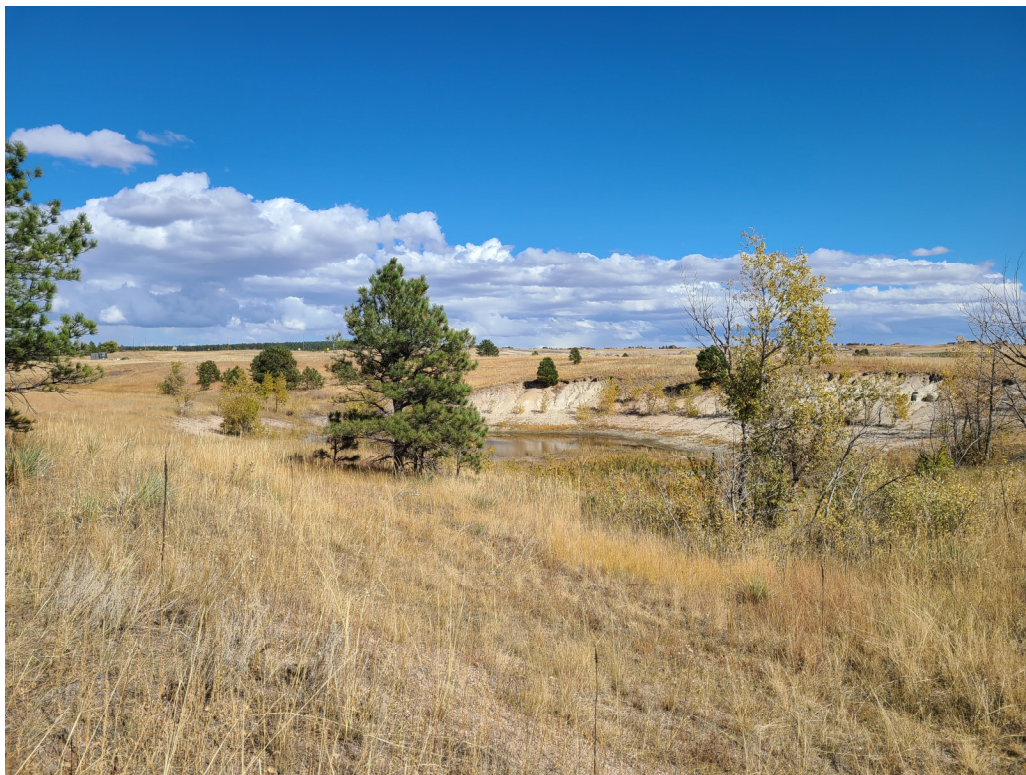
**Looking northeast  
towards pond in the  
northeastern portion of  
the site.**

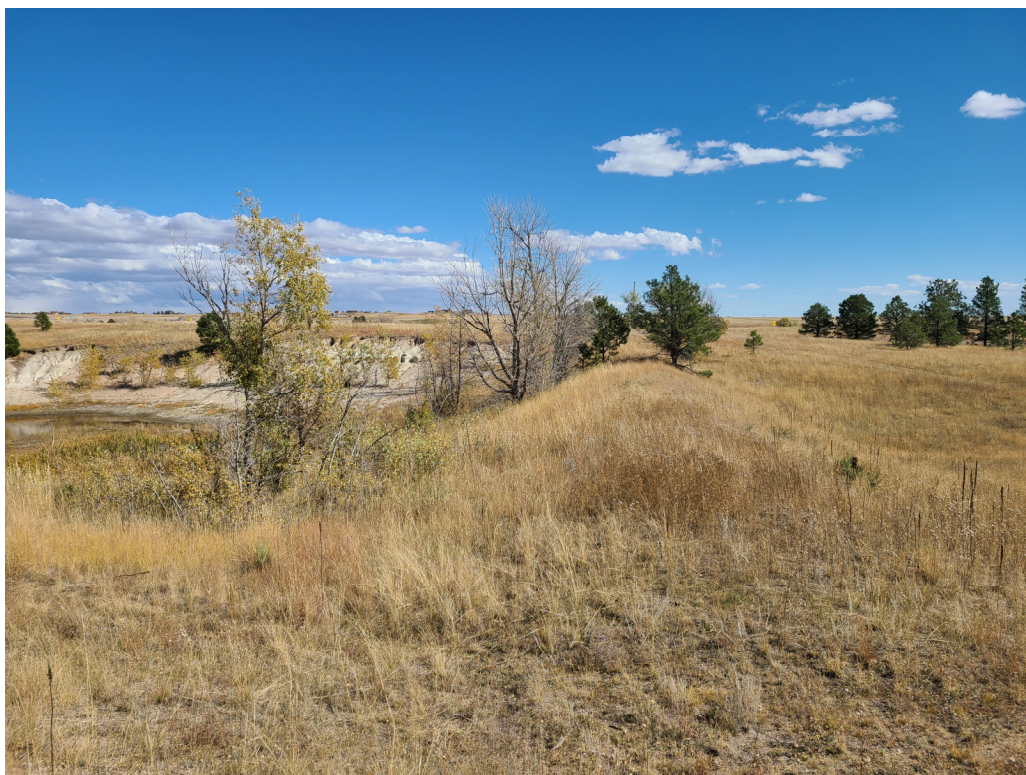
These are recent man-made fill deposits associated with the earthen dam located in the eastern portion of the site. It is anticipated that this dam will be removed and filled during the site grading process. At the time of the investigation, the condition of the dam was observed, and appeared to be in good condition.

**Looking east along  
earthen dam in the  
eastern portion of the  
site.**

Mitigation: The earthen dam lies within a defined drainage and should be avoided as building sites. The fill on this site is considered uncontrolled for construction purposes. Any uncontrolled fill encountered beneath foundations will require removal and recompaction at a minimum of 95% of its maximum Modified Proctor Dry Density, ASTM D-1557.
