**ENTECH**  
ENGINEERING, INC.

Re: Soil, Geology and Geologic Hazard Evaluation  
Big O Tires  
6985 Meridian Road  
Falcon, Colorado

**PCD File No. SF-18-003**

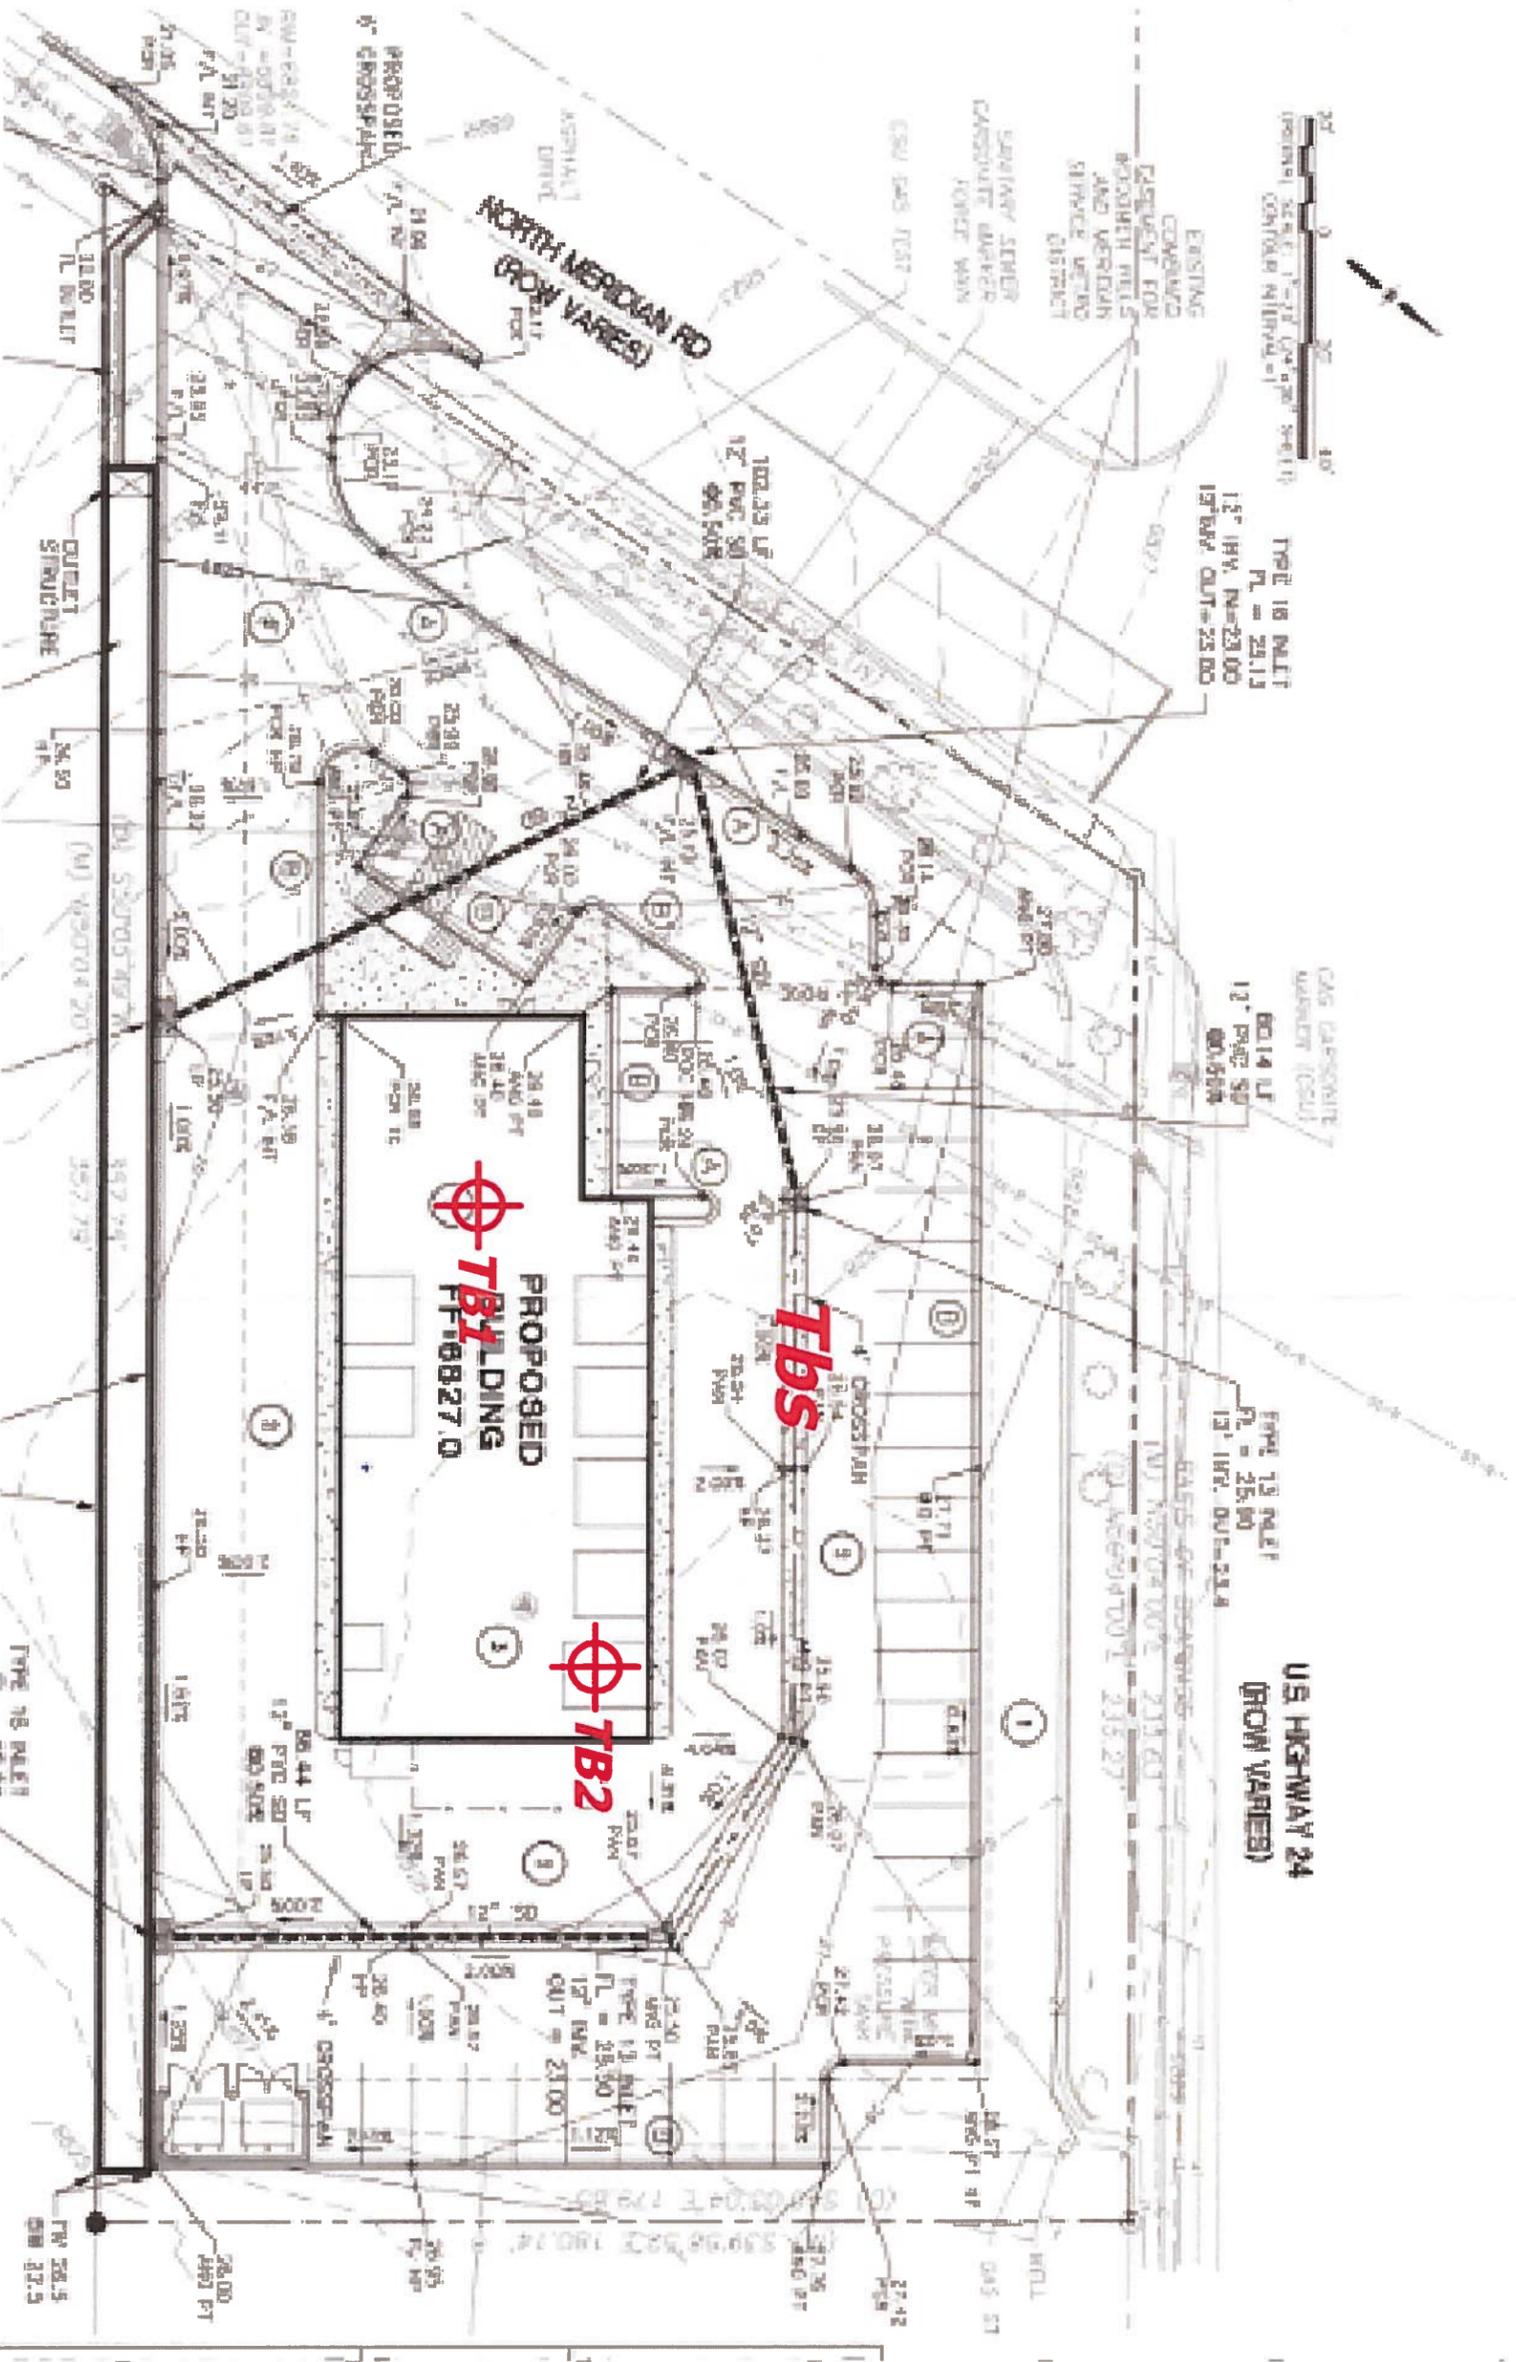
Site/Test Boring Location Map  
 6985 Meridian Road  
 Colorado Springs, CO.  
 For: Hammers Construction

The geology of the site was evaluated using the *Geologic Map of the Falcon Quadrangle*, by Morgan and White in 2012, (Reference 4, Figure 4). The Geology for the site is indicated in Figure 2. One mappable unit was identified on this site which, is as follows:

**Tbs**      **Black Squirrel Formation of Tertiary Age:** The Black Squirrel Formation typically consists of arkosic sandstone with interbedded fine-grained sandstone, siltstone and claystone. Overlying this formation is a variable layer of residual soil. The residual soils were derived from the in-situ weathering of the bedrock materials on-site. These soils consisted of silty sands and may contain layers of sandy clays.

Up to three feet of fill was encountered in one of the borings test drilled on site. Fill likely exists associated with the existing buildings, as well.

Loose to very loose soils were encountered in borings drilled on site (Reference 1). Loose soils encountered beneath the foundation or floor slabs will require mitigation.

Mitigation: It is anticipated the fill will be removed during site grading. The old fill and debris from the existing buildings should be completely removed. All old formation remnants and utilities should be completely removed. Any uncontrolled fill encountered beneath new foundations should be removed and recompact at a minimum of 95% of its maximum Modified Proctor Dry Density, ASTM D-1557.

Mitigation: Should loose soils be encountered beneath any new foundations or floor slabs, mitigation will be necessary. Overexcavation and recompaction at a minimum of 95% of its maximum Modified Proctor Dry Density, ASTM D-1557 is a suitable mitigation, which is common in the area. An overexcavation depth of 2 to 3 feet is anticipated.

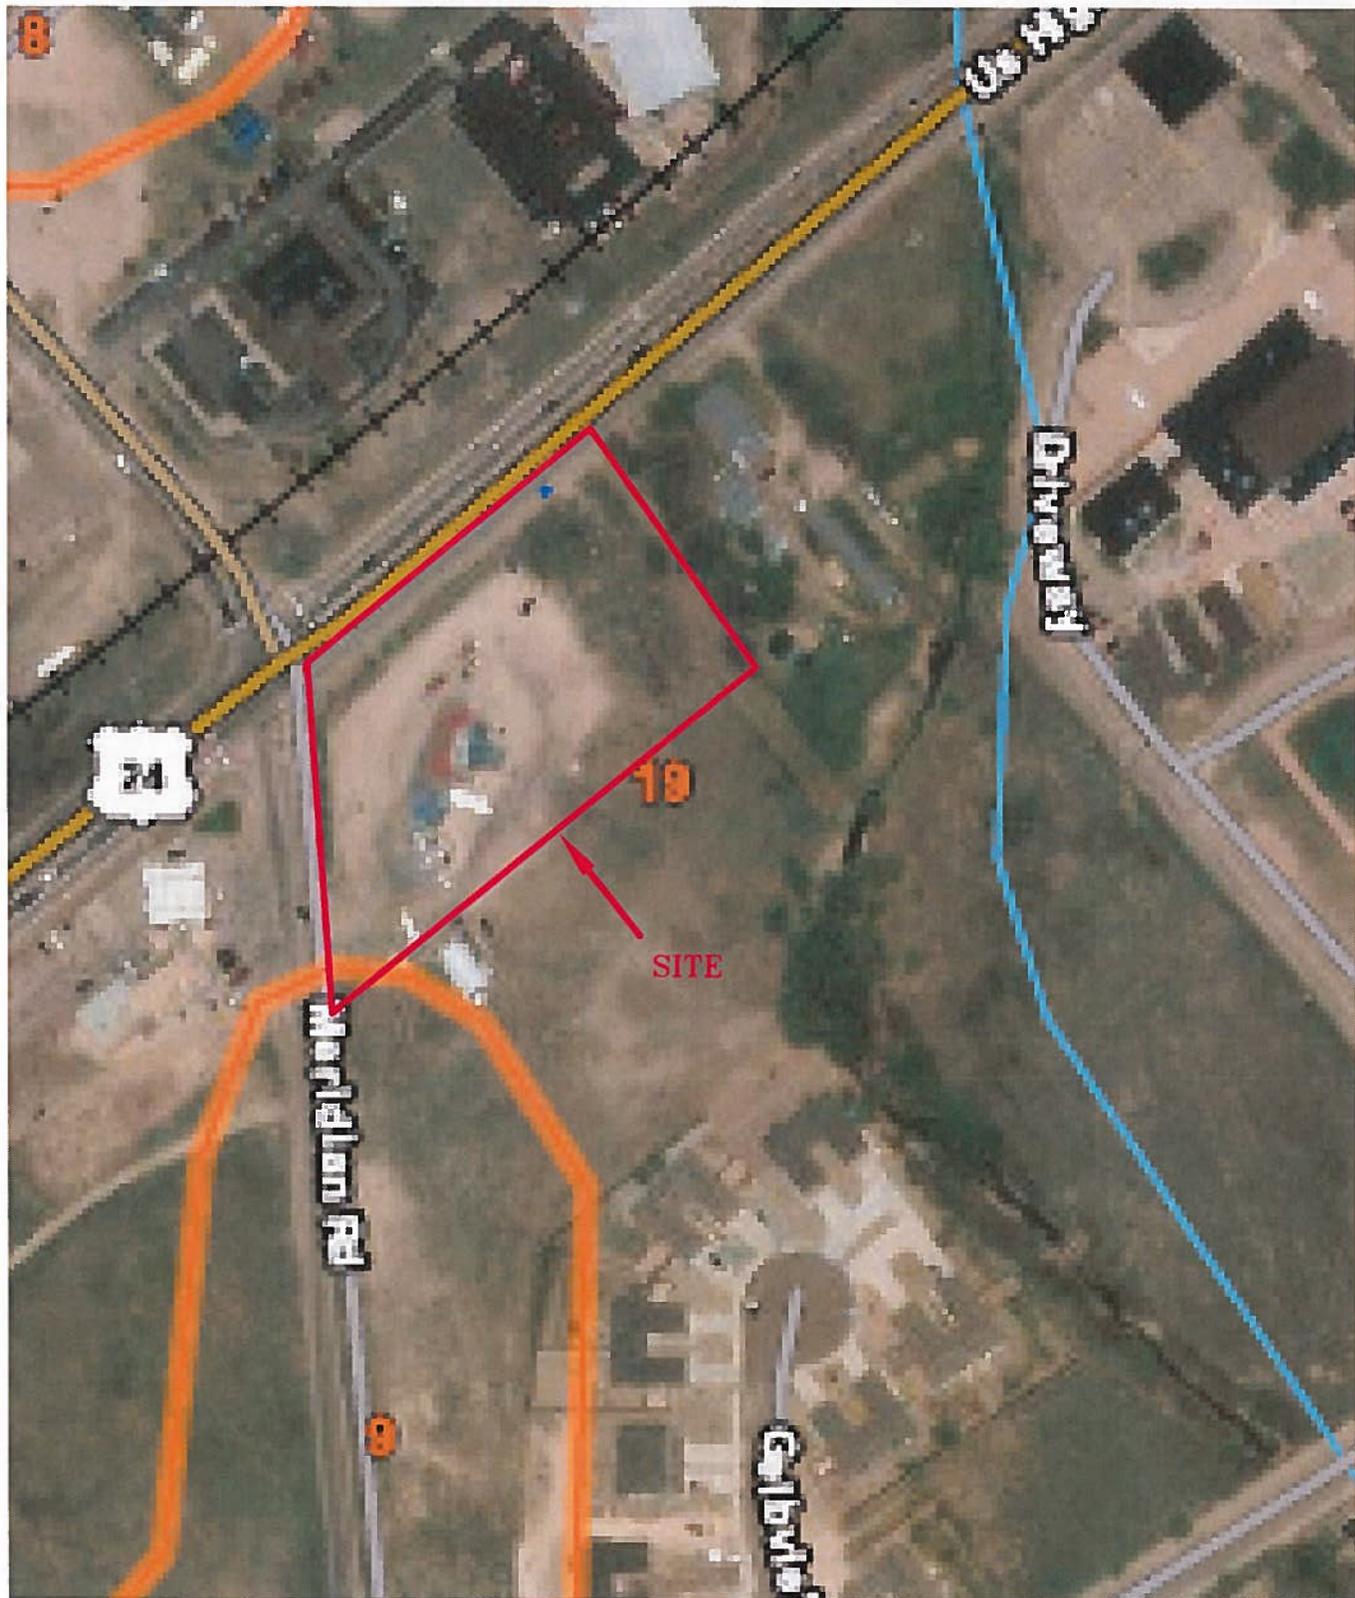
Soil Survey Map  
 6985 Meridian Road  
 Falcon, CO.  
 For: Hammers Construction

The Natural Resource Conservation Service (NRCS) (Reference 2, Figure 3), previously the Soil Conservation Service (Reference 3) has mapped one soil type on the site. Complete

<u>Type</u>	<u>Description</u>
19	Columbine gravelly sand loam, 0-3% slopes
