**Palmer Solar Pavement
Assessment– Draft Report**

August 16, 2019

juwi Inc.
1710 29th St., Suite 1068
Boulder, CO 80301

Stantec Consulting Services Inc.
3133 West Frye Road, Suite 300
Chandler, AZ 85226

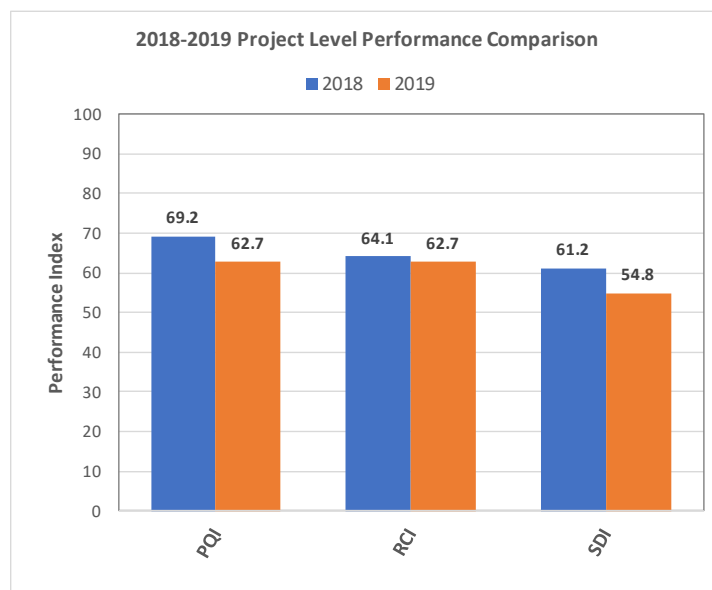
Figure ES.2: Project Level Performance Comparisons – 2018-2019

- The information presented above in Figure ES.2 indicate a reasonable decrease in PQI, RCI and SDI from 2018 to 2019. PQI decreased by approximately 6 points from 69 in 2018 to 63 in 2019, RCI decreased by approximately 1 point from 64 in 2018 to 63 in 2019, and SDI decreased by approximately 6 points from 61 in 2018 to 55 in 2019. Depending on the condition of the road and the type of deterioration curve it follows, the annual performance drop could typically range between 0 and 8 points for the various performance indices.
- Project level 2018-2019 comparisons of IRI and Rutting data are graphically presented below in Figure ES.3.

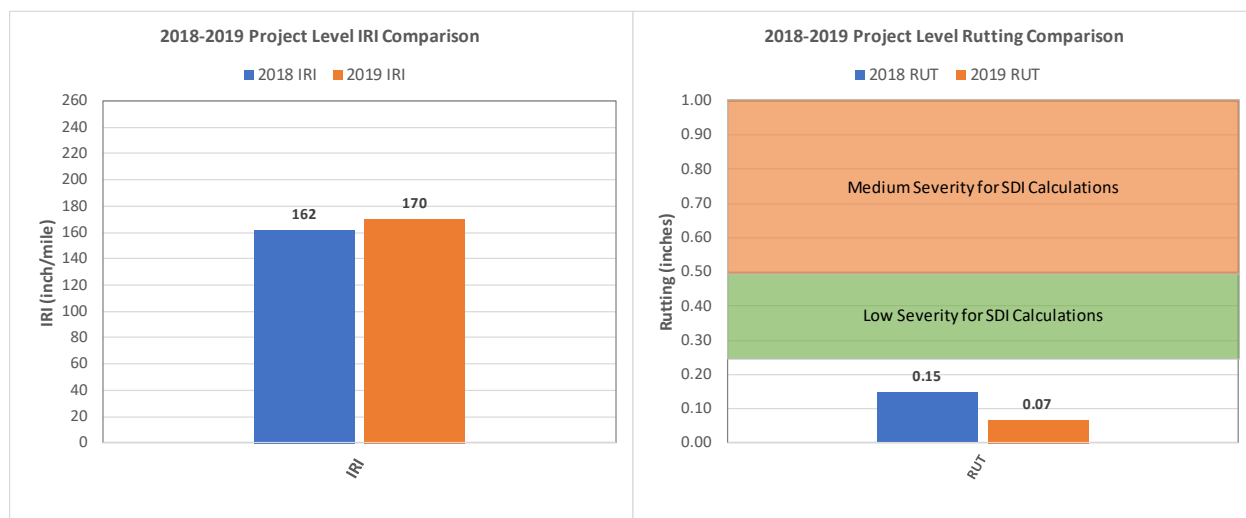
Figure ES.3: Project Level IRI and Rutting Comparisons – 2018-2019

- The information presented above in Figure ES.3 indicate a reasonable IRI and rutting trends with an increase in IRI of approximately 8 inches/mile (162 inches/mile in 2018 to 170 inches per mile in 2019). and a negligible decrease of 0.08 inches in rutting readings (0.15 inches in 2018 to 0.07 inches in 2019). While an increase in IRI is an expected trend with age, a decrease in rut depth is not expected. This decrease however is small and could potentially be attributed to riding in a slightly different wheel path compared to 2018. Rutting on this project was generally low and mostly below the 0.25 inches threshold, which is the minimum for inclusion in the SDI calculations, as indicated by the green and orange zones shown above in Figure ES.3.

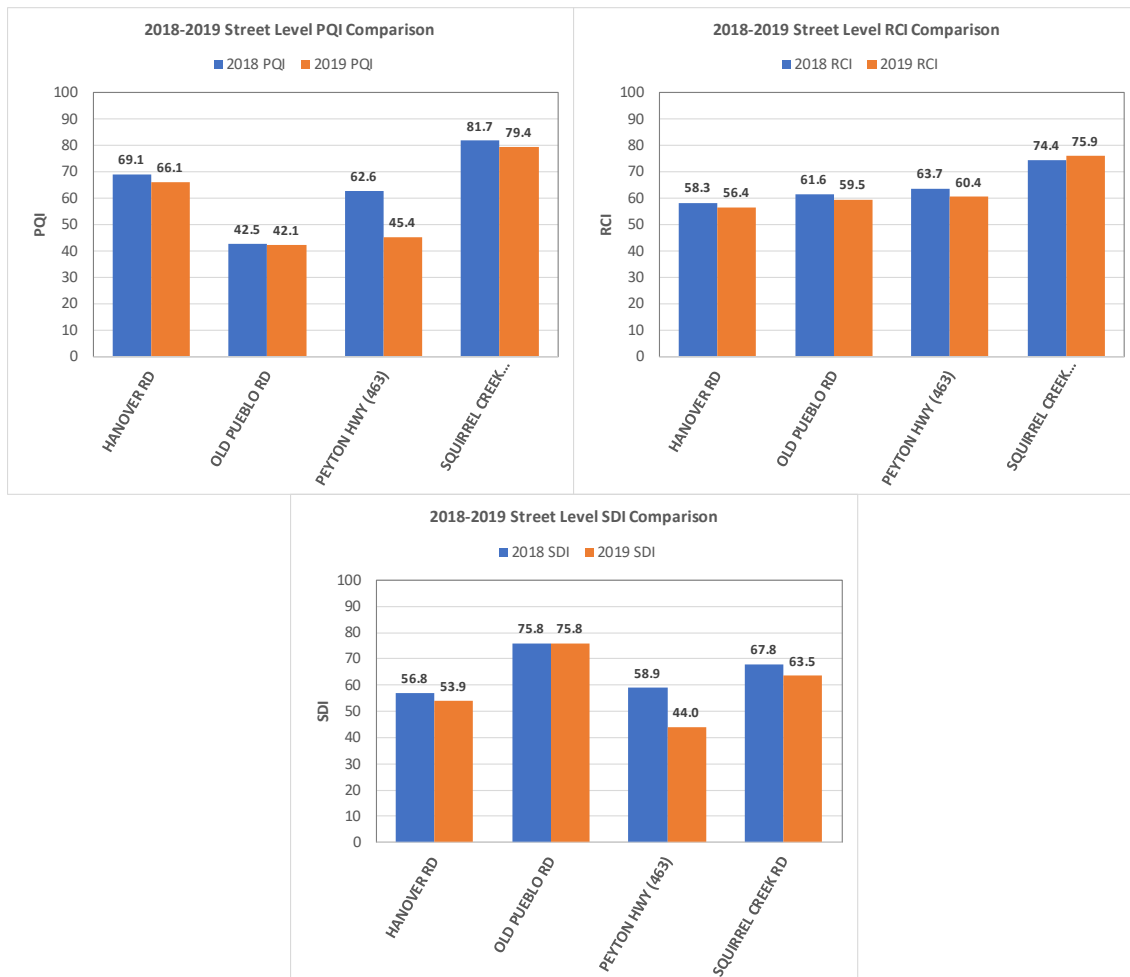
Figure ES.4: Project Level PQI, RCI and SDI Comparisons – 2018-2019

- Street level 2018-2019 performance comparisons (PQI, RCI, SDI) are graphically presented below in Figure ES.4.
 - The results in Figure ES.4 below indicate, as expected, a decrease in the PQI, RCI and SDI performance scores from 2018 to 2019 for all four streets. With the exception of Peyton Hwy 463, PQI on the other three roads decreased between 1 and 3 points, RCI decreased approximately 2 points and SDI decreased between zero, (i.e. no decrease), and 4 points.

- The results for Peyton Hwy 463A indicate a somewhat larger than expected decrease in PQI and SDI. In reviewing the detailed data along the various sections of Peyton Hwy 463, it was determined that light severity raveling was overrated by the field crew which have caused the SDI to drop significantly, because raveling contributes largely to the SDI score calculations.

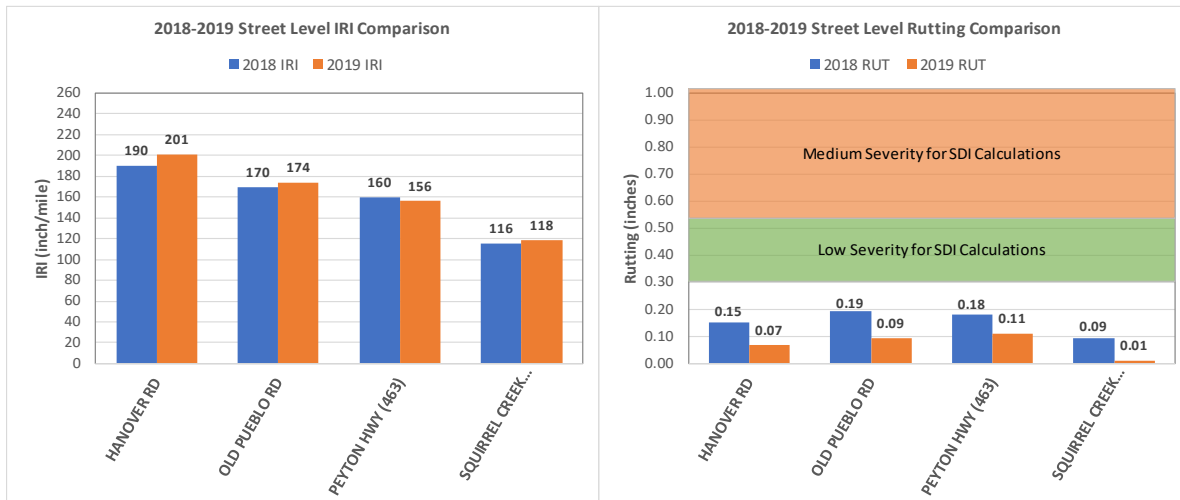
Figure ES.5: Street Level IRI and Rutting Comparisons – 2018-2019

- Street level 2018-2019 IRI and Rutting comparisons are graphically presented below in Figure ES.5.
 - The results presented in Figure ES.5 indicate an increase in IRI readings in the range of 2 to 11 inches/mile, except for Peyton Hwy 463 where the IRI slightly decreased by approximately 4 inches/mile. As for rutting, the results indicate a negligible decrease (≤ 0.1 inches) on all 4 streets.
- Street/Lane level 2019 performance comparisons (PQI, RCI, SDI) are graphically presented below in Figure ES.6 for the positive and the negative lanes tested in 2019.

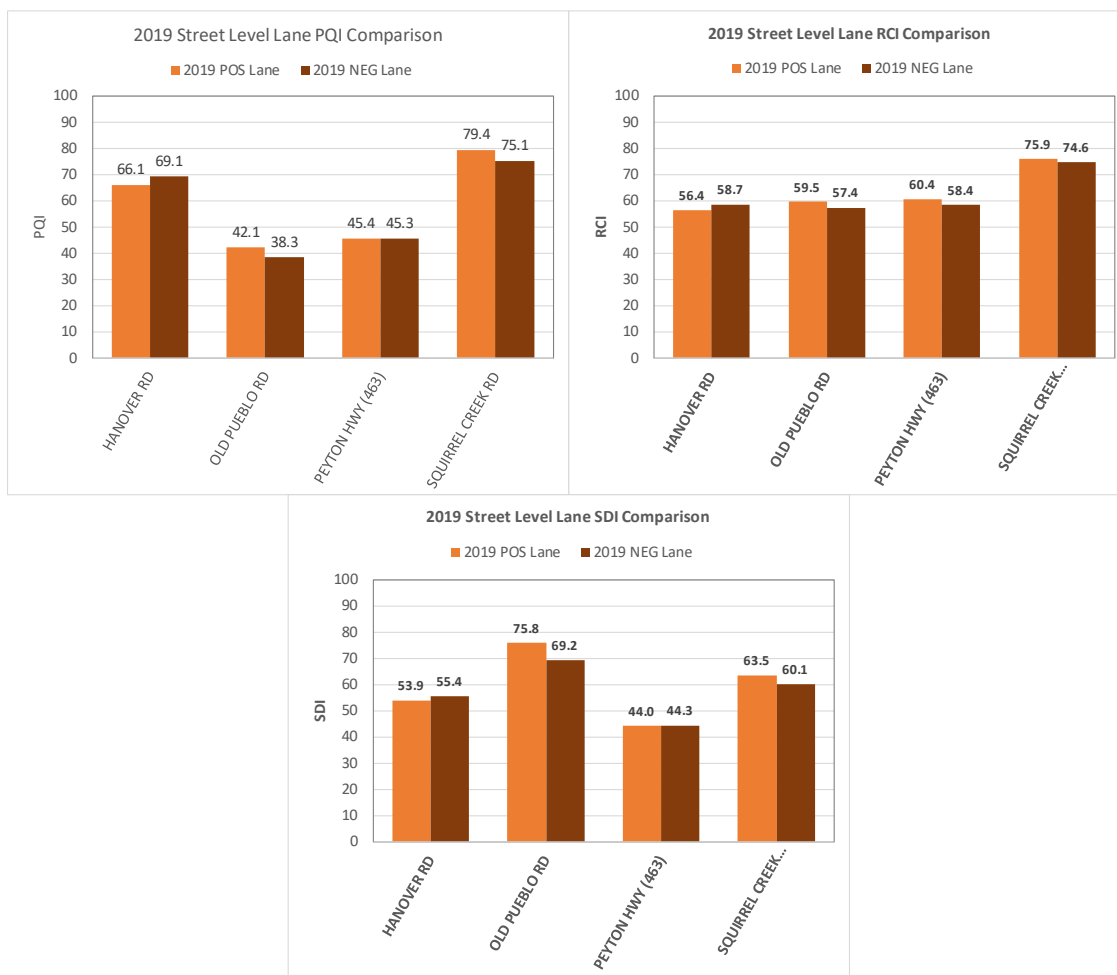
Figure ES.6: Street/Lane Level PQI, RCI, SDI Comparisons – 2019

- The results presented in Figure ES.6 indicate comparable PQI, RCI and SDI results between the opposite direction lanes. The results indicate a difference in the range of 0 to 4 points in PQI, 1 to 3 points in RCI and 0 to 7 points in SDI between 2018 and 2019.
- The PQI, RCI and SDI comparison results also indicate that Peyton Hwy 463 shows the closest agreement in surface distress ratings between the opposite direction lanes.
- Street/Lane level 2019 IRI and rutting comparisons are graphically presented below in Figure ES.7.

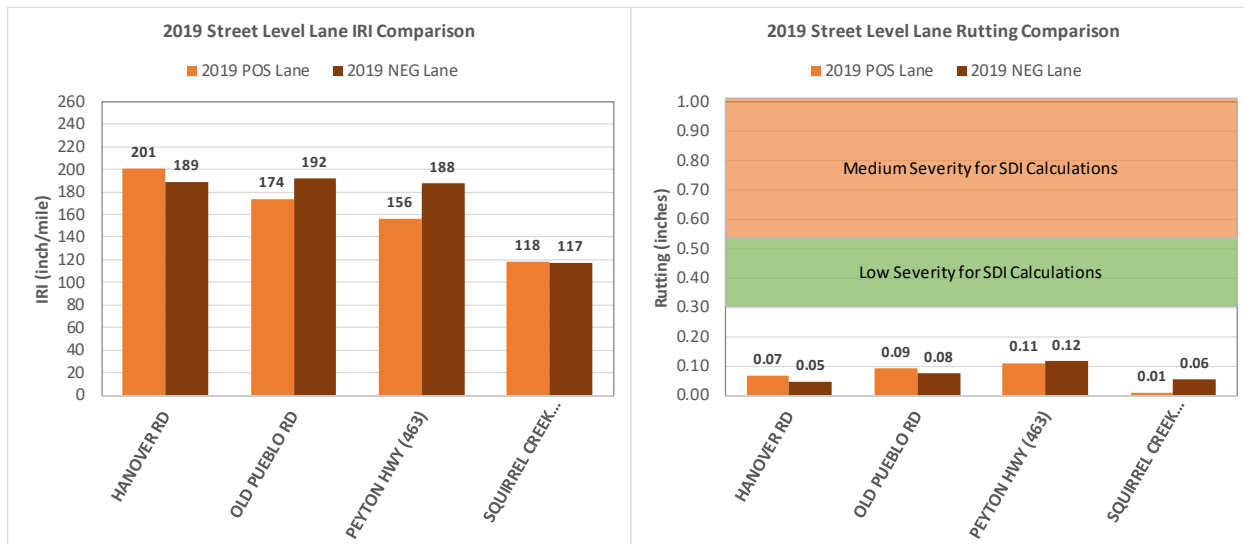
Figure ES.7: Street/Lane Level IRI and Rutting Comparisons – 2019

- The results presented in Figure ES.7 indicate comparable IRI and rutting results between the opposite direction lanes. The results indicate a difference in the range of 1 inch/mile to 32 inches/mile in IRI and a difference of ≤ 0.05 inches in rutting. The largest difference in IRI of 32 inches/mile belongs to Peyton Hwy 463 and the smallest difference in IRI of 1 inches/mile belongs to Squirrel Creek Road.

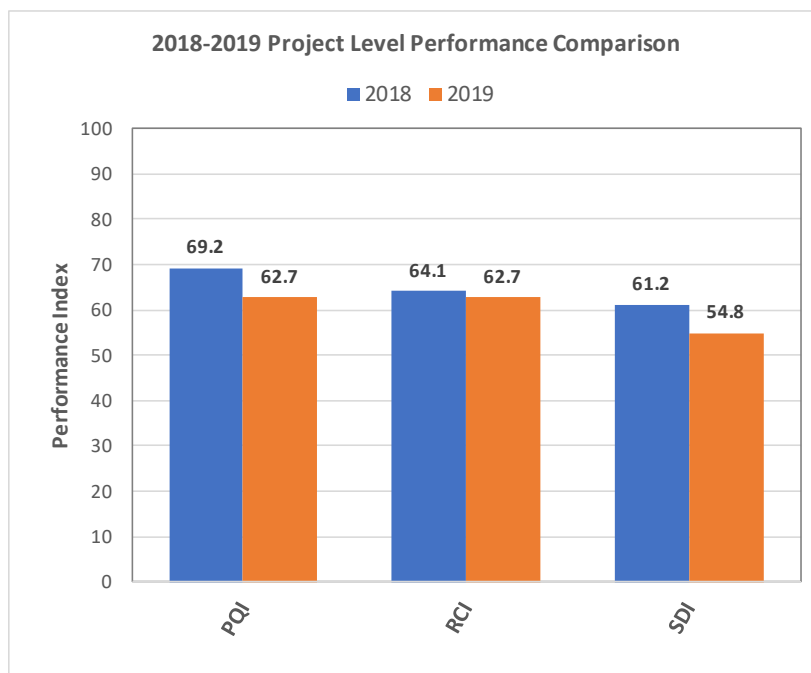
Figure 3.1: Project Level Performance Comparisons - 2018-2019

The results presented above in Table 3.1 and Figure 3.1 indicate an overall decrease in the performance scores at the project level. PQI decreased by approximately 6 points, RCI decreased by approximately 1 point and SDI decreased by approximately 6 points. Considering the 2018 performance scores and the correspondence location on the deterioration curves that tend to decrease rapidly within this performance region, this decrease in performance could be considered reasonable. Depending on the condition of the road and the type of deterioration curve it follows, the annual performance drop could typically range between 0 and 8 points for the various performance indices.

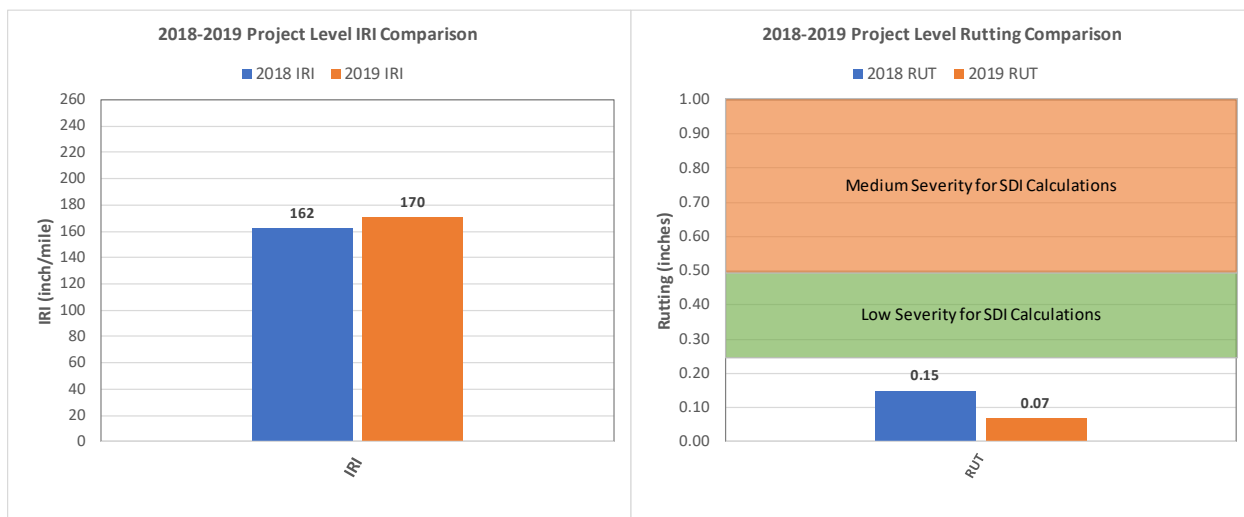
Figure 3.2: Project Level IRI and Rutting Comparisons - 2018-2019

The results presented above in Table 3.2 and Figure 3.2 indicate an increase in IRI readings of approximately 8 inches/mile and a decrease of 0.08 inches in rutting readings. While an increase in IRI is an expected trend with age, a decrease in rut depth is not expected. This decrease however is small and could potentially be attributed to riding in a slightly different wheel path compared to 2018. Also considering that rutting values smaller than 0.25" are ignored when calculating the SDI, and the fact that the measured rut values on this project are small to begin with, this decrease in rut values can be ignored. The rutting side of Figure 3.2 above shows that rutting values between 0.25 inches and 0.5 inches are considered as low severity rutting for SDI calculations whereas rutting values between 0.5 inches and 1.0 inches are considered medium severity rutting for SDI calculations.

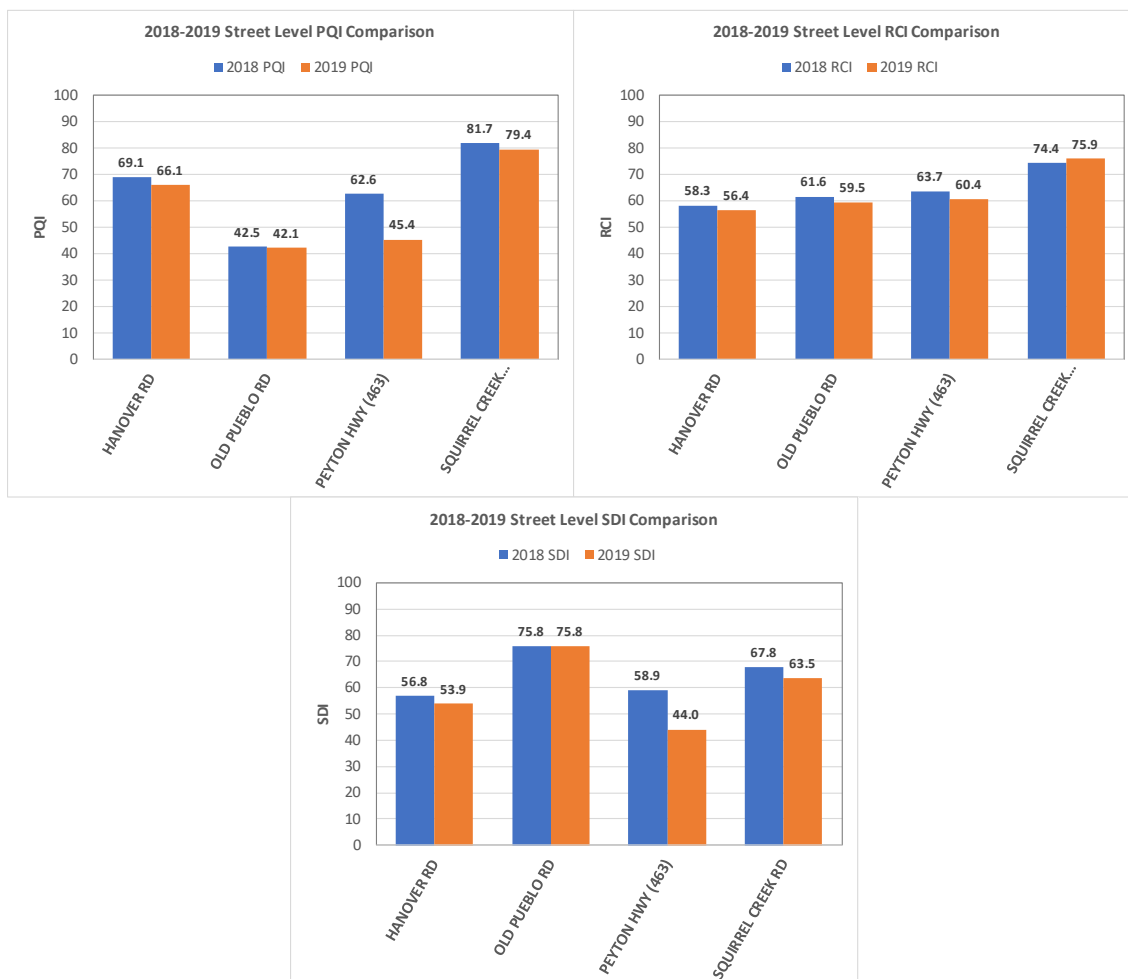
Figure 3.3: Street Level PQI, RCI and SDI Comparisons - 2018-2019

The results presented above in Table 3.3 and Figure 3.3 indicate, as expected, a decrease in the performance scores for all four streets. With the exception of Peyton Hwy 463, PQI on the other three roads decreased between one and three points, the RCI decreased approximately 2 points and SDI decreased between zero, i.e. no decrease, and 4 points total.

As for Peyton Hwy 463, the PQI decrease was approximately 18 points and the SDI decrease was approximately 15 points. With the RCI decrease being around 4 points, it is obvious that the large PQI decrease is influenced mainly by the SDI large decrease.

In reviewing the detailed data along the various sections of Peyton Hwy 463, it was determined that light severity raveling was overrated by the field crew which have caused the SDI to drop significantly, because raveling contributes largely to the SDI score calculations.

Understanding that raveling is a surface deficiency that occurs due to aging rather than heavy loading and that raveling usually takes place over time, and also considering that the annual RCI drop was reasonable at approximately 4 points, it can be concluded that the large drop is SDI, and consequently in the PQI score is not mainly due to heavy loading for a short duration, rather for a field overrating incident. This conclusion is also supported by the IRI and rutting results as presented below under Section 3.2.2.

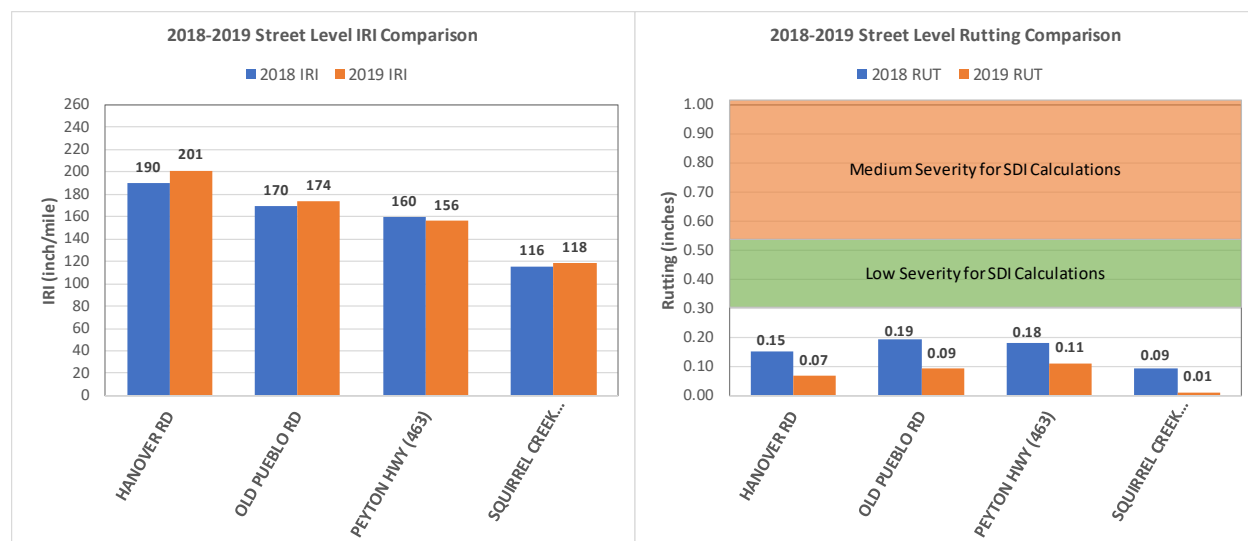
Figure 3.4: Street Level IRI and Rutting Comparisons - 2018-2019

The results presented above in Table 3.4 and Figure 3.4 indicate an increase in IRI readings in the range of 2 to 11 inches/mile, except for Peyton Hwy 463 where the IRI slightly decreased by approximately 4 inches/mile. As for rutting, the results indicate a negligible decrease (≤ 0.1 inches) in rutting values on all 4 streets. While a decrease in rut depth is not expected. This decrease however is small and could potentially be attributed to riding in a slightly different wheel path compared to 2018. Also considering that rutting values smaller than 0.25 inches are ignored when calculating the SDI, and the fact that the measured rut values on this project are small to begin with, this decrease in rut values can be ignored.

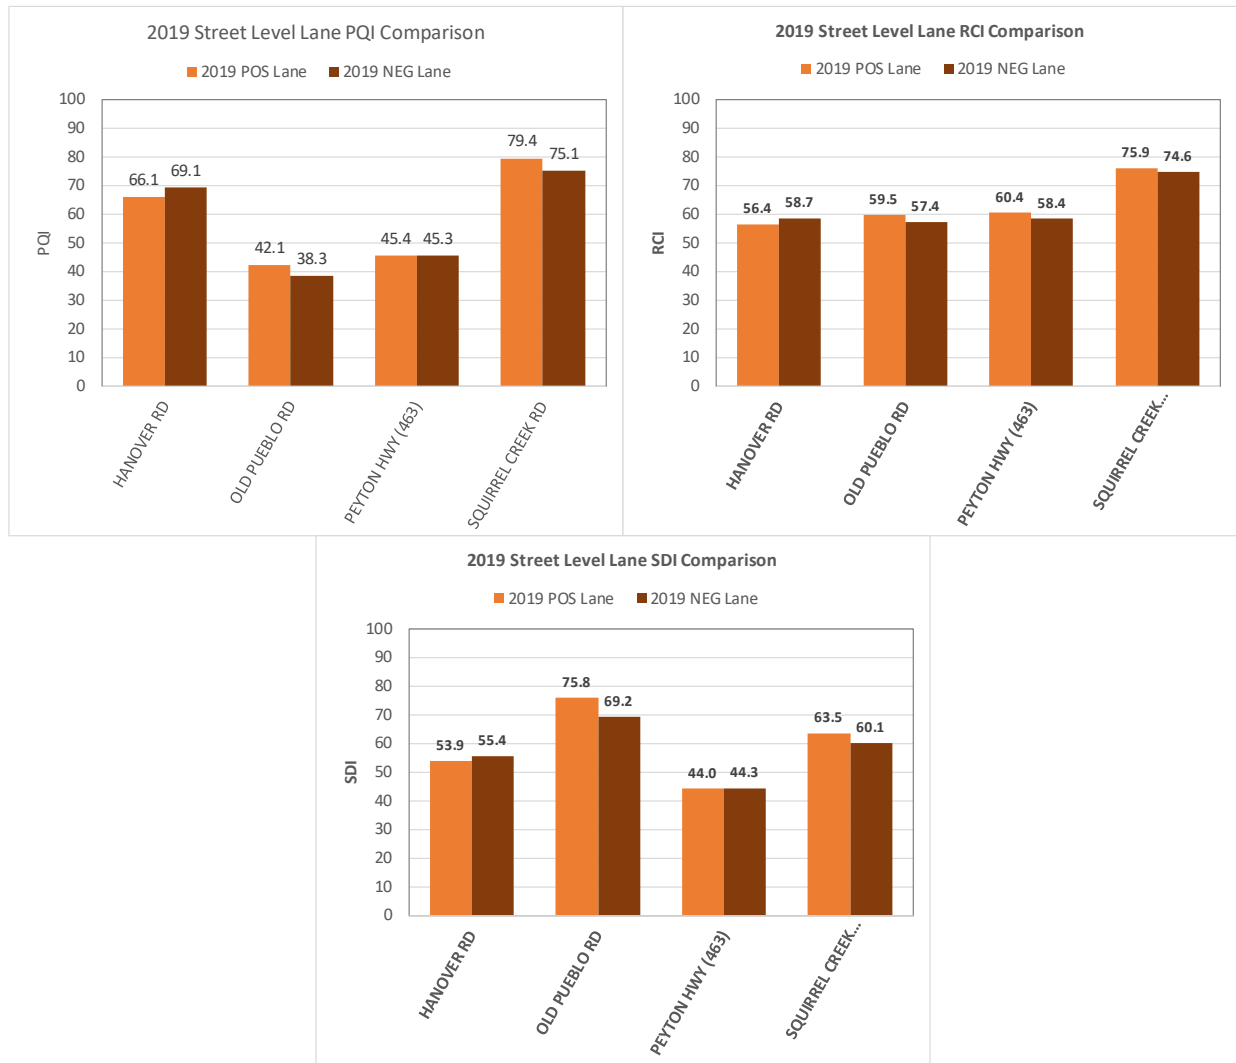
Figure 3.5: Street/Lane Level PQI, RCI, SDI Comparisons – 2019

As mentioned earlier, the purpose of testing the opposite (Negative) direction lanes is to have another set of performance ratings that validate the data collected on the positive lanes, which is compared with the County’s 2018 ratings. This validation assumes that the condition of the opposite lanes is expected to somewhat be similar to that of the positive lanes, which is not unreasonable to assume.

The results presented above in Table 3.5 and Figure 3.5 generally indicate comparable PQI, RCI and SDI results between the opposite direction lanes, i.e. a validation of the ratings collected on the positive lanes. The results indicate a difference in the range of 0 to 4 points in PQI, 1 to 3 points in RCI and 0 to 7 points in SDI. The results also indicate that Peyton Hwy 463 shows the closest agreement in surface distress ratings between the opposite direction lanes. In light of what was presented under Section 3.2.1.1 above,

this also indicates that the field crew may have consistently overrated raveling on Peyton Hwy 463 lanes in both directions.

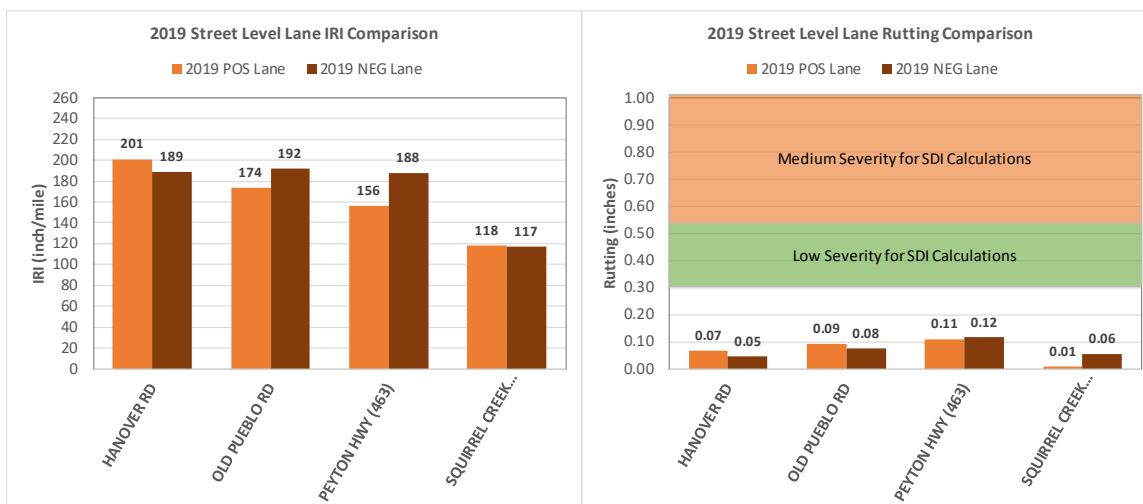
Figure 3.6: Street/Lane Level IRI and Rutting Comparisons - 2019

The results presented above in Table 3.6 and Figure 3.6 indicate a somewhat comparable IRI and rutting results between the opposite direction lanes. The results indicate a difference in the range of 1 inch/mile to 32 inches/mile in IRI and a difference of ≤ 0.05 inches in rutting. The largest difference in IRI of 32 inches/mile belongs to Peyton Hwy 463 and the smallest difference in IRI of 1 inches/mile belongs to Squirrel Creek Road.
