## Forest Lakes Bridges

Work Order No.: 21-8536.DrilledPiers.0001; ver: 2  
Reviewed by: Josiah Johnson

### Straight Shaft Drilled Piers

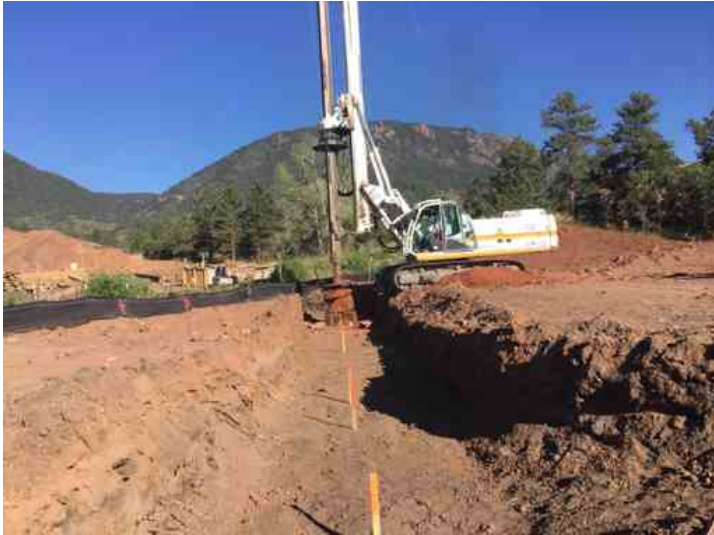
Drilling Hole for WB Pier at Location 1

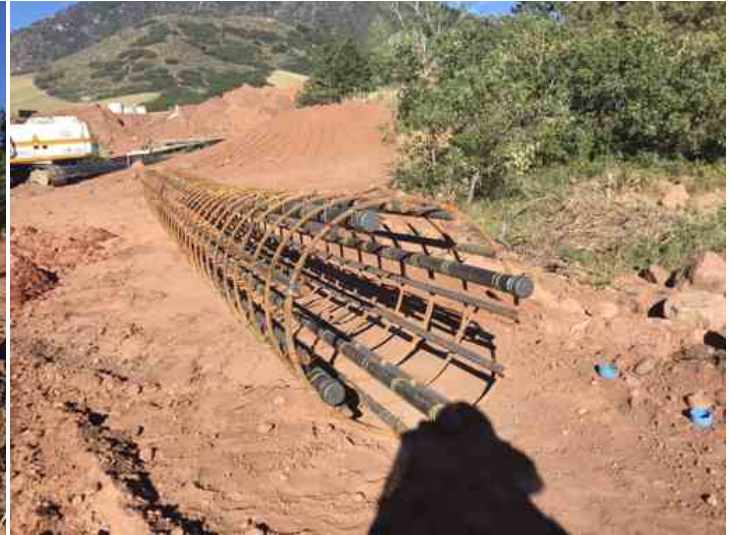
Re-bar Cage

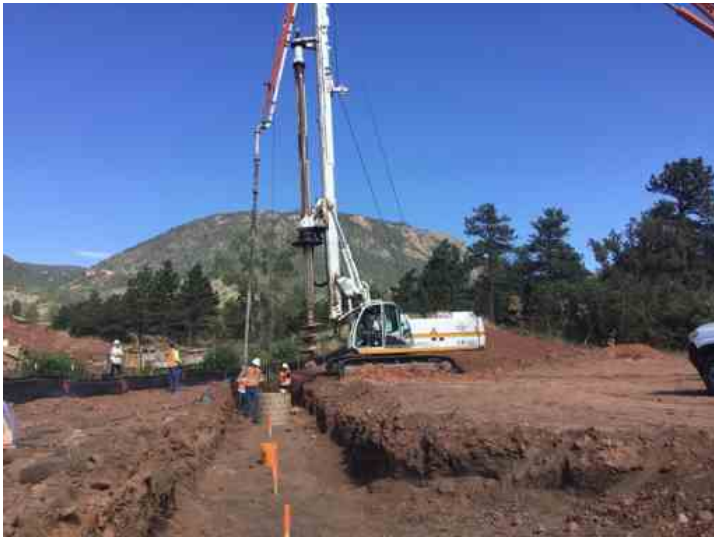
35' Long Tremmie Pipe for Concrete Placement

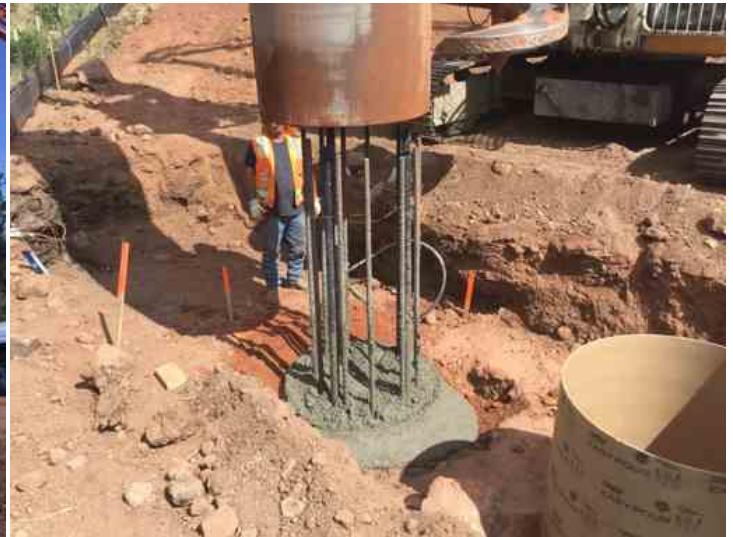
Concrete After Casing removal

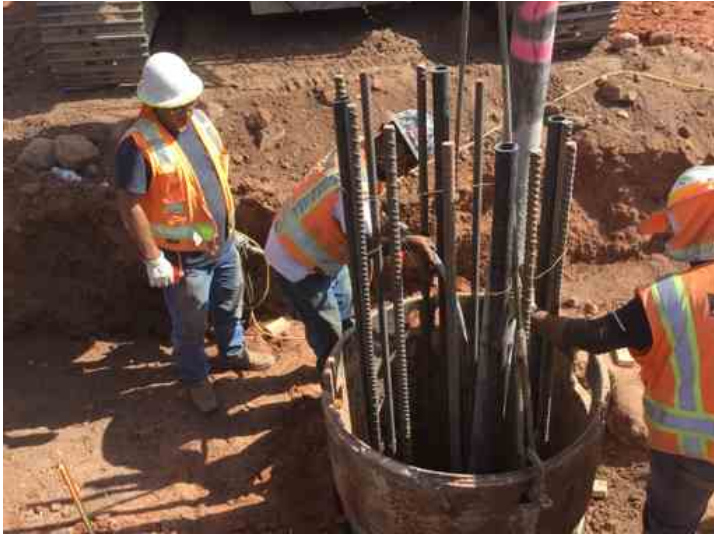
Vibrating Top 5' of Pier after concrete Placement

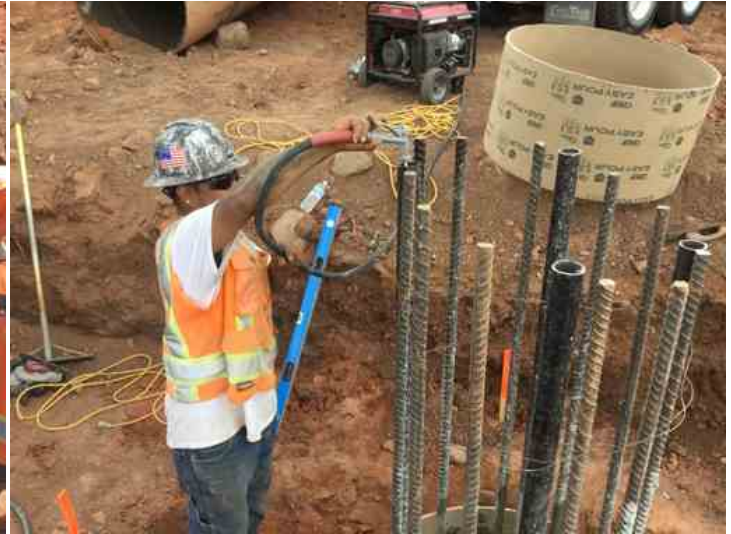
Filling CSL tubes with water

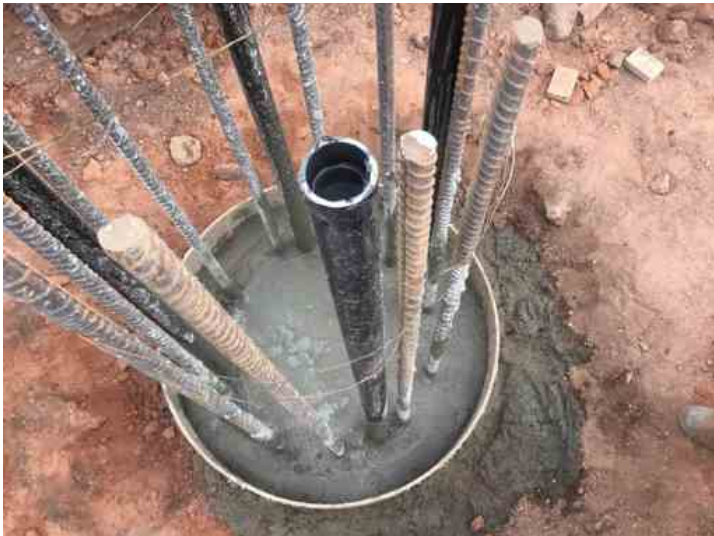
Water Level inside CSL tube

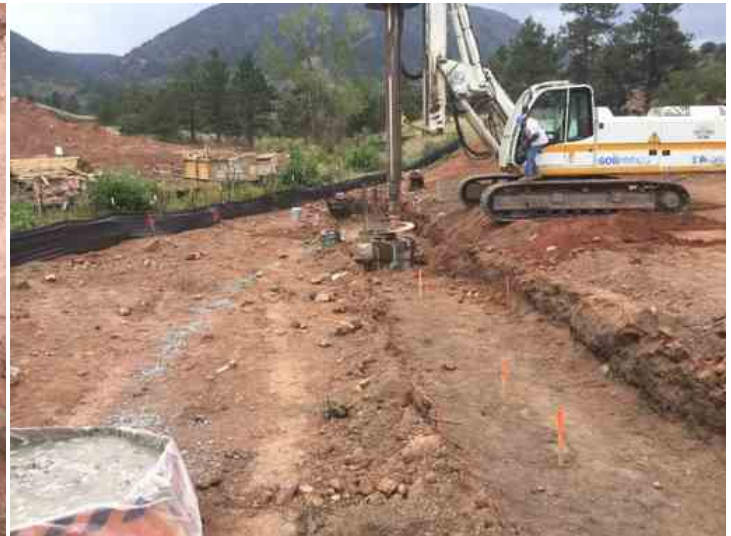
Contractor stopped drilling hole at Location 2 after reaching 12' deep (prior to reaching bedrock depth) & Placed Casing inside hole to continue drilling on the following day.

Casing Placed after Drilling Hole at Location 2

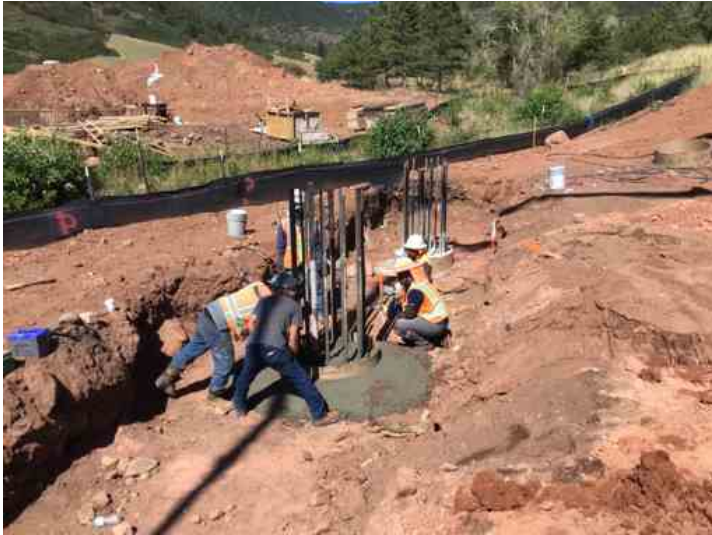
Concrete finishing in WB-2

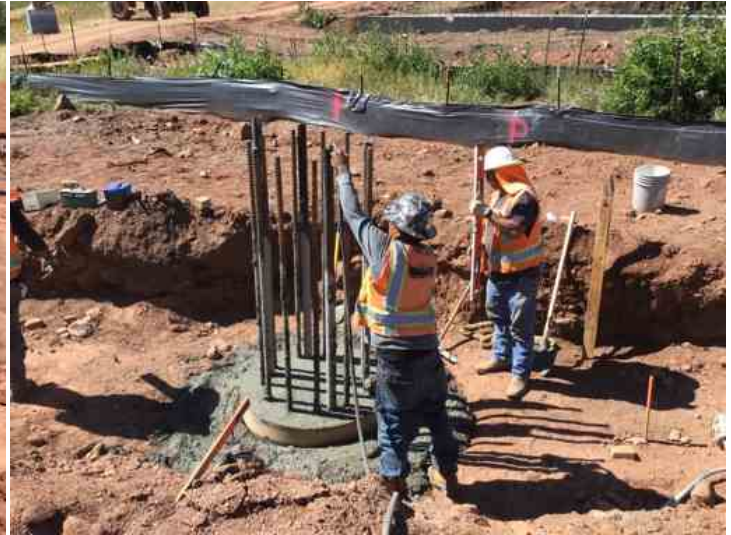
Filling of CSL tubes in WB-2

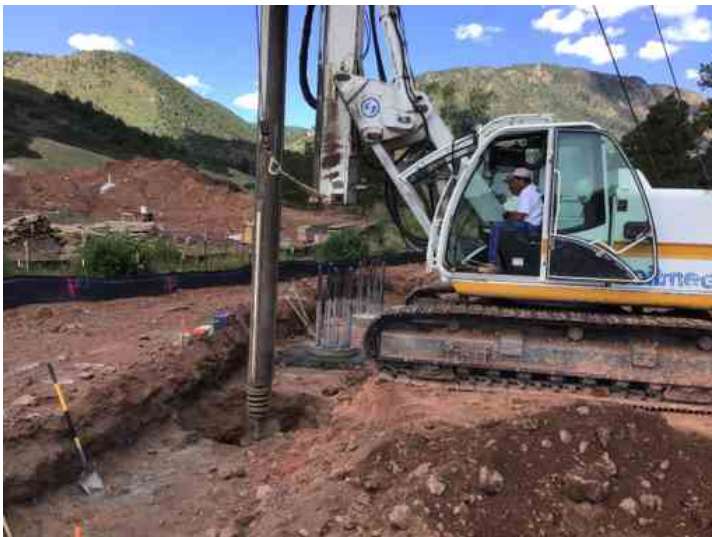
Drilling of WB-3

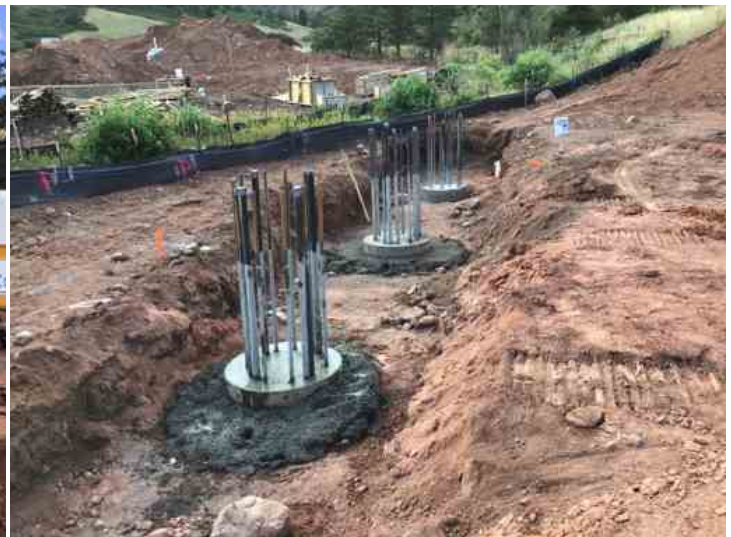
WB-3, CSL tubes filled and covered with duct tape

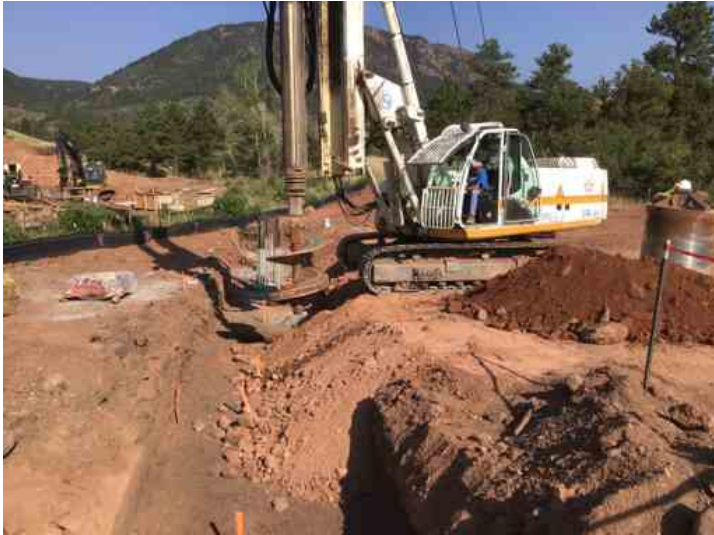
EB-1 drilling

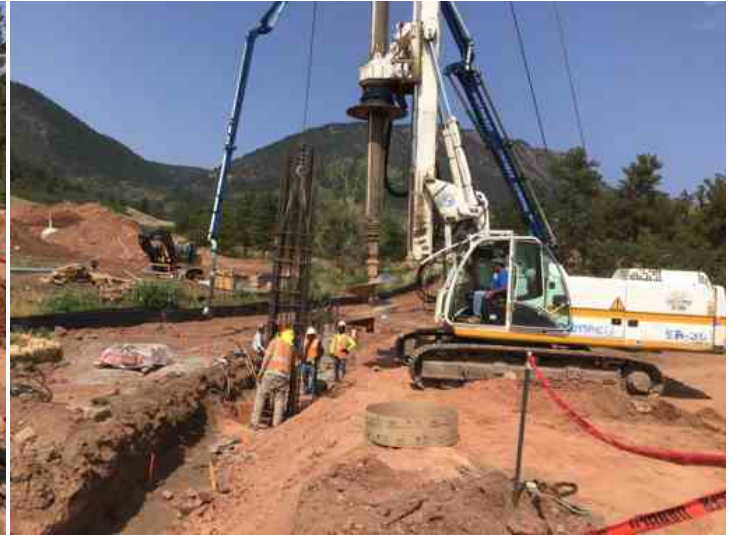
Placing rebar cage in EB-1

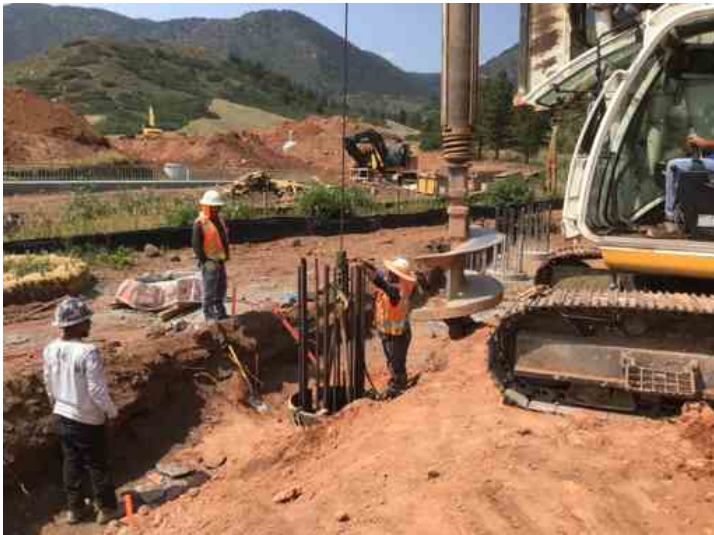
Filling of CSL tubes on EB-1 prior to concrete placement

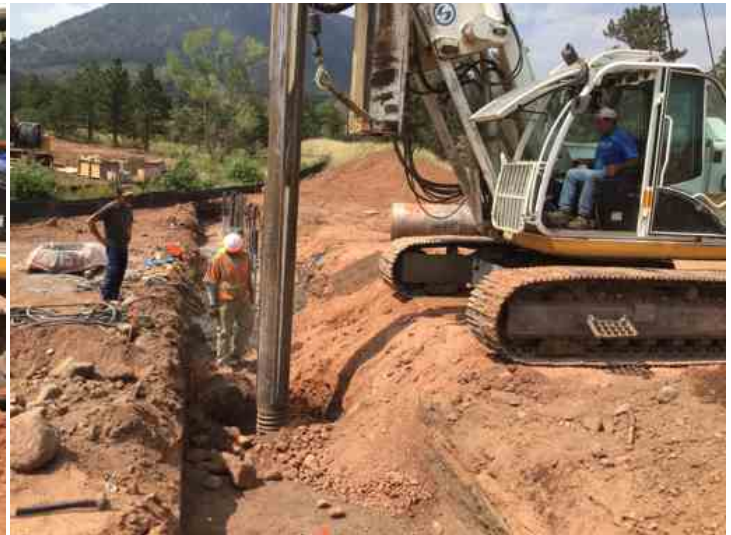
EB-2 drilling

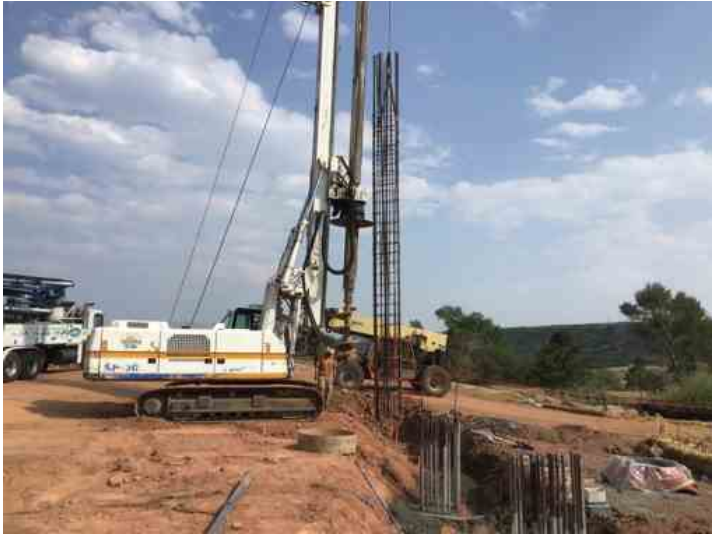
Placement of rebar cage in EB-2

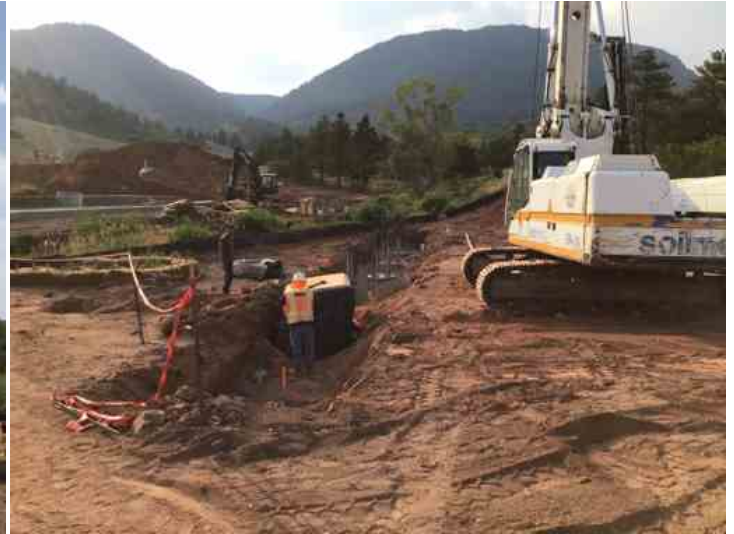
Caisson hole for EB-2 left open overnight. Caisson Note #9 on sheet B09 states "Concrete should be placed in the caisson immediately after drilling and must be placed the same day the holes are drilled."

<i>Pier No.</i>	<i>Depth Comments</i>	<i>Additional Comments</i>
4		
5		Concrete not placed, hole covered and left open with casing and rebar cage.

Covering of EB-2 to be left overnight.

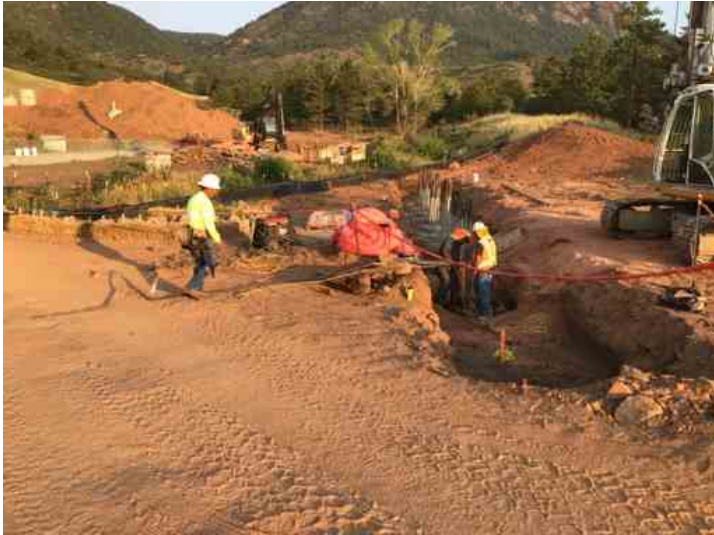
Drilling Contractor: LMS Drilling  
Concrete Contractor: Structures, Inc  
Reinforcing Contractor: Structures, Inc  
Placement Location: Eastbound caissons  
Comments: Per Larry Urioste, drilled pier EB-2 was approved to be left overnight by engineer because it was in bedrock. As a result of the pier being left open overnight, approximately 3 feet of water was observed in the bottom of EB-2 at 7:15 am. A pump was used by Structures, Inc at 7:15 am. No water came out of hole due to insufficient pump force and pumping was aborted at 7:35. During concrete placement the tremie pipe appeared to remain in the concrete.

Pumping water out of EB-2

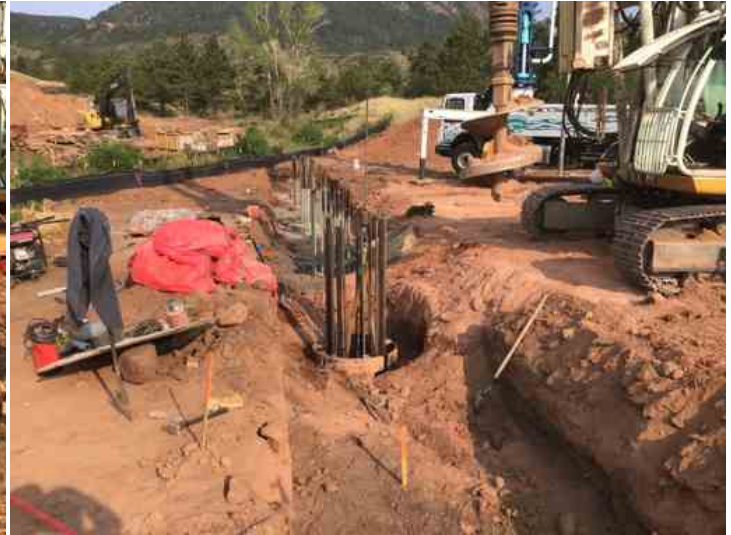
EB-2 cage in place

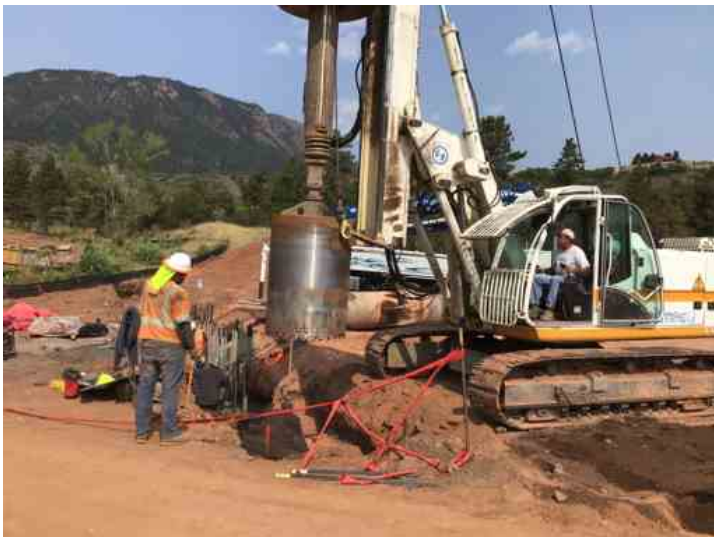
EB-3 drilling

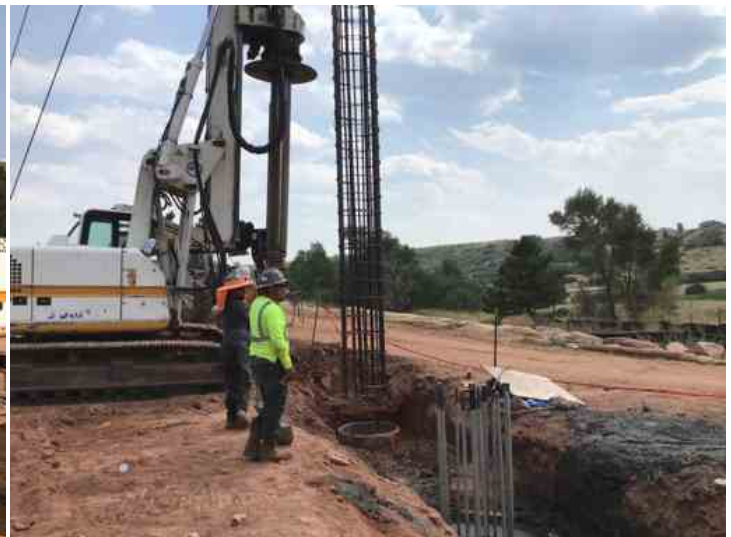
Cage placement in EB-3

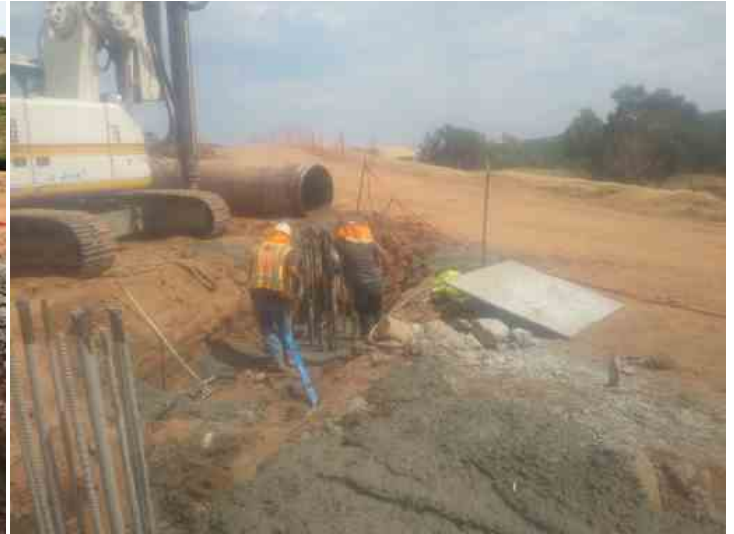
Filling of EB-3 CSL tubes prior to concrete placement
