Department of Public Works

October 31, 2023

Re: Falcon Underdrain Site Visit and Investigation

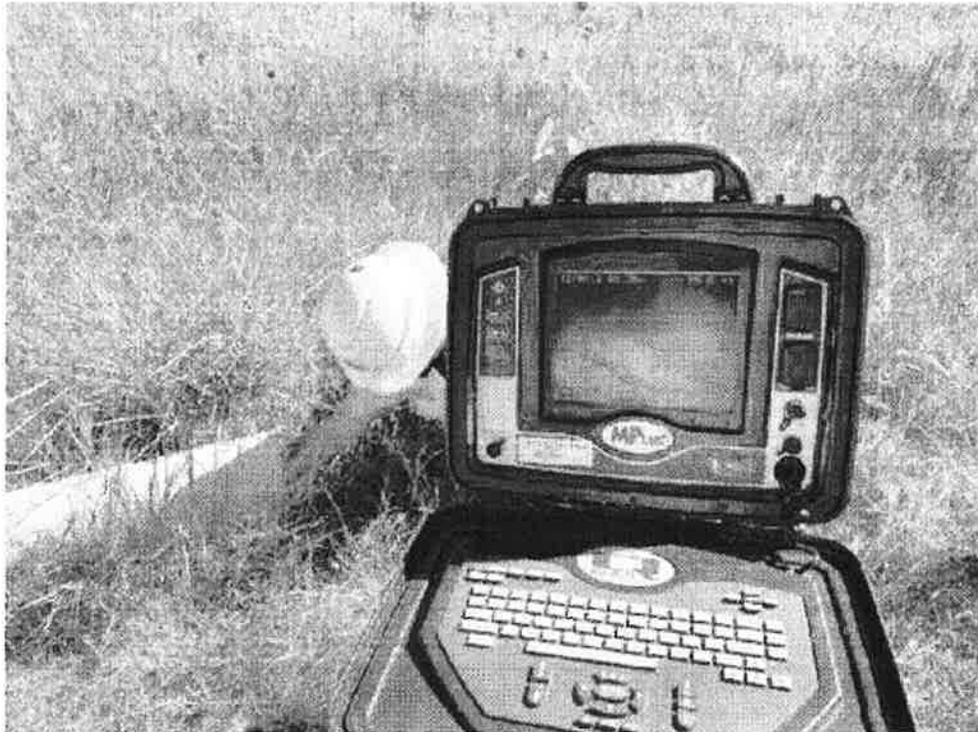
On Thursday September 21, 2023 I went out to Falcon Highlands with two EPC inspectors to see if we could scope the underdrain system from the outlet and or locate the cleanout near the 45° bend at the creek crossing. We located the outlet which was dry both now and upon a previous visit. We were able to scope the pipe approximately 47' from the outlet before encountering rocks and other debris that prevented the camera from extending further (Figures 1 & 2). Moisture was detected at the obstruction point and along with the presence of rocks would indicate possible damage to the underdrain, but there would be no way to verify without excavating the pipe

Figure 1 – Debris as seen through the scope

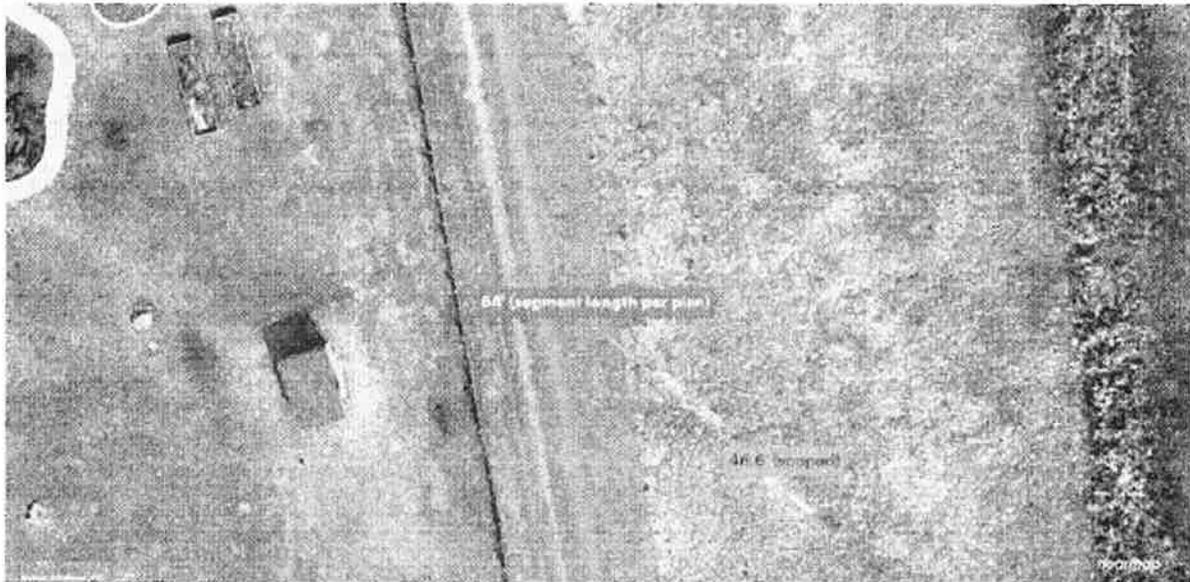
EPC was only able to access the pipe at the outlet end and could not scope beyond 47' due to obstructions within the pipe. No other cleanouts were accessible from the surface. The full replacement cost could be between \$9-16M depending on subgrade conditions with shallow bedrock being present along with other factors.

Figure 2 – Aerial of scoped distance (46.6', green) relative to the underdrain pipe length prior to the bend (64', red)

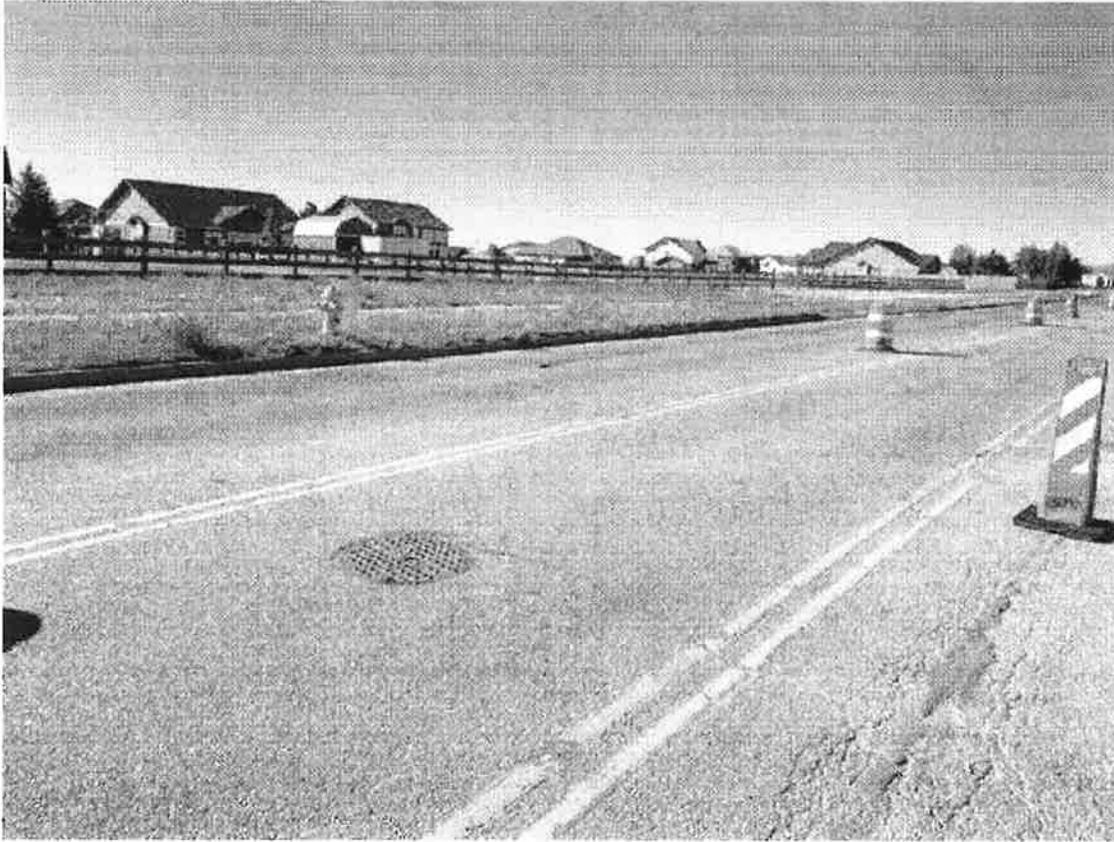
Per the contractor, all of the cleanouts have PVC caps and are buried beneath the pavement throughout the subdivision except the ones alongside the creek that are believed to be buried beneath the maintenance trail. The contractor did indicate that there was a cleanout approximately 3' west of the manhole on Rolling Thunder and highlighted its location beneath the pavement as indicated in the plans (Figures 3–5)

Figure 3 - Rolling Thunder (looking west)

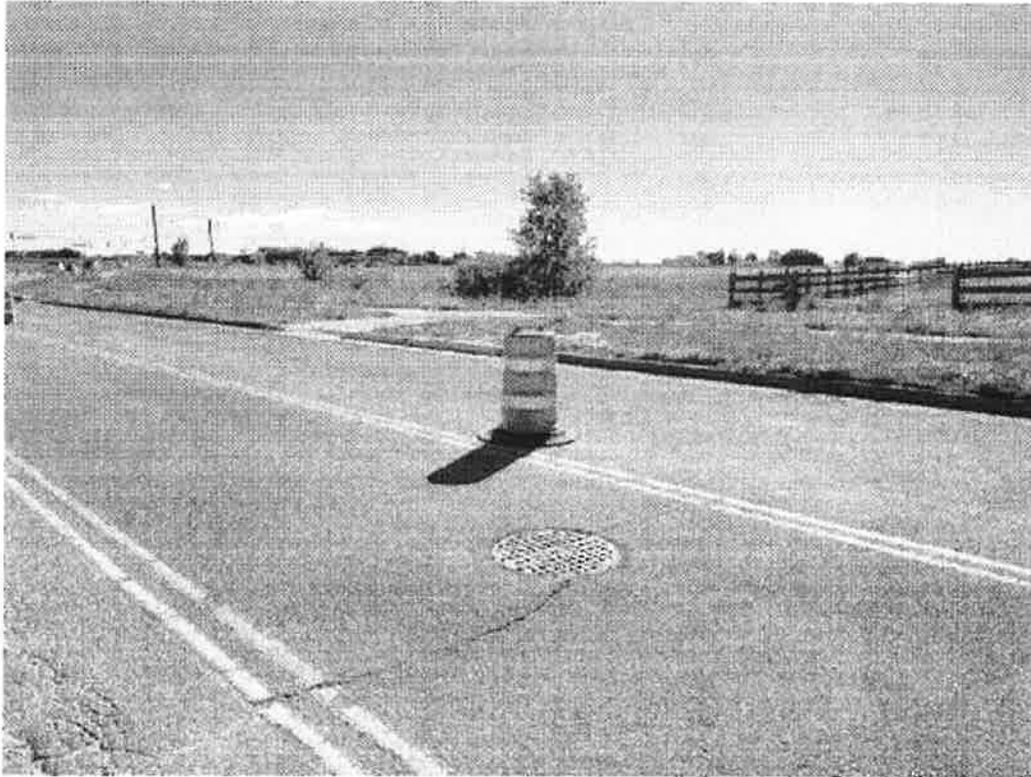
Figure 4 - Rolling Thunder (looking east)

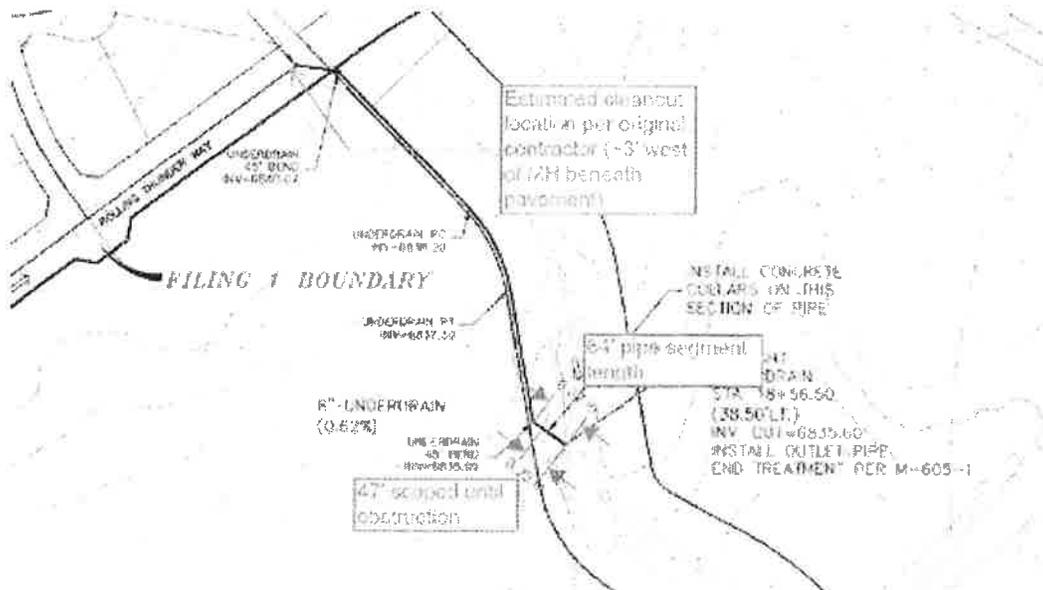
Figure 5 - Rolling Thunder (looking east)
