Final Acceptance Punchlist
El Paso County – Department of Public Works - Stormwater Section

Project Name:	Hannah Ridge F7
EDARP Filing Number(s):	CON1932, SF1840
ESQCP Number:	ESQ1926
Attendees:	DPW SW: Dylan Finley DPW Development Services: Brad Walters, Spencer Pirzadeh Developer: Adam Doyle
Date of Walk-Thru:	10/12/2023
Walk-Thru Number:	1

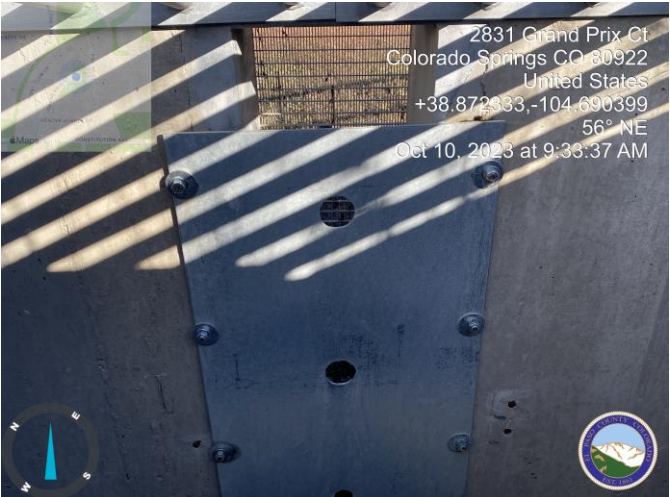
- Site specific items to address:
 - The orifice plate was installed such that there is a vertical orifice at the top of it that is not accounted for in the UD-Detention spreadsheet. Update calcs or field condition.

<p>Photo 1: The orifice plate was installed such that there is a vertical orifice at the top of it that is not accounted for in the UD-Detention spreadsheet. Update calculations or field condition.</p>	<p>Photo 2: Micropool is over capacity. No longer functioning as designed. Remove sediment and debris to allow adequate drainage flow.</p>

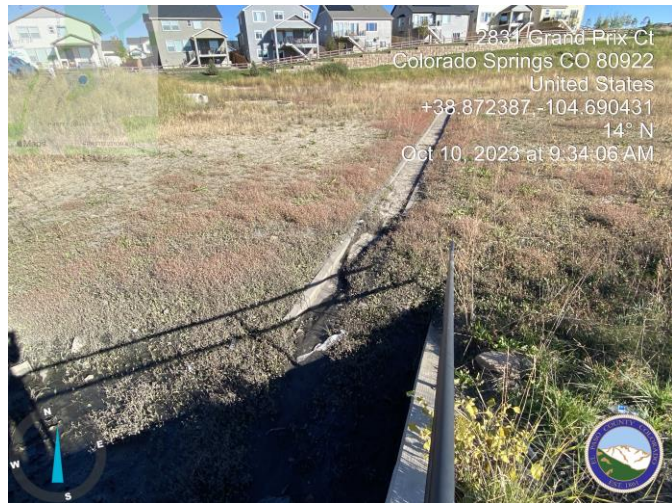
Photo 3: Trickle channel requires maintenance.

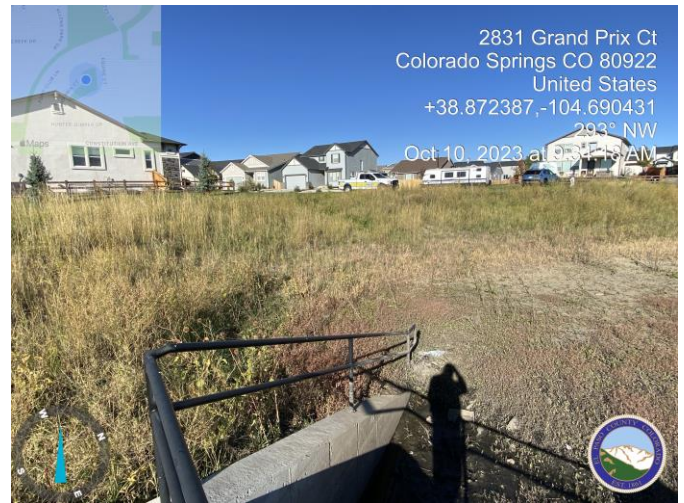
Photo 4: Mow pond bottom, pond embankments, and spillway.

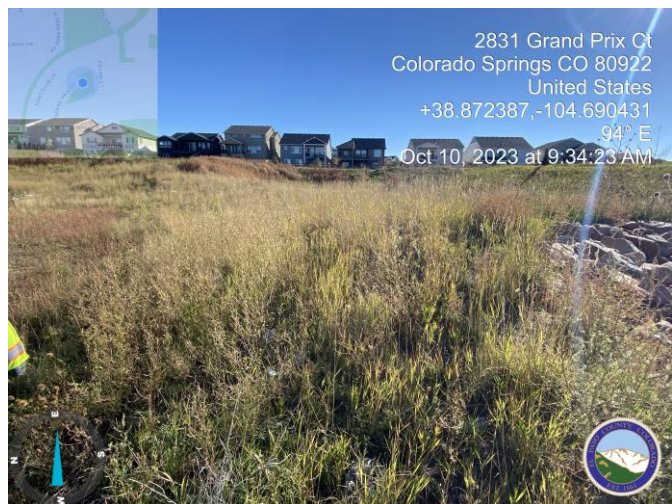
Photo 5: Mow pond bottom, pond embankments, and spillway.

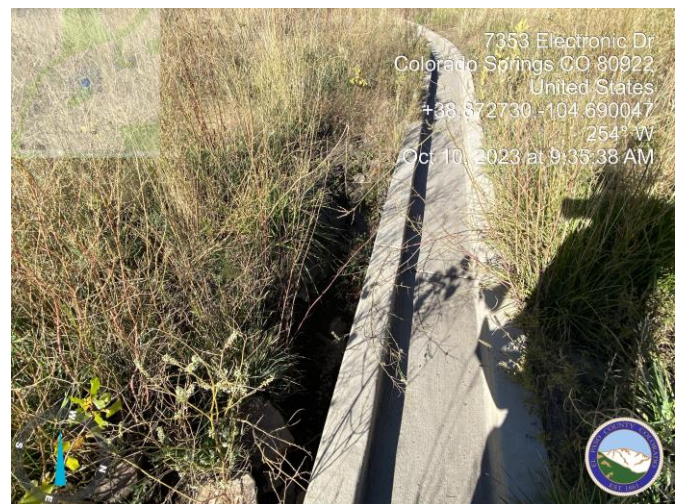
Photo 6: Address erosion near trickle channel.

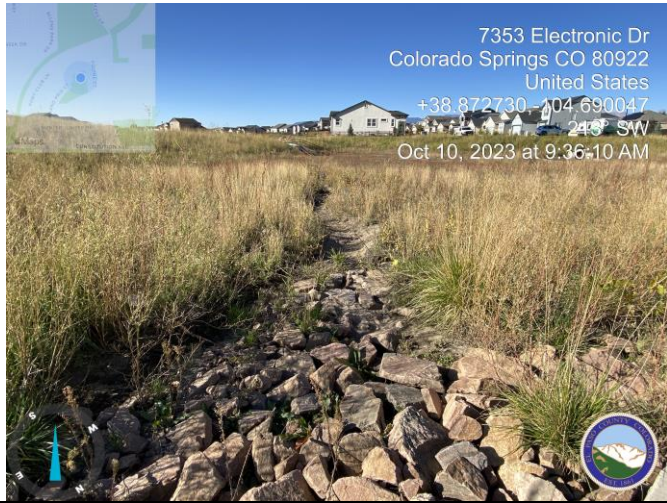
Photo 7: Address erosion near Eastern forebay and mow pond bottom
