March 4, 2020
Revised December 10, 2020

ENTECH
ENGINEERING, INC.

Re: Soil, Geology, and Geologic Hazard Study
Sedona Sun Acres
13235 Vollmer Road
Parcel No. 52000-00-303
El Paso County, Colorado

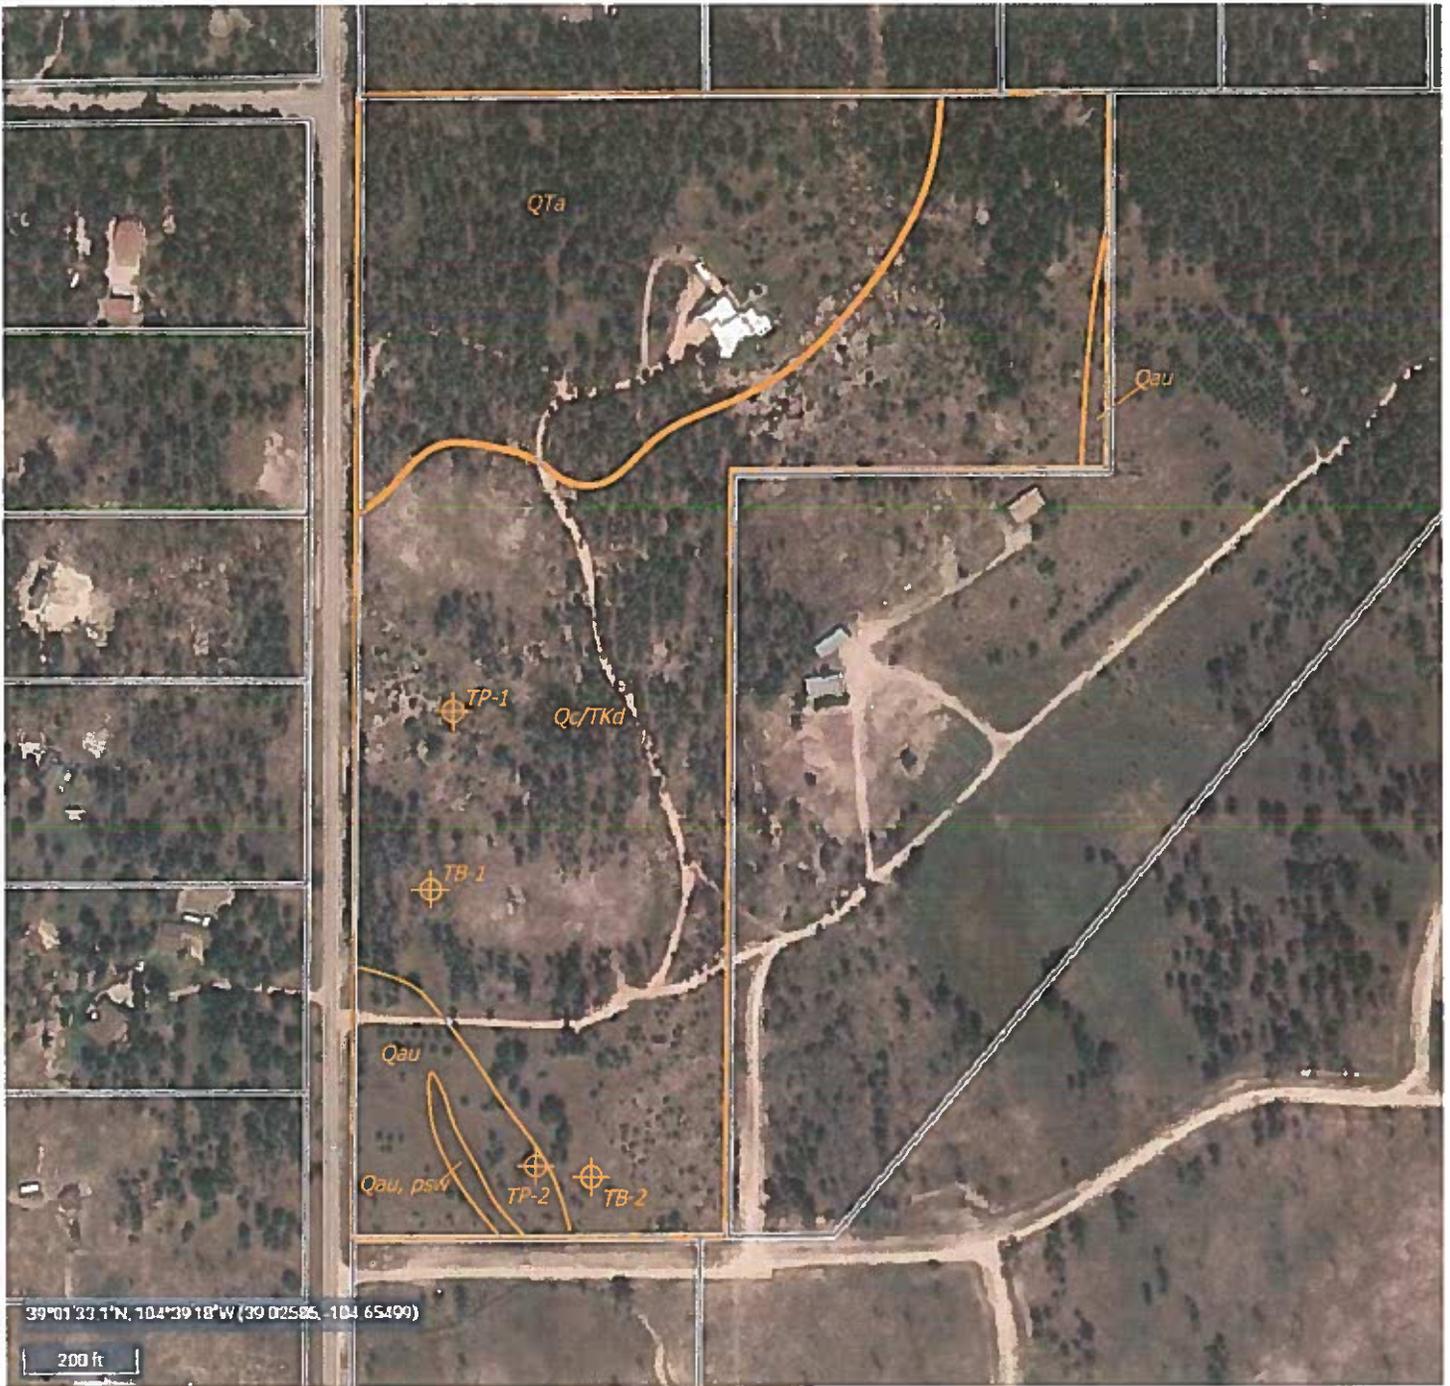
FIG NO.:
6

The site is not mapped within any floodplains according to the FEMA Map No. 08041CO320G, dated December 7, 2018 (Figure 7, Reference 7). Minor areas of potentially seasonal shallow groundwater were observed on the site (Figure 6). In these areas, we would anticipate the potential for periodically high subsurface moisture conditions and frost heave potential. These areas lie within low-lying areas and along the head of a minor drainage in the southern portion of the site located on Lot 3. Water was not observed in any of the drainages at the time of our site investigation. These areas can likely be avoided or properly mitigated by development. The potential exists for high groundwater levels during high moisture periods and should structures encroach on these areas the following precautions should be followed.

A minor area of potentially seasonal shallow groundwater was observed on the site (Figure 6). In these areas, we would anticipate the potential for periodically high subsurface moisture conditions and frost heave potential. These areas lie within low-lying area and along the head of a minor drainage in the southern portion of the site on Lot 3. These areas can likely be avoided or properly mitigated by development. The potential exists for high groundwater levels during high moisture periods and should structures encroach on these areas. A subsurface perimeter drain is recommended should structures encroach on this area. Typical drain details are presented in Figure 8. Septic systems are not recommended in these areas due to the potential for shallow groundwater. Any grading in these areas should be done to direct surface flow around construction to avoid areas of ponded water. All organic material should be completely removed prior to any fill placement. Specific drainage studies are beyond the scope of this report. The site is not mapped within any floodplains according to the FEMA Map No. 80841C0320G (Figure 7, Reference 7).

Mitigation: Foundations must have a minimum 30-inch depth for frost protection. In areas where high subsurface moisture conditions are anticipated periodically, subsurface perimeter drains are recommended to help prevent the intrusion of water into areas below grade. Typical drain details are presented in Figure 8. Any grading in these areas should be done to direct surface flow around construction to avoid areas of ponded water. All organic material would be completely removed prior to any fill placement. **Specific drainage studies are beyond the scope of this report.**

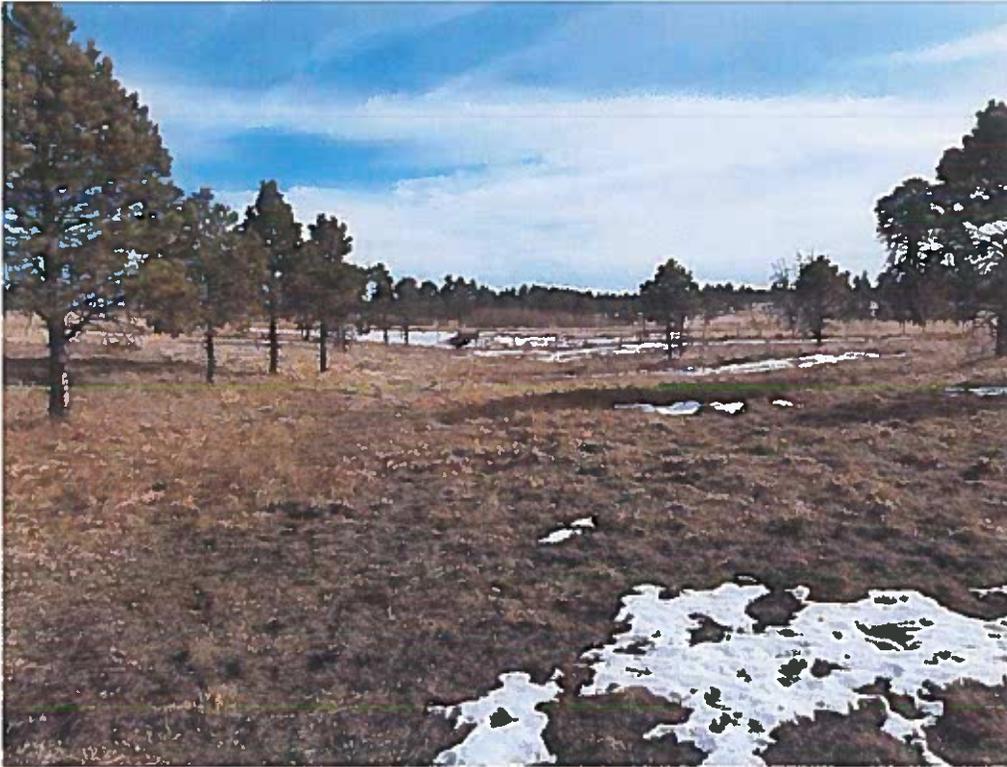
Looking south along head of minor drainage in the southern portion of the site.
