EP-21-0084 Frindt Residence (Crystal Park Site S-124)

NW¼ NW¼ SE¼ Section 17, T14S, R67W, 6th Meridian

The applicant proposes a single-family residence at 5291 Neeper Valley Road in the Crystal Park development. With the original referral, we received the Site Plan (Haddon Architecture, April 14, 2021), Elevations (Hadden Architecture, April 14, 2021), and Soils Report (Geoquest, LLC, stamped November 3, 2020). The resubmittal documents include a Geologic Hazard Study (Rocky Mountain Group, March 17, 2021). RMG states, “Based on our evaluation of the geologic conditions, it is our professional opinion that the proposed residential development is feasible.”

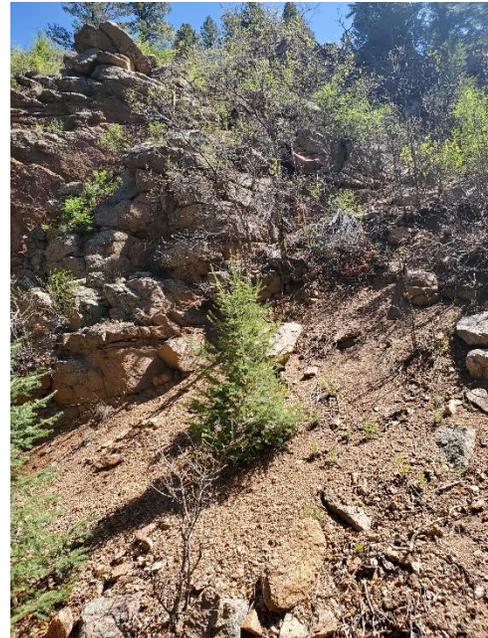
I visited the site on May 24, 2021. Site observations and available LiDAR show slopes ranging from 20 to 40 percent upslope and downslope from the proposed residence. While onsite, I did not observe signs of slope instability, such as soil creep or surface cracking. Two large outcrops are associated with the site. The outcrop on the northern portion of the site included some detached, precarious rocks (Photo 1). However, this outcrop is located approximately 65 feet to the north of the proposed building footprint and does not appear to be a risk to the proposed building. The outcrop to the east and upslope of the proposed structure includes some detached rocks; however, most are lichen-covered and partially embedded (see Photo 2). I also observed scattered rocks further upslope from this outcrop (Photo 3).

Photo 1: Northern outcrop with detached rocks

As previously stated, the bedrock at the site is the Pikes Peak Granite, forming outcrops directly upslope (to the east) and adjacent to the proposed building footprint (to the north) as well as scattered throughout the site. The existing rocks and boulders are likely to be disturbed during construction activities and/or freeze/thaw, resulting in an increased potential for a rockfall hazard. It may be prudent to remove such rocks during construction.

CGS continues to recommend the county require the risk for rockfall hazards be evaluated prior to construction and a mitigation plan established to reduce the potential risk. The appropriate mitigation measures should be noted on the project plans.

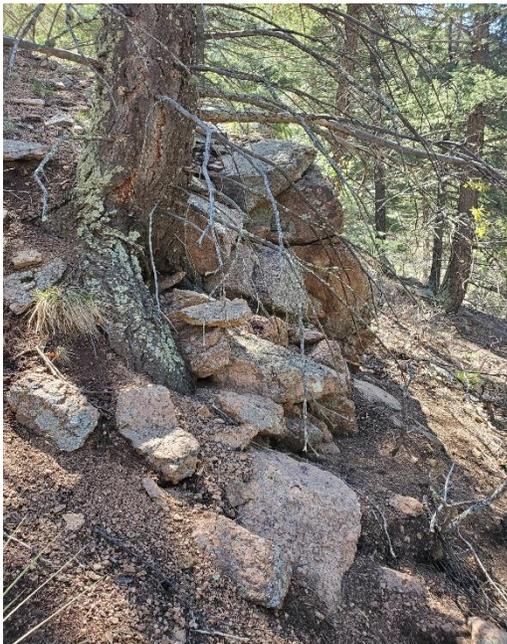
Photo 2: Upslope Outcrop, some detached rocks

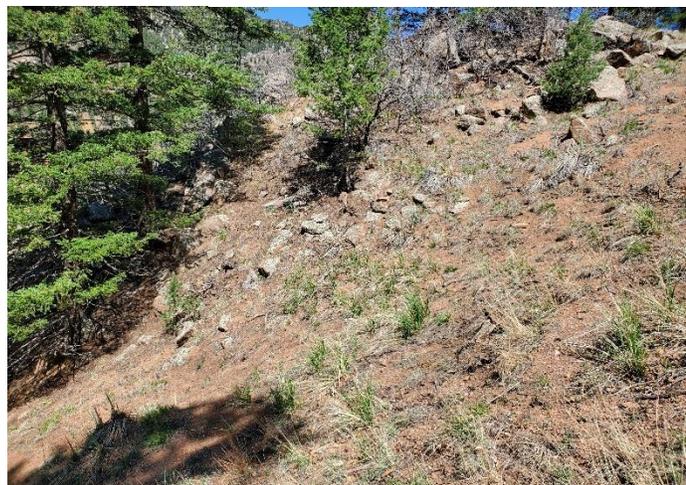
Photo 3: Scattered rocks observed upslope
