Re: Soils and Geology Study
8035 Meridian Park Drive
Lot 1A, Bent Grass East Commercial Fil. No. 2A
El Paso County, Colorado
Entech Job No. 230132

The project consists of the construction of a Dunkin' Donuts restaurant on the southern portion of a 1.46-acre lot. This report addresses potential geologic constraints and hazards effecting the proposed construction.

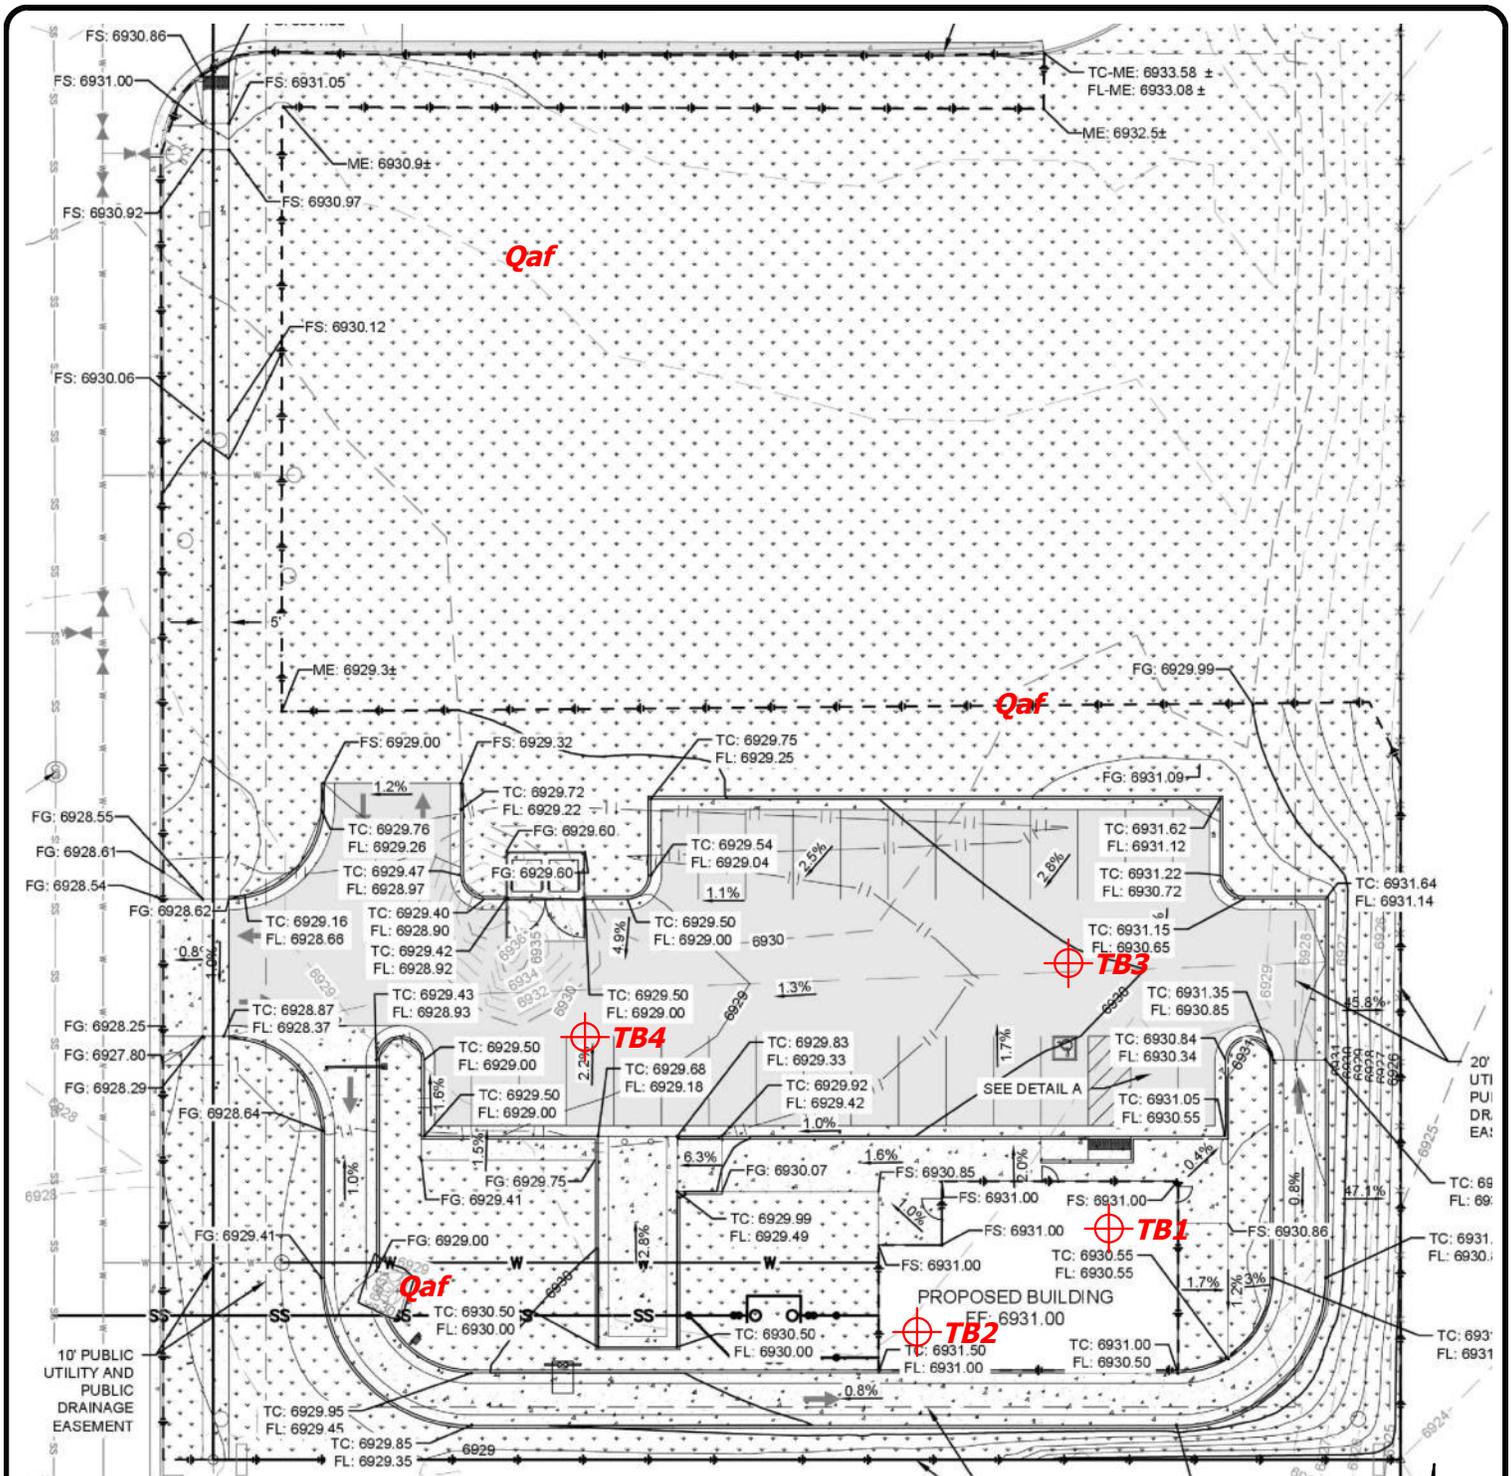
FIG NO.:
6

Qaf Artificial Fill of Late Holocene Age: These are man-made fill deposits associated with controlled fill placed on the site, and minor fill piles observed on the site. Areas of fill other than those mapped may be encountered.

The soils listed above were mapped from site-specific mapping, the *Geologic Map of the Falcon Quadrangle* distributed by the Colorado Geologic Survey in 2012 (Reference 5, Figure 5), and the *Geologic Map of the Pueblo 1° x 2° Quadrangle*, distributed by the US Geological Survey in 1978 (Reference 6). The test borings used in evaluating the site are included in Appendix B. The Geology Map prepared for the site is presented in Figure 6.

Fill associated with controlled fill placed on the site, and minor fill piles observed on the site. Areas of fill other than those mapped may be encountered. The fill at the site was periodically observed and tested by personnel of Entech Engineering Inc. Any uncontrolled fill encountered beneath foundations will require complete penetration and removal and recompaction under controlled conditions.

Mitigation: It is anticipated that the fill piles will be removed during site grading. Areas of fill other than those encountered may be encountered. The fill piles are considered uncontrolled. Any uncontrolled fill encountered beneath foundations should be removed and recompacted at a minimum of 95% of its maximum Modified Proctor Dry Density, ASTM D-1557.

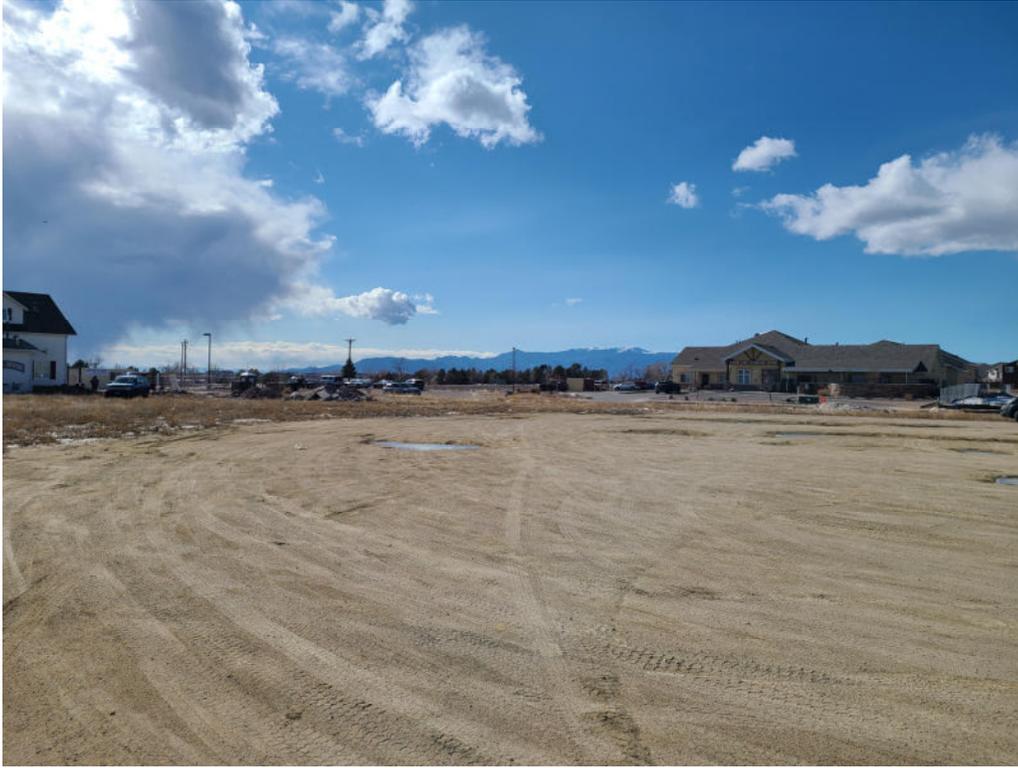
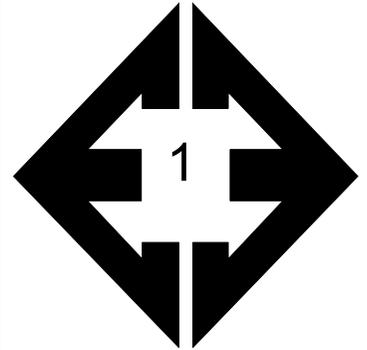
**Looking southwest
from the northeastern
side of the site.**

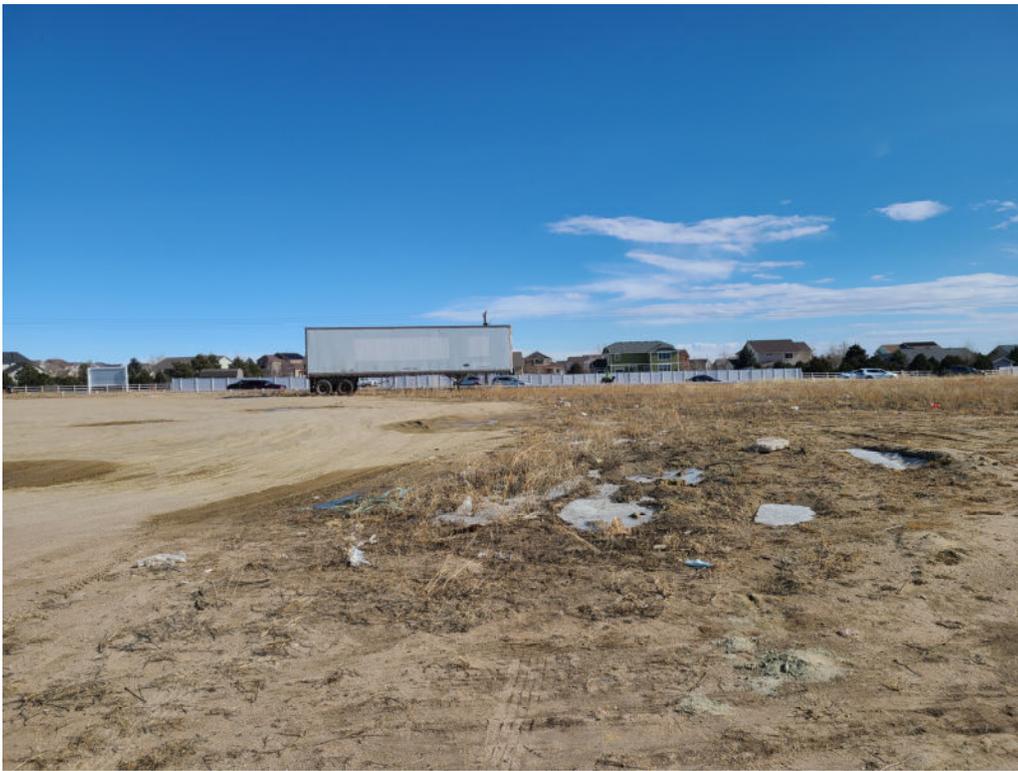
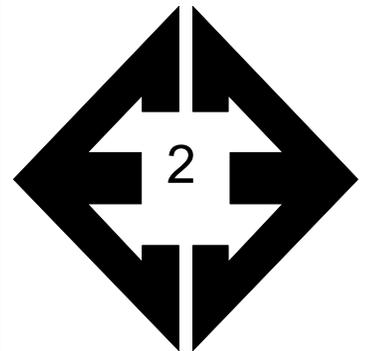
**Looking east from the
western side of the
site.**
