GEOLOGIC HAZARD EVALUATION
STERLING RANCH RESIDENTIAL
EL PASO COUNTY, COLORADO

Morley-Bentley Investments, LLC
20 Boulder Crescent Street, Suite 200
Colorado Springs, Colorado 80903

Entech Job No. 30898
ZMSW/rep/2008/Geor/30898GeohazEval

January 20, 2009

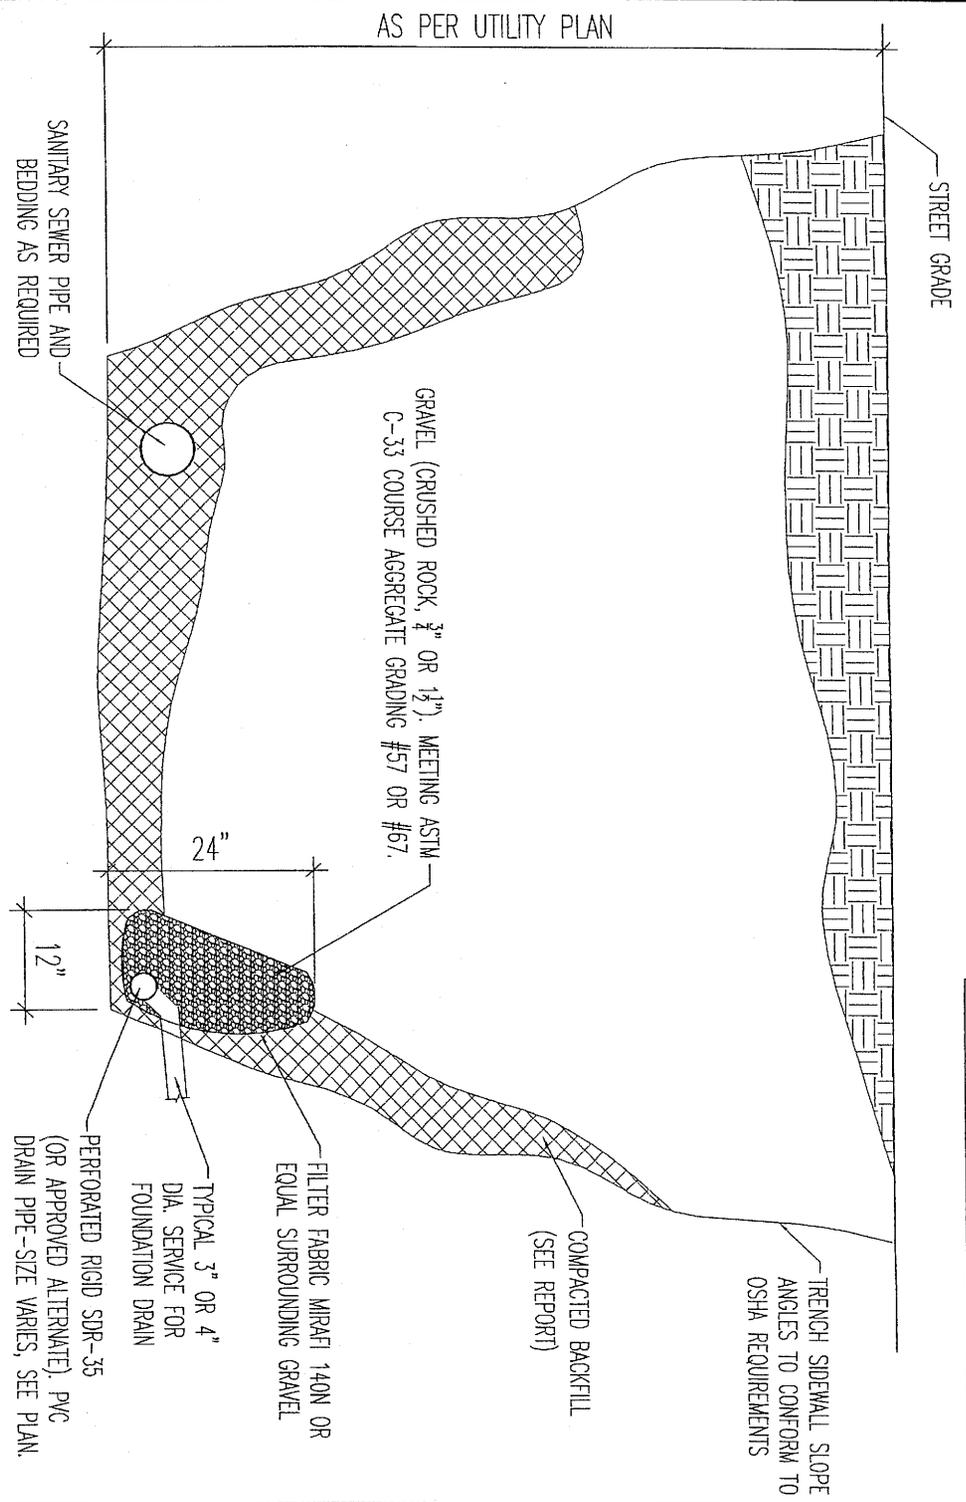
ACTIVE DRAIN BESIDE SEWER

Shallow groundwater: These are areas where shallow groundwater was encountered in the test borings or site conditions and vegetation indicate the potential for shallow groundwater. The same mitigation as discussed for seasonal shallow groundwater is recommended for areas of shallow groundwater. Basement construction is not recommended in these areas unless the area is regraded and raised with the placement of fill. Unstable soils should be anticipated where excavations approach the groundwater level. Geo-grids or shotrock may be necessary to stabilize excavations in these areas. Utility trenches will be affected by shallow groundwater in these areas. A typical sewer underdrain detail is presented in Figure 13.

NOTE:
 TO BE USED IN CASES WHERE GROUNDWATER IS
 FOUND DURING TRENCHING OR WHERE SHALLOW
 GROUNDWATER IS KNOWN TO EXIST.
