**Final Acceptance Punchlist**  
**El Paso County – Department of Public Works - Stormwater Section**

Project Name:	The Gardens at North Carefree
EDARP Filing Number(s):	SF195, CON2012
ESQCP Number:	ESQ1912
Attendees:	DPW SW: Dylan Finley, Mikayla Hartford, Ben Jones DPW Development Services: Brad Walters, Joe Jackman, Spencer Pirzadeh, David Parkerson Developer: Grace Covington
Date of Walk-Thru:	02/01/2024
Walk-Thru Number:	1 <sup>st</sup>

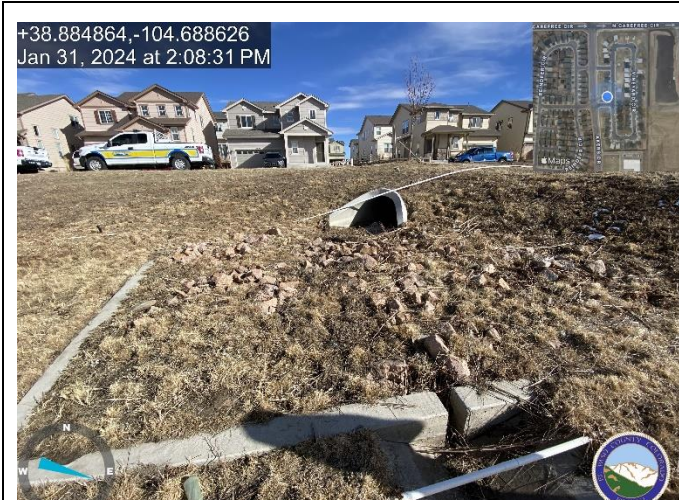
- **North Pond: (Page 24 of Construction Drawings)**
  - Pond forebay not installed per forebay cross section detail. Re-establish to pond details. Riprap to be installed per plan with a 12” drop between the top of the forebay curb and the riprap.

Photo 1: North pond forebay not installed per spec. (Page 24 Forebay cross section)

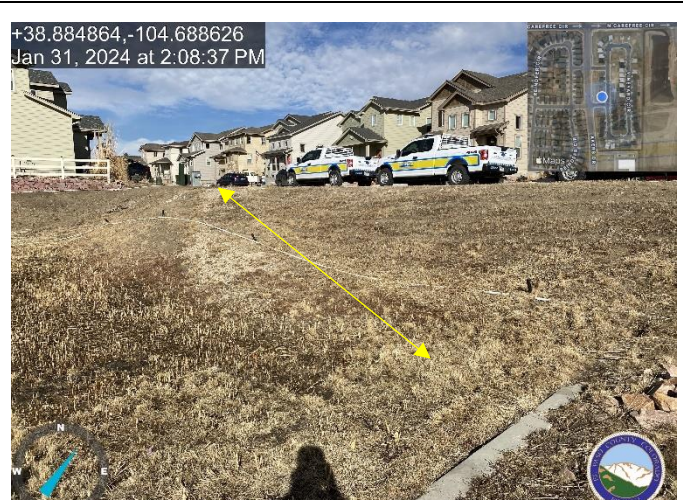
- Maintenance road not installed per plan. Re-establish per pond detail, maintenance path to be 12-foot wide and extending to the pond bottom.
  - Orifice plate caulking missing. Re-establish caulking to create a watertight seal.

Photo 2: North pond maintenance road not installed per spec. ( 12' wide with 2" rock and extends to forebay)

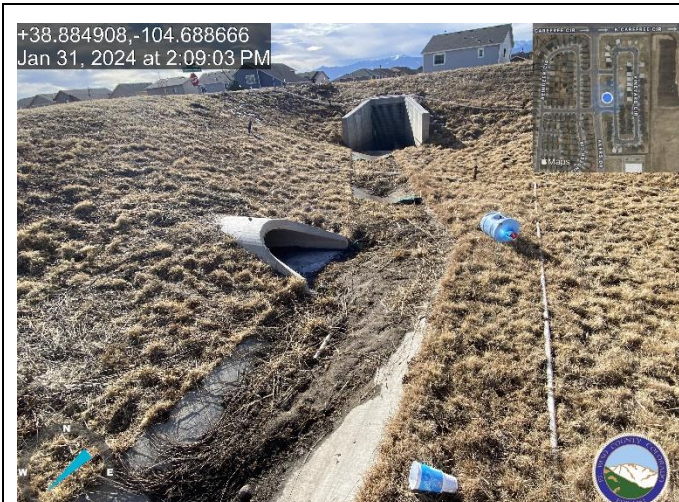
Photo 3: Trickle channel requires maintenance. Remove sediment and temporary control measures. (North Pond)

- Stabilize disturbed areas and fill holes at north pond overflow weir.
- Remove temporary control measures throughout site.
- Remove sediment from flared end sections and trickle channel.

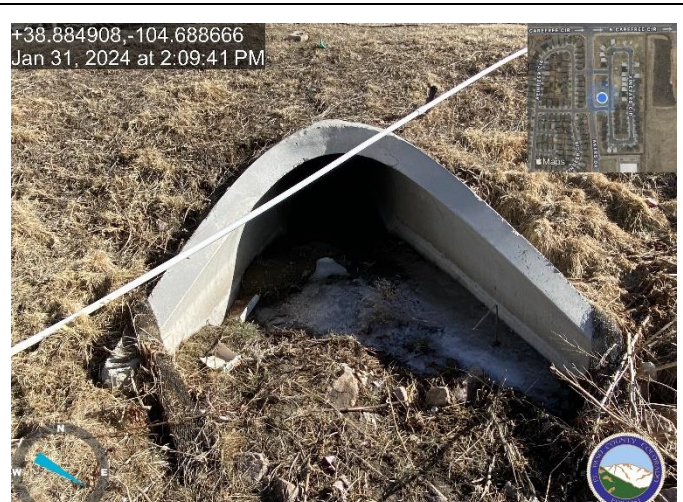
Photo 4: Remove sediment from flared end section. (North Pond)

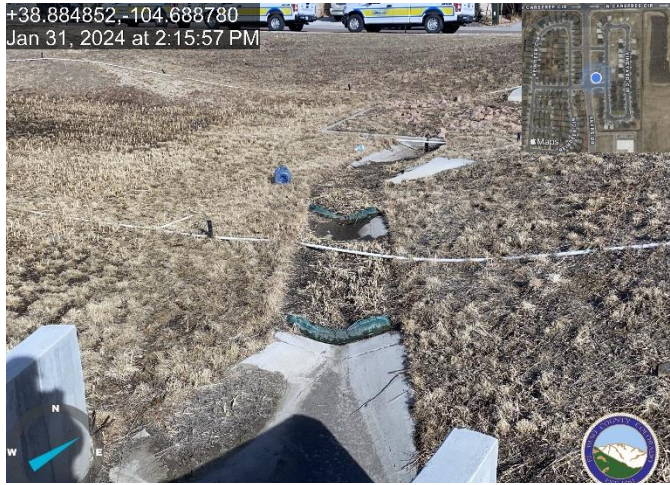
Photo 5: Trickle channel requires maintenance. Remove sediment and temporary control measures. (North Pond)

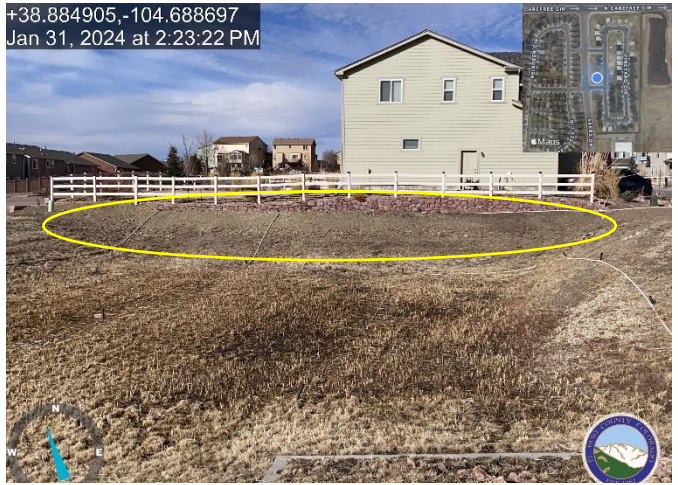
- North embankment requires stabilization.
- **South Pond**
  - Pond forebay not installed per forebay cross section detail. Riprap to be installed per plan with a 6” drop between the top of the forebay curb and the riprap.

Photo 6: Stabilize northern pond embankment at north pond.

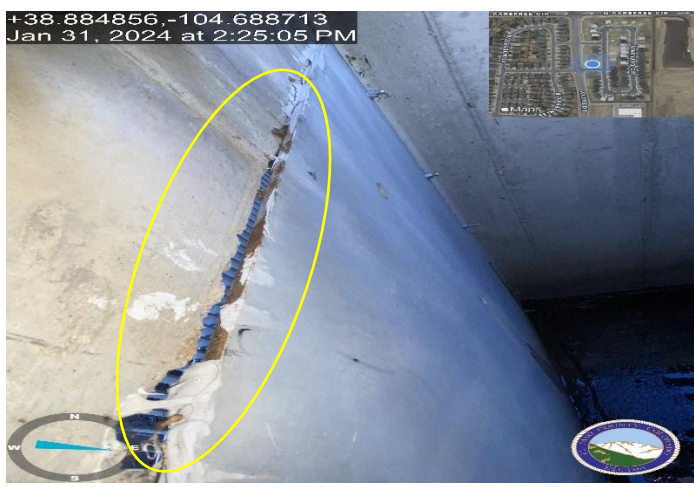
Photo 7: Re caulk orifice plate at outlet structure.

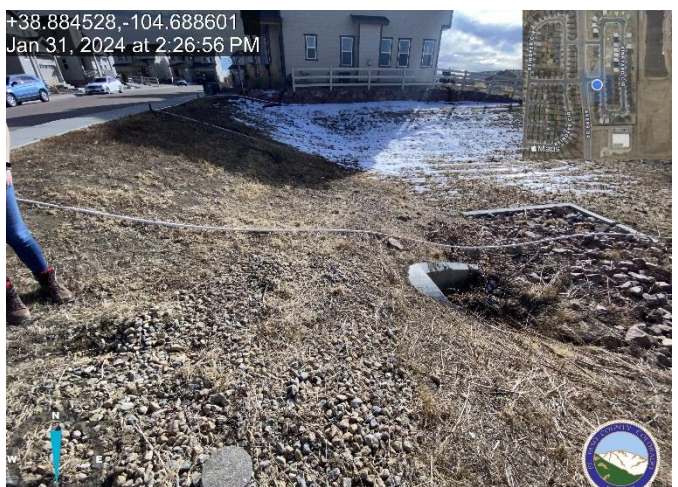
- Maintenance road not installed per plan. Re-establish per pond detail, maintenance path to be 12-foot wide and extending to the pond bottom.
  - Reshape the emergency spillway (called overflow weir in plans) so that it is the lowest point along the pond embankments. Properly restabilize.

Photo 8: South pond maintenance road not installed per spec. ( 8' wide with 2" rock and extends to forebay)

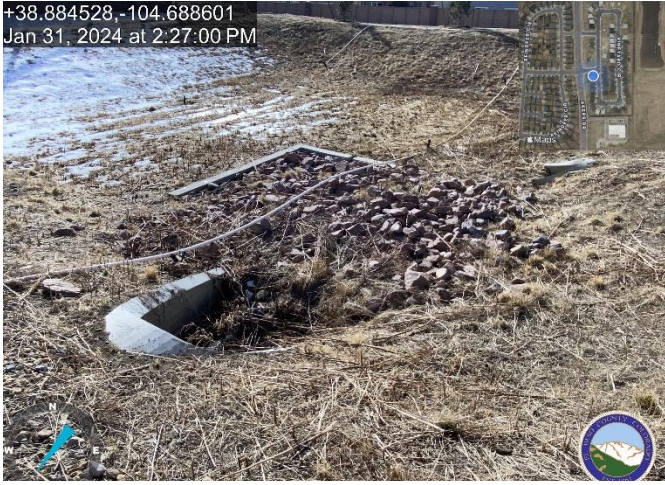
Photo 9: South pond forebay not installed per spec. (Page 25 Forebay cross section)

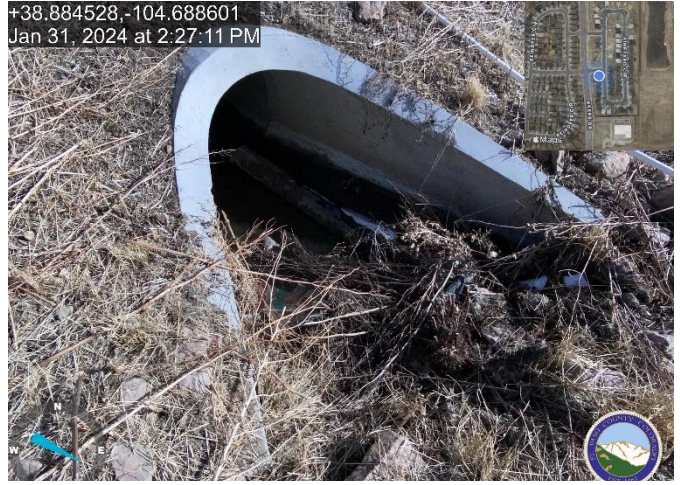
Photo 10: Remove sediment and debris from south pond flared end section.

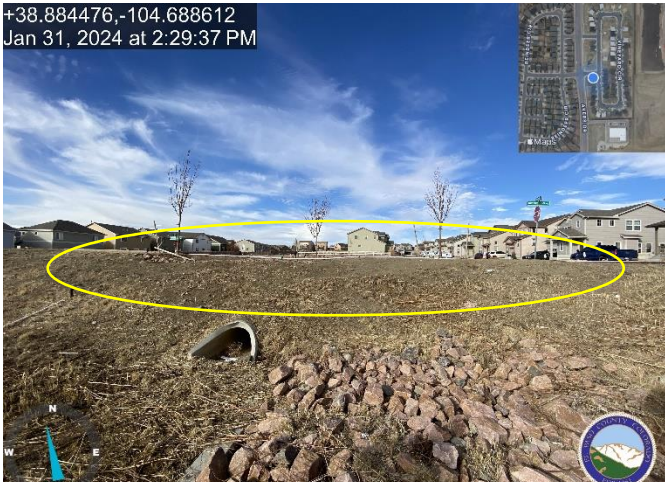
Photo 11: Reshape the overflow weir so that it is the lowest point along the pond embankments
