**SOIL, GEOLOGY, AND GEOLOGIC HAZARD STUDY
STERLING RANCH HOMESTEAD NORTH FILING NO. 2
PARCEL NO. 11
EL PASO COUNTY, COLORADO**

July 22, 2020
Revised February 18, 2022

Entech Job No. 201421
F:/AAPProjects/2020/201421 Geohaz

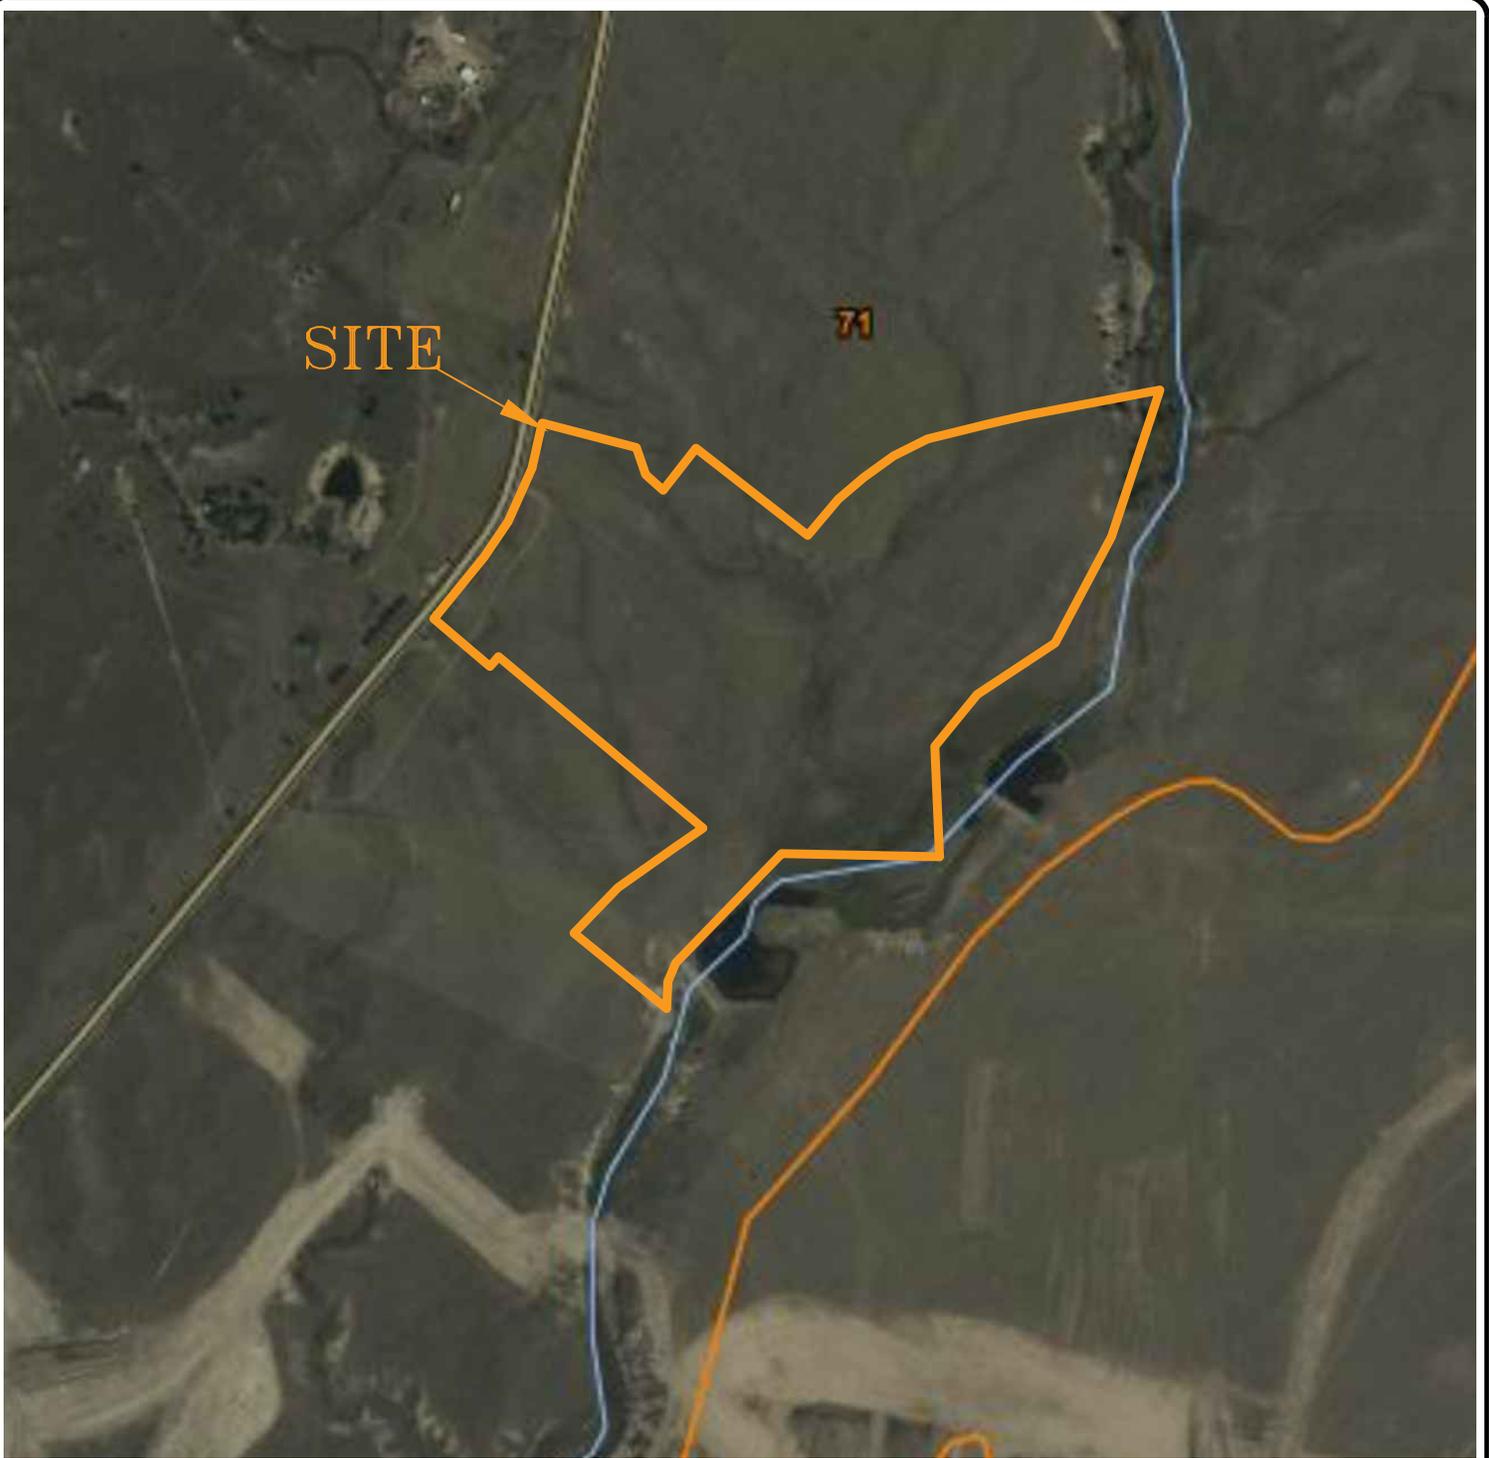
DRAWN L.L.
CHECKED
DATE 2/16/22
SCALE AS SHOWN
JOB NO. 201421
FIGURE No. 4

Groundwater was encountered in four of the test borings (Test Boring Nos. 1, 5, 6, and 8) at depths ranging from 8.5 to 18 feet bgs. Groundwater was not encountered in the other test borings which were drilled to 20 feet. Groundwater depths are summarized in Table 2. Fluctuations in the groundwater conditions may occur due to conditions such as variations in rainfall, precipitation infiltration and development of nearby areas. Areas of floodplains and potentially seasonal shallow groundwater have been identified on the site. These areas will be discussed in the following section.

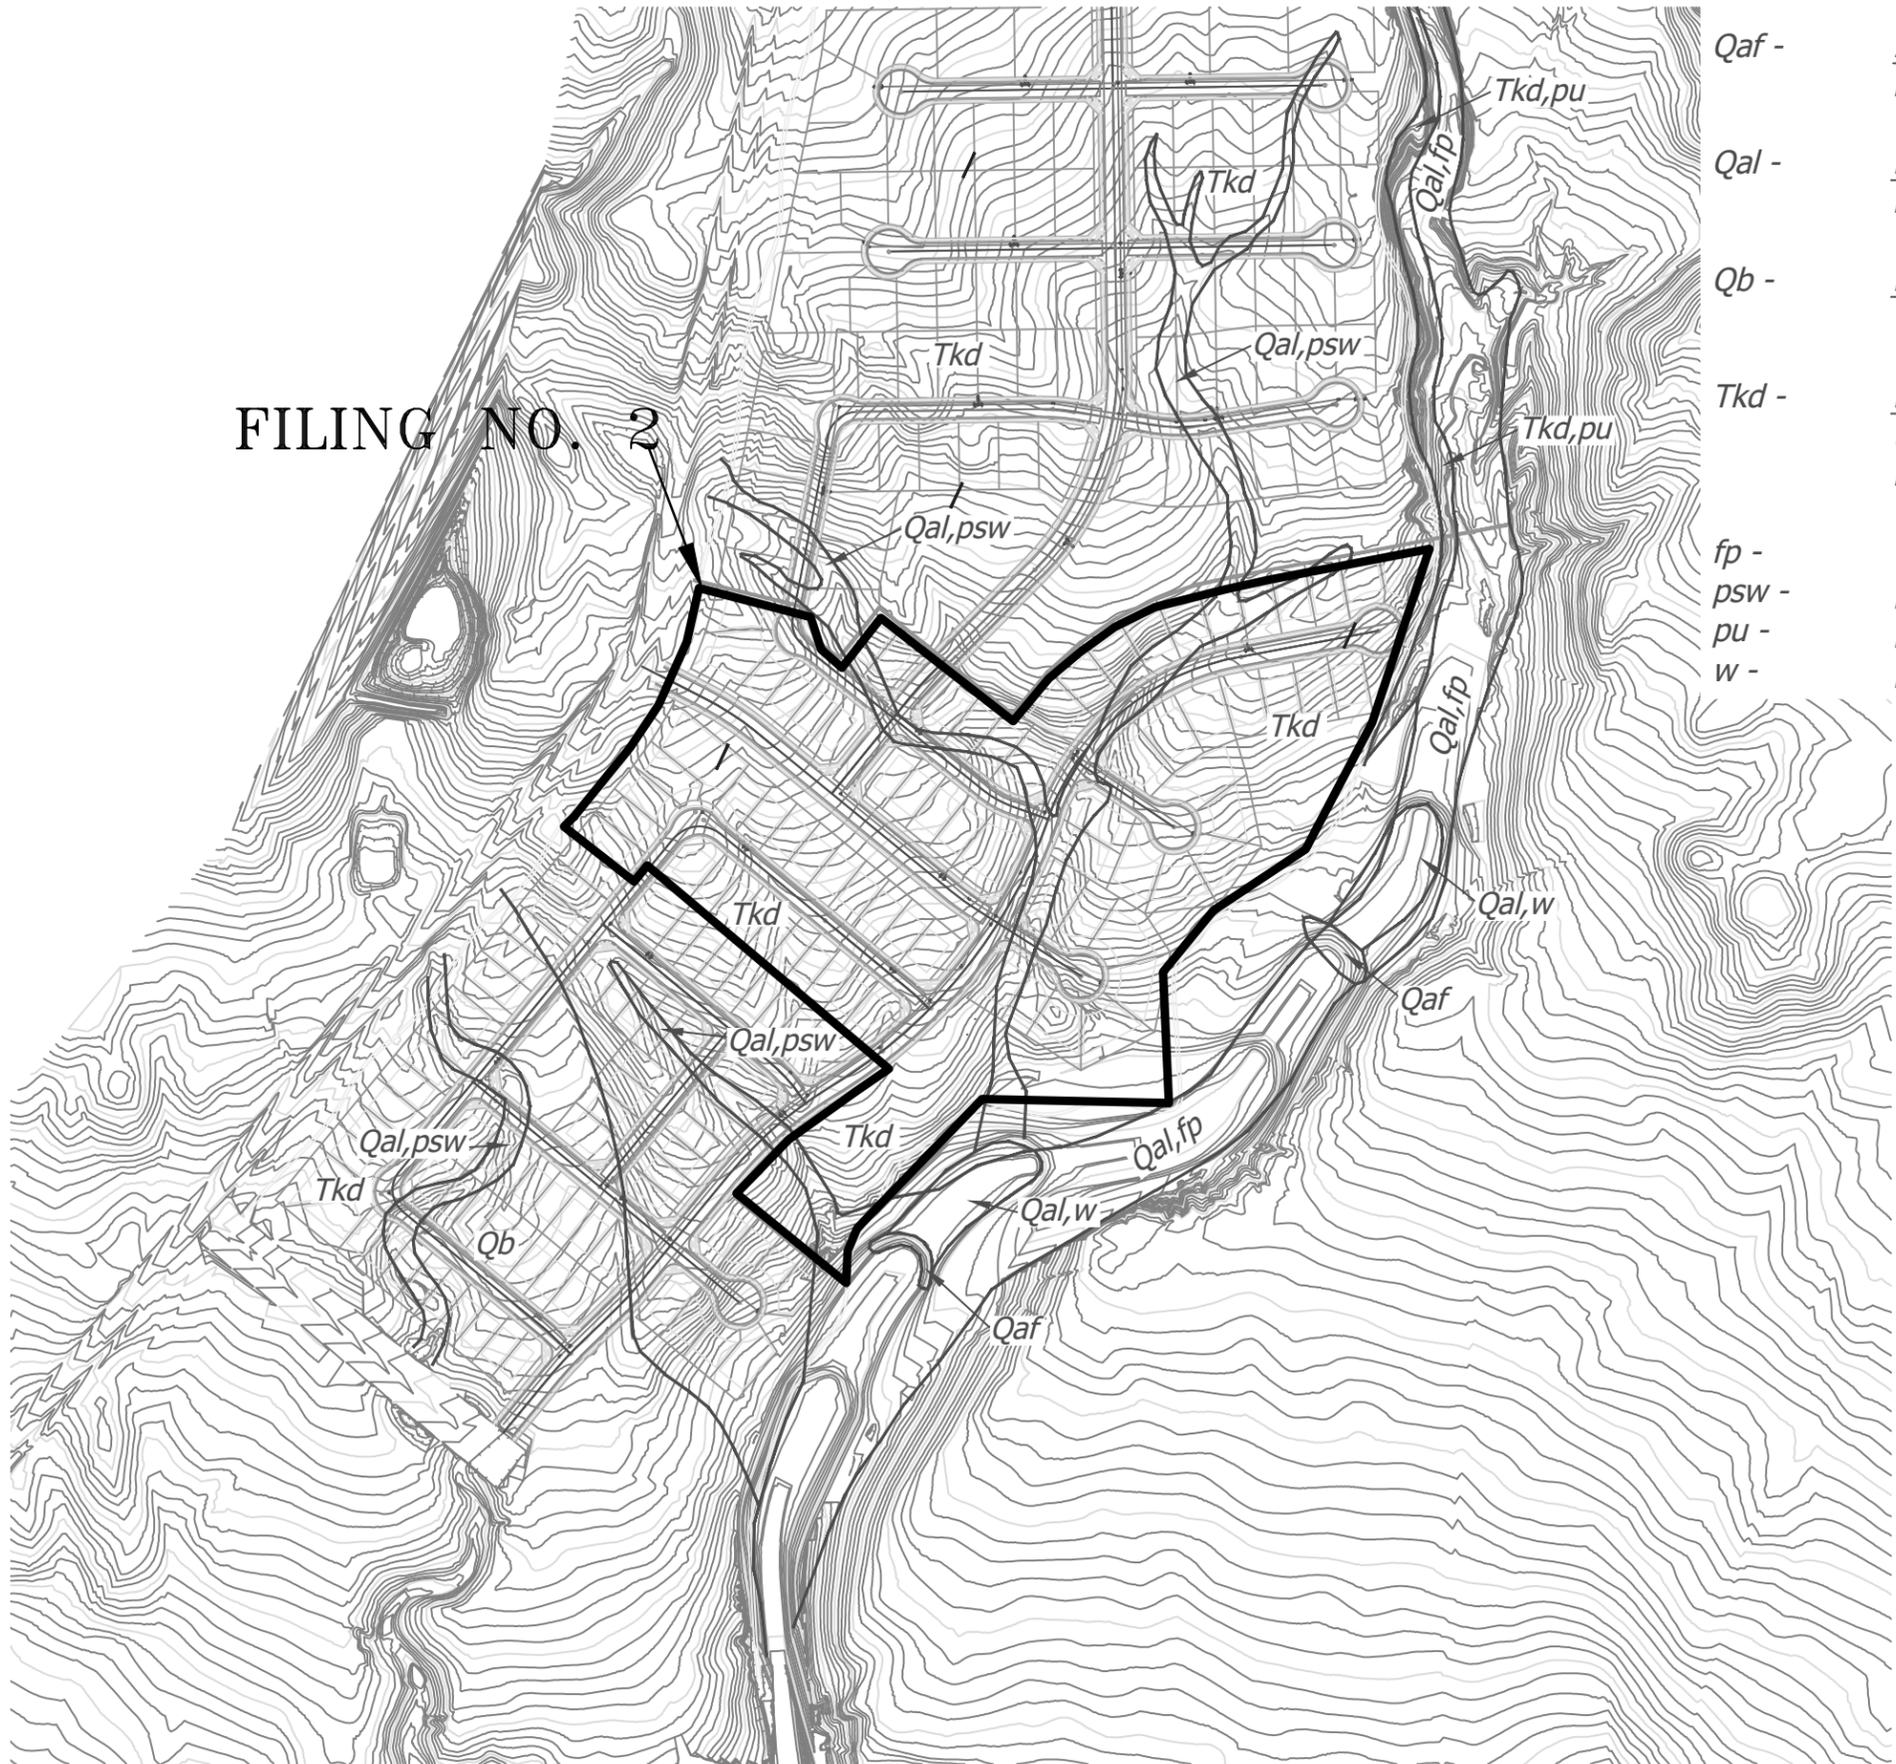
The positions of mappable units within the subject property are shown on the Geologic Map (Figure 7). Our mapping procedures involved field reconnaissance, measurements and interpretation. The same mapping procedures have also been utilized to produce the Engineering Geology Map which identifies pertinent geologic conditions affecting development (Figure 7).

Detailed mapping has been performed on this site to produce an Engineering Geology Map (Figure 7). This map shows the location of various geologic conditions of which the developers and planners should be cognizant during the planning, design and construction stages of the project. The hazards identified on this site include artificial fill, potentially unstable slopes, potentially expansive soils, floodplains, and potentially seasonal shallow groundwater areas. The following hazards have been addressed:

Some of the steep slopes along the Sand Creek drainage have been identified as potentially unstable. Considerable care must be exercised in these areas not to create a condition which would tend to activate instability.

Mitigation: According to the grading plan shown on Figure 7, Much of this area is to be regraded or avoided by development. Building should be avoided on any remaining potentially unstable slopes unless stabilized. A setback of 20 feet from the crest of these slopes is recommended. Stabilization could involve regrading to slope angles no steeper than 3:1 or the use of engineer-designed retaining walls, tiebacks, or buttresses. Where retaining walls are not used, erosion protection may be necessary to prevent undercutting

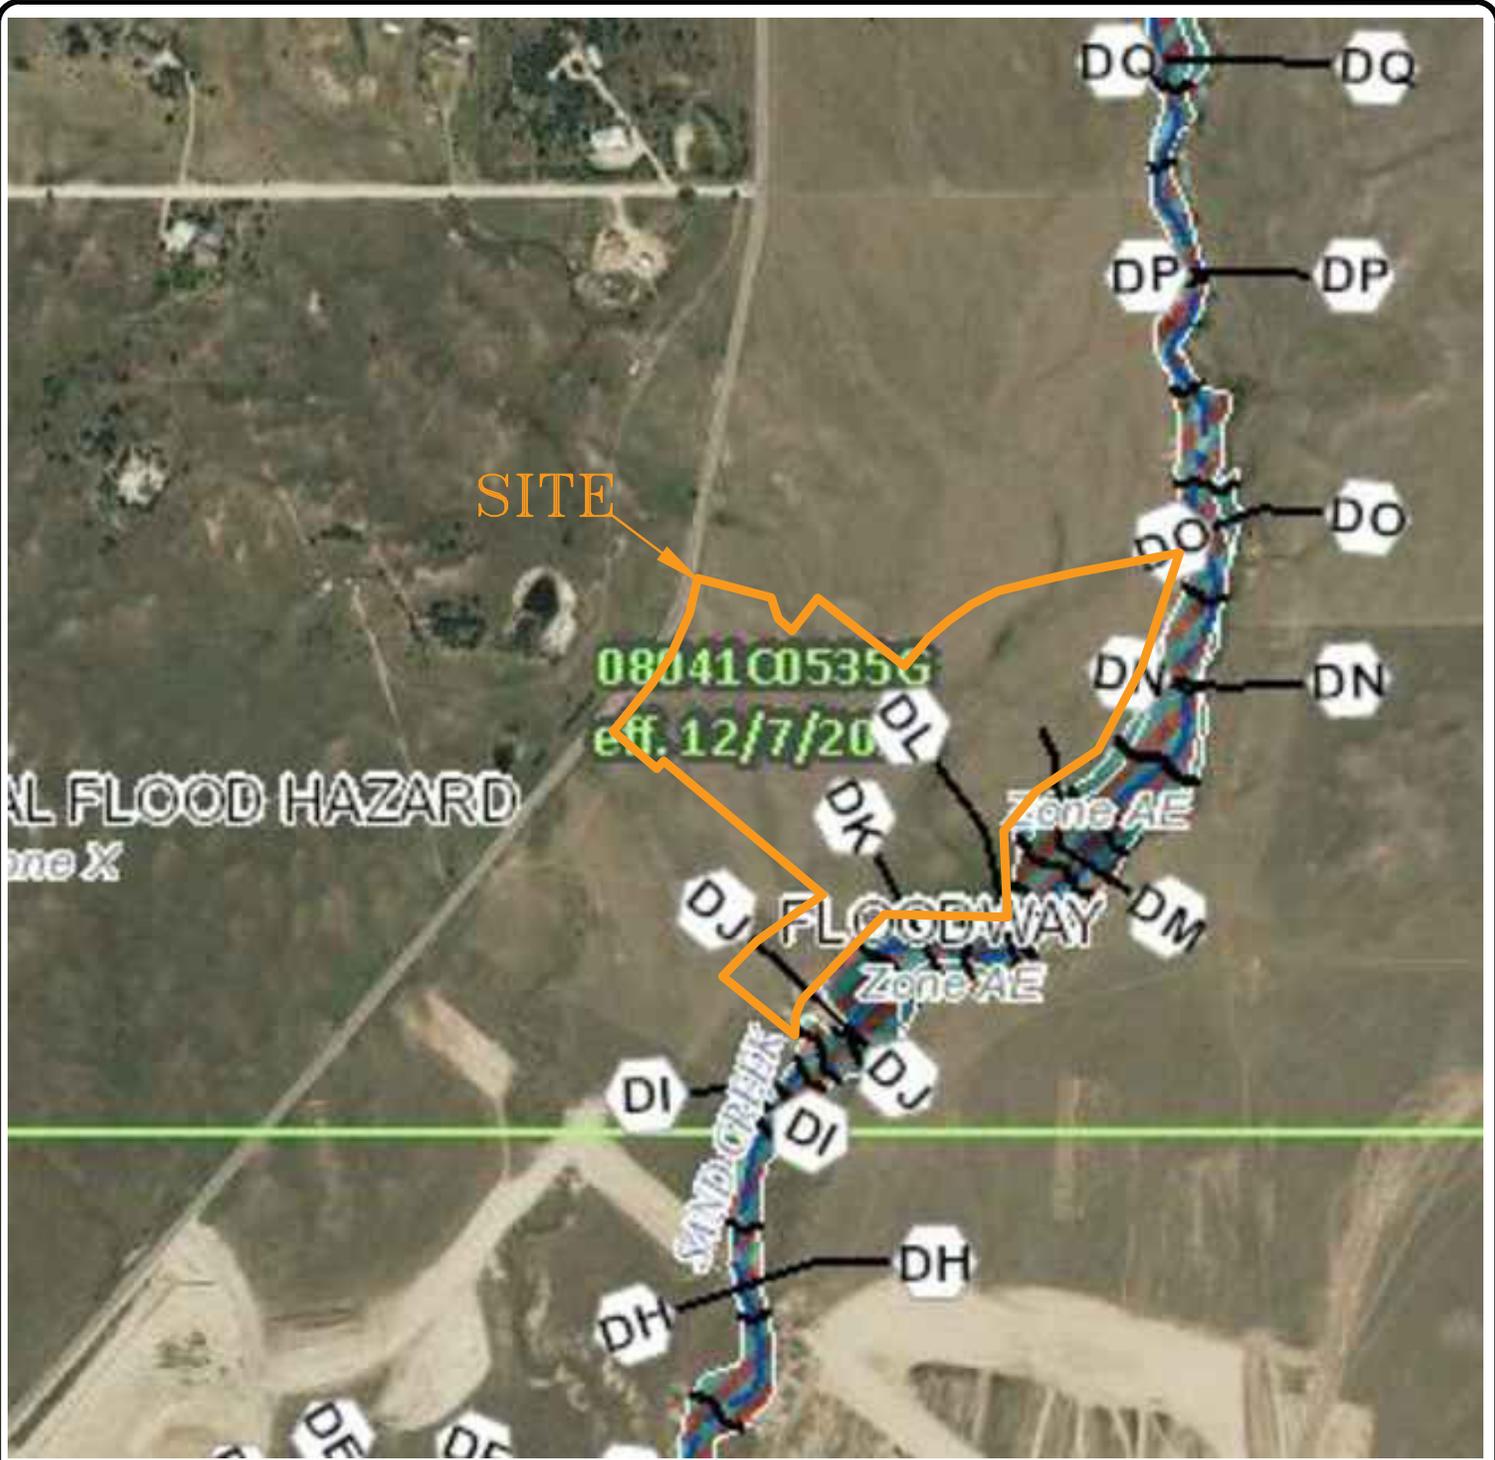
FIG NO.:
8

The floodplain areas of the Sand Creek drainage exist along the eastern boundary of the site. According to the Overall Site Plan, Figure 3, this area is to be preserved as open space. Should development be considered in the floodplain, channelization and drainage improvements would be necessary as well as raising building site grades above the floodplain level. According to the development plan, the lots are proposed outside the floodplain zone. Finished floor elevations must be a minimum of one foot above the floodplain level. Drains may be necessary for foundations immediately adjacent to the floodplain to help prevent the intrusion of water into areas below grade. Specific floodplain location and drainage studies are beyond the scope of this report.

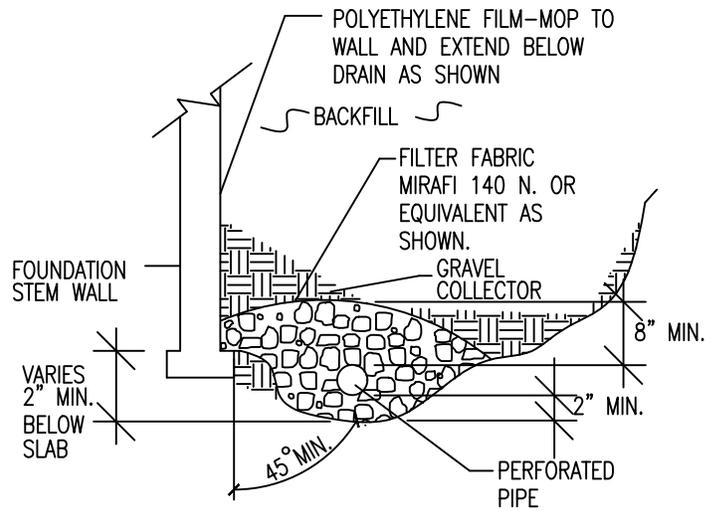
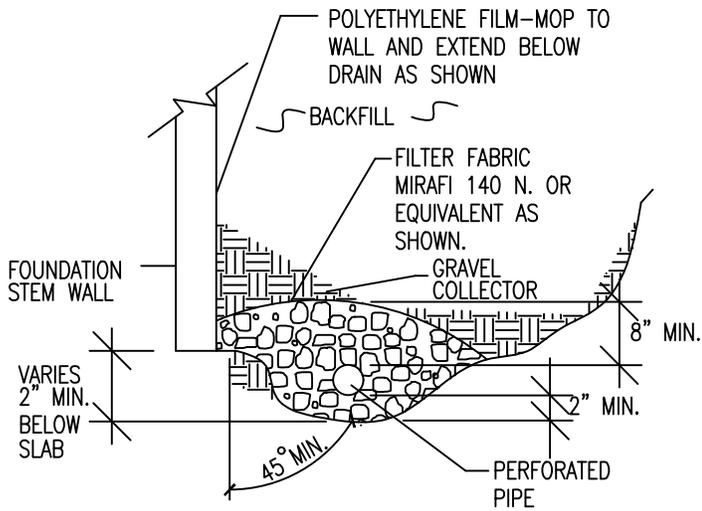
JOB NO.:
 201421
 FIG NO.:
 9

Areas of potentially seasonal shallow groundwater have been mapped in minor drainage swales and low areas on the site. According to the grading plans, these areas are to be regraded. Structures immediately adjacent to the detention ponds or Sand Creek may experience higher water levels during periods of high moisture. Shallow groundwater areas may also affect utility installation. Geo-grids or shotrock may be necessary to stabilize excavation. In or adjacent to seasonal shallow groundwater areas, drains may be necessary to control seepage within the foundation zone. A typical perimeter drain detail is presented in Figure 9.
