**SOILS AND GEOLOGY STUDY  
THE COMMONS AT FALCON FIELD, FILING NO. 1  
DEVELOPMENT PLAN AND FINAL PLAT  
EL PASO COUNTY, COLORADO**

May 1, 2025

**PCD No. SF2435**

Entech Job No. 240260

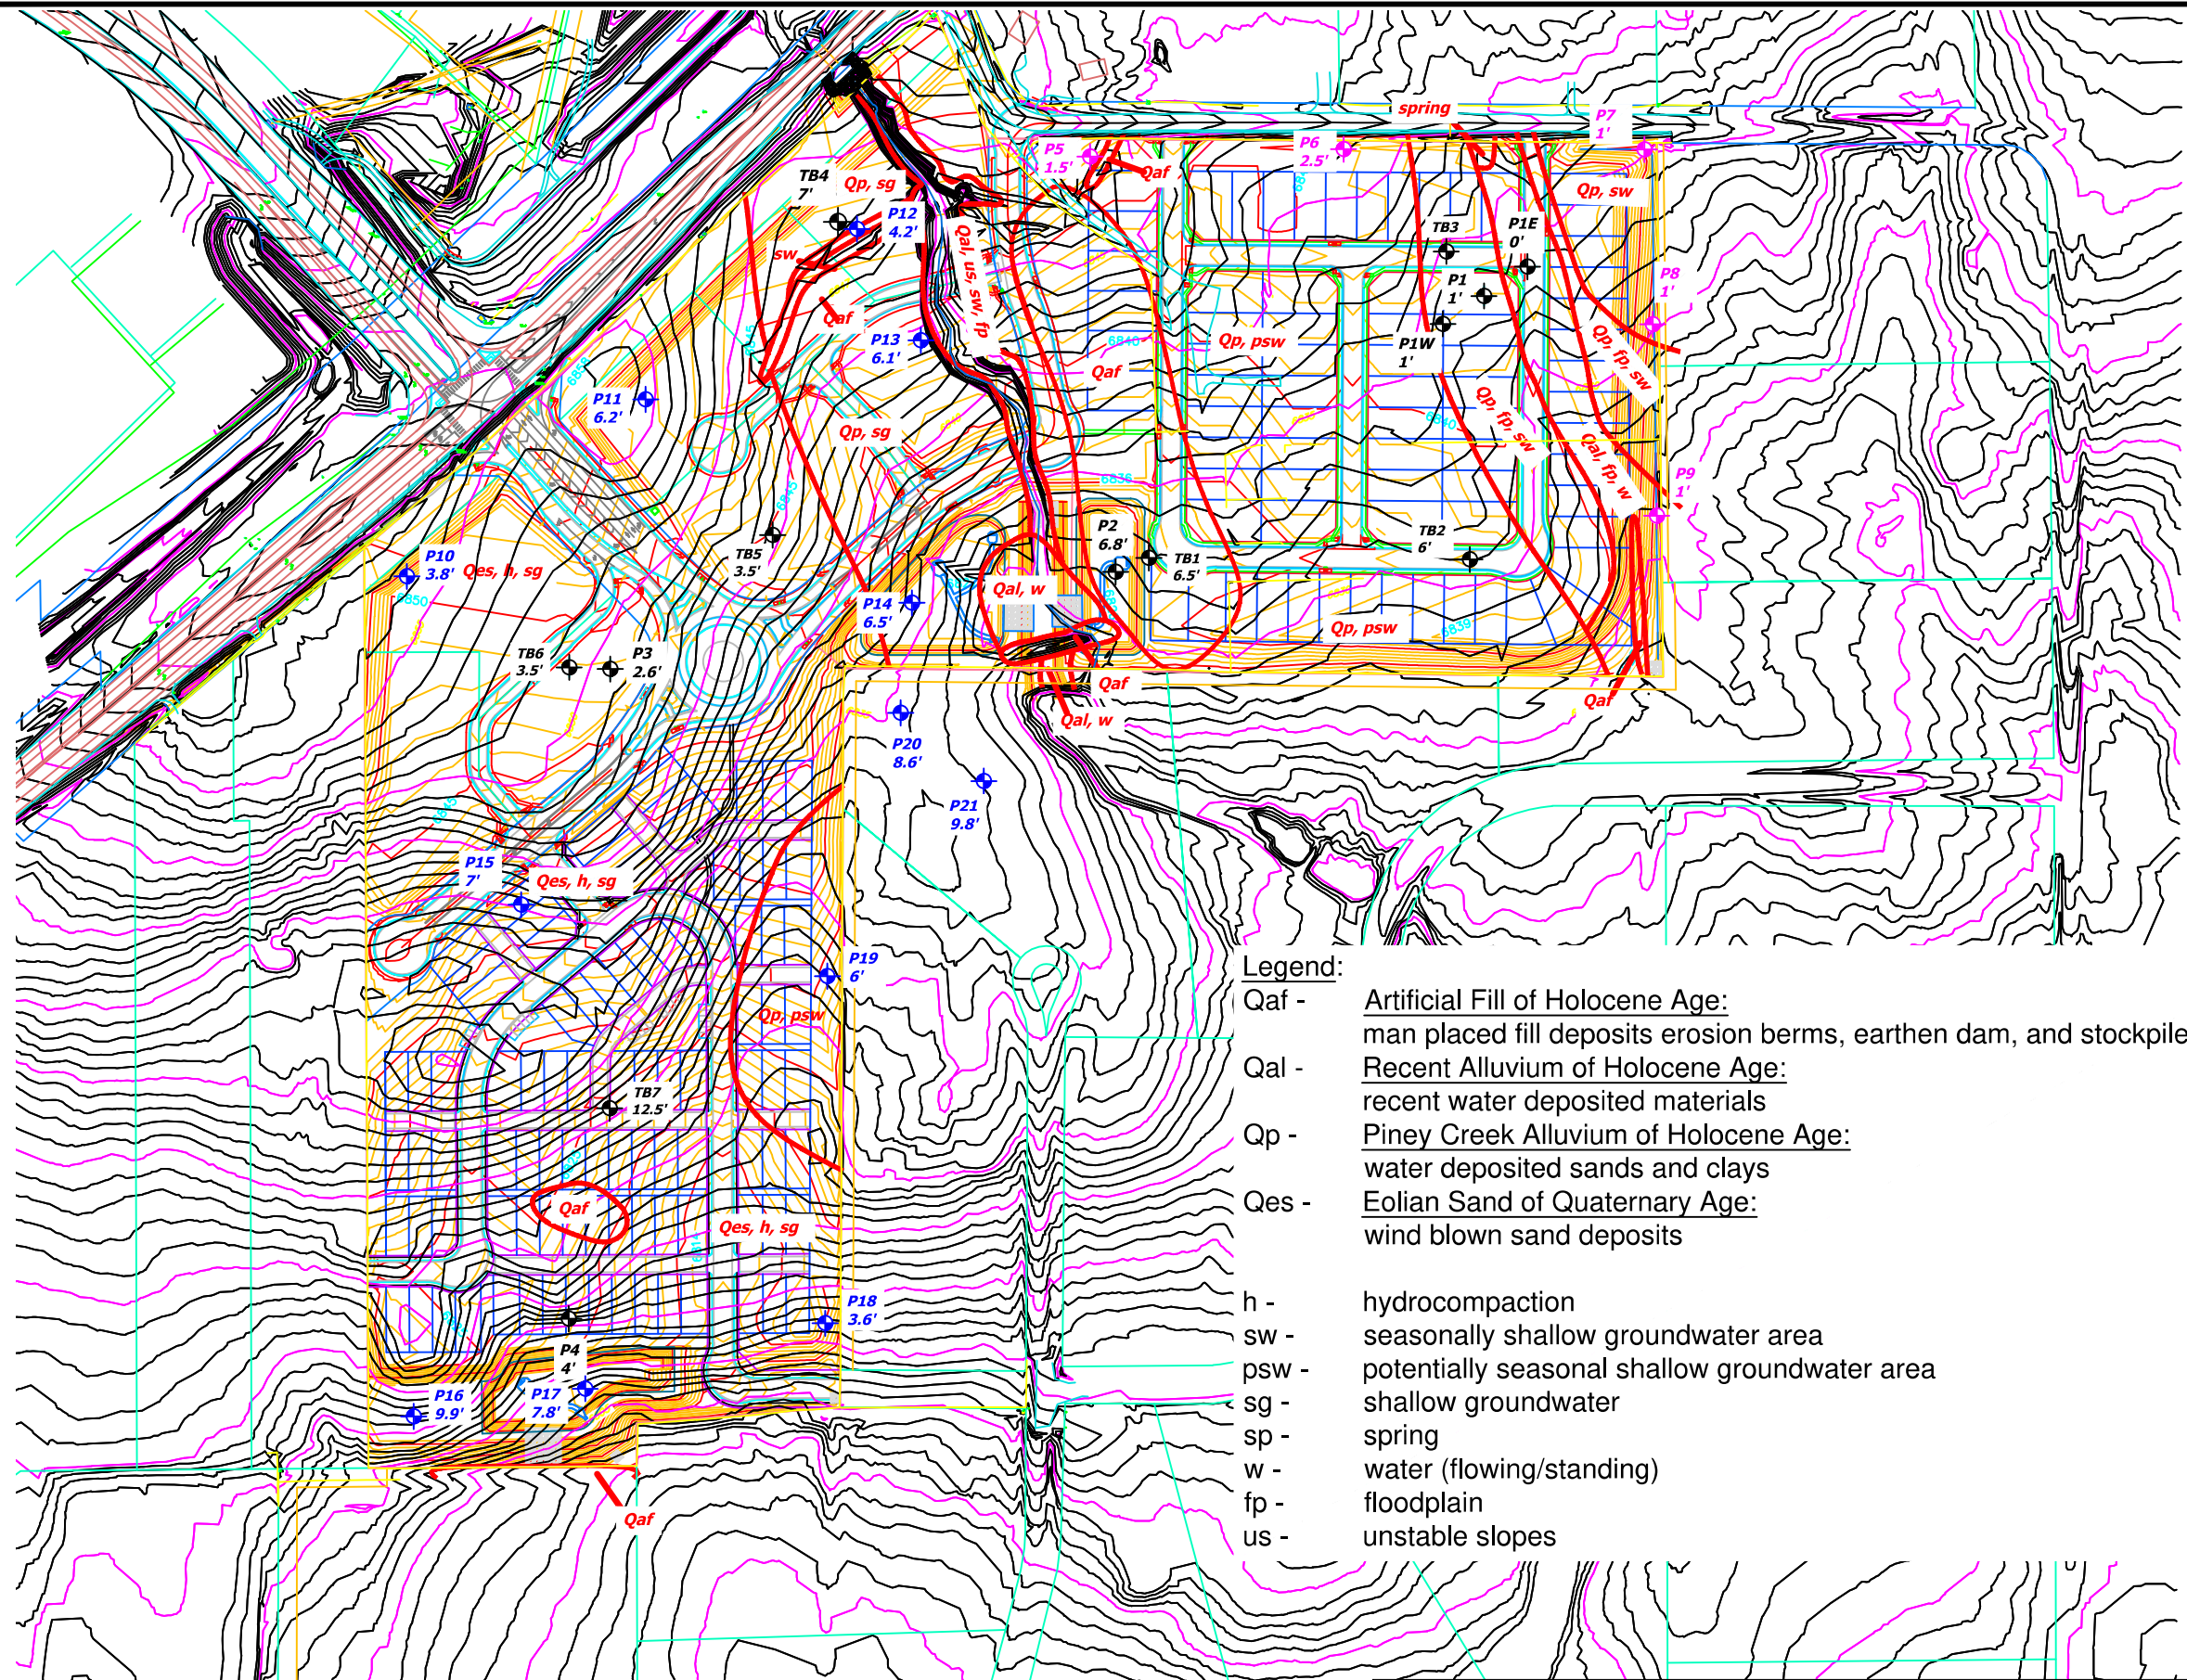
JOB NO.  
240260  
**FIG. 7**

Detailed mapping has been performed on this site to produce an Engineering Geology Map (Figure 7). This map shows the location of various geologic conditions that the developers should monitor during the planning, design, and construction stages of the project. The constraints/hazards identified on this site include artificial fill, hydrocompaction, potentially expansive soils, seasonal and potentially seasonal shallow groundwater areas, areas of ponded water, springs, unstable slopes, and floodplains. These constraints/hazards and the recommended mitigation techniques include:

These are areas of man-made fill associated with an earthen dam, erosion berms, and temporary stockpile observed on the site to be used in the overlot grading of the property.

The majority of the slopes on-site are gently sloping and do not exhibit any past or potential unstable slopes or landslides. Some of the steeper slopes along the drainage in the central portion of the site have been identified as unstable slopes. The mitigation recommendation for these areas is as follows:

Areas of the site have been identified as seasonal and potentially seasonal shallow groundwater areas. Additionally, shallow groundwater was encountered in some of the borings (less than 5 feet) and is identified as areas of shallow groundwater. A spring is located in the northeastern portion of the property along Rio Lane. Water was observed flowing in this area and along the drainage at the time of our recent site observations. The drainage in the central portion of the site west of the existing house has been mapped as a floodplain zone according to the FEMA Map Nos. 08041CO553G and 08041CO561G (Figure 8, Reference 8). The minor drainage to the east of the house is not mapped as a FEMA floodplain; however, it is a physiographic floodplain. These areas are indicated on the Geology/Engineering Geology Map (Figure 6). The existing drainages will be routed through a pipe or box culvert. These areas are further discussed as follows:

Mitigation: According to the grading plan prepared by Drexel Barrell & Company, the drainage area with the unstable slopes in the central portion of the site will be regraded and filled, mitigating the unstable slopes hazard. Fill should be placed on native soils or bedrock and properly benched into the slopes. Dewatering of the area may be required during site grading prior to placing fill. The drainage is to be routed through a pipe or box culvert.

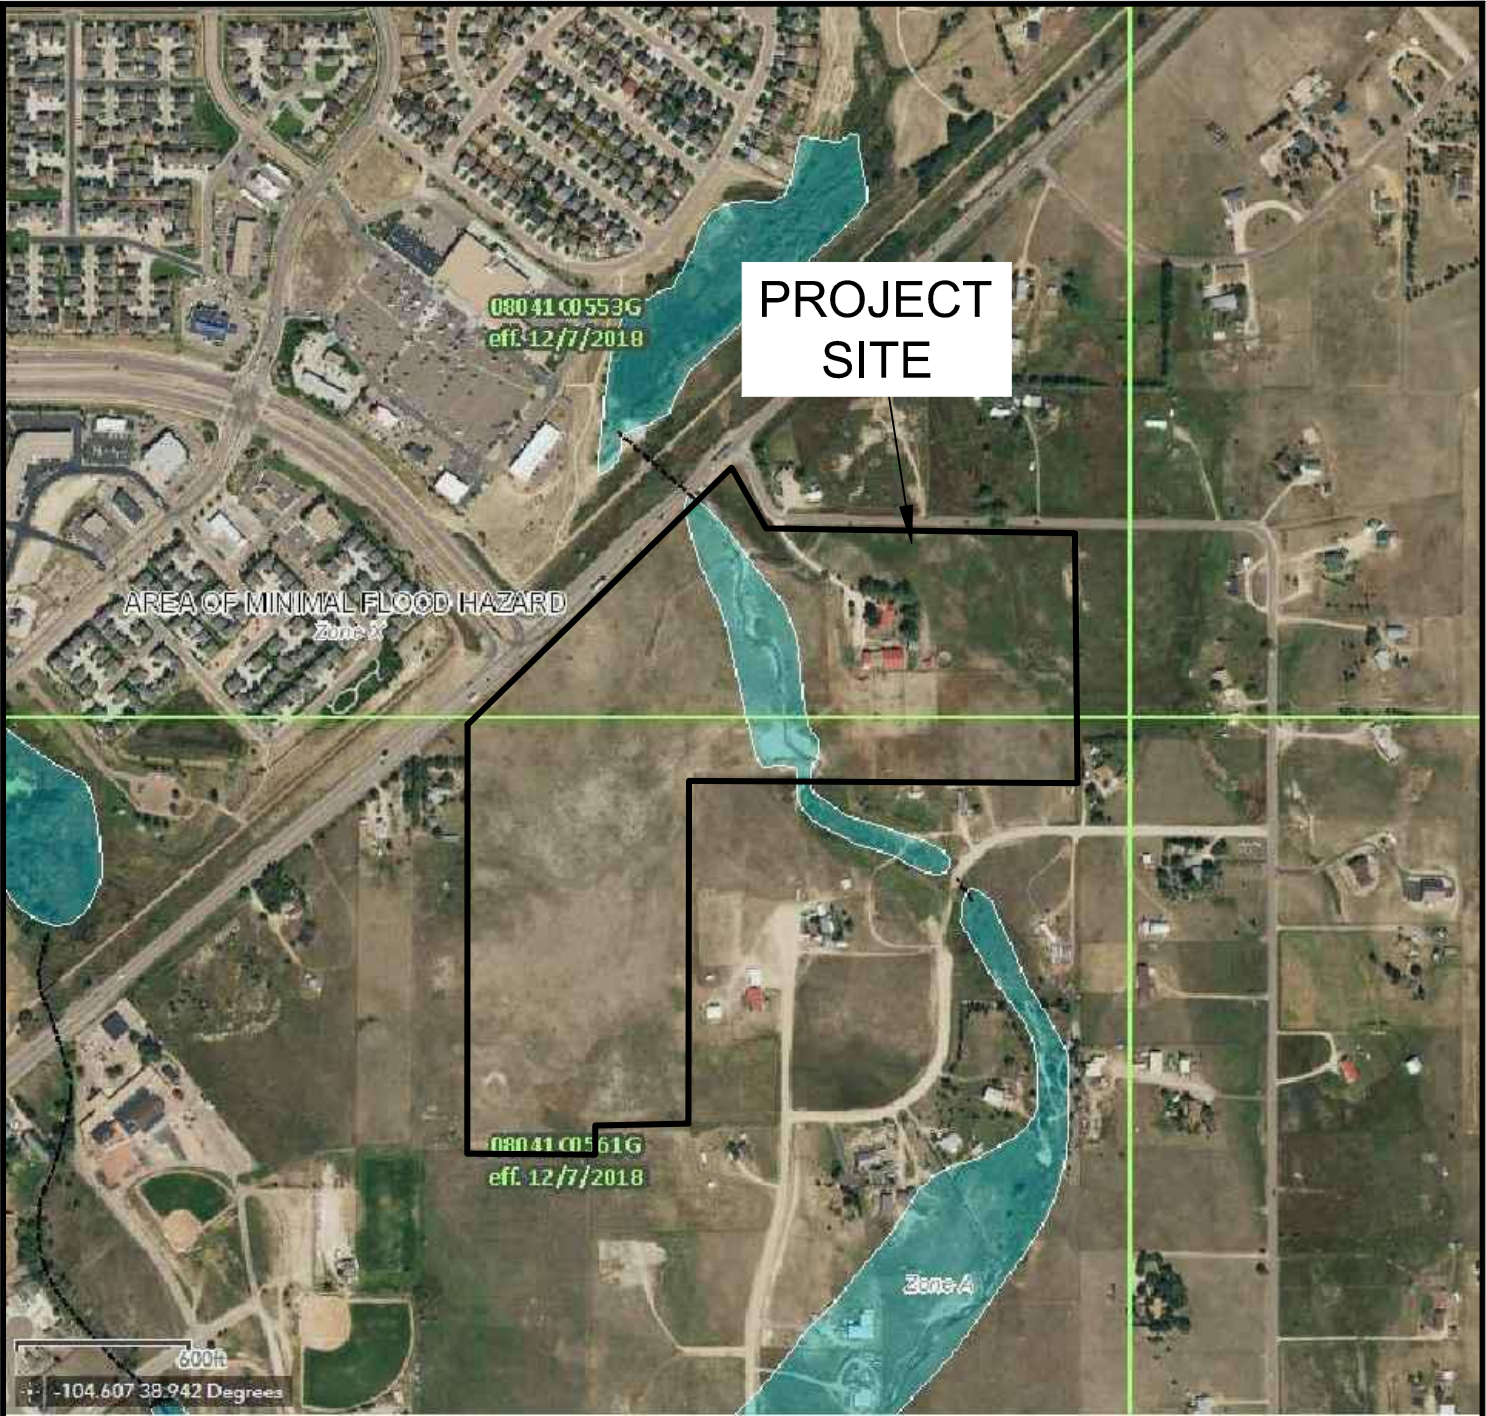
**FIG. 8**

Floodplain – Constraint: The drainage in the central portion of the site has been mapped as a floodplain zone according to the FEMA Map Nos. 08041CO553G and 08041CO561G (Figure 8, Reference 8). There is also an unmapped physiographic floodplain in the eastern portion of the site. Any construction considered in a floodplain area will require approval of the drainage plan. Lots immediately adjacent to the floodplain may experience higher groundwater levels during peak flows. Subsurface perimeter drains are recommended for structures adjacent to the floodplain to help prevent the intrusion of water into areas below grade. Typical drain details are presented in Figure 8. Finished floor levels must be a minimum of one floor above the floodplain level. Exact floodplain locations by drainage studies are beyond the scope of this report.

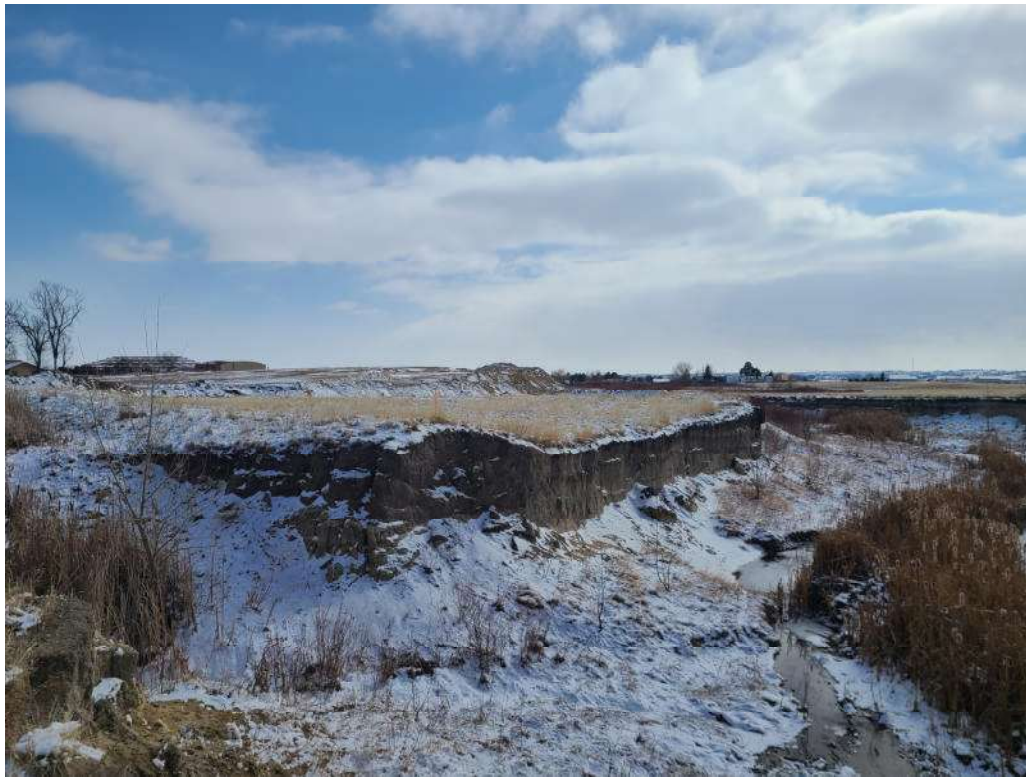
**Looking south along  
drainage from the  
northern portion of the  
site.**

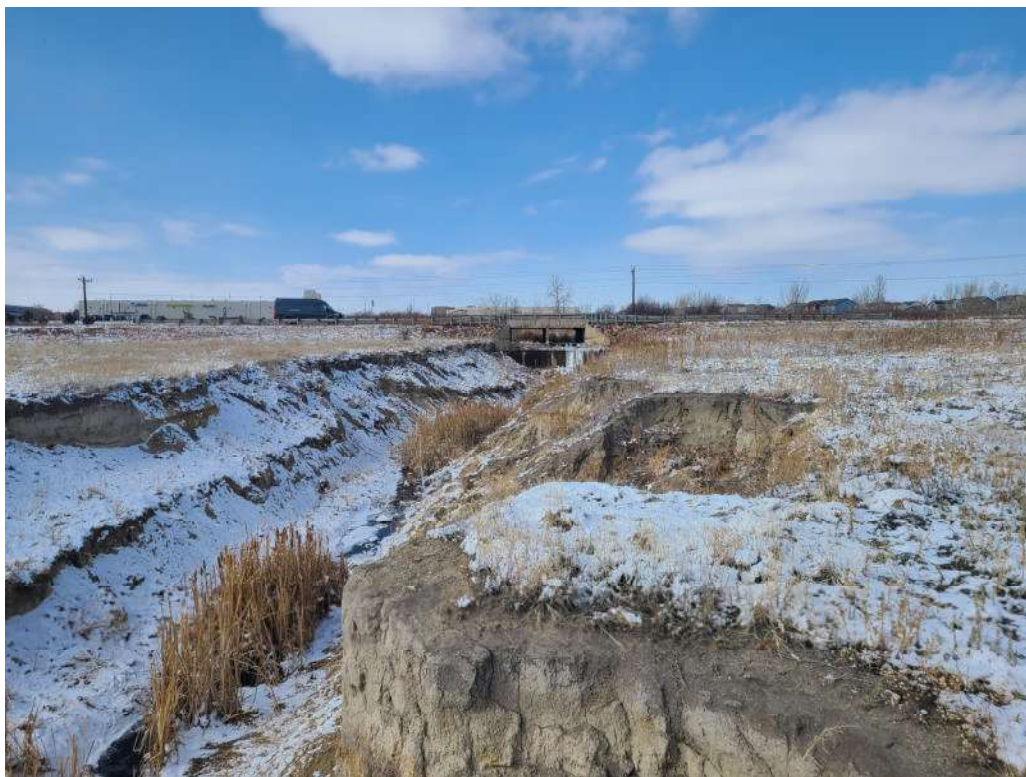
**Looking northwest  
along drainage  
towards Highway 24  
northern portion of the  
site.**

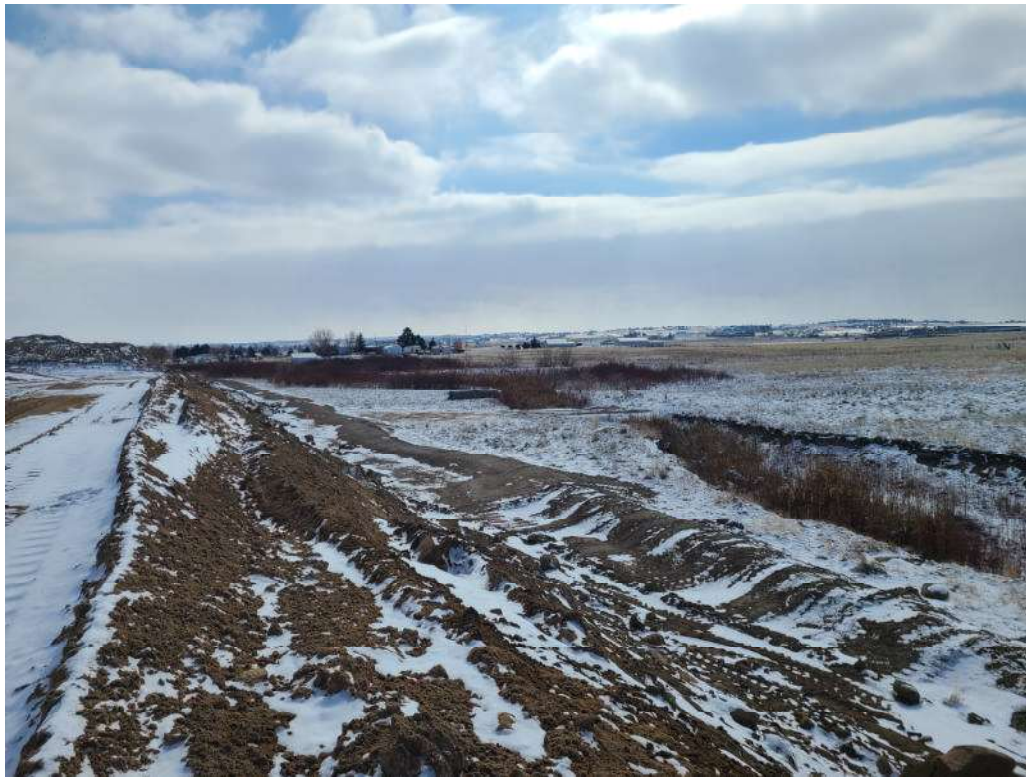
**Looking south from  
the central portion of  
the site.**

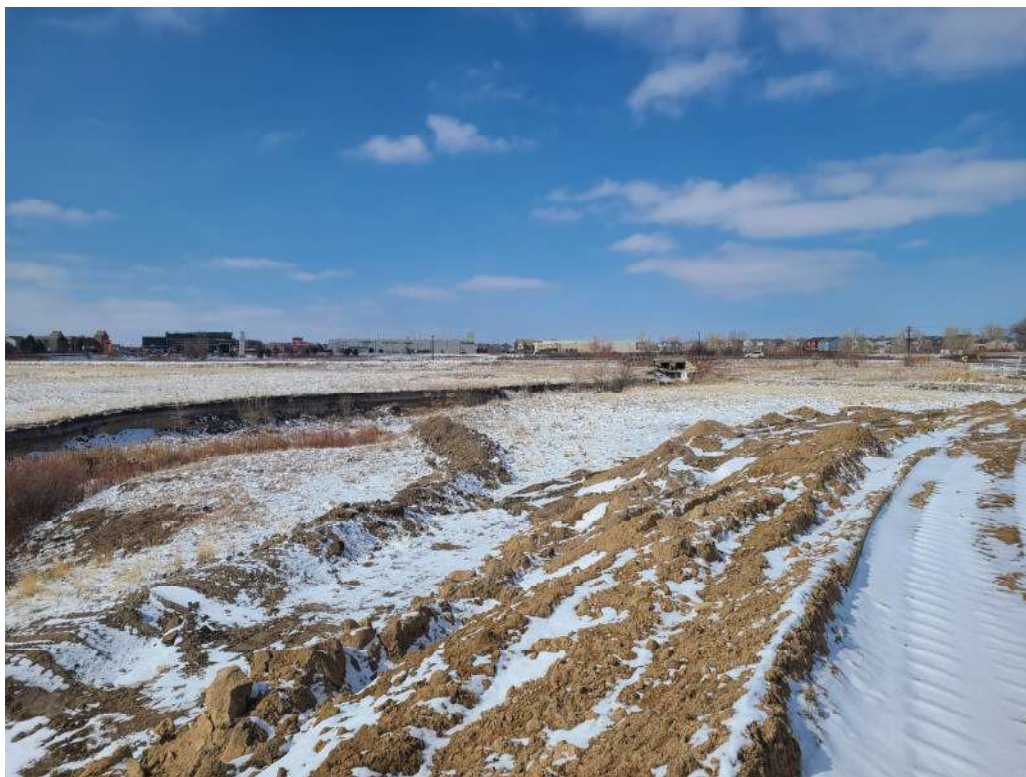
**Looking northwest  
from the central  
portion of the site.**

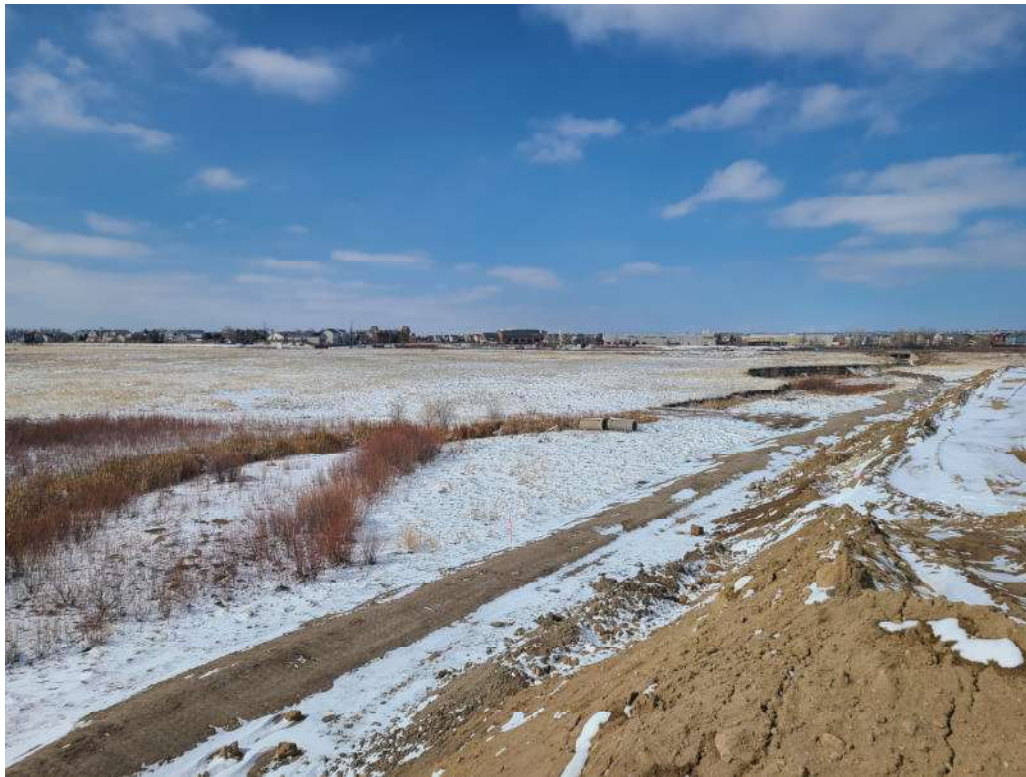
**Looking north from the southern side of the site.**

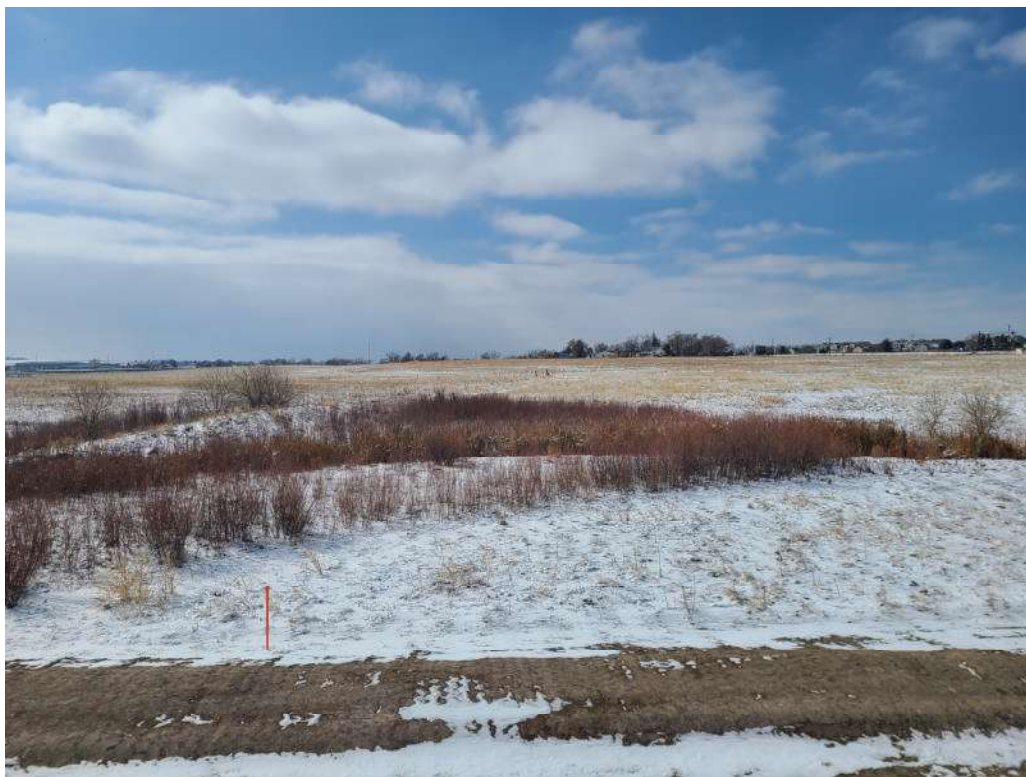
**Looking west from the southern side of the site.**
