**SOILS AND GEOLOGY STUDY
RETREAT AT TIMBERRIDGE FILING NO. 4
PARCEL NO. 52220-00-023
EL PASO COUNTY, COLORADO**

Prepared for:
**TimberRidge Development Group, LLC
2138 Flying Horse Club Drive
Colorado Springs, CO 80921**

December 21, 2023

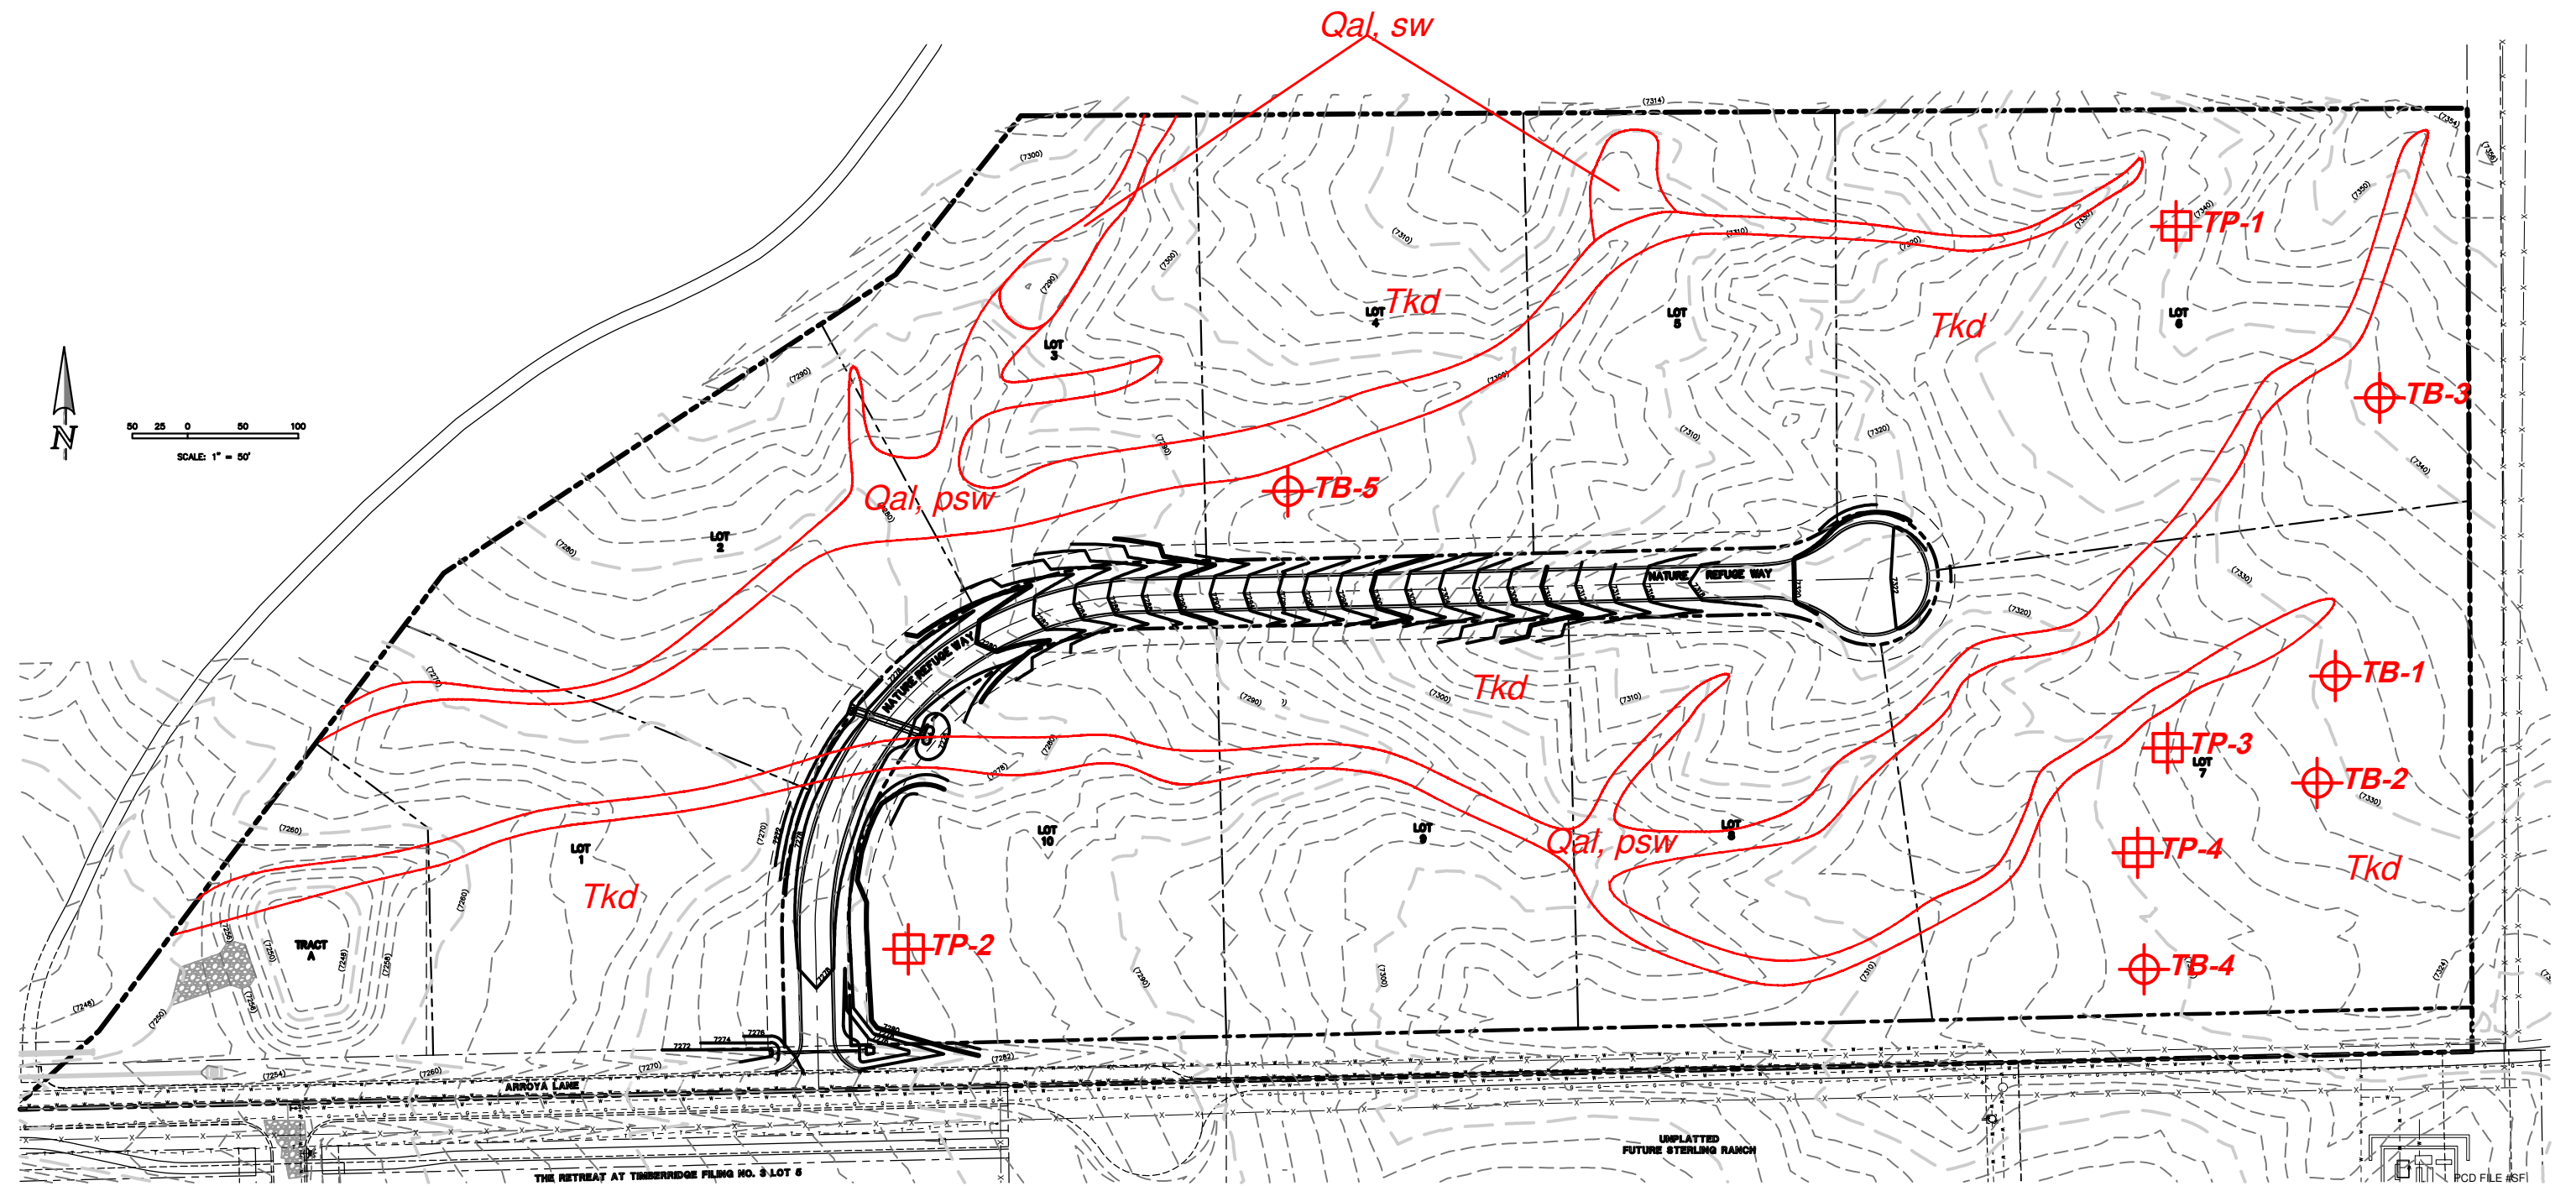
FIG. 6

Areas of potential seasonally and seasonally shallow groundwater were observed on site. The seasonally shallow groundwater areas are located in the northern portions of Lots 3 and 5. The potentially shallow groundwater areas have been identified across the site, in these areas we would anticipate the potential for higher groundwater levels. Drains may be necessary for structures adjacent to these areas to help prevent the intrusion of water into areas below grade. Typical drain details are presented in Figures 9 to 11. The site does not lie within any floodplain zones according to the FEMA Map No. 08041CO535G, dated December 7, 2108 (Figure 8, Reference 8). Exact locations of floodplain and specific drainage studies are beyond the scope of this report.

Mitigation: Foundations must have a minimum 30-inch depth for frost protection. In areas where high subsurface moisture conditions are anticipated periodically, subsurface perimeter drains are recommended to help prevent the intrusion of water into areas below grade. The seasonally shallow groundwater areas are located in the northern portions of Lots 3 and 5. The potentially shallow groundwater areas have been identified across the site, in these areas we would anticipate the potential for higher groundwater levels. Fill added to these areas further raise foundations above groundwater levels. Foundations should be kept as high as possible. Areas may experience higher groundwater levels during period of higher precipitation where water can flow through permeable sands on top of less permeable bedrock materials. Subsurface perimeter drains may be necessary to prevent the intrusion of water into areas below grade. Typical drain details are presented in Figure 8. Where shallow groundwater is encountered, underslab drains or interceptor drains may be necessary. Typical drain details are presented in Figures 9 and 11. It is anticipated that the shallow water areas will be avoided or mitigated with site grading and the installation of sewer underdrains. Specific recommendations should be made after additional investigation and site grading has been completed.

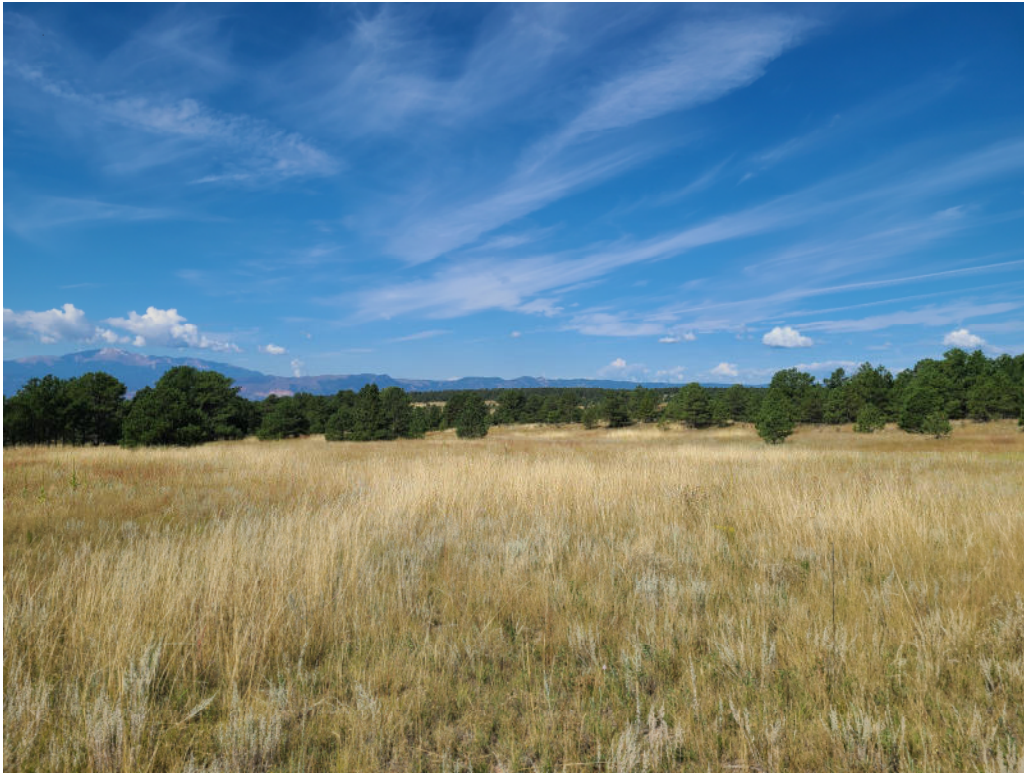
Looking west from the eastern side of the site.

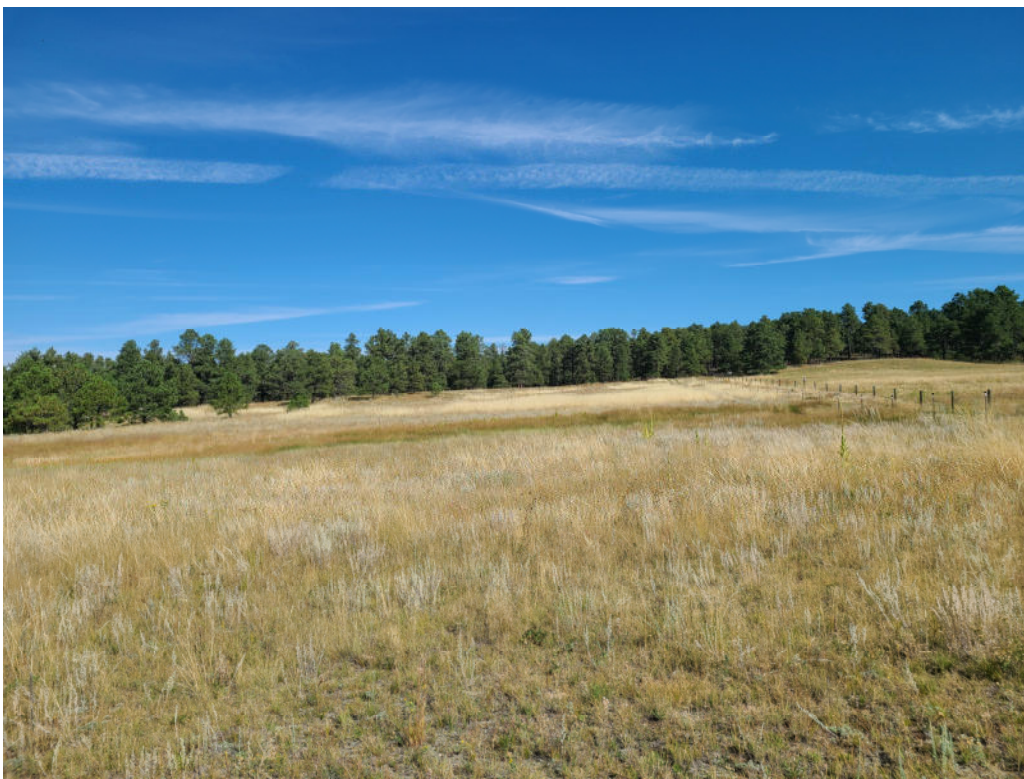
Looking north from the eastern side of the site.

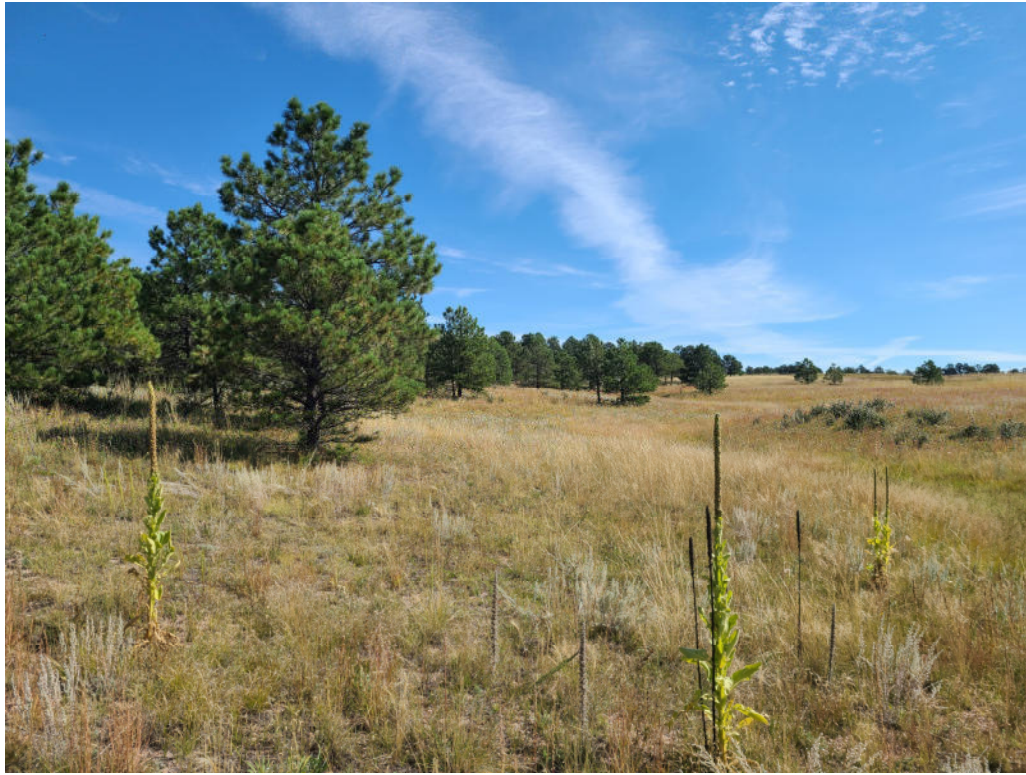
**Looking east towards
erosion feature eastern
side of site.**

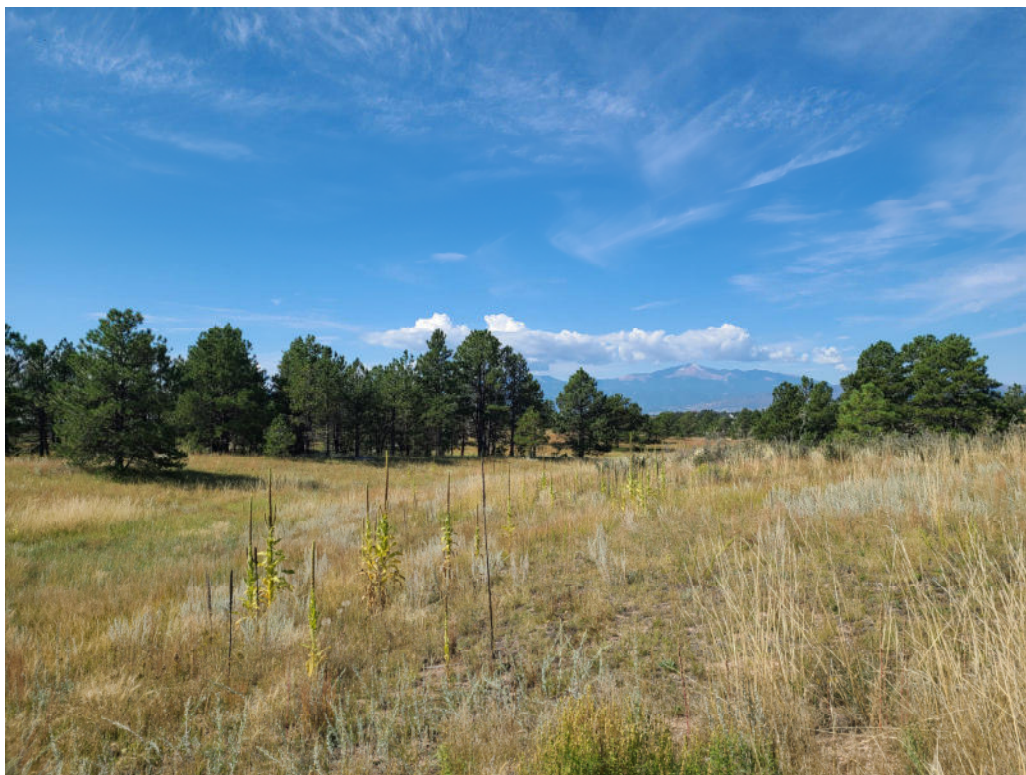
**Looking west from the
central portion of the
site.**

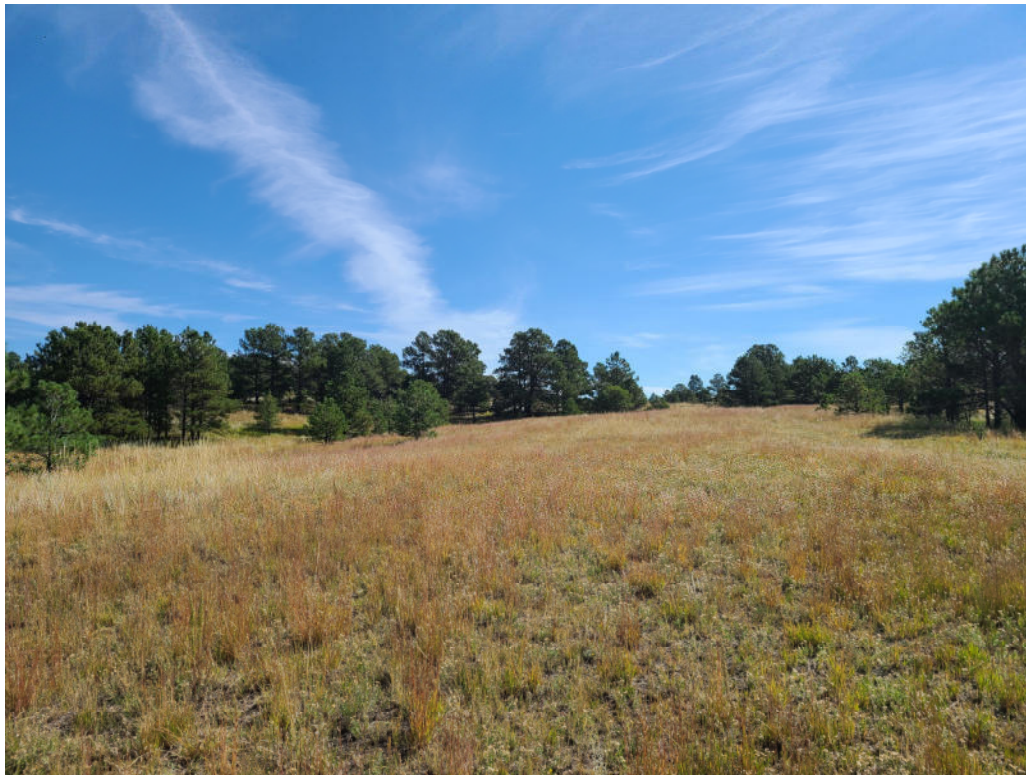
**Looking east from the
northwestern portion
of the site.**

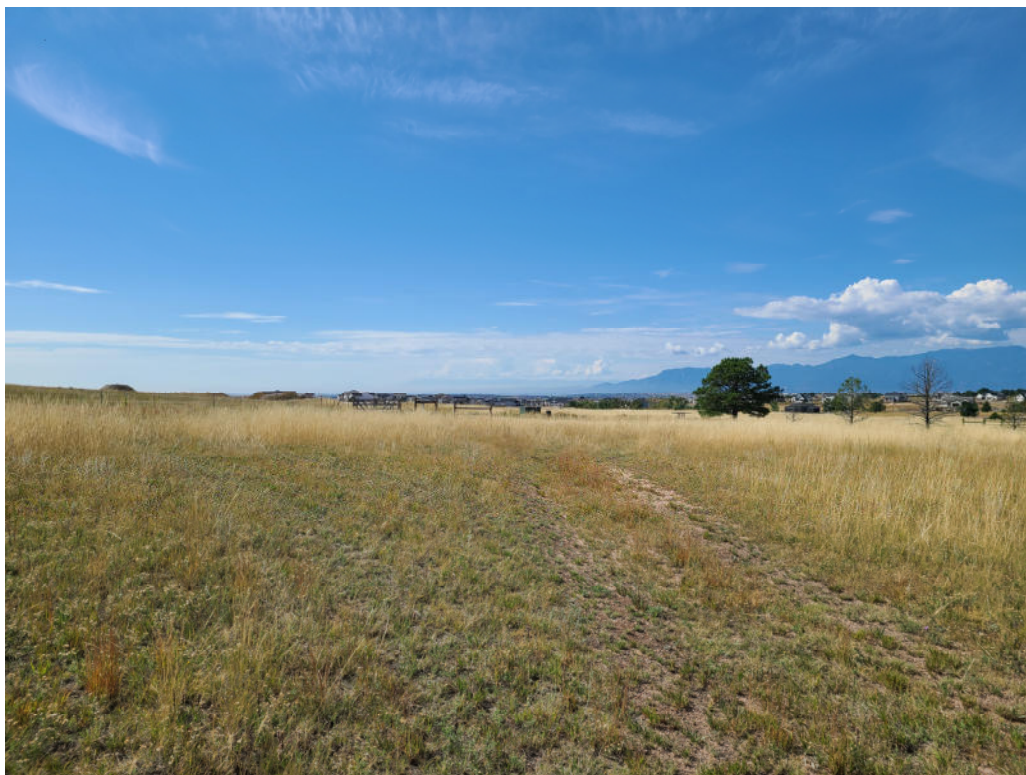
**Looking south from
the northwestern
portion of the site.**
