**SOILS AND GEOLOGY STUDY
11745 OWL PLACE
PARCEL NO. 53010-01-015
EL PASO COUNTY, COLORADO**

Prepared for:
**Doubletree Ventures
106 South Kyrene Road, Suite 2
Chandler, Arizona 85226**

June 22, 2023

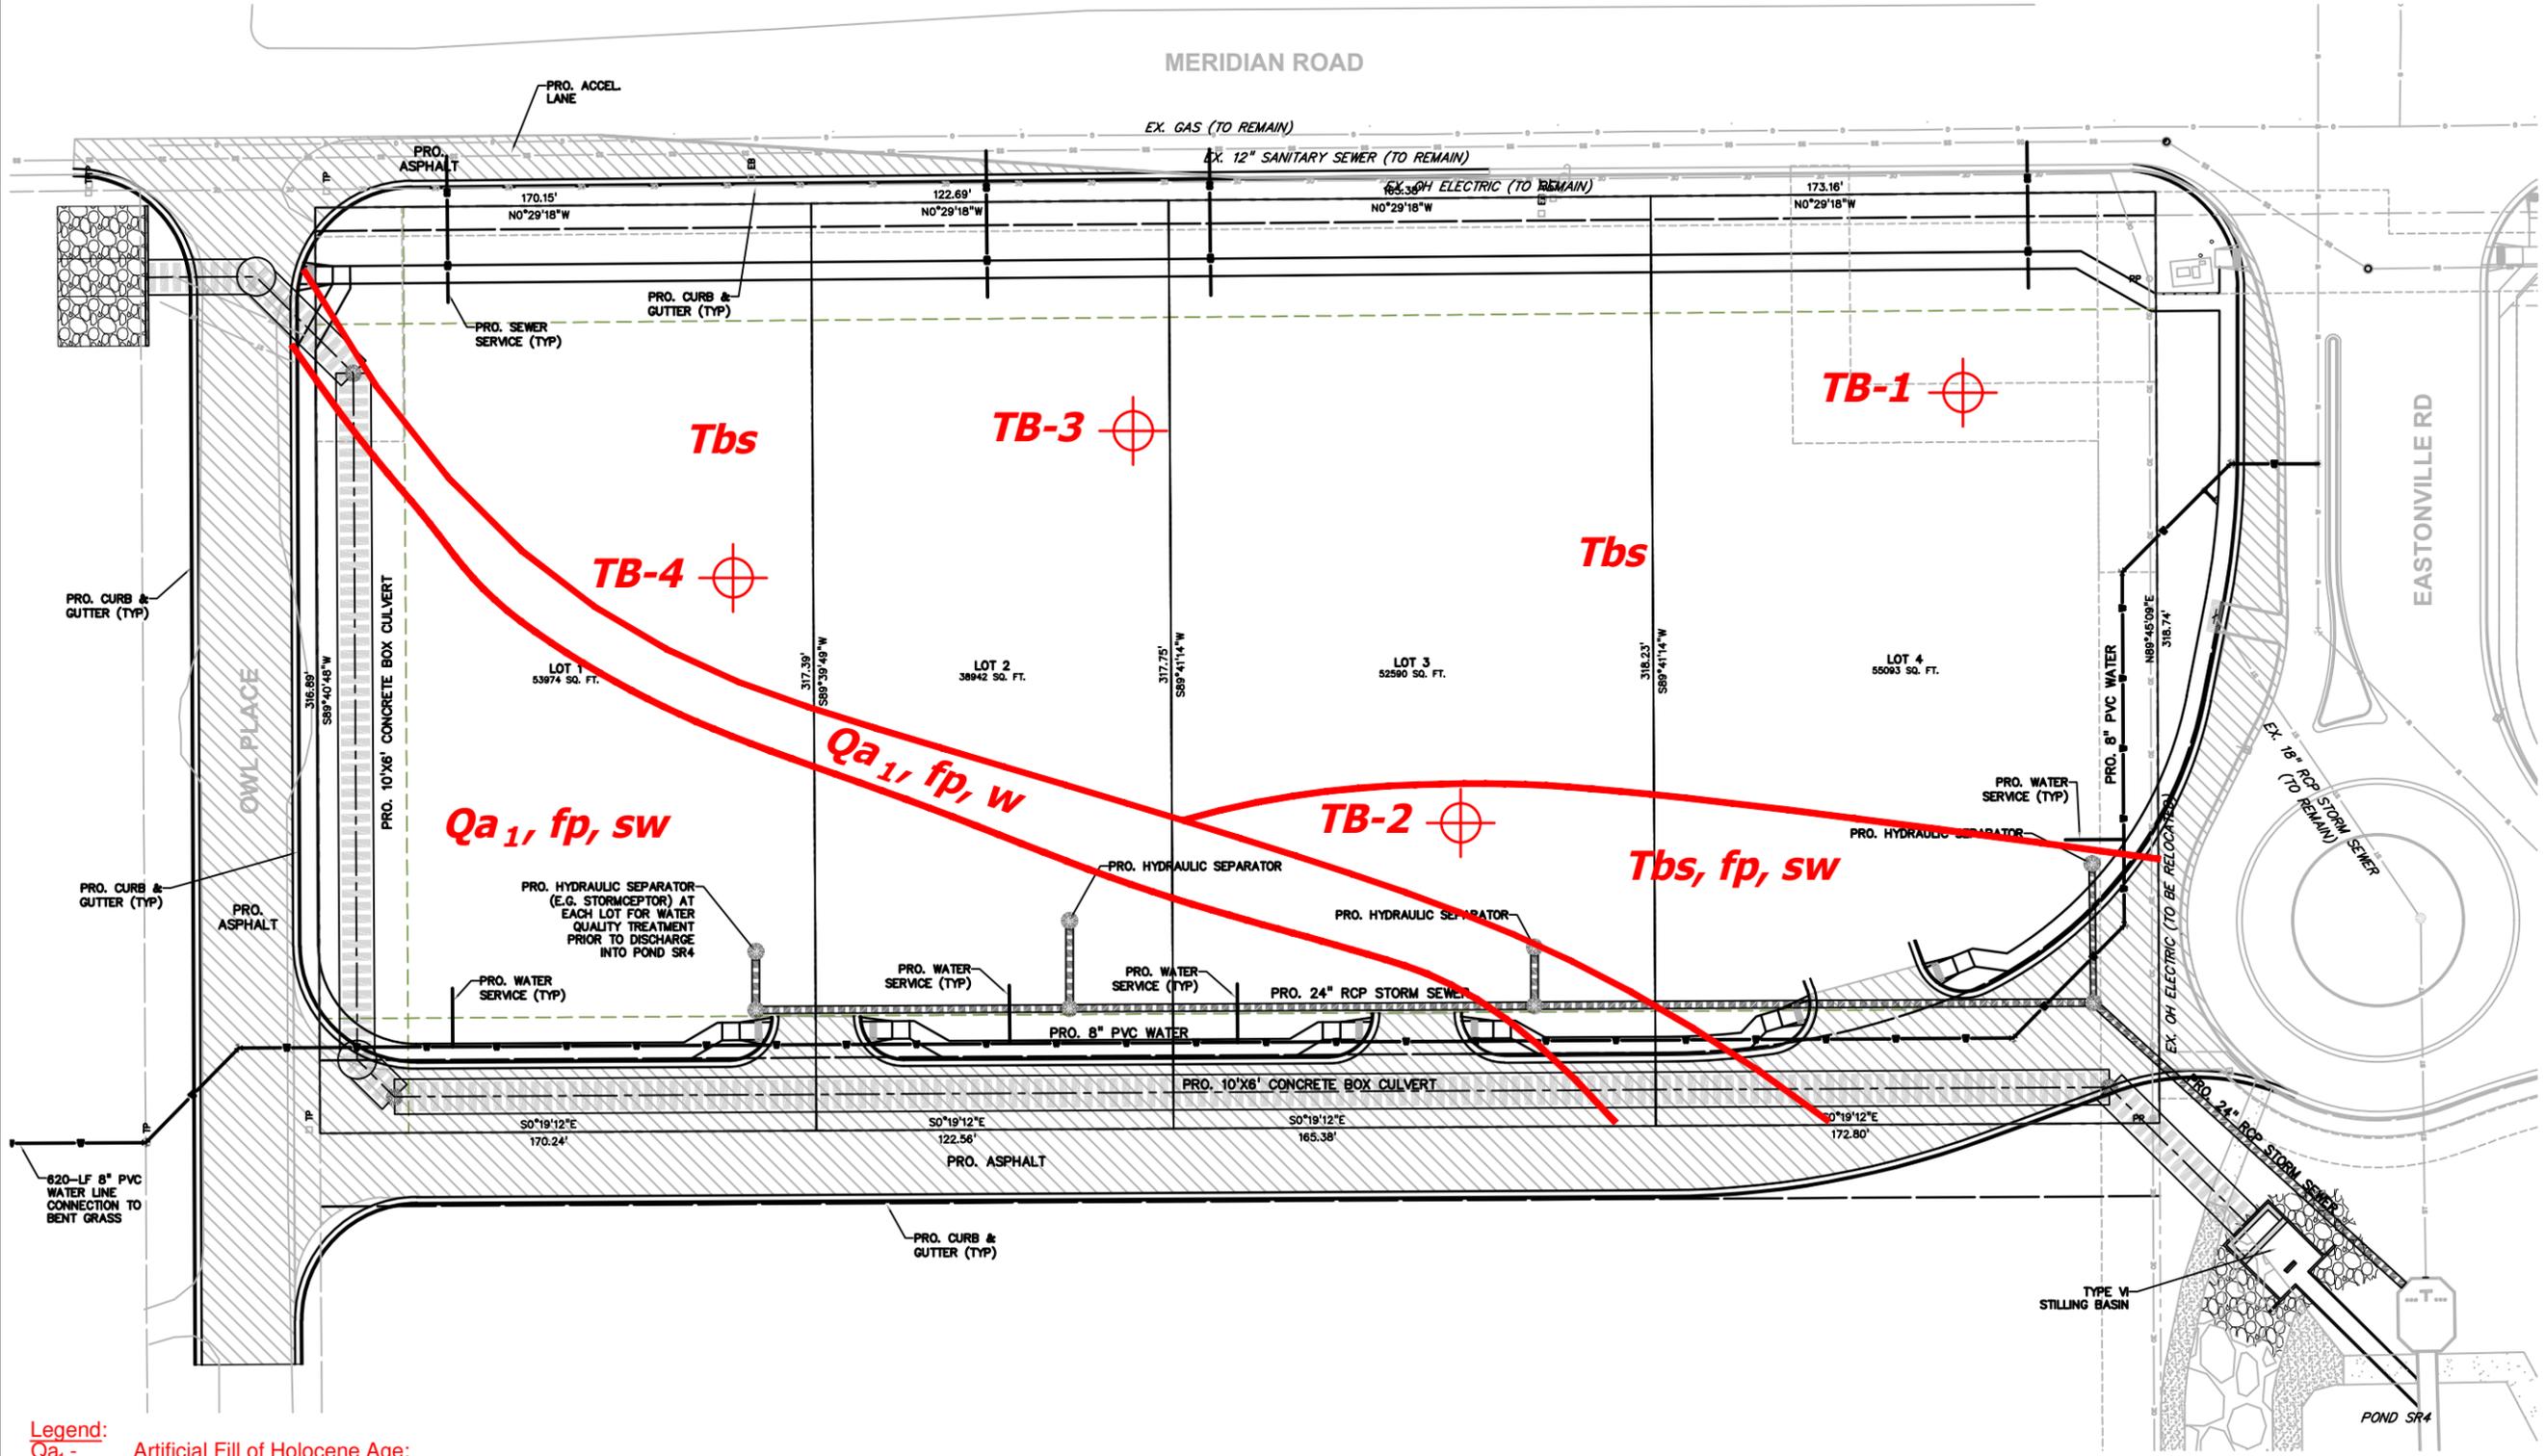
JOB NO.
230745
FIG. 6

Detailed mapping has been performed on this site to produce an Engineering Geology Map Figure 6. This map shows the location of various geologic conditions of which the developers should be cognizant during the planning, design and construction stages of the project. These hazards and the recommended mitigation techniques are as follows:

A portion of the site is mapped within floodplain Zone A according to the FEMA Map No. 08041CO553G, (Figure 7, Reference 7). A drainage crosses the site from the northeast to the southwest, and flowing and standing water were observed within the mapped floodplain area at the time of our field mapping and site investigation. The proposed development plan indicates that a 10'x8' box culvert will be installed rerouting the drainage around the northern and western sides of the site. Groundwater encountered in the test borings at depths of 10 to 16.5 feet

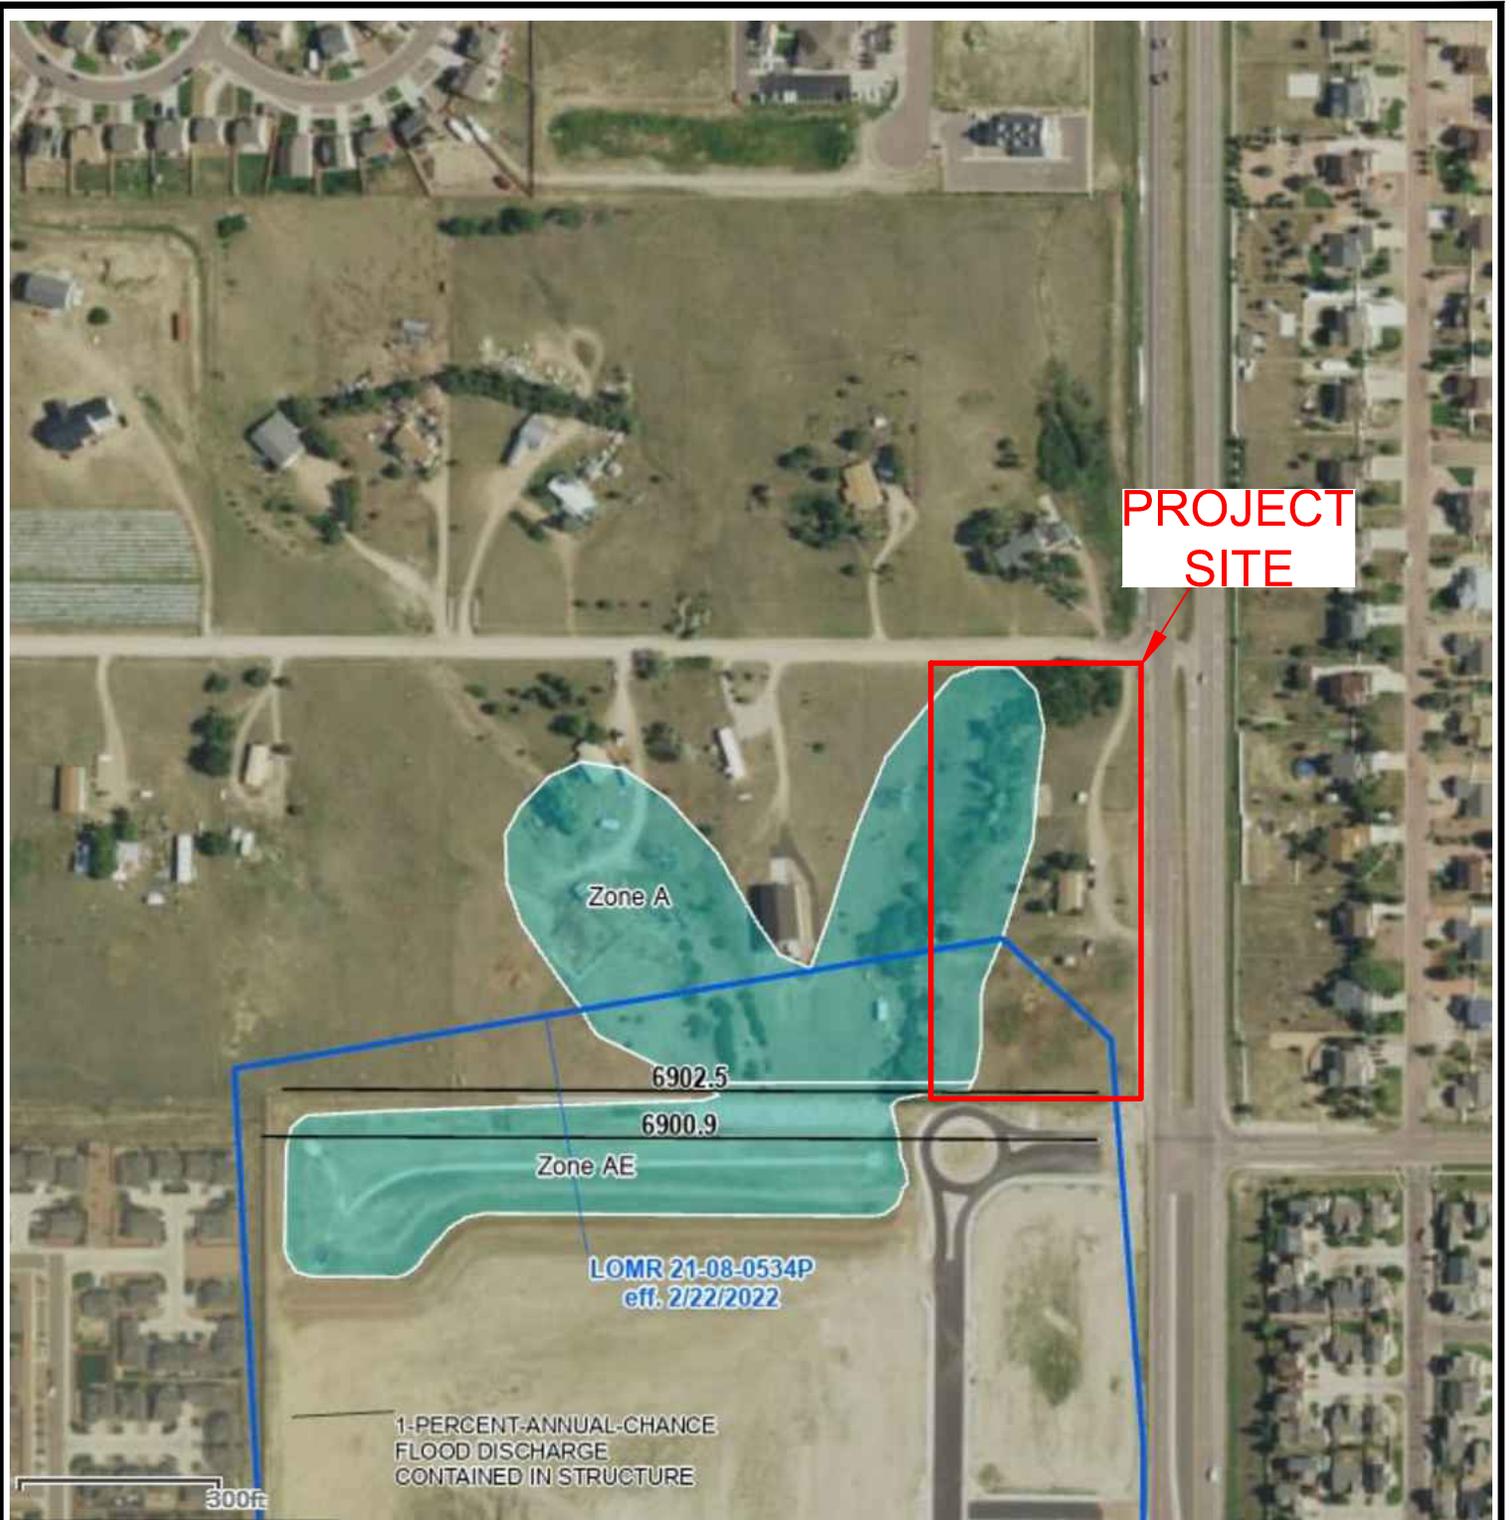
FIG. 7

A portion of the site is mapped within floodplain Zone A according to the FEMA Map No. 08041CO553G, (Figure 7, Reference 7). A drainage crosses the site from the northeast to the southwest, and flowing and standing water were observed within the mapped floodplain area at the time of our field mapping and site investigation. The proposed development plan indicates that a 10'x8' box culvert will be installed rerouting the drainage around the northern and western sides of the site. It is anticipated that the shallow water areas will be mitigated with site grading and the installation of the box culvert, however, additional site investigation should be conducted following the installation of the box culvert and prior to construction on the new lots. Groundwater encountered in the test borings at depths of 10 to 16.5 feet subsequent to drilling on April 26, 2023. **Exact locations of floodplain and specific drainage studies are beyond the scope of this report.** Subsurface perimeter drains may be necessary to prevent the intrusion of water into areas below grade. Typical drain details are presented in Figure 8. Where shallow groundwater

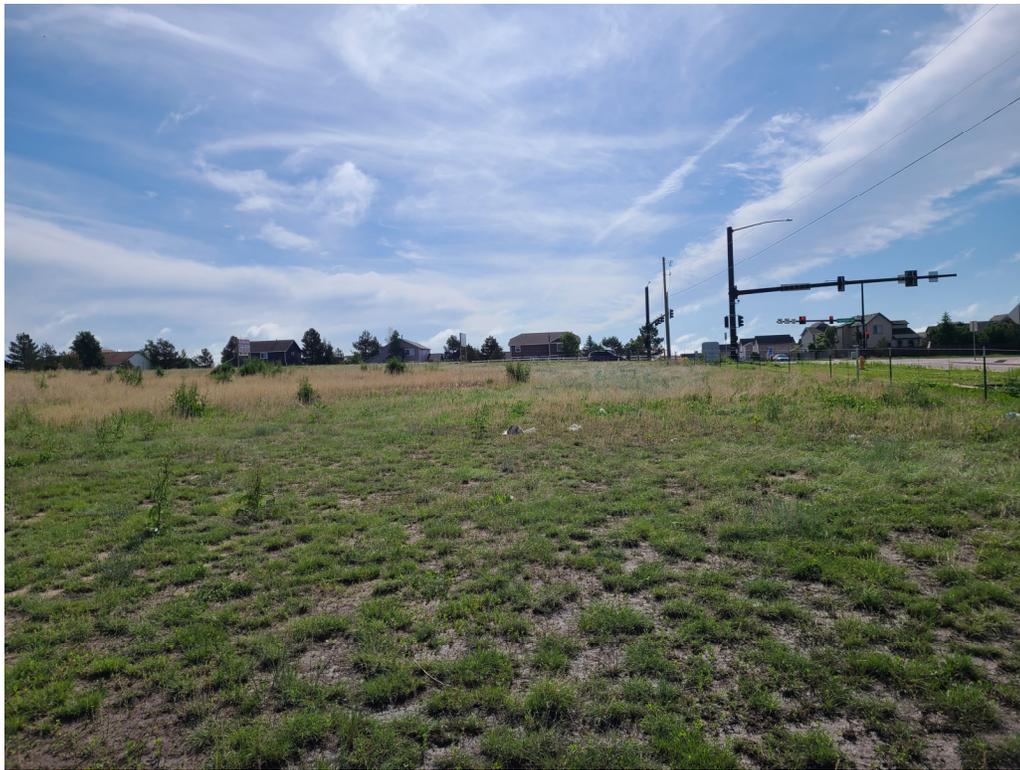
Looking east from the southwestern side of the site.

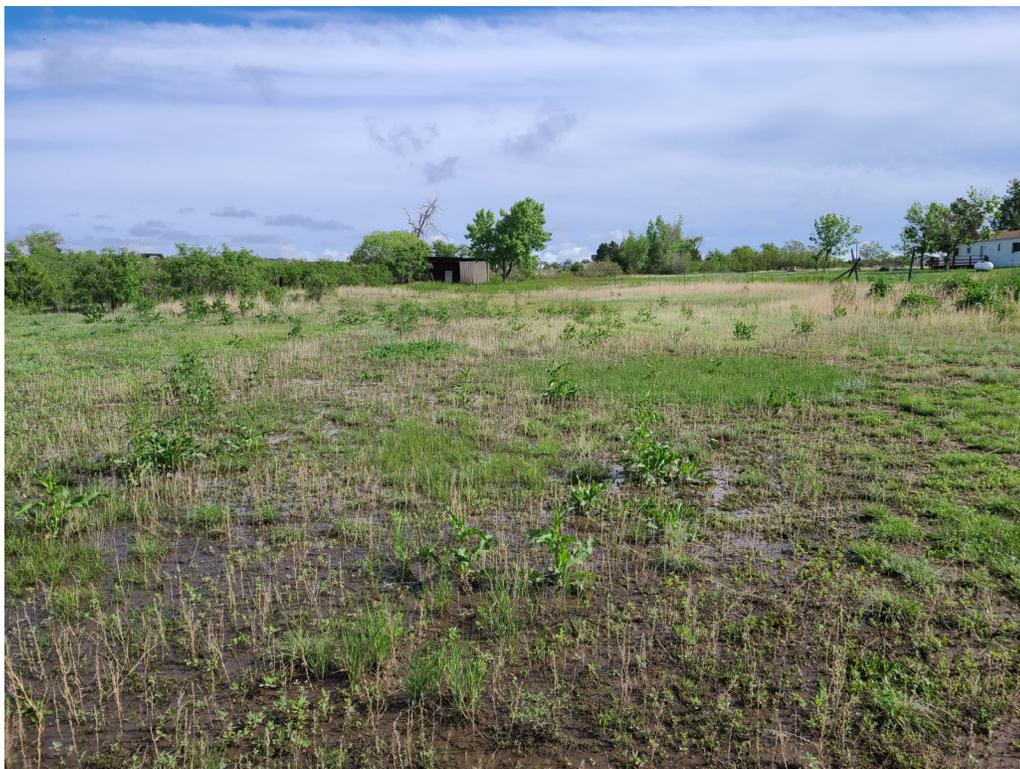
Looking north from the southwestern side of the site.

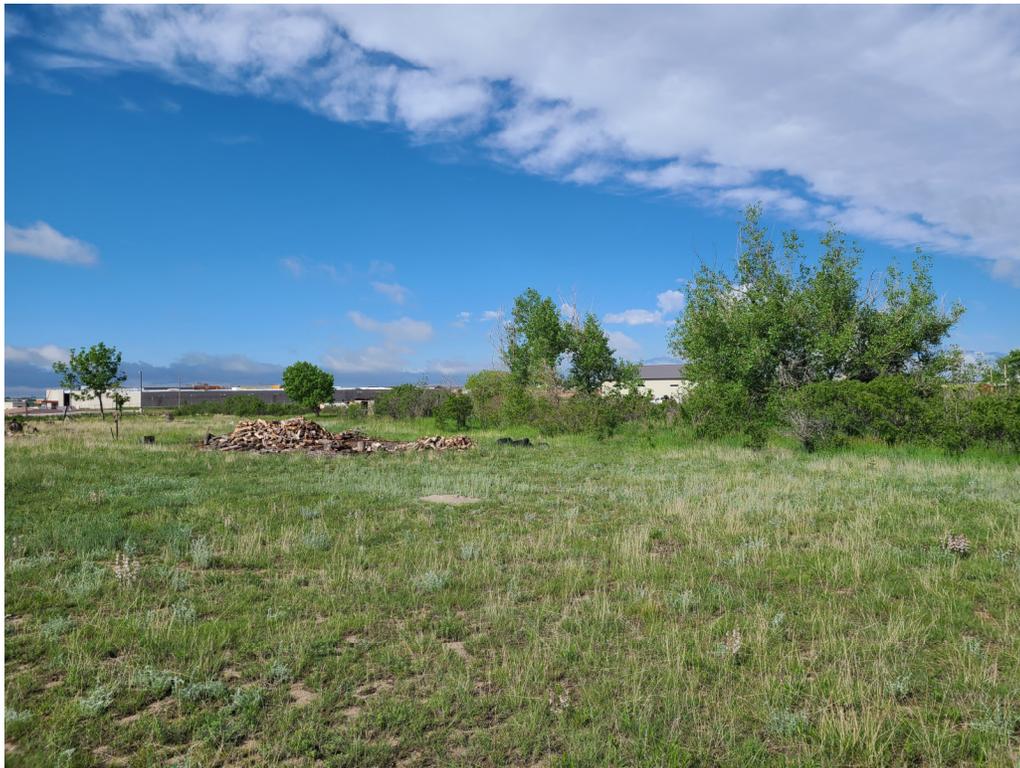
**Looking southwest
from the northeastern
side of the site.**

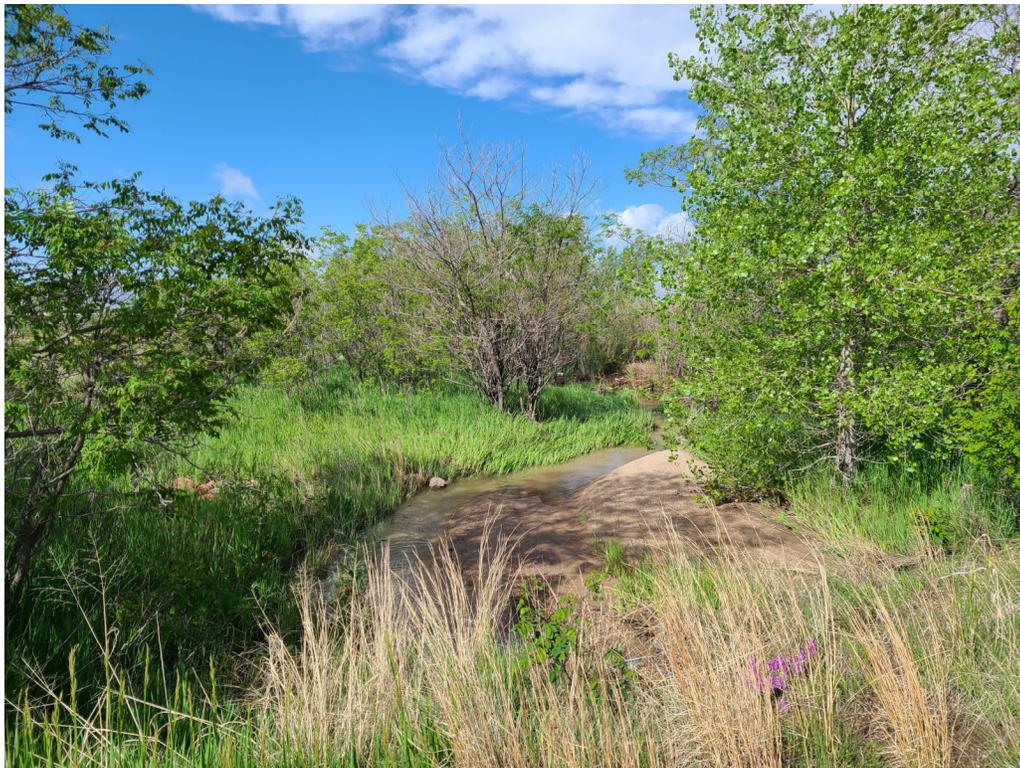
**Looking south along
drainage in the
northeastern portion of
the site.**
