**Final Acceptance Punchlist**  
**El Paso County – Department of Public Works - Stormwater Section**

Project Name:	Glen at Widefield F9
EDARP Filing Number(s):	SF204
ESQCP Number:	ESQ201
Attendees:	DPW SW: Natasha Grimaldo, Ben Jones, Christina Prete DPW Development Services: David Parkerson, Brad Walters, Spencer Pirzadeh, Gilbert LaForce Developer: Rudy Cross
Date of Walk-Thru:	07/26/2023
Walk-Thru Number:	1 <sup>st</sup>

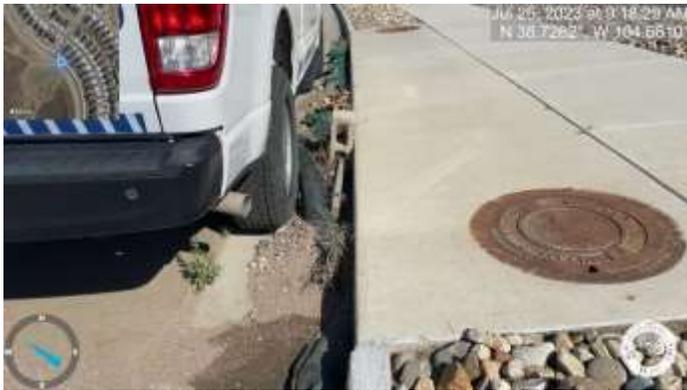
Photo 1: Spring Glen Dr.: Remove temporary inlet protections.

- Remove temporary inlet protections from inlets along Spring Glen Dr. (see Photo 1 and 2)

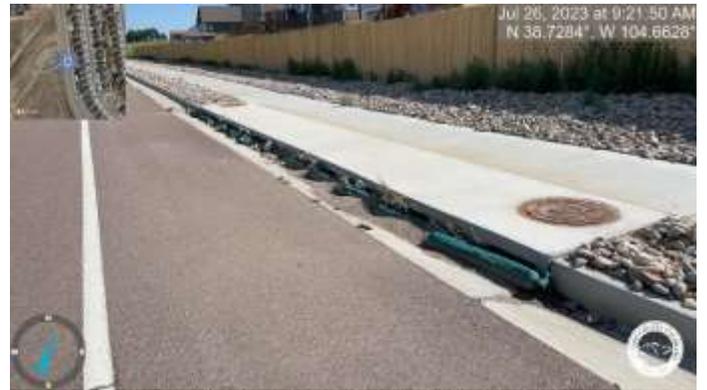
Photo 2: Spring Glen Dr.: Remove temporary inlet protections.

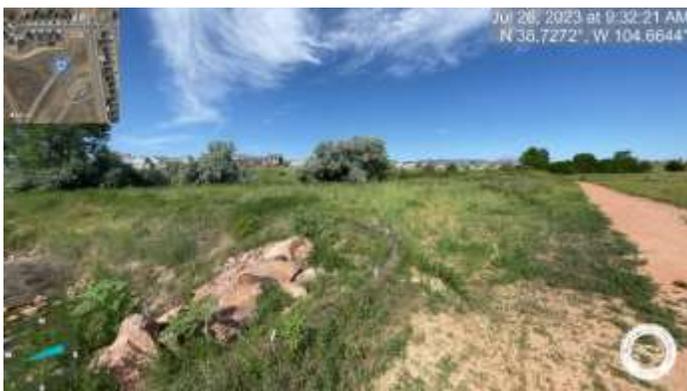
Photo 3: Southern Ditch (above culvert): Remove temporary control measure straw wattle.

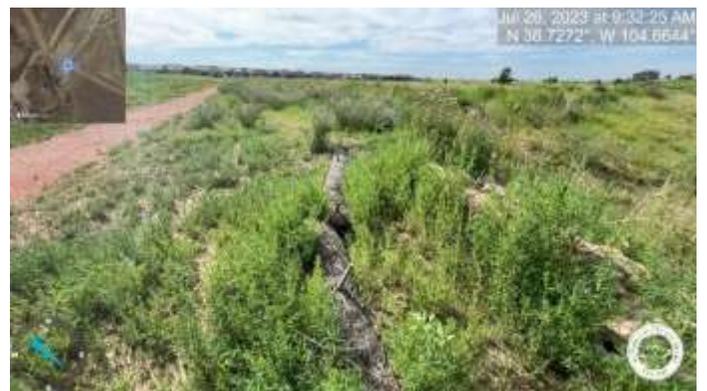
Photo 4: Southern Ditch (above culvert): Remove temporary control measure straw wattle.

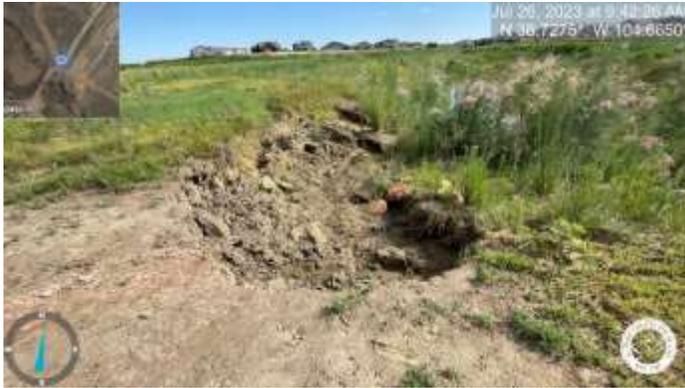
Photo 5: Northern Ditch (at culvert): Repair blowout, fine grade, and implement stabilization.

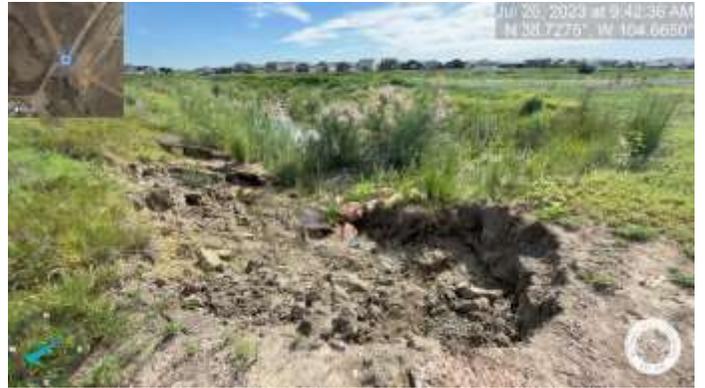
Photo 6: Northern Ditch (at culvert): Repair blowout, fine grade, and implement stabilization.

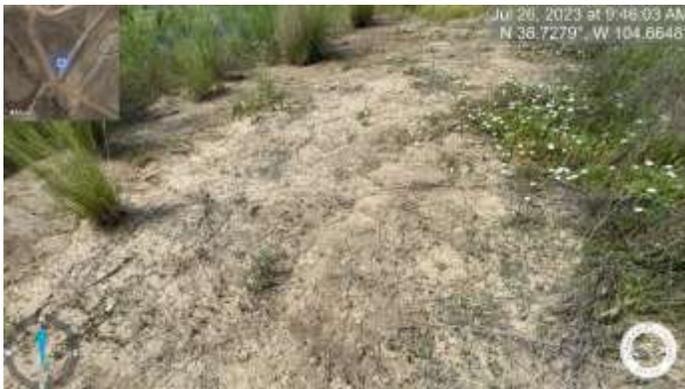
Photo 7: Northern Ditch: Vegetative growth does not show uniform coverage along ditch slopes. Stabilize all bare areas within the ditch until 70% of uniform coverage can be achieved.

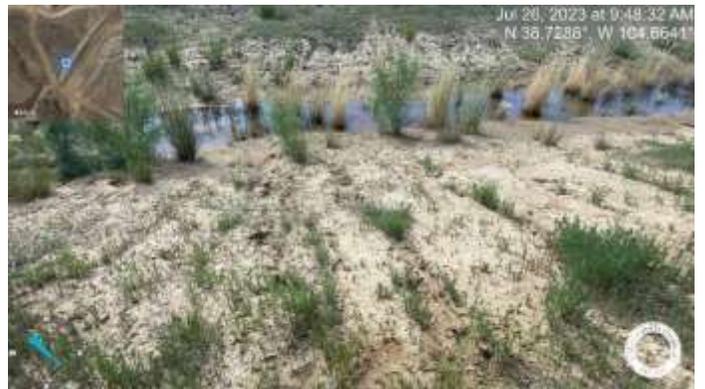
Photo 8: Northern Ditch: Vegetative growth does not show uniform coverage along ditch slopes. Stabilize all bare areas within the ditch until 70% of uniform coverage can be achieved.

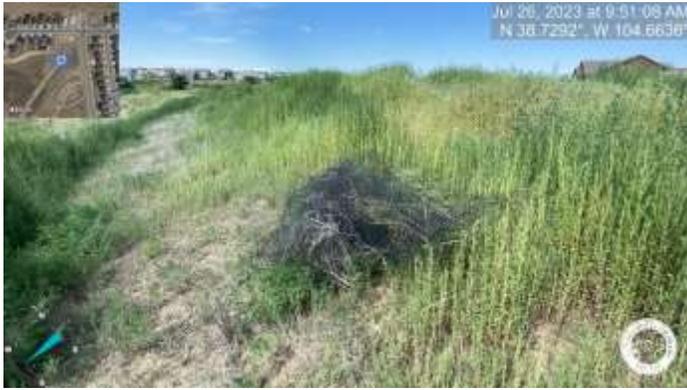
Photo 9: Northern Ditch: Remove and properly dispose of erosion control blanket netting.

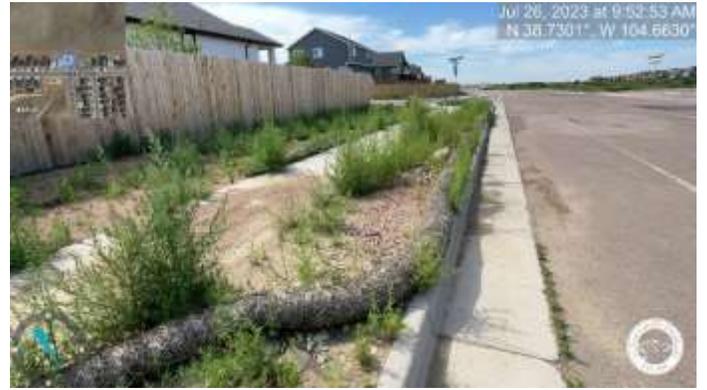
Photo 10: East end of Spring Glen Dr.: Remove temporary control measures.

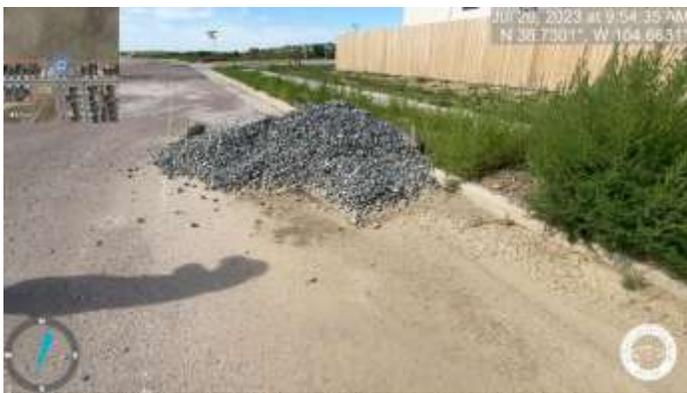
Photo 11: East end of Spring Glen: Remove gravel stockpile.

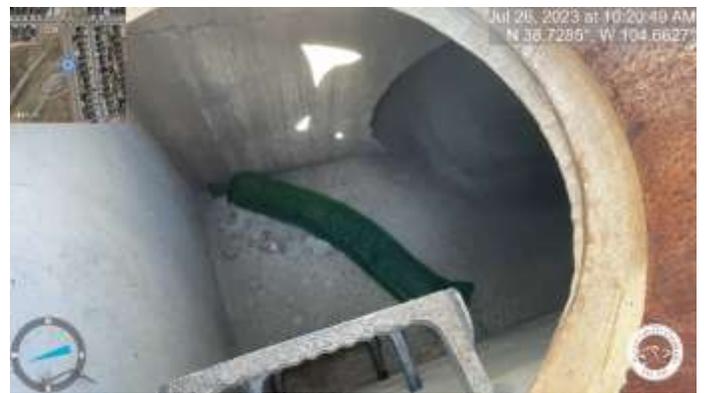
Photo 12: STA 10+89.58: Remove rock sock from inlet.

- Inlets that need to be cleaned of sediment and debris (marked with green dot):
  - STA 10+89.58 – Springs Glen Dr (see Photo 12)
  - STA 29+15.30 - corner of Golden Bluffs Dr. and Bigtooth Maple Dr (see Photo 14)

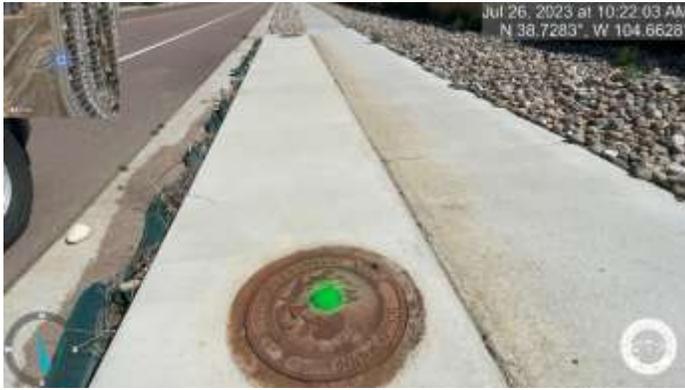
Photo 13: Example of marked inlet.

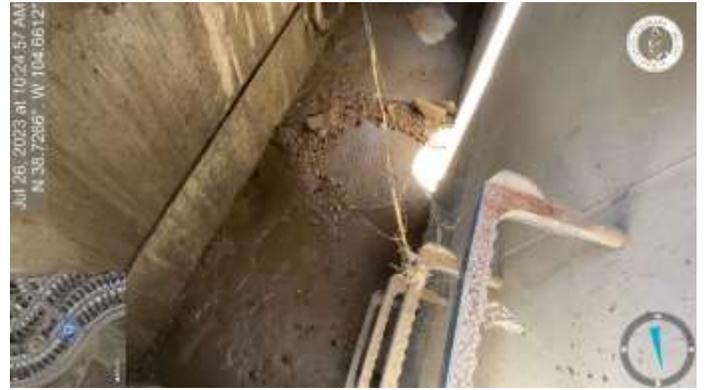
Photo 14: STA 29+15.30 (corner of Golden Bluffs Dr. and Bigtooth Maple Dr): Remove broken cinderblock from inlet.

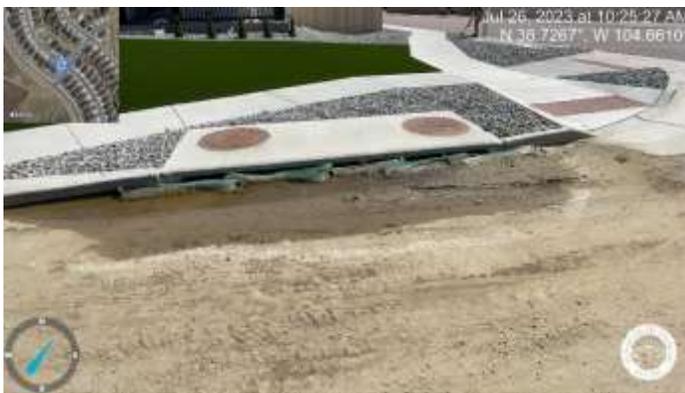
Photo 15: Corner of Golden Bluffs and Bigtooth Maple: Remove temporary inlet protections.

- Remove temporary inlet protections from inlets on the corner of Golden Bluffs Dr. and Peachleaf Dr (see Photo 16).
- Remove temporary inlet protections from inlets on the corner of Golden Bluffs Dr. and Bigtooth Maple Dr (see Photo 15).

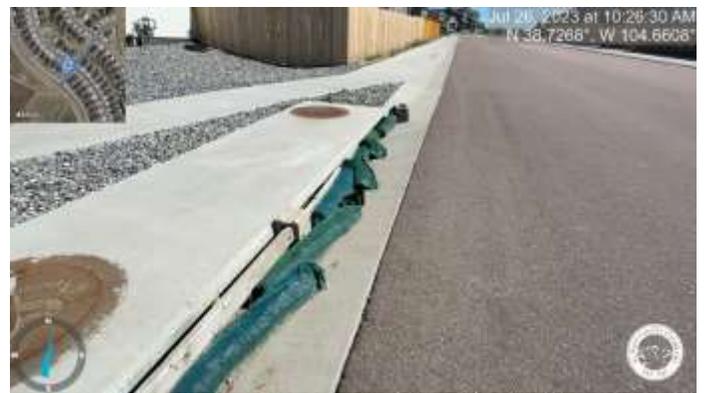
Photo 16: Golden Bluffs: Remove temporary inlet protections.

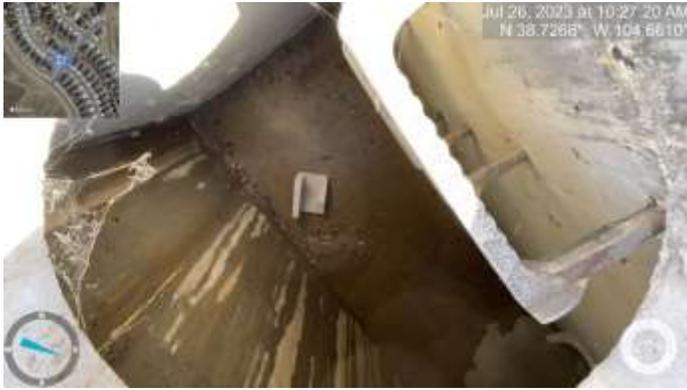
Photo 17: STA 25+81.56, 17.0'R (corner of Golden Bluffs Dr. and Peachleaf Dr): Remove broken cinderblock from inlet.

- STA 25+81.56, 17.0'R - corner of Golden Bluffs Dr. and Peachleaf Dr (see Photo 17)
  - STA 25+81.56, 17.0'L - corner of Golden Bluffs Dr. and Peachleaf Dr (see Photo 18)

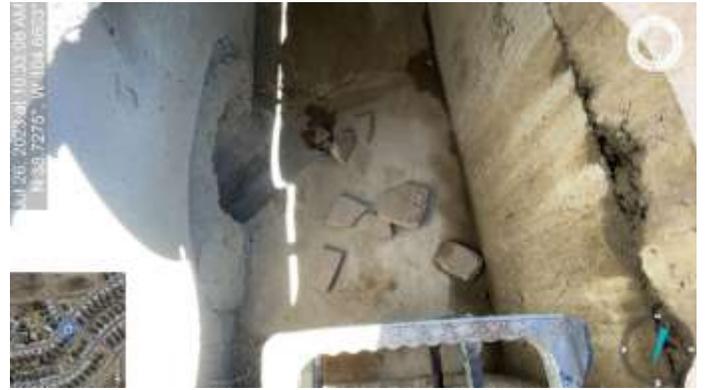
Photo 18: STA 25+81.56, 17.0'L (corner of Golden Bluffs Dr. and Peachleaf Dr): Remove broken cinderblock from inlet.

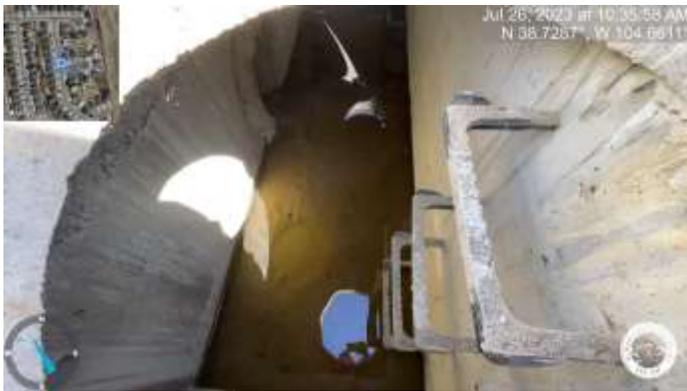
Photo 19: STA 34+60.06 (corner of Bee Balm Pl. and Peachleaf Dr.): Inlet is holding water. Remove standing water and fine grade to allow for positive drainage.

- STA 34+60.06 (corner of Bee Balm Pl. and Peachleaf Dr.): Inlet is holding water. Remove standing water and level with concrete to allow for positive drainage (see Photo 19 and 20).

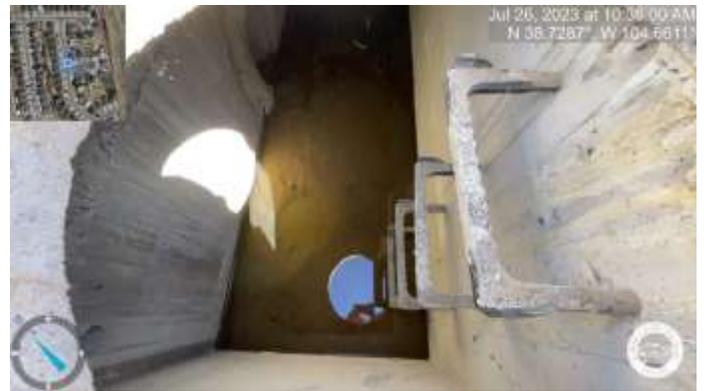
Photo 20: STA 34+60.06 (corner of Bee Balm Pl. and Peachleaf Dr.): Inlet is holding water. Remove standing water and fine grade to allow for positive drainage.

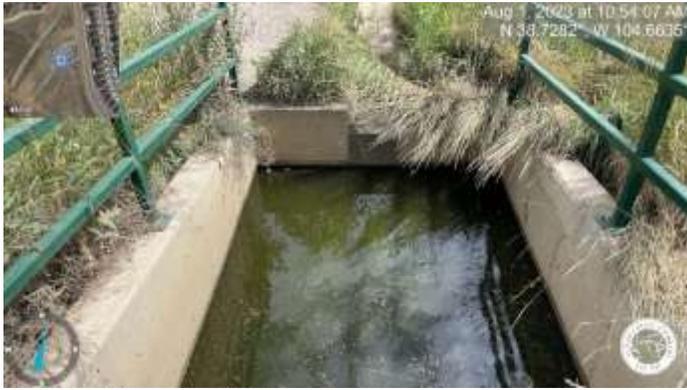
Photo 21: Pond: Micropool is not adequately holding water. Implement solution to seal orifice plate to prevent leaking.

- Micropool is not adequately holding water. Implement solution to seal orifice plate to prevent leaking (see Photos 21 and 22).

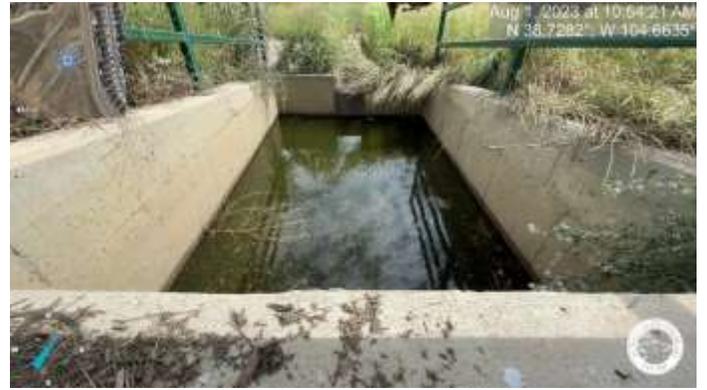
Photo 22: Micropool is not adequately holding water. Implement solution to seal orifice plate to prevent leaking.
