January 22, 2021

ENTECH
ENGINEERING, INC.

Re: Soil, Geology, and Geologic Hazard Study
Bradley Point Filing No. 1
Parcel Nos. 65034-00-038 and 65034-00-040
El Paso County, Colorado

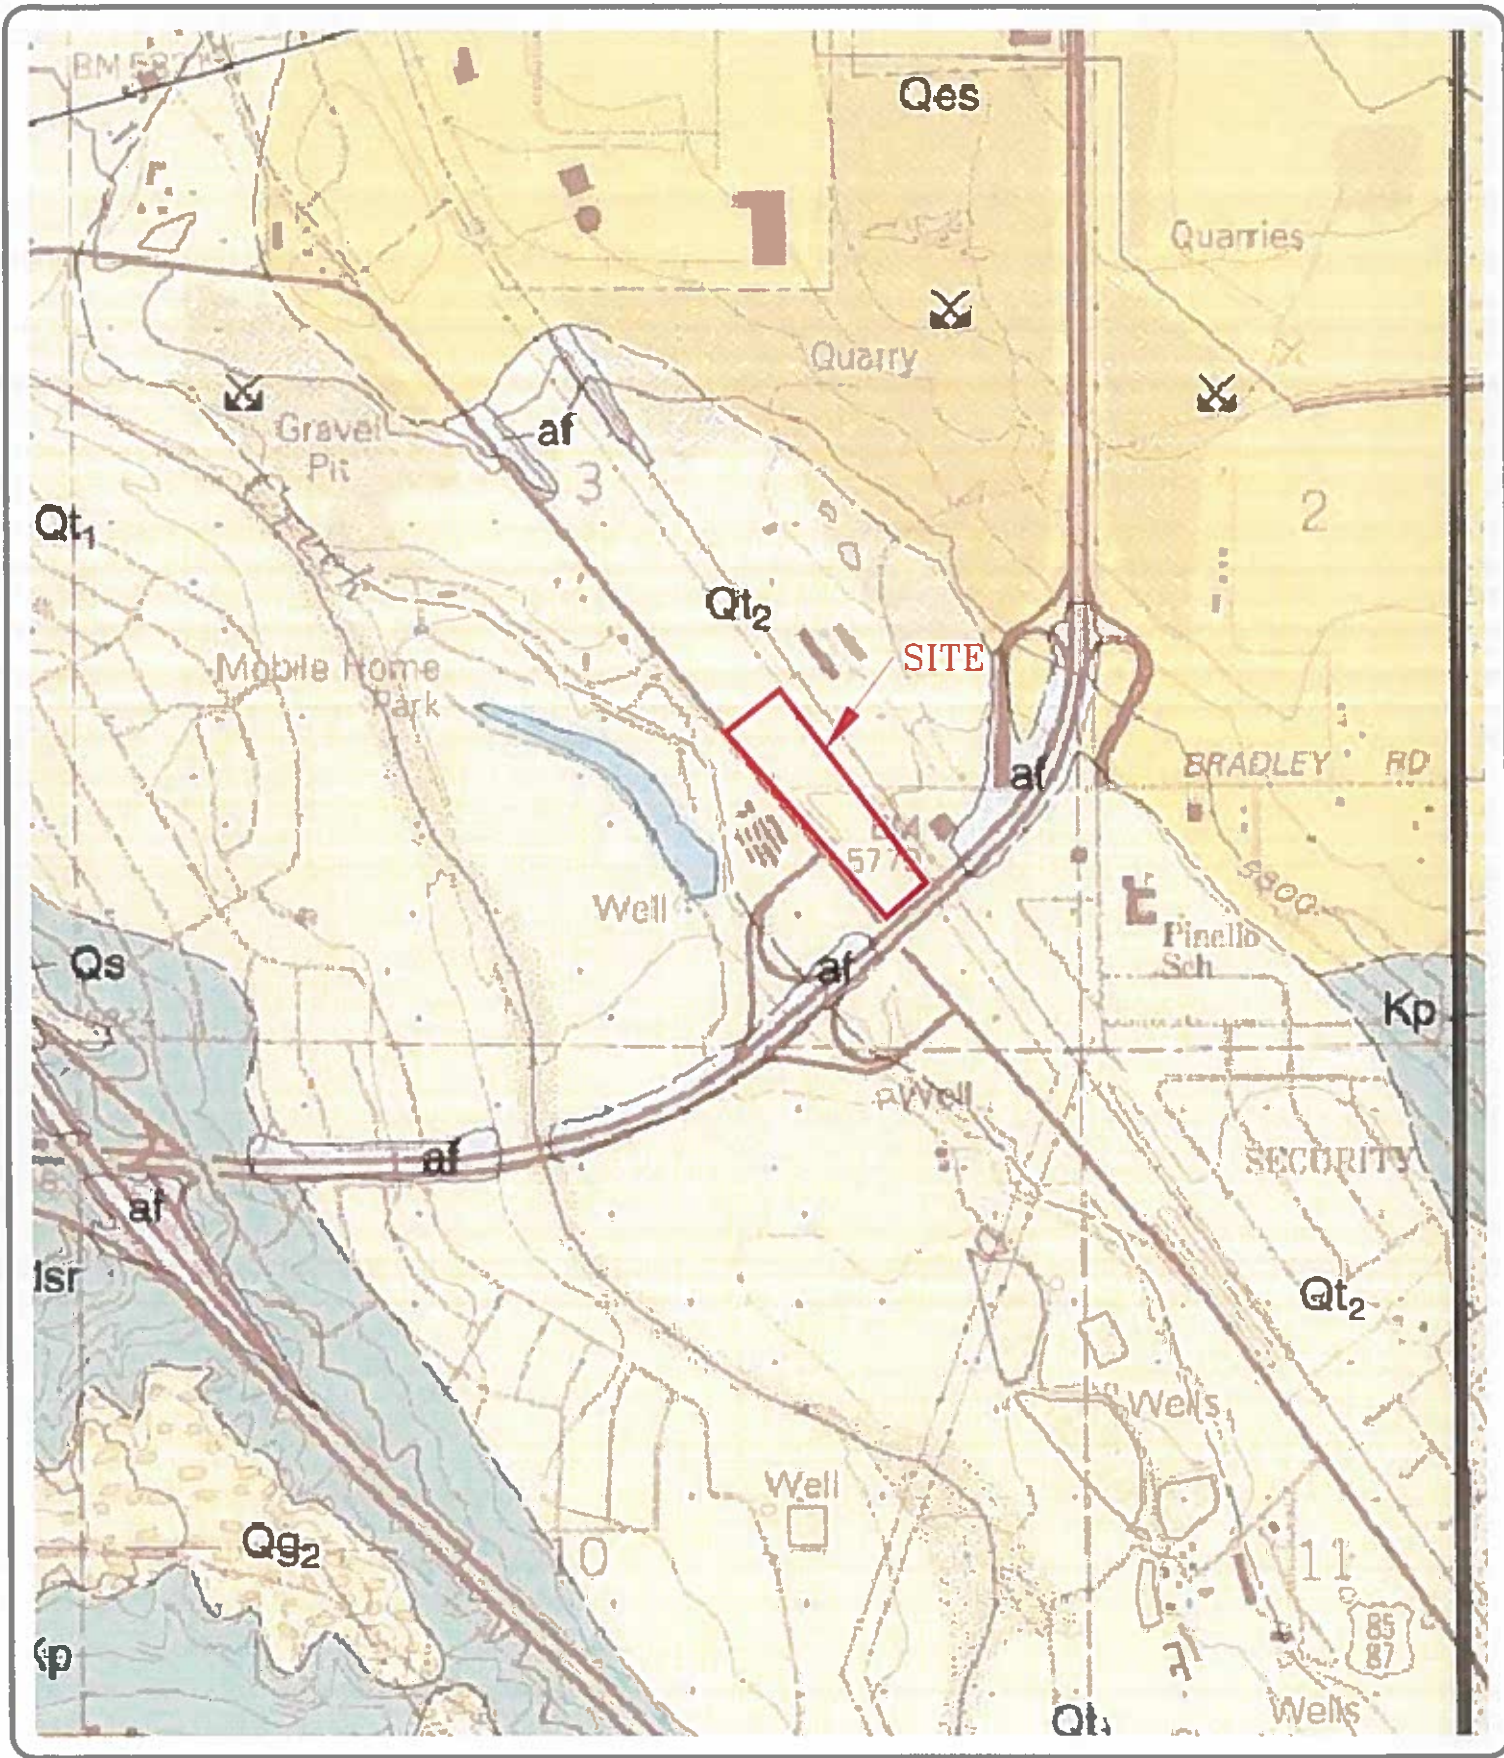
COLORADO SPRINGS QUADRANGLE
GEOLOGY MAP
BRADLEY POINT FILING 1
EL PASO COUNTY, CO.
FOR: HIGHWAY 85-87 PROPERTIES, LLC

The geology of the site was evaluated using the *Geologic Map of the Colorado Springs Quadrangle*, by Carroll and Crawford in 2000, (Reference 4, Figure 5). The Geology Map for the site is presented in Figure 6. Two mappable units were identified on this site which are described as follows:

Qaf Artificial Fill of Quaternary Age: These are man-made fill graded across portions of the site. The fill materials encountered in the test borings and observed on site consisted of slightly silty to silty sands at a depth of 3 feet. Areas of deeper fill could be encountered.

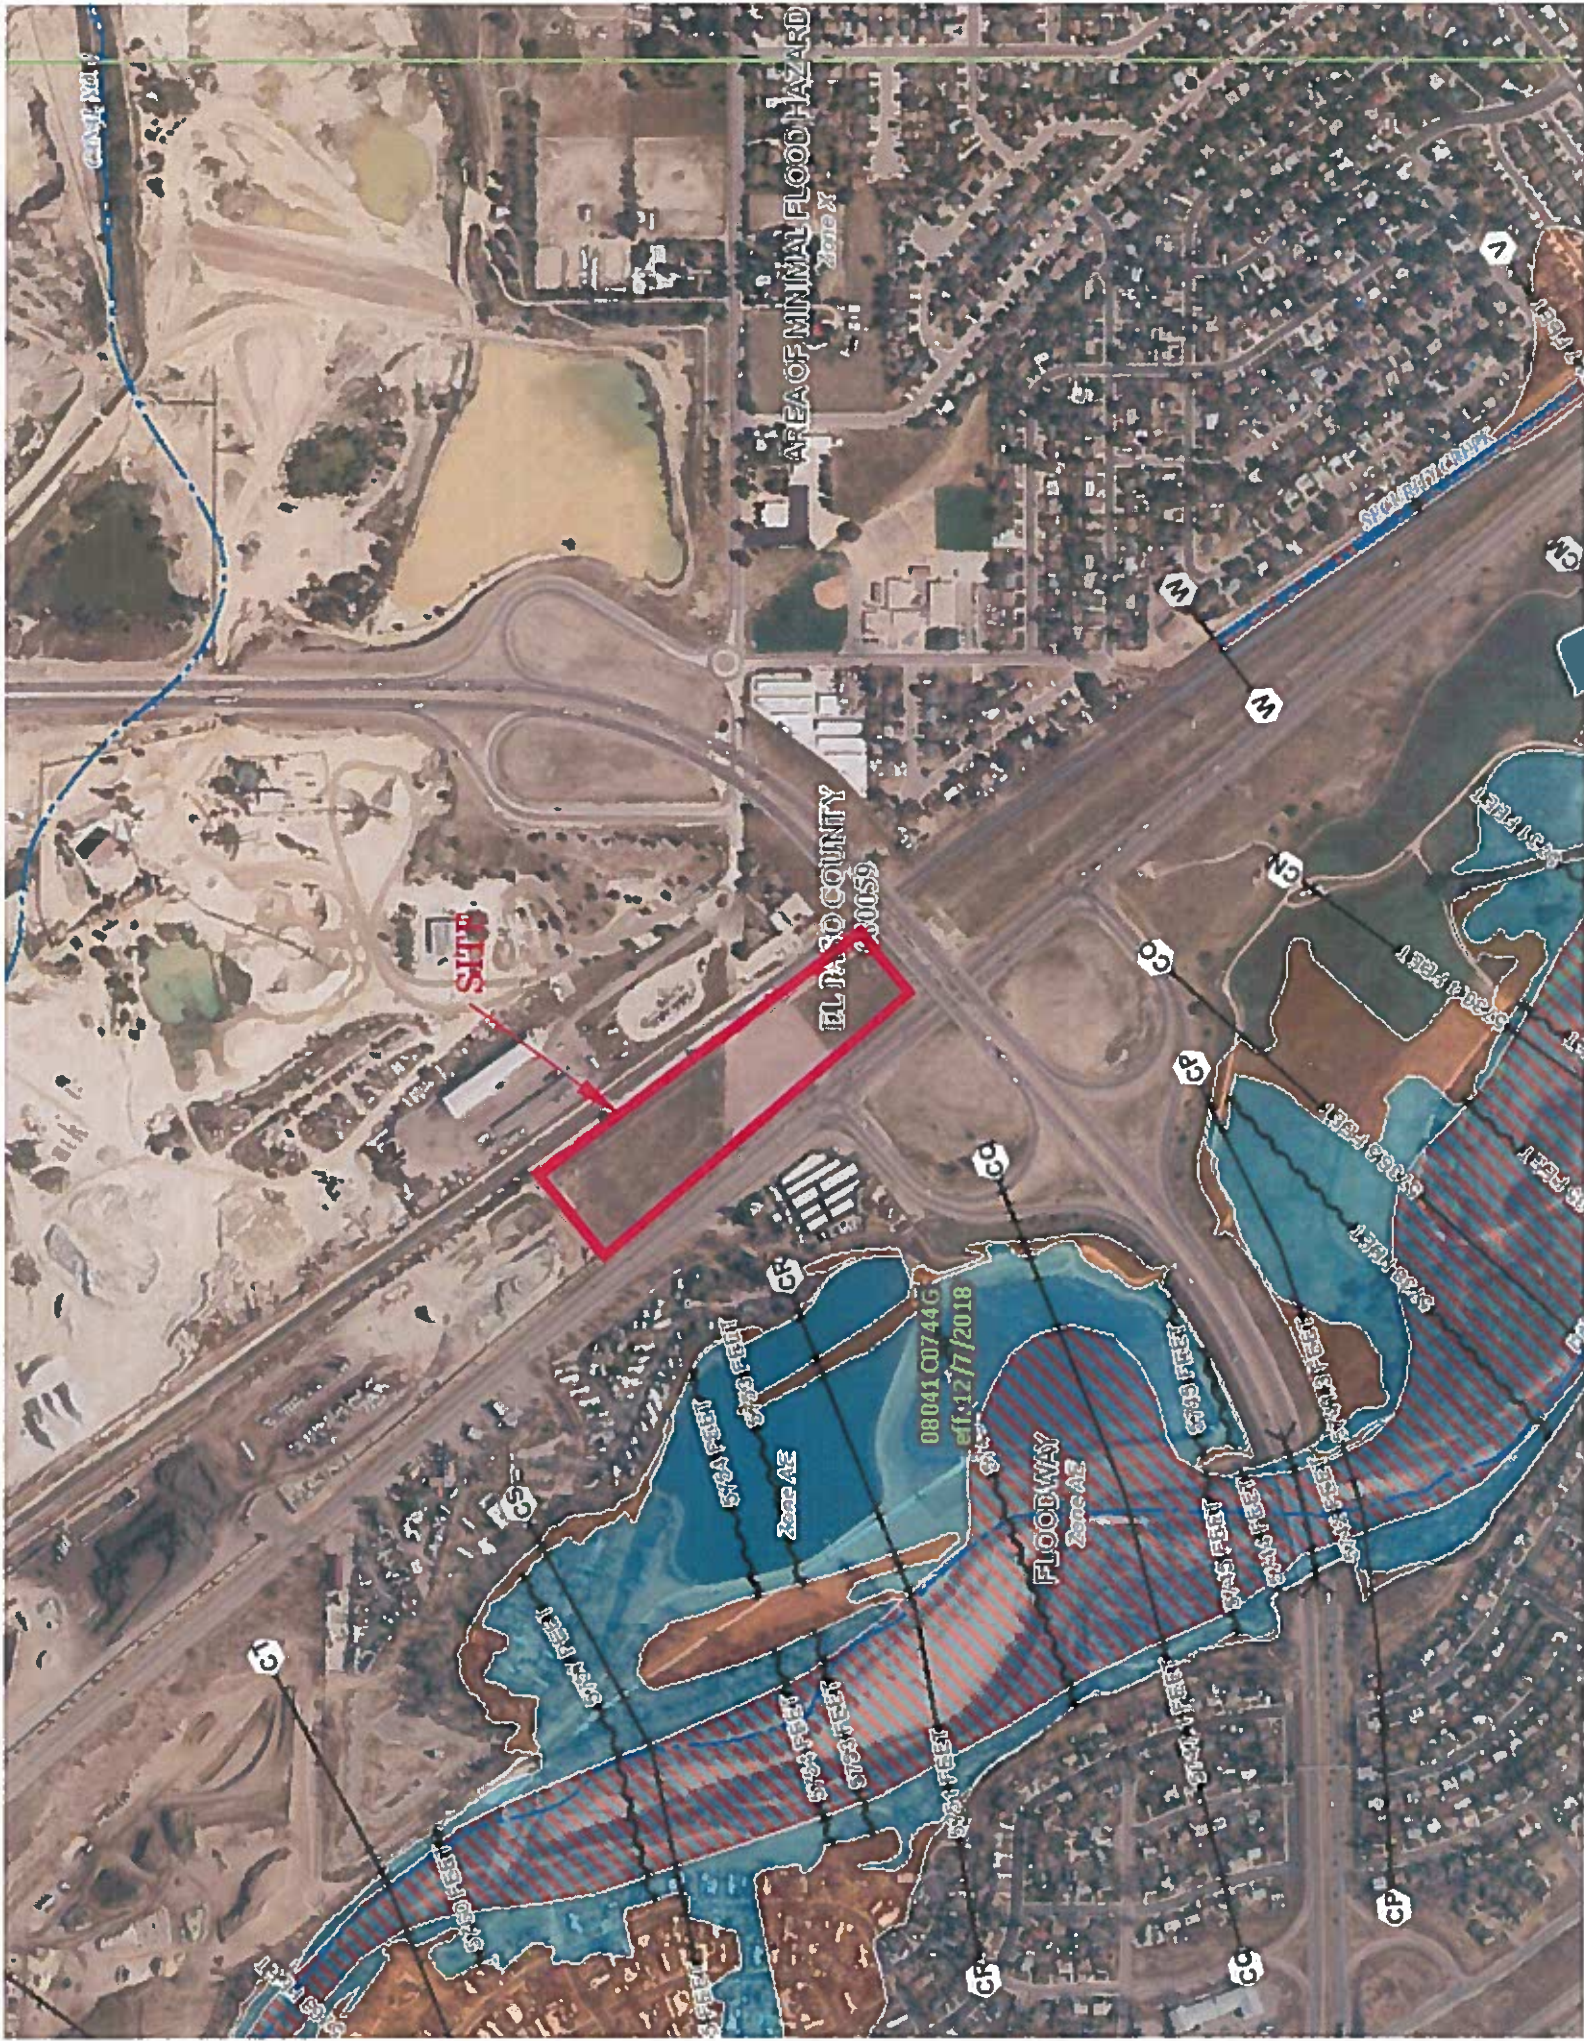
FLOODPLAIN MAP
BRADLEY POINT FILING 1
EL PASO COUNTY, CO.
FOR: HIGHWAY 85-87 PROPERTIES, LLC

No drainages were observed on the site and the site does not lie within any floodplain zones according to the FEMA Map No. 08041CO744G dated December 7, 2018 (Figure 7, Reference 7). Exact locations of floodplain and specific drainage studies are beyond the scope of this report.

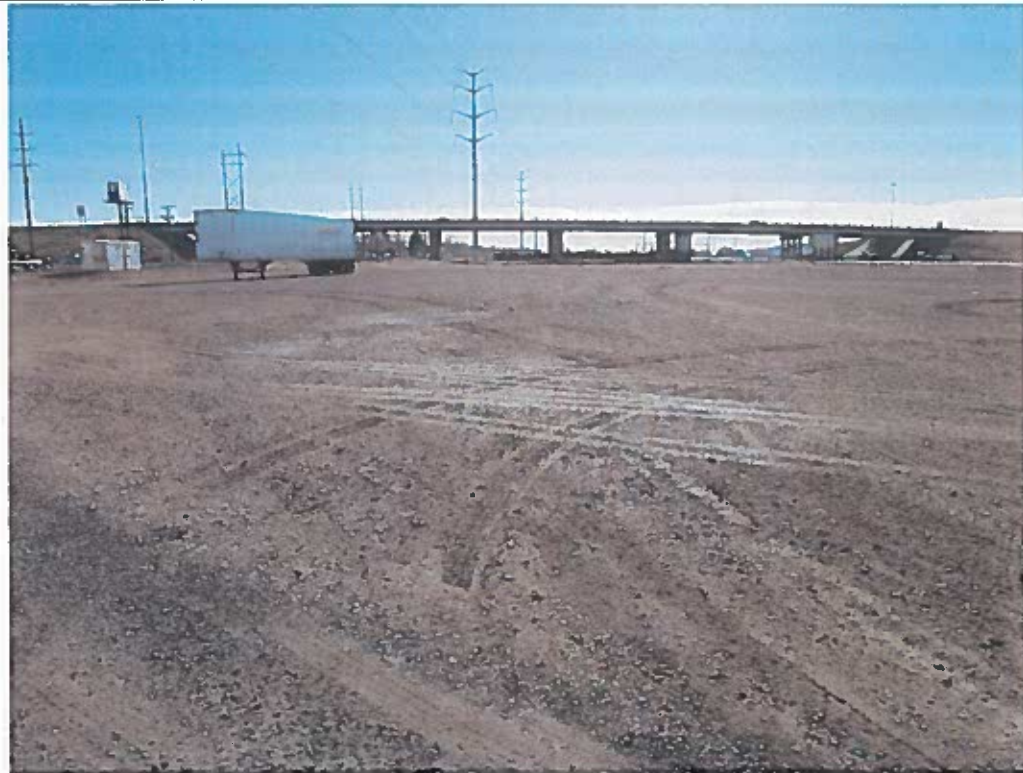
**Looking south from
central portion of the
site.**

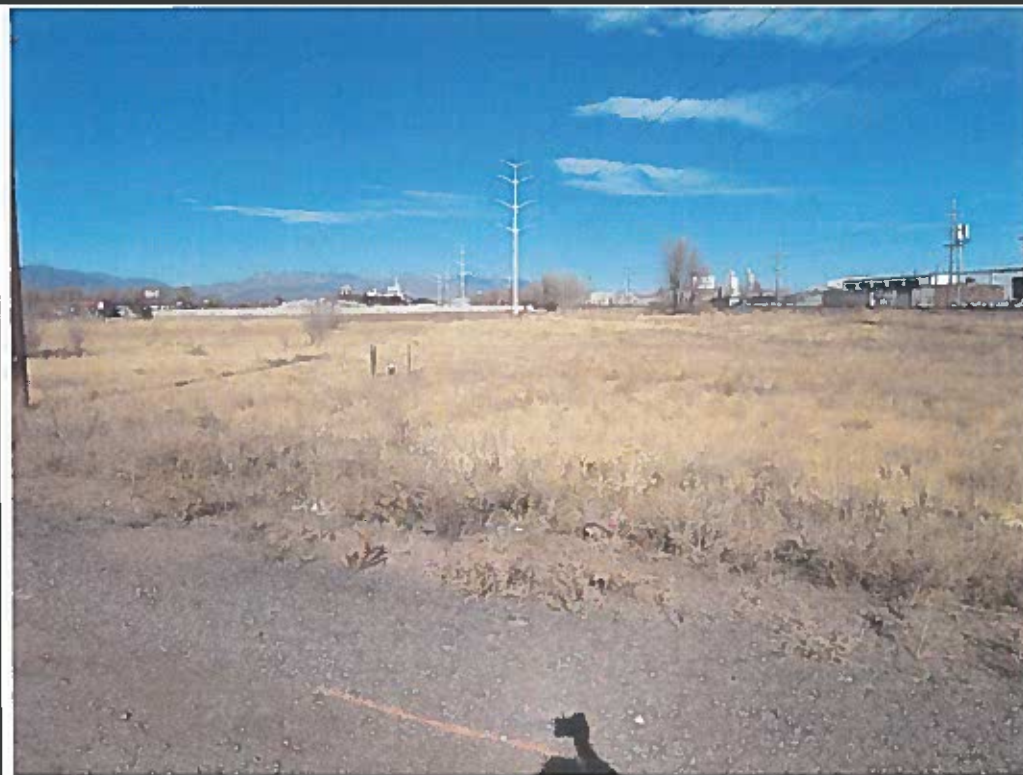
**Looking north from
central portion of the
site.**
