**PRELIMINARY SOIL, GEOLOGY, GEOLOGIC HAZARD,
AND WASTEWATER STUDY,
MCCUNE RANCH SUBDIVISION
PARCEL NO. 51000-00-493
17480 MERIDIAN ROAD NORTH
EL PASO COUNTY, COLORADO**

Proterra Properties, LLC
1864 Woodmoor Drive, Suite 100
Monument, Colorado 80132

October 2, 2018

Entech Job No. 181459
AAprojects/2018/181459 countysoil/geo/ww

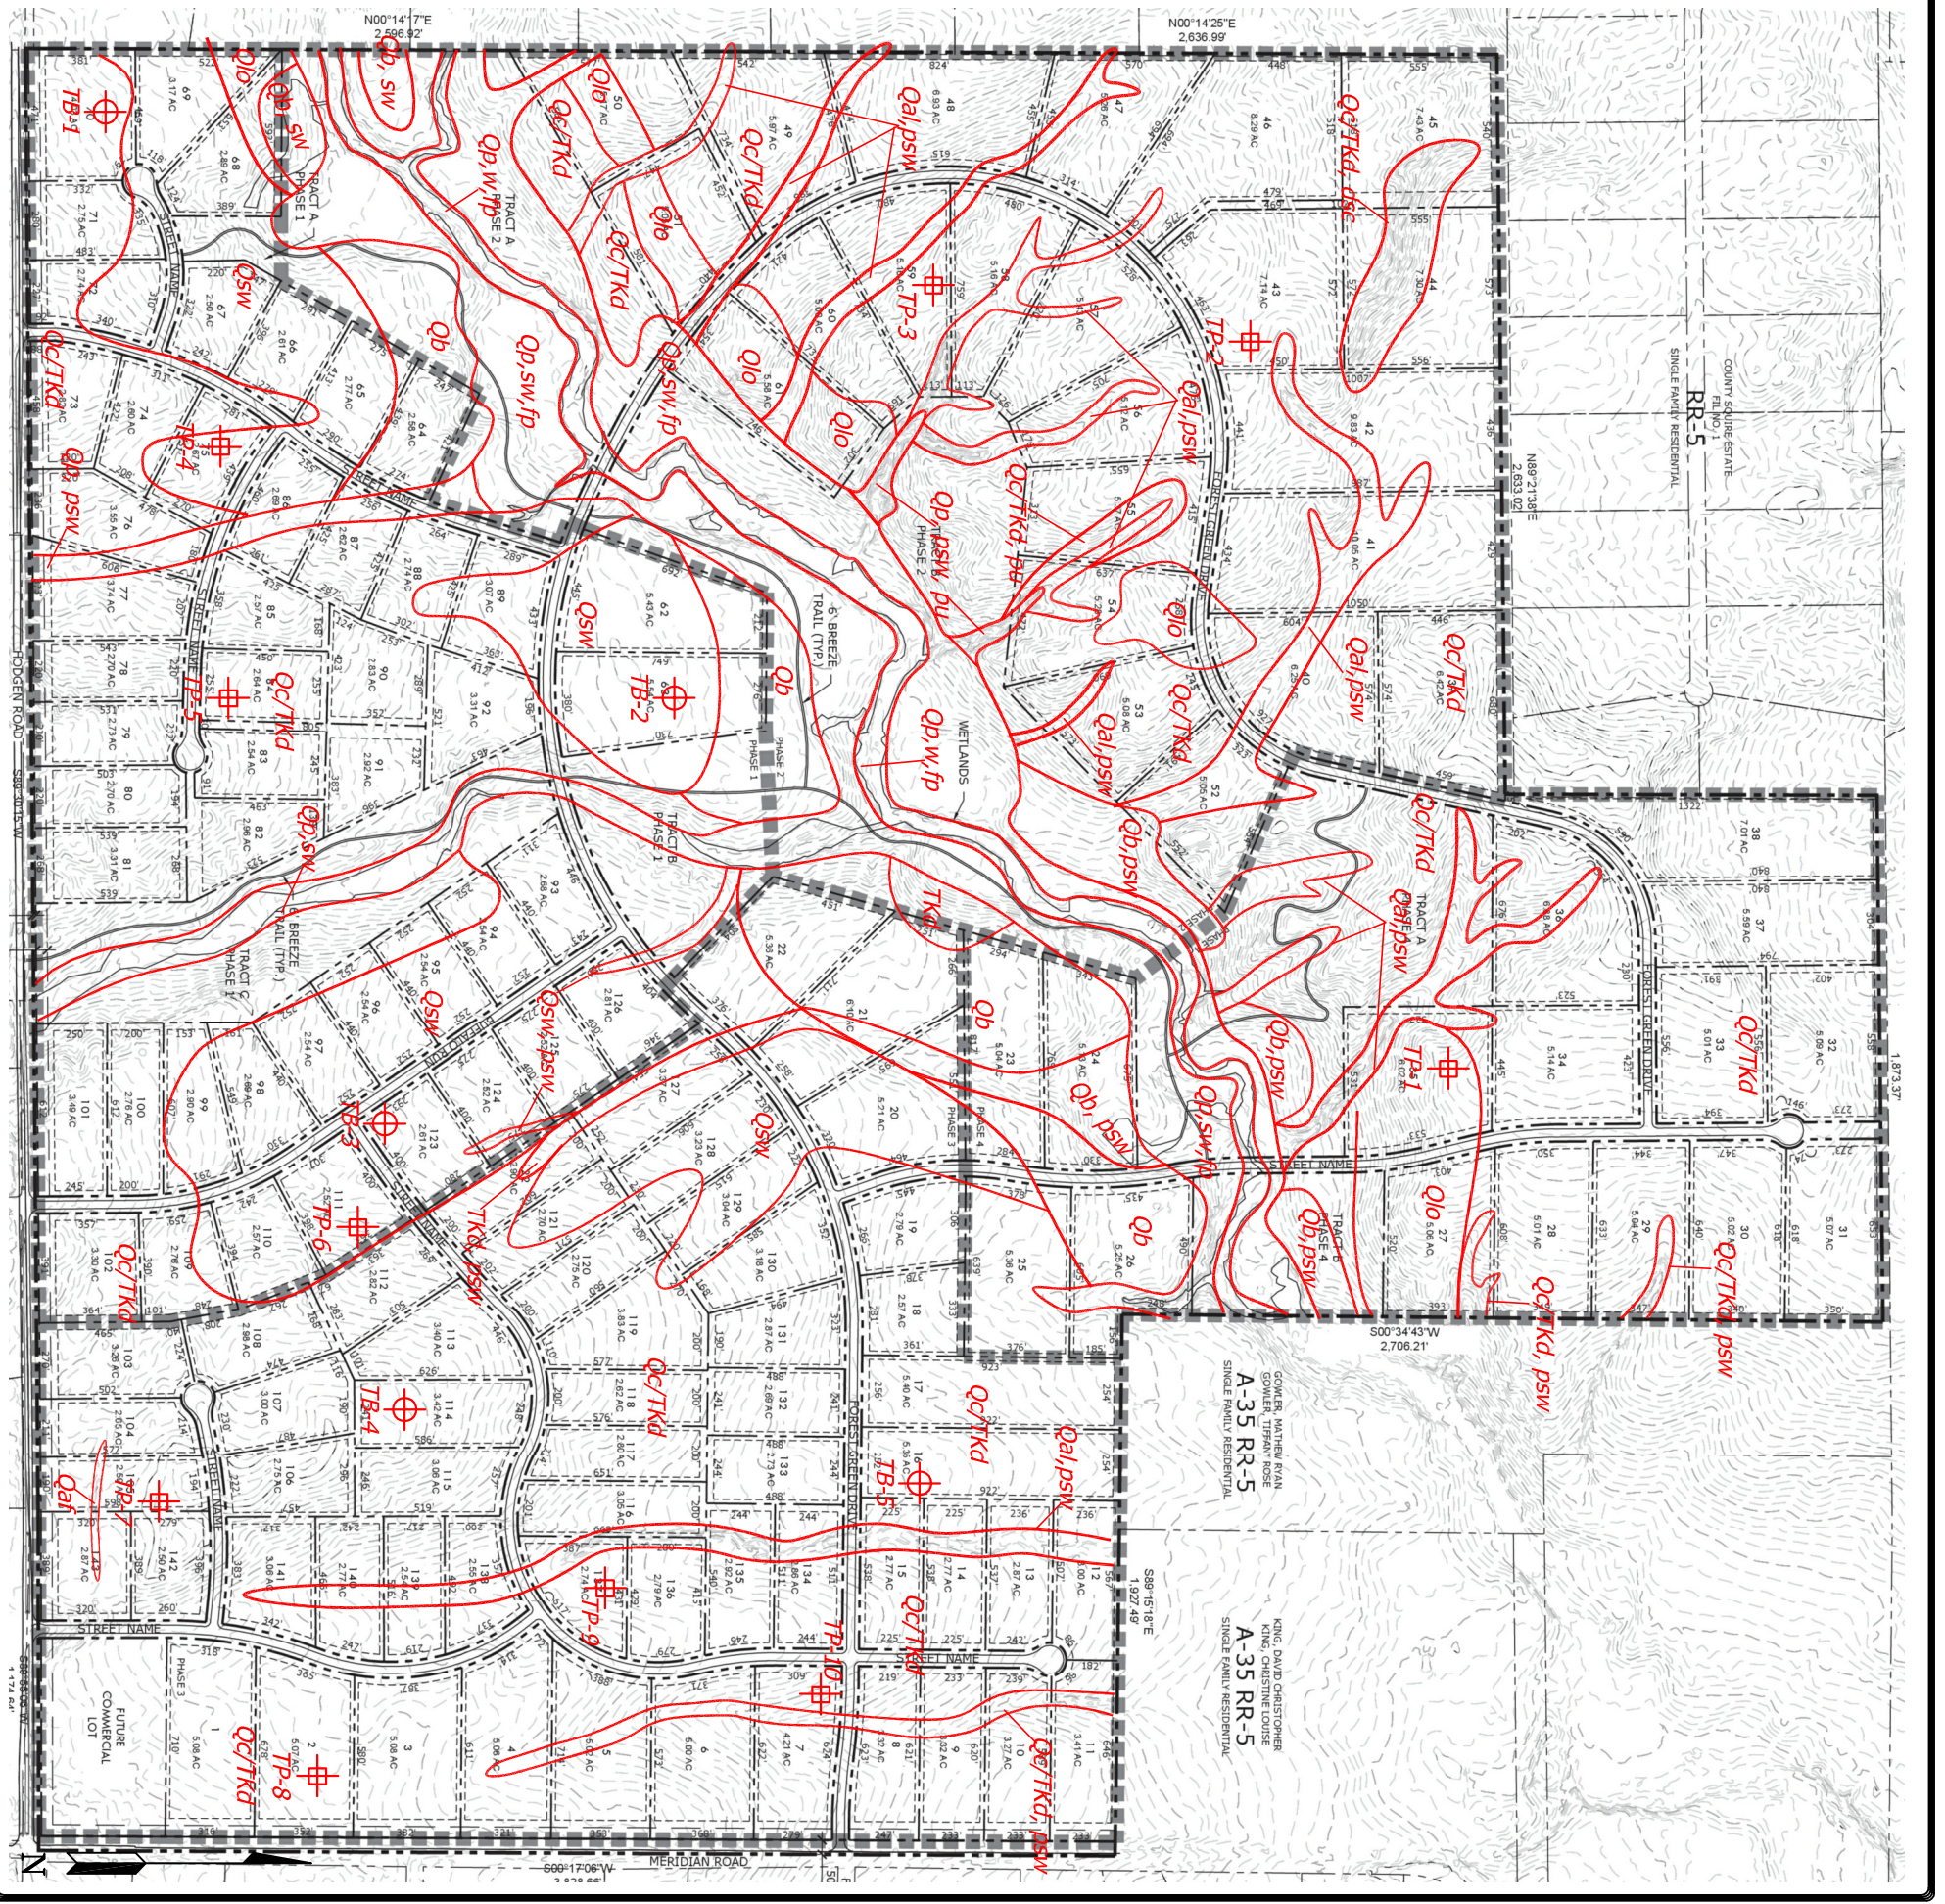
DATE	9/21/18
SCALE	AS SHOWN
JOB NO.	181459
FIGURE NO.	6

As mentioned previously, detailed mapping has been performed on this site to produce an Geology/Engineering Geology Map (Figure 6). This map shows the location of various geologic conditions of which the developers should be cognizant during the planning, design and construction stages of the project. These hazards and the recommended mitigation techniques are as follows:

The majority of the slopes in the building areas on site are gently to moderately sloping and do not exhibit any past or potential unstable slopes or landslides. However, the steeply sloping areas along the drainage in the central portion of the site have been identified as potentially unstable slopes. Additionally, areas of downslope creep have been mapped on the site. These areas are identified on the Geology/Engineering Geology Map, Figure 6. The recommendations for these areas are as follows:

The area identified with this hazard is located along a portion of a minor drainage where cut banks have created potentially unstable slopes. Considerable care must be exercised in these areas not to create a condition which would tend to activate instability.

The areas identified with this hazard includes some of the steeper slopes on site, particularly in the northwest portion of the site. In these areas, we would anticipate lateral and vertical movement of the near surface soils in the downslope direction. These areas are acceptable as building sites with the following constraints on construction.

Mitigation: Building should be avoided in these areas. The lot most significantly affected by potentially unstable slopes is Lot 55. The structures on these lots should be set back a minimum of 30 feet from the crest of these slopes. It appears there is sufficient room on the lots to avoid this hazard. Proper control of drainage at both the surface above the slope and the subsurface is extremely important. Areas of ponded water at the surface should be avoided. Utility trenches, basement excavations and other subsurface features should not be permitted to become water traps which may promote saturation of the subsurface materials. Drainage should not be permitted over the potentially unstable slope but directed in a non-

Mitigation: Building is possible in these areas if the following engineering and construction mitigation steps are taken: This type of movement will increase lateral pressures against foundation walls on the uphill side of structures. The design of foundations in these areas should account for this additional pressure. Additionally, the foundation should be designed to withstand pressures where steeper areas slope away from the foundation. Tie beams and buttresses are recommended to stiffen the foundation system.

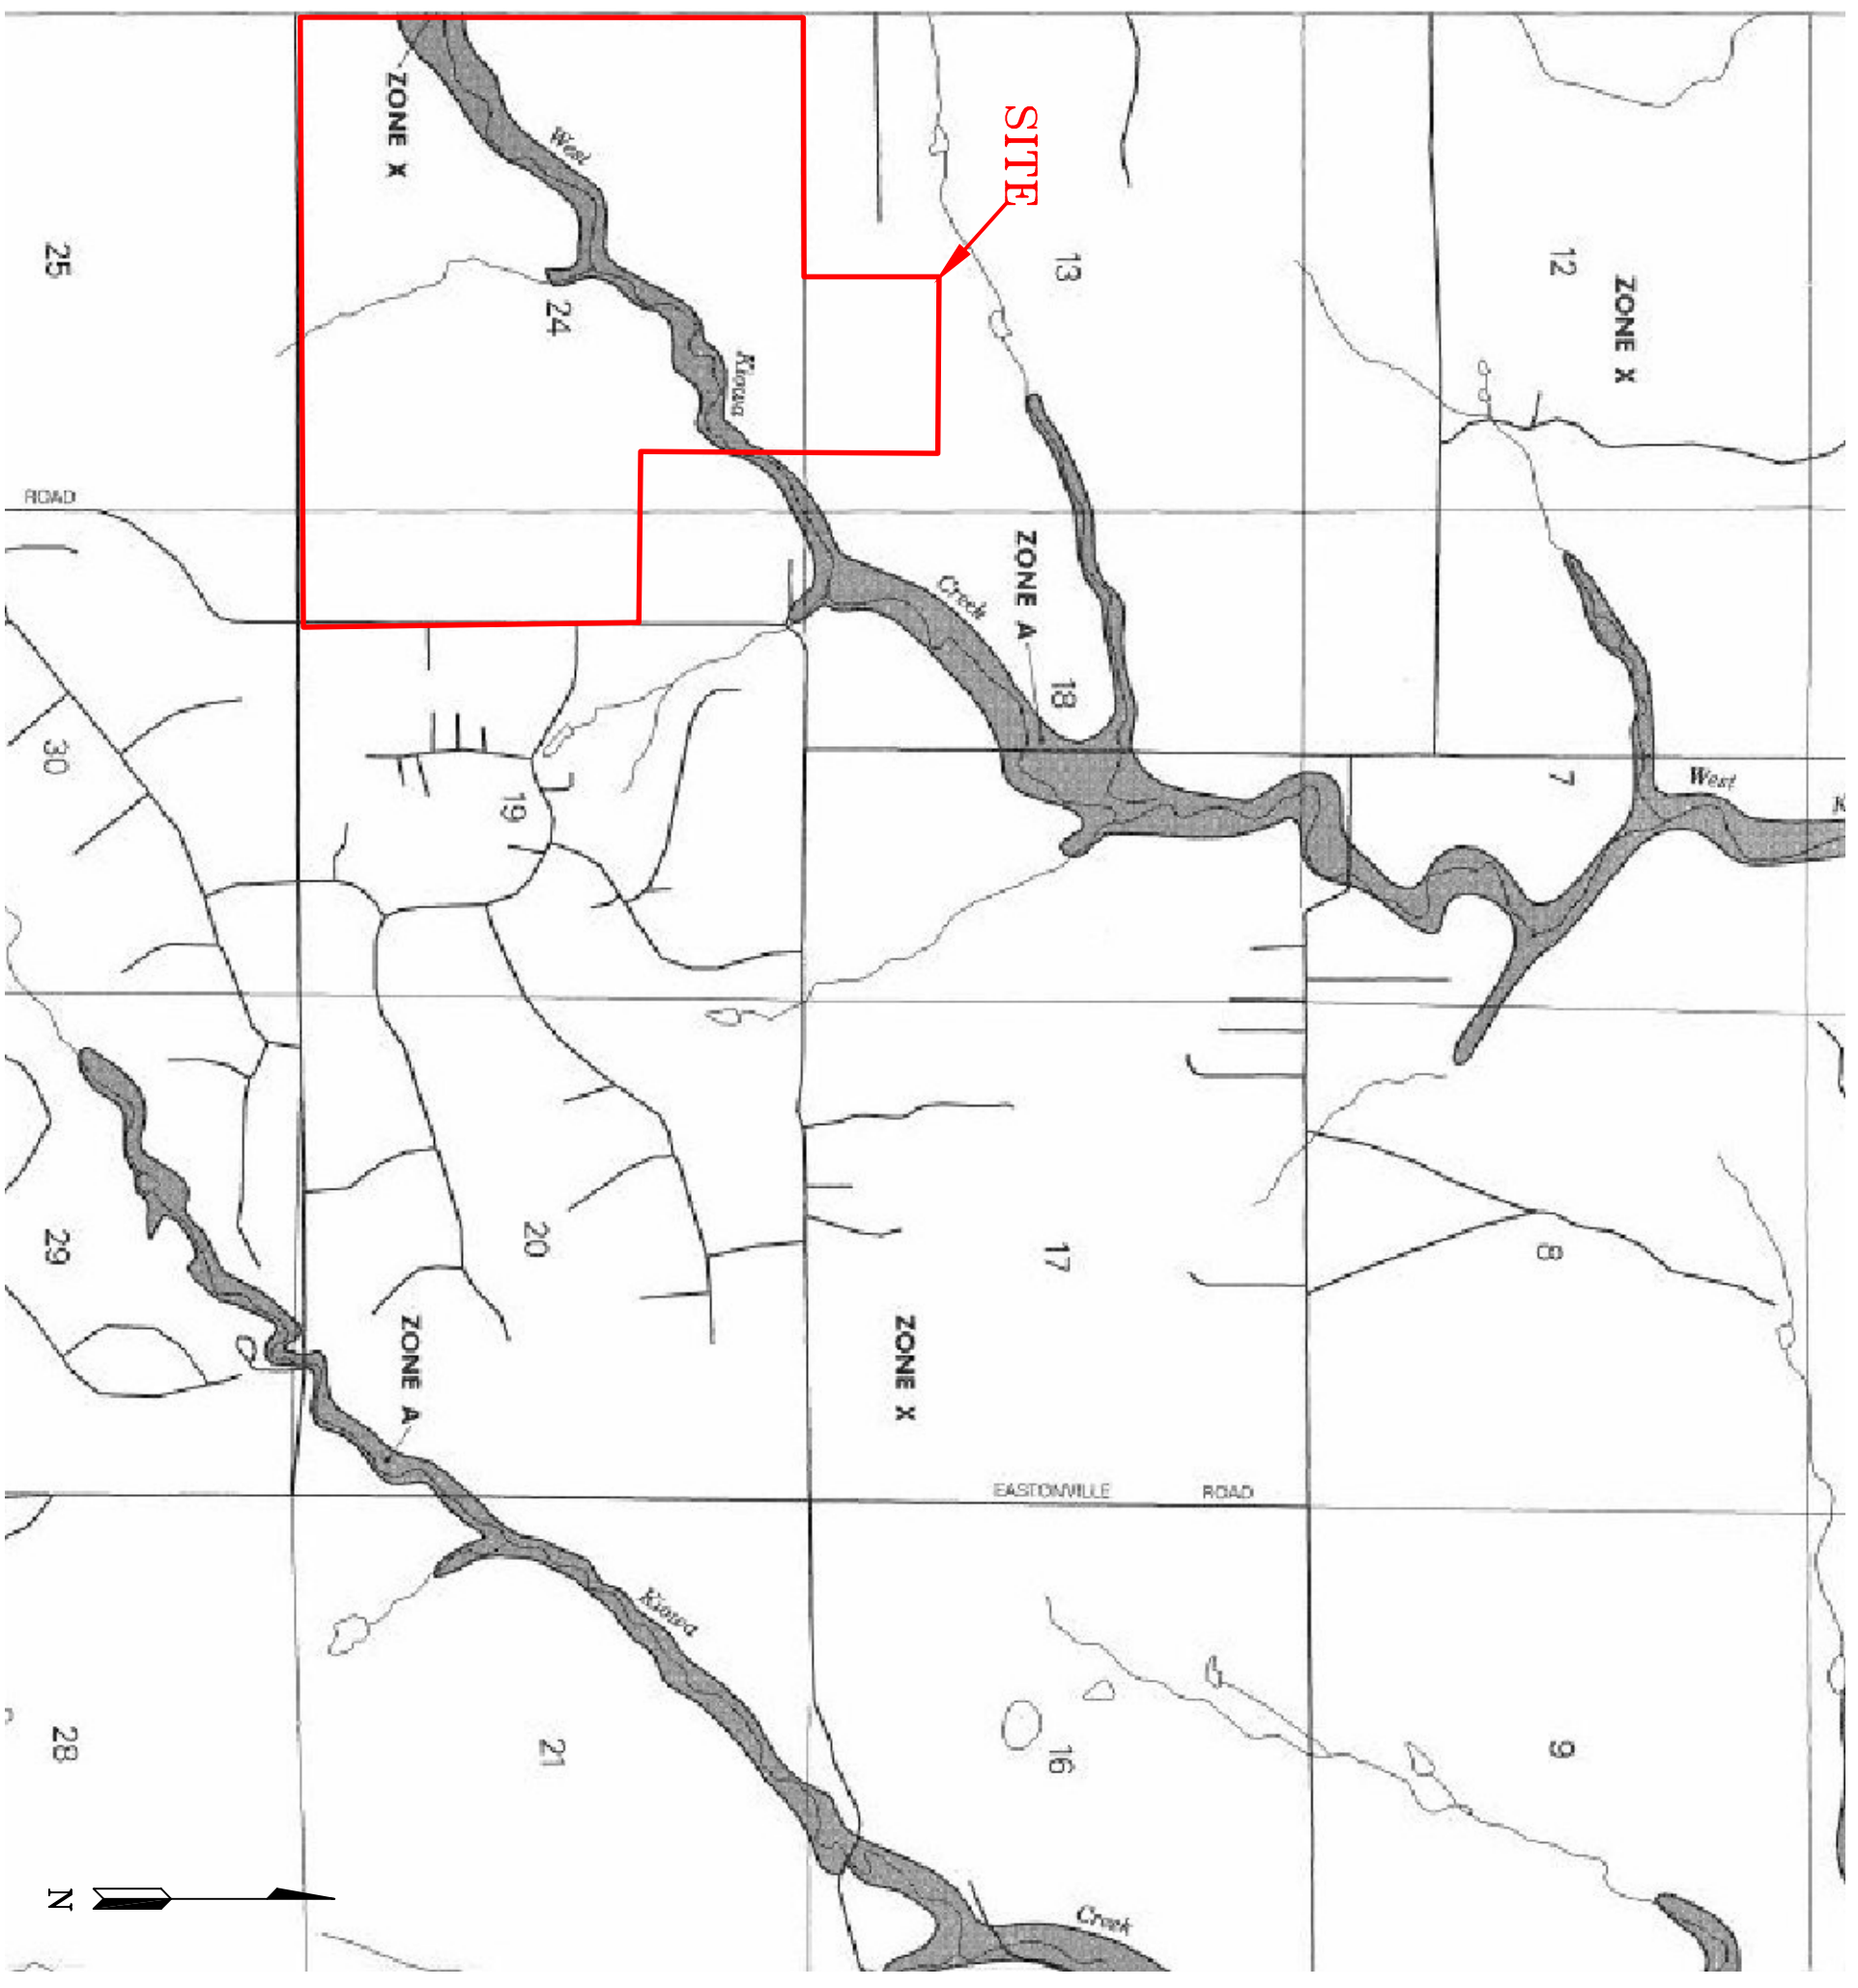
FLOODPLAIN MAP
MCCUNE RANCH SUBDIVISION
 17480 MERIDIAN ROAD NORTH
 EL PASO COUNTY, CO.
 FOR: PROTERRA PROPERTIES, LLC

Portions of the site associated with the West Kiowa Creek drainage are mapped within a floodplain zone according to the FEMA Map No. 08041CO350F, dated March 17, 1997 (Figure 7, Reference 6). Water was observed flowing in West Kiowa Creek. The floodplain areas have been designated as open space and/or can be avoided by construction. Additionally, areas of seasonal and potentially seasonal shallow groundwater were observed across the site. In these areas, we would anticipate the potential for periodically high subsurface moisture conditions and frost heave potential. These areas lie within low-lying areas along the drainage in the southeastern portion of the site and in the low-lying areas and minor drainages across the site. Water was not observed in any of the minor drainages at the time of our site investigation. These areas can likely be avoided or properly mitigated by development. The floodplain should be avoided by construction unless site-specific floodplain determination and drainage studies are performed. The potential exists for high groundwater levels during high moisture periods and should structures encroach on these areas the following precautions should be followed.

Mitigation: Foundations must have a minimum 30-inch depth for frost protection. In areas where high subsurface moisture conditions are anticipated periodically, subsurface perimeter drains are recommended to help prevent the intrusion of water into areas below grade. Typical drain details are presented in Figure 8. Some of the minor drainage swales can be avoided or regraded. The main drainage that bisects the site is designated as open space and will be avoided. Any grading in these areas should be done to direct surface flow around construction to avoid areas of ponded water. Finished floors must be located at least one foot above floodplain levels. Specific drainage studies and exact floodplain locations are beyond the scope of this report.

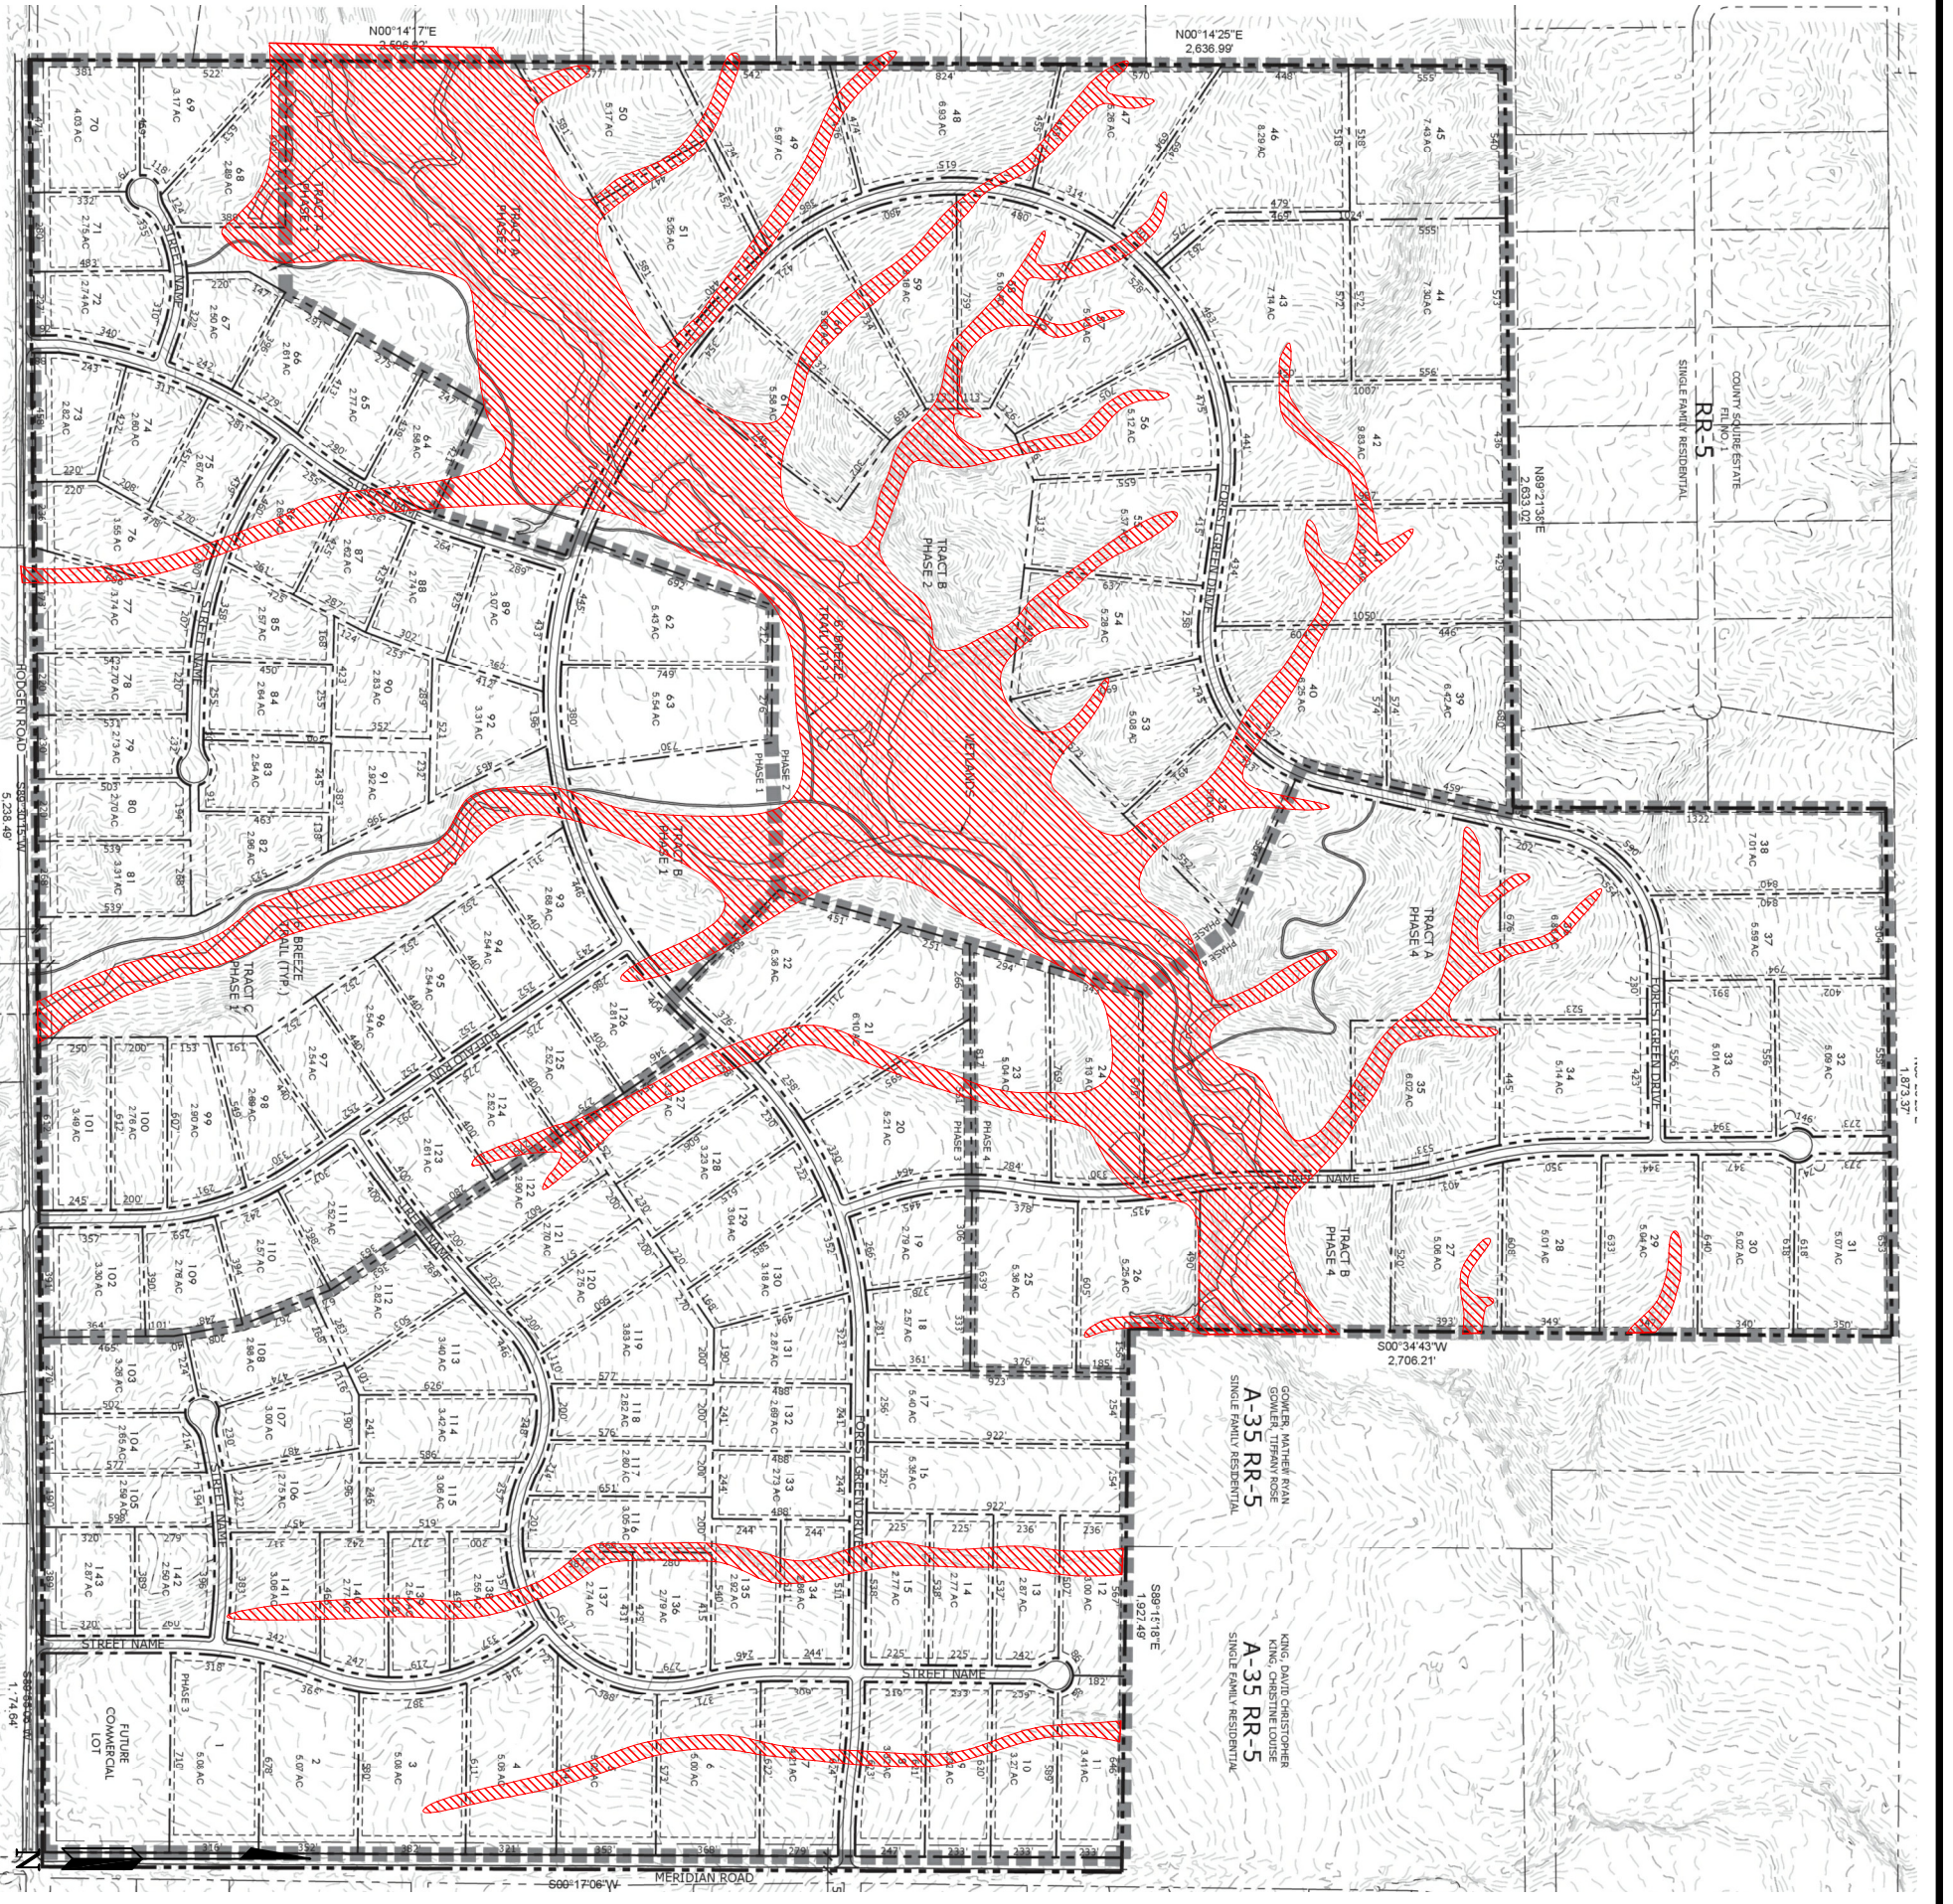
DATE	9/27/18
SCALE	AS SHOWN
JOB NO.	181459
FIGURE NO.	9

Soils encountered in the tactile test pits consisted of loamy sand, sandy clay loam and sandy clay. Bedrock was not encountered in the test pits which were excavated to 7 to 8 feet. The limiting layers encountered in the test pits are the sandy loam (Soil Type 2), and sandy clay (Soil Type 4A) which corresponds to LTAR values of 0.80 to 0.15 gallons per day per square foot. The conditions encountered in the Test Pit Nos. 1 through 4 and 6 through 8 will require a designed system. Additional investigation may identify areas where suitable for conventional systems could be used.

In summary, it is our opinion the site is suitable for individual on-site wastewater treatment systems (OWTS) and that contamination of surface and subsurface water resources should not occur provided the OWTS sites are evaluated and installed according to El Paso County and State Guidelines and properly maintained. Based on the testing performed as part of this investigation designed systems will likely be required for the majority of the lots. A Septic Suitability Map is presented in Figure 9. Areas where OWTS sites are not recommended are indicated on Figure 9. Individual soil testing is required on the lots prior to construction. Absorption fields must be located a minimum of 100 feet from any well, including those on adjacent properties. Absorption fields must also be located a minimum of 50 feet from any drainages, floodplains or ponded areas and 25 feet from dry gulches.

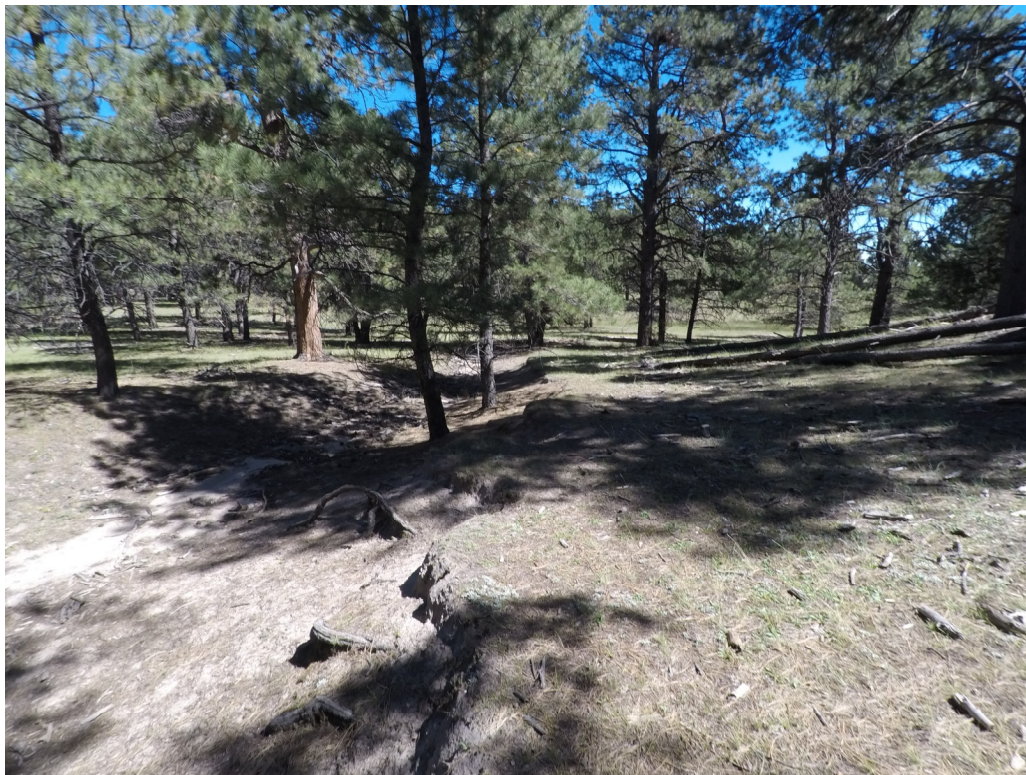
Looking east along drainage in the northern portion of the site.

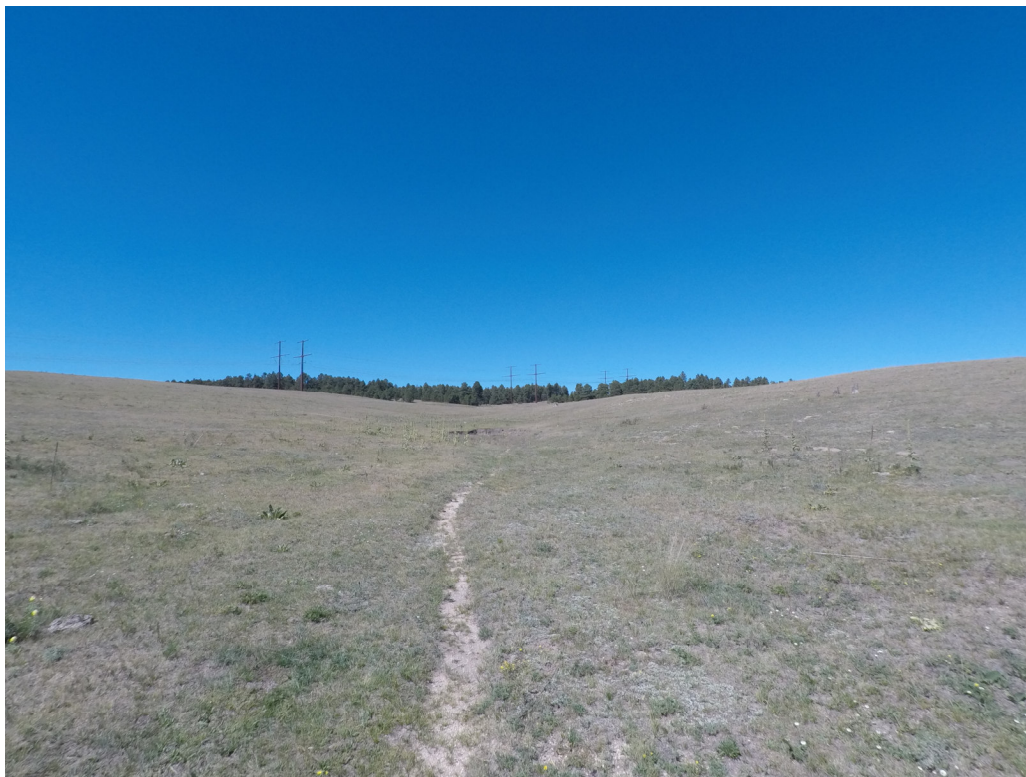
**Looking north along
small drainage in the
western portion of the
site.**

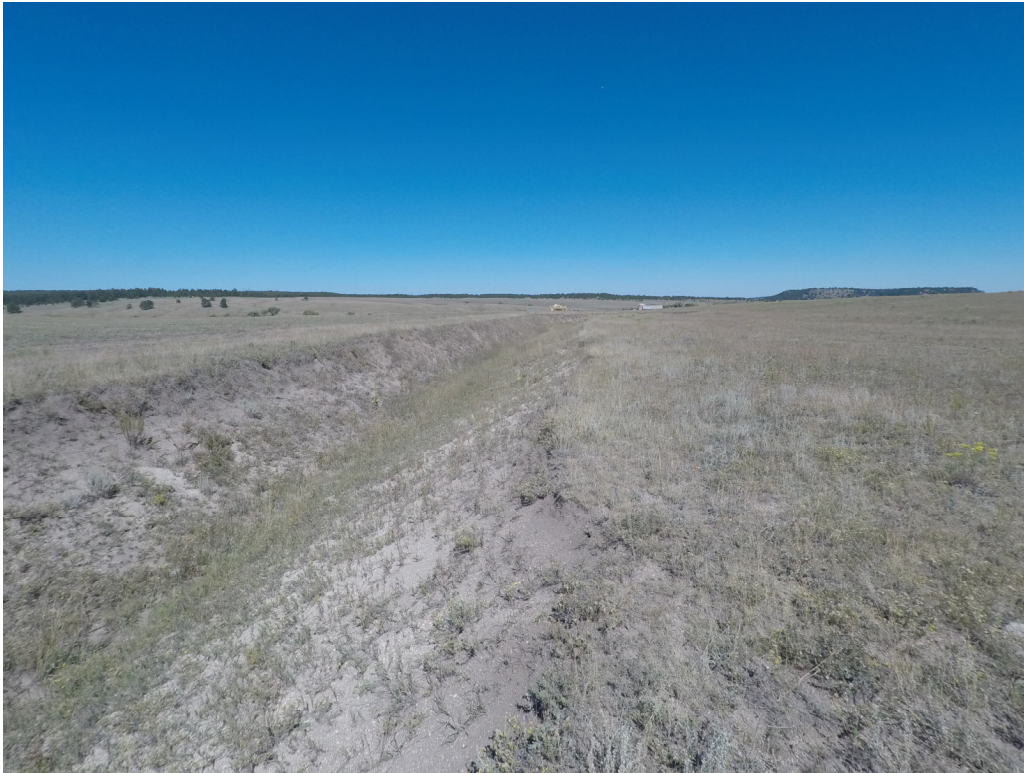
**Looking north along
drainage in the
northeastern portion of
the site.**
