April 17, 2026

**ENTECH**  
ENGINEERING, INC.

Re: **Geologic Hazard Review – Revised No-Build Line**  
4619 Redstone Ridge Road – Guest House  
El Paso County, Colorado  
Entech Job No. 260429

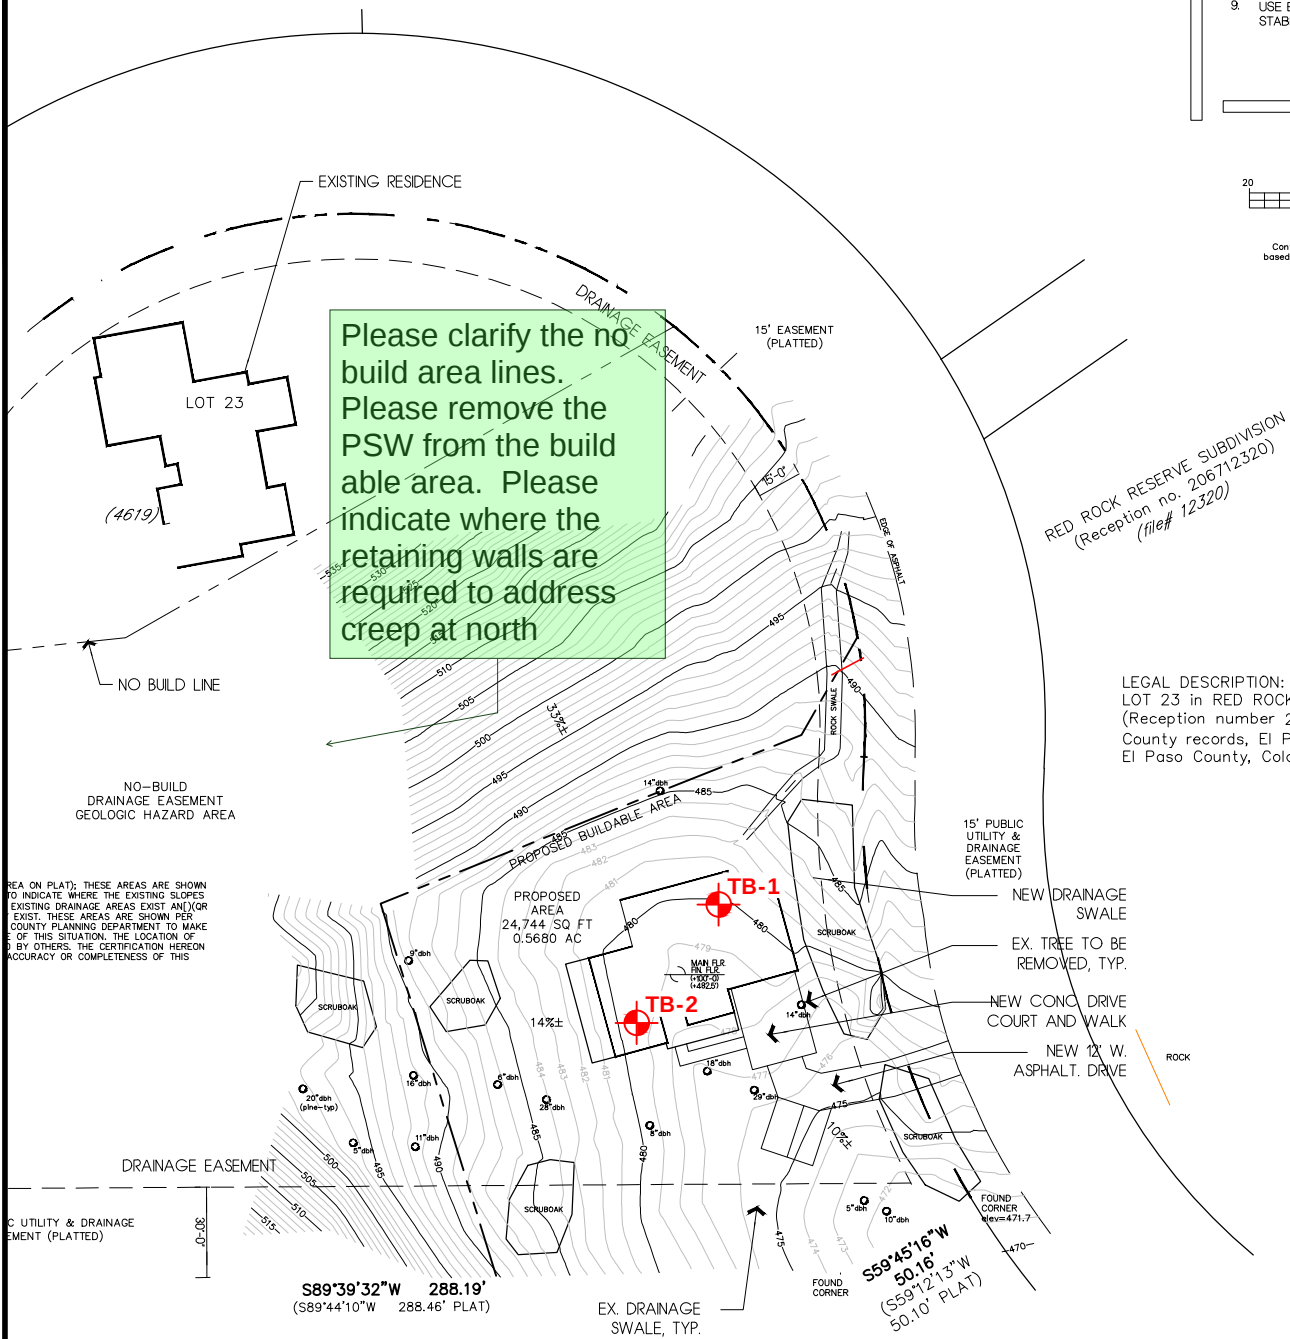
FIG. 3

Please clarify the no build area lines. Please remove the PSW from the build able area. Please indicate where the retaining walls are required to address creep at north

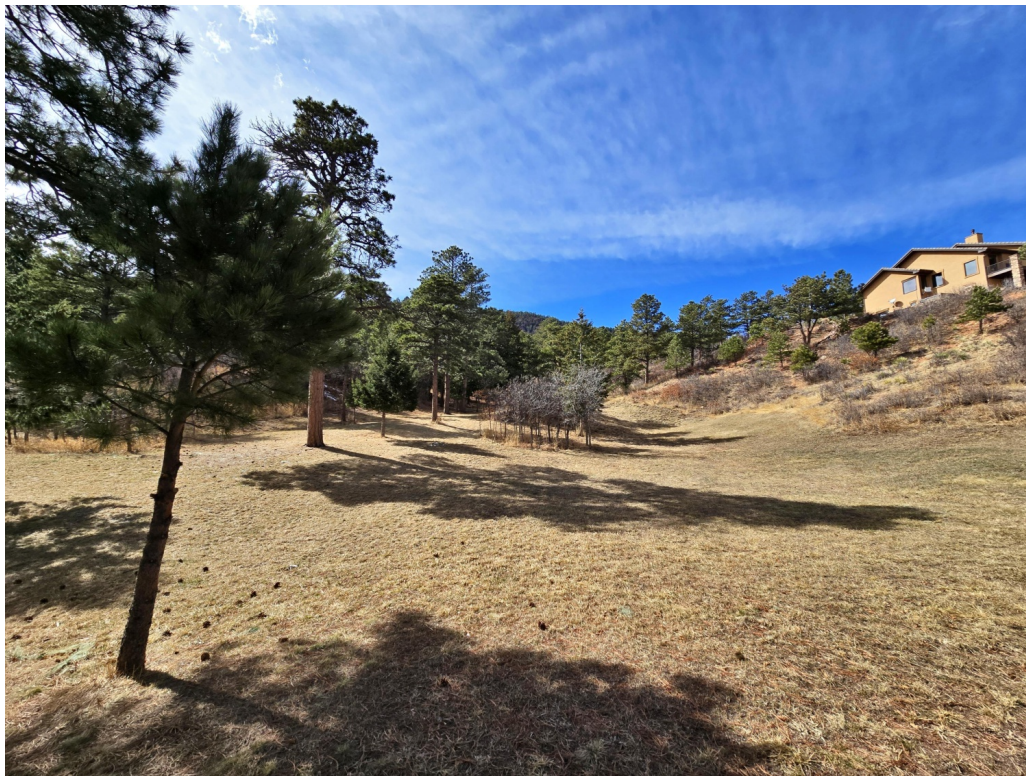
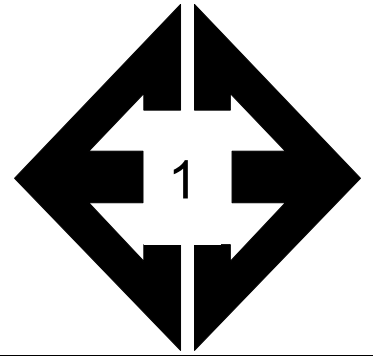
**Looking northwest  
from the proposed  
building area.**

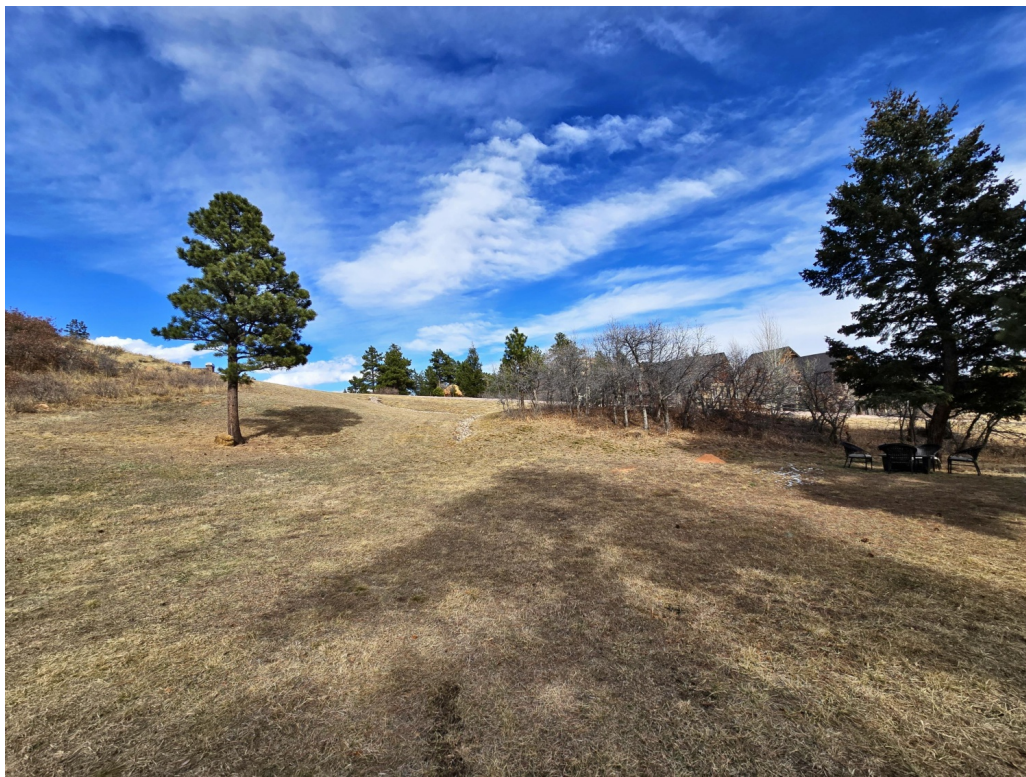
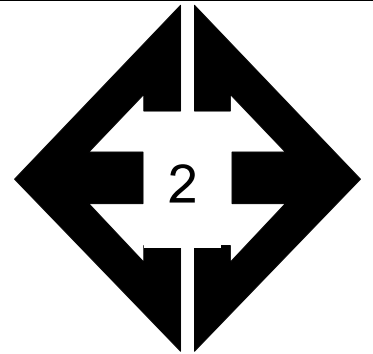
**Looking northeast  
from the proposed  
building area.**
