ELECTRONIC STORAGE GRADING AND EROSION CONTROL PLAN GRADING DETAILS SHEET

EXTENDED DETENTION BASIN AS-BUILT
 DANE FRANK, TERRA NOVA ENGINEERING, 2024/10/30

ELECTRONIC STORAGE
 PROPOSED DRAINAGE MAP
 PROPOSED DRAINAGE MAP

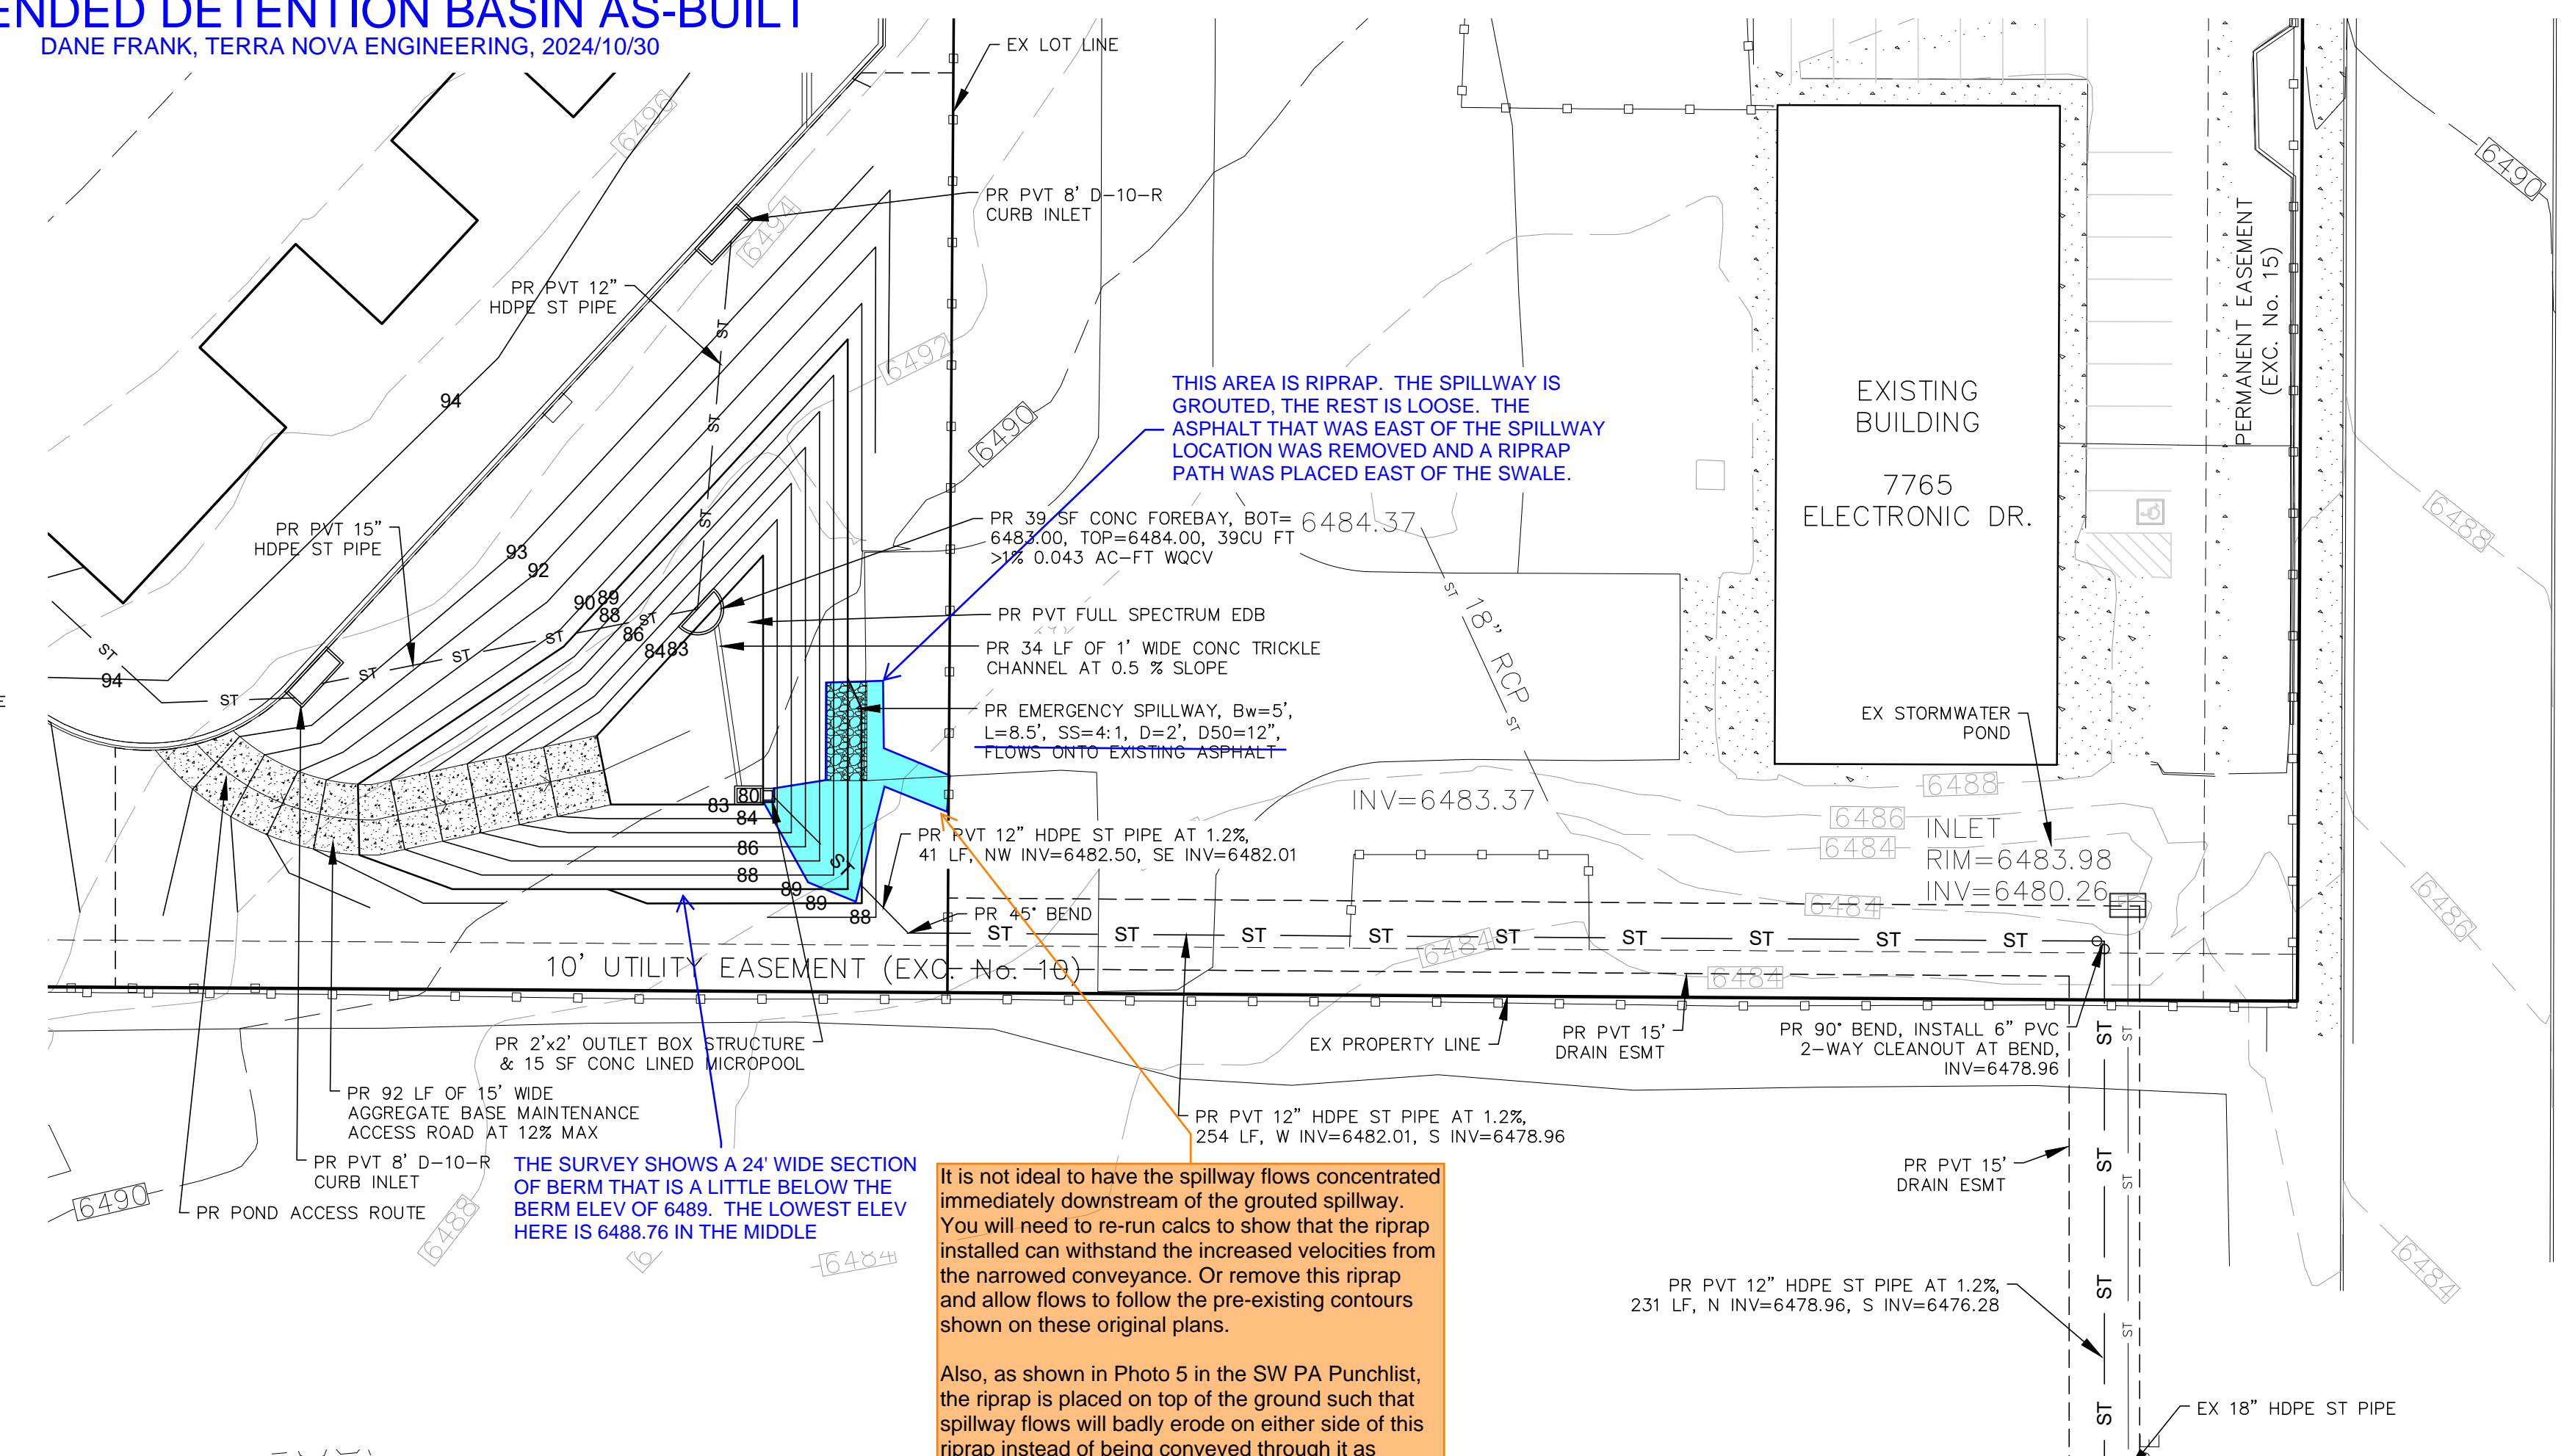
Access must be provided to the outlet structure (via steps per DCMv2 Chap 4.2: "Access to critical elements of the pond (inlet, outlet, spillway, and sediment collection areas) must be provided." And: Either a ladder or steps shall be installed when manhole depth exceeds 30 inches (see ECM Storm Sewer Manhole Detail SD_3-2).
 This is a general safety concern for if someone ends up in the outlet structure, there must be a way for them to exit. And it allows for removing sediment and debris from the outlet structure.

It is not ideal to have the spillway flows concentrated immediately downstream of the grouted spillway. You will need to re-run calcs to show that the riprap installed can withstand the increased velocities from the narrowed conveyance. Or remove this riprap and allow flows to follow the pre-existing contours shown on these original plans.
 Also, as shown in Photo 5 in the SW PA Punchlist, the riprap is placed on top of the grouted spillway. This riprap will badly erode on either side of this riprap instead of being conveyed through it as intended like a swale.

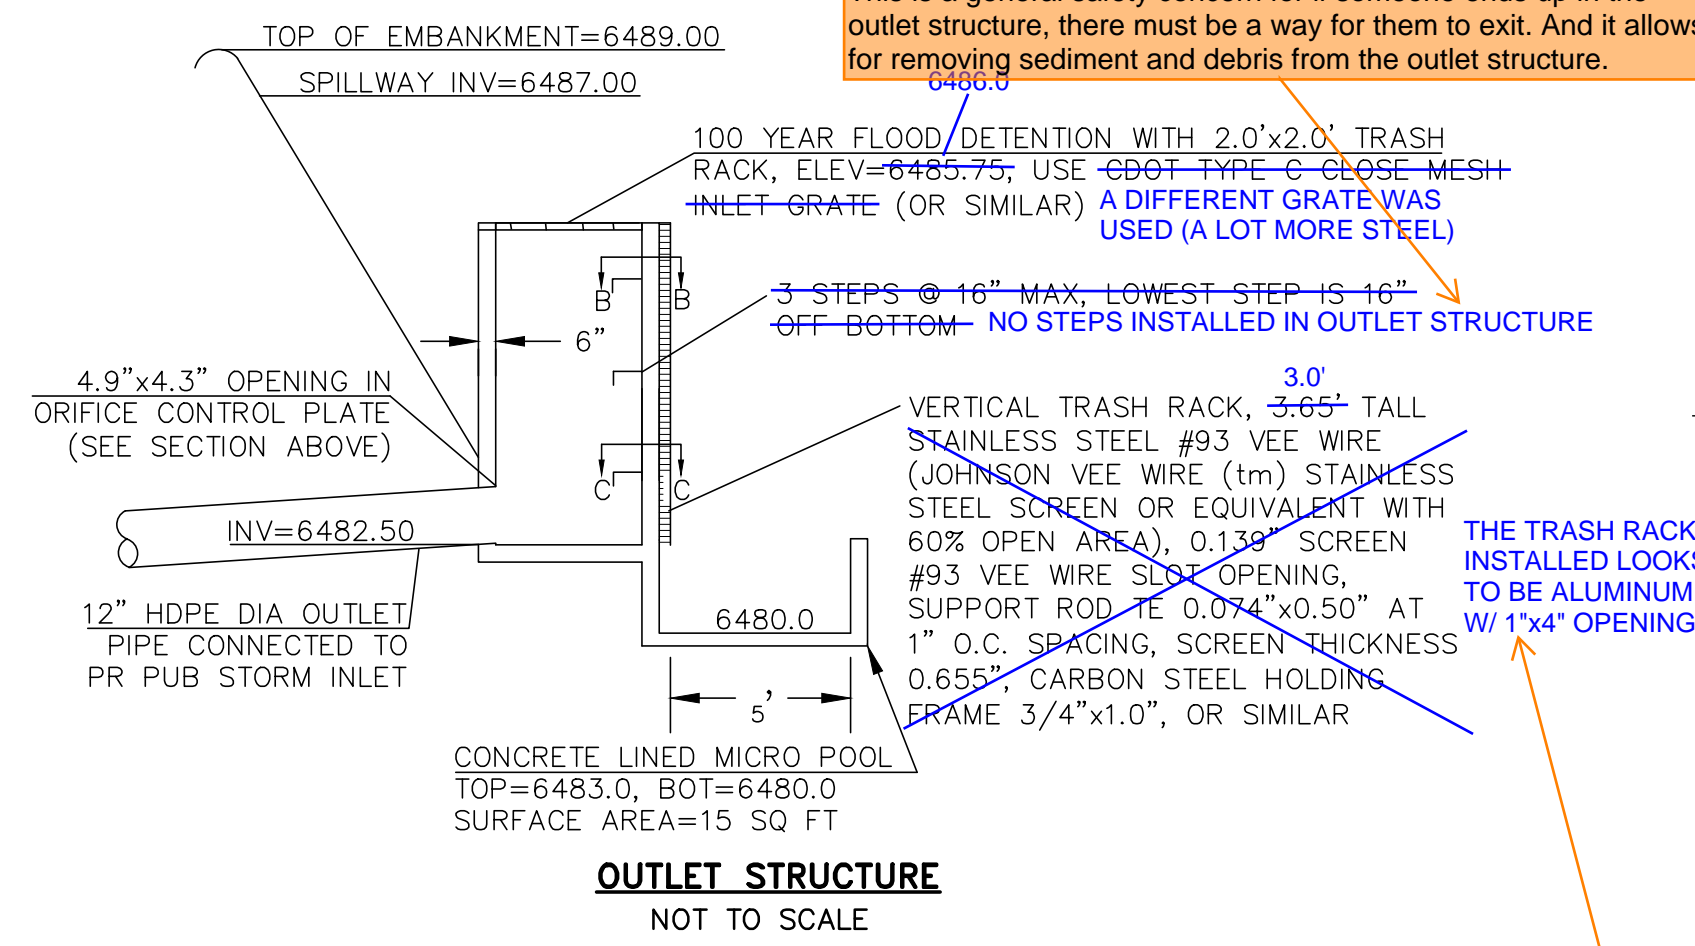
This is not acceptable as an "or equivalent" alternative. The intent of the trash rack in front of the orifice plate is for the openings in the trash rack to be less than the orifice holes. That way debris that is large enough to clog the orifice plate cannot pass through the trash rack.
 DCMv2 Chap 4.2: "Provide a trash rack of sufficient size to prevent clogging of the primary water quality outlet."
 MHFD DCMv3 states: Eliminating well screen [is acceptable] if orifices are large enough to be protected by standard bar grating. Orifice dimensions greater than 1.25 inches are generally large enough to eliminate the well screen in favor of standard bar grating. Do not eliminate the well screen if the smallest orifice dimension is less than 1.25 inches.
