Re: Soil, Geology, and Geologic Hazard Study
Hill Subdivision
Parcel Nos. 51290-04-018 and 51290-09-002
Alpaca Heights and Black Forest Road
El Paso County, Colorado

Doug Hill
Soil, Geology, and Geologic Hazard Study
Hill Subdivision
Parcel Nos. 51290-04-018 and 51290-09-002
Alpaca Heights and Black Forest Road
El Paso County, Colorado
Entech Job No. 221947

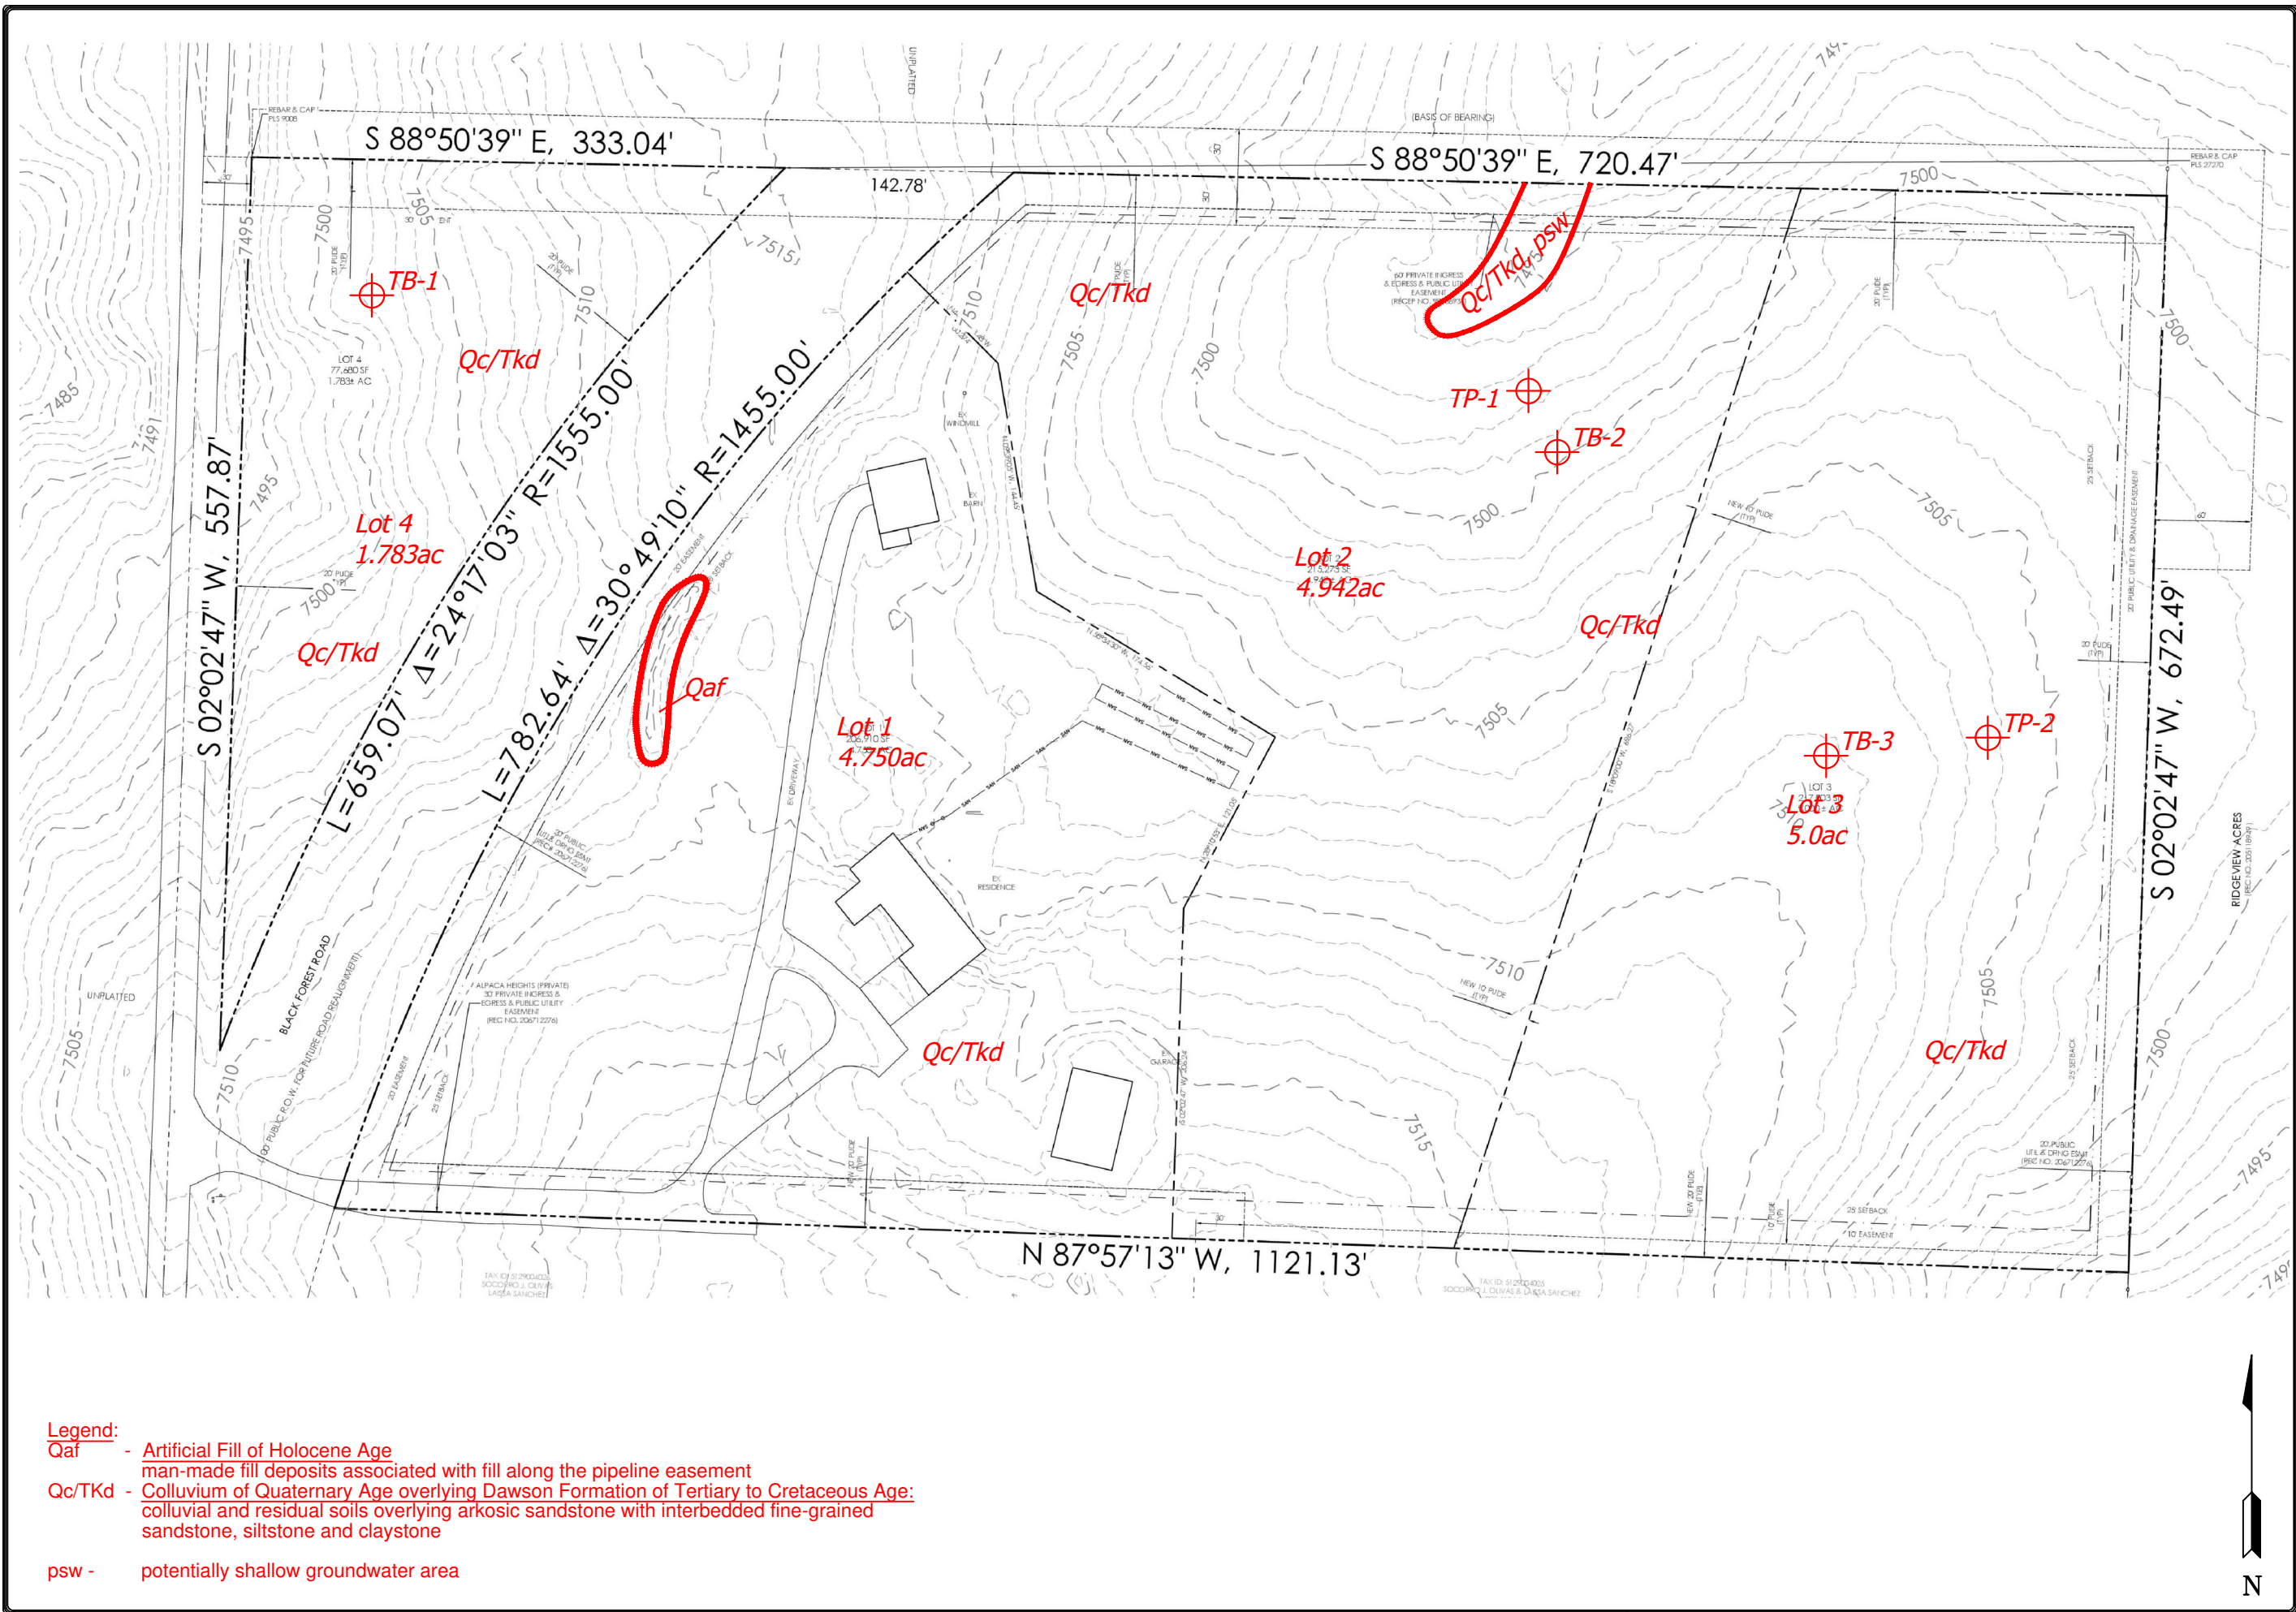
DRAWN LLI CHECKED
DATE 10/20/22
SCALE AS SHOWN
JOB NO. 221947
FIGURE No. 6

Qaf Artificial Fill of Holocene Age: These are man-made fill deposits associated with a small embankment in the western portion of Lot 1.

These are areas of man-made fill associated with an embankment located in the western portion of Lot 1. Areas of fill other than those mapped may exist on the site.

A minor drainage areas exist in the northeastern portion of proposed Lot 2. No water was observed flowing in the drainage, however, this area has the potential for seasonal shallow groundwater. This area is indicated in the Geology/Engineering Geology Map (Figure 6) and are discussed below. Due to the size of the proposed lot this area can be avoided or redirected around proposed structures or proposed soil treatment areas. The site does not lie within any floodplain zones according to the FEMA Map No. 08041CO305G dated December 7, 2018 (Figure 7, Reference 7). Exact locations of floodplain and specific drainage studies are beyond the scope of this report.

The minor drainage area in the northeastern portion of proposed Lot 2 has been identified as a potentially seasonal shallow groundwater area. In this area we would anticipate the potential for periodically high subsurface moisture conditions, frost heave potential and highly organic soils. This area lies within defined minor drainage and can be avoided by the proposed development. Construction in any portions of these areas, if required, or immediately adjacent to these areas should follow these precautions.

Mitigation: It is anticipated these would be avoided by development or regraded. Should any uncontrolled fill be encountered beneath foundations, removal and recompaction at a minimum of 95% of its maximum Modified Proctor Dry Density, ASTM D-1557 will be required.

Mitigation: Foundations must have a minimum 30-inch depth for frost protection. In areas where high subsurface moisture conditions are anticipated periodically, subsurface perimeter drains are recommended to help prevent the intrusion of water into areas below grade. Typical drain details are presented in Figure 8. Any grading in these areas should be done to direct surface flow around construction to avoid areas of ponded water. All organic material would be completely removed prior to any fill placement. **Specific drainage studies are beyond the scope of this report.**

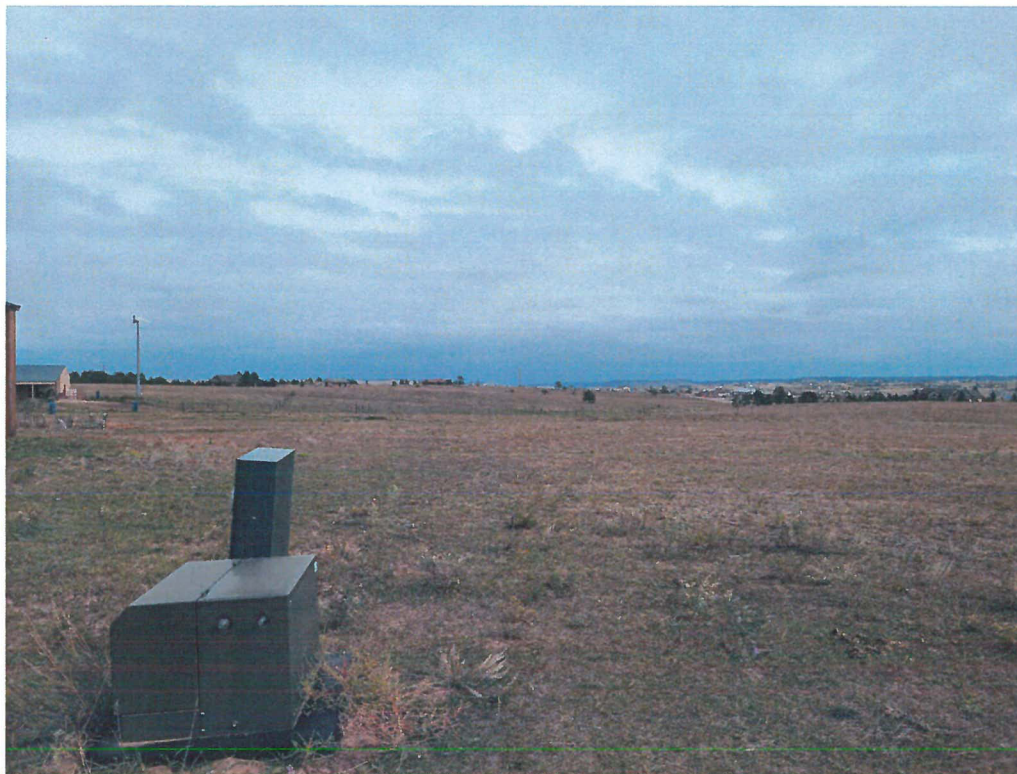
**Looking northwest
from the southern
portion of the site.**

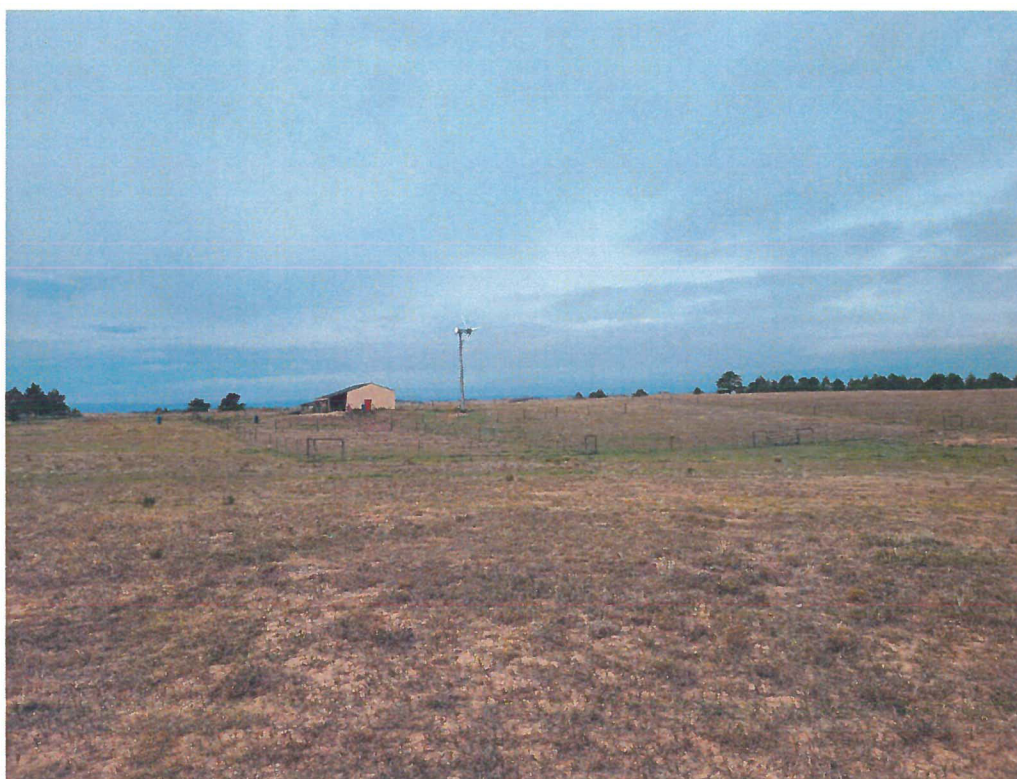
**Looking northwest
from the central
portion of the site.**

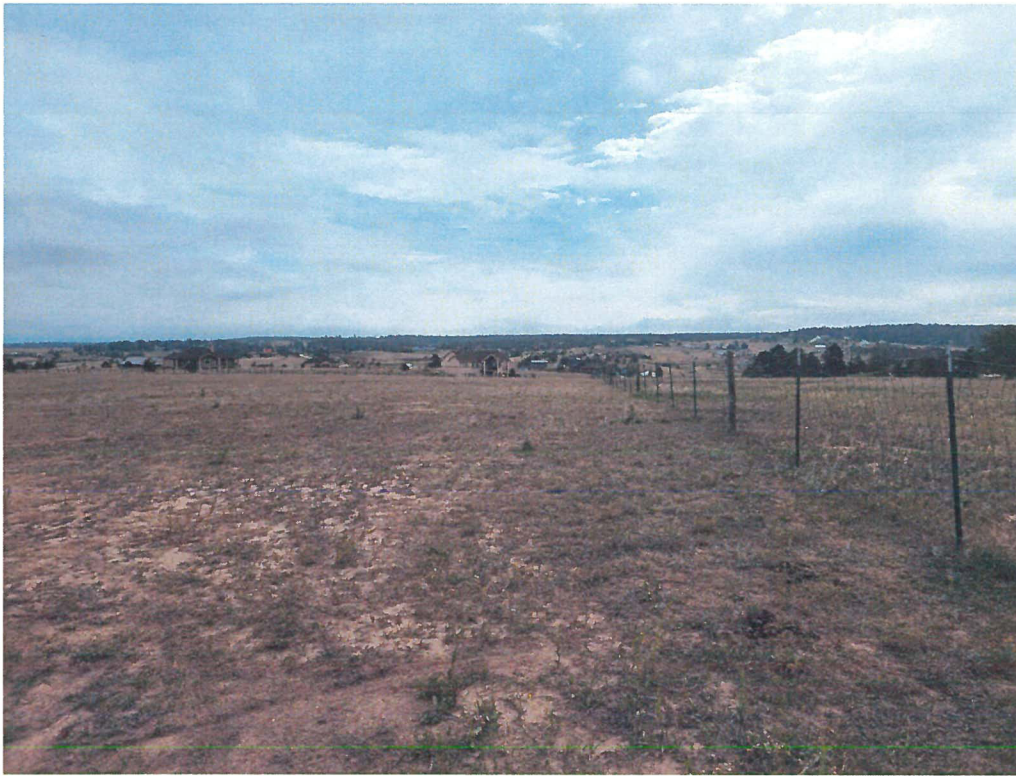
**Looking north along
from the southeastern
portion of the site.**

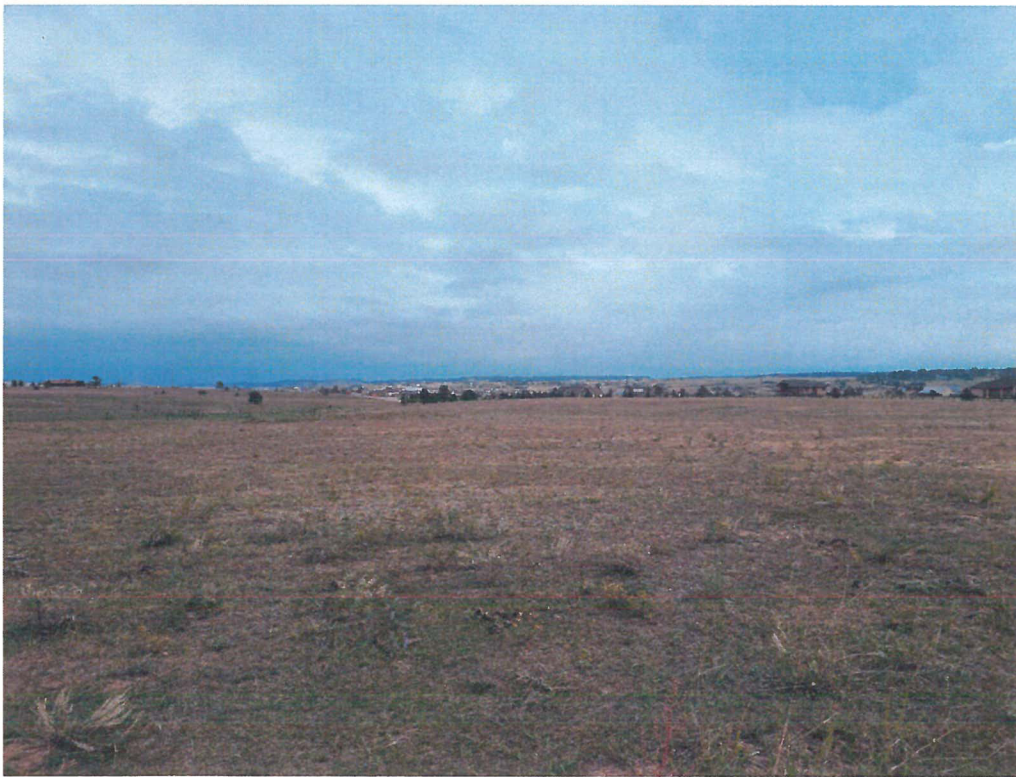
**Looking northeast
from the southern
portion of the site.**

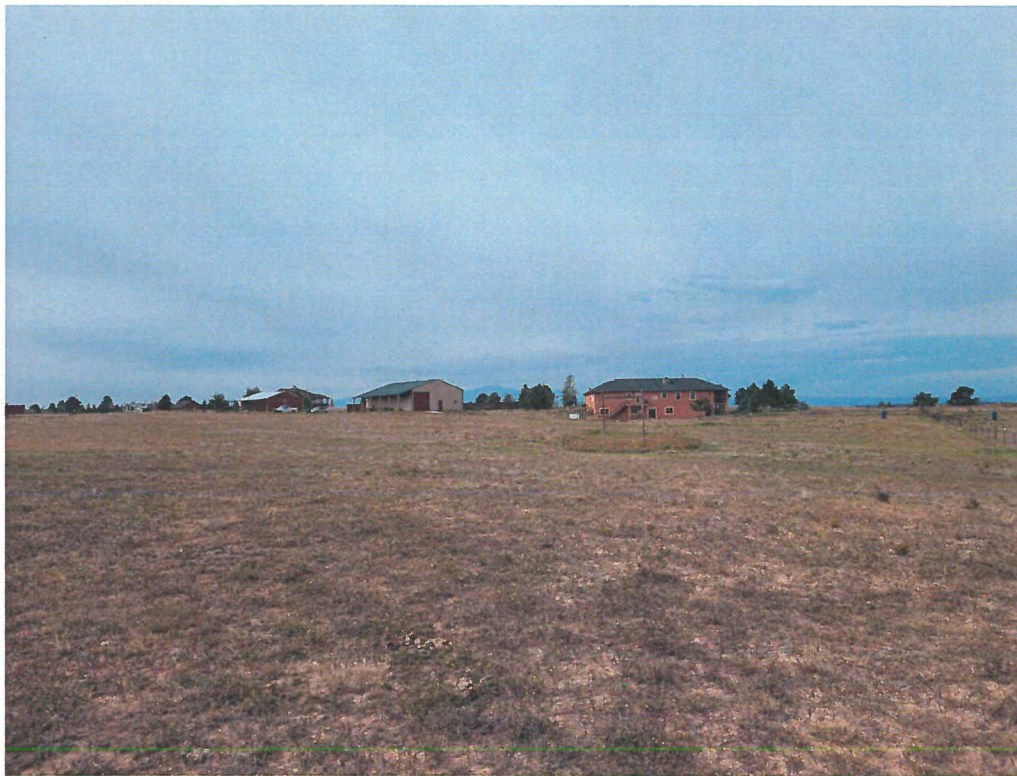
**Looking southwest
from the northeastern
portion of the site.**

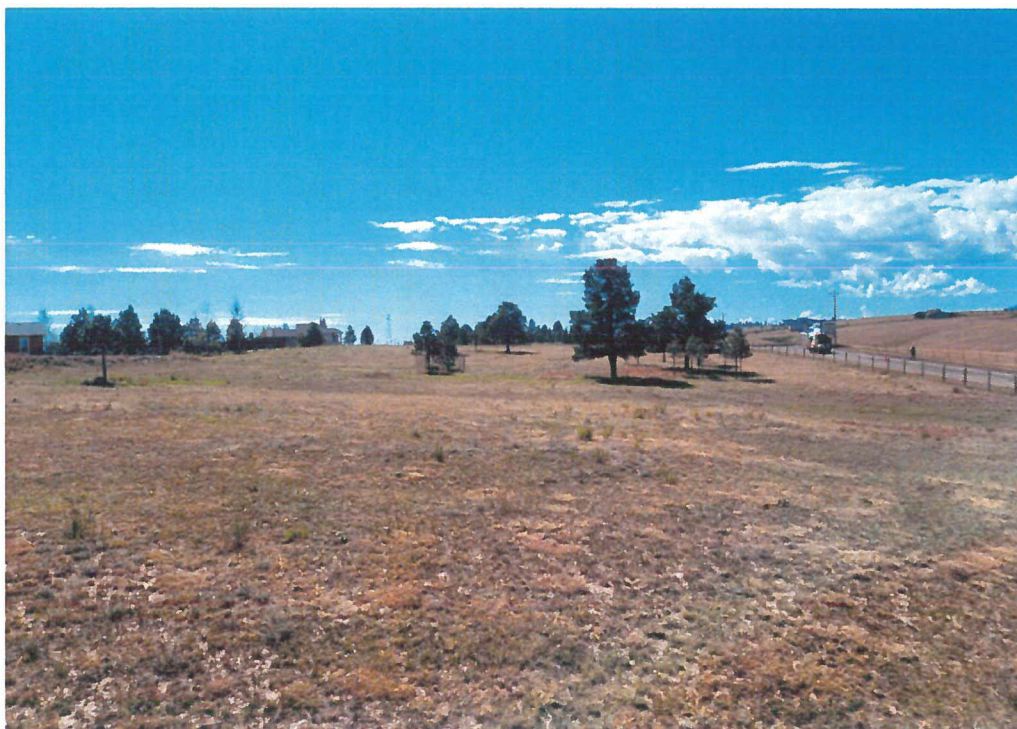
**Looking south from
the northwestern
portion of the site.**

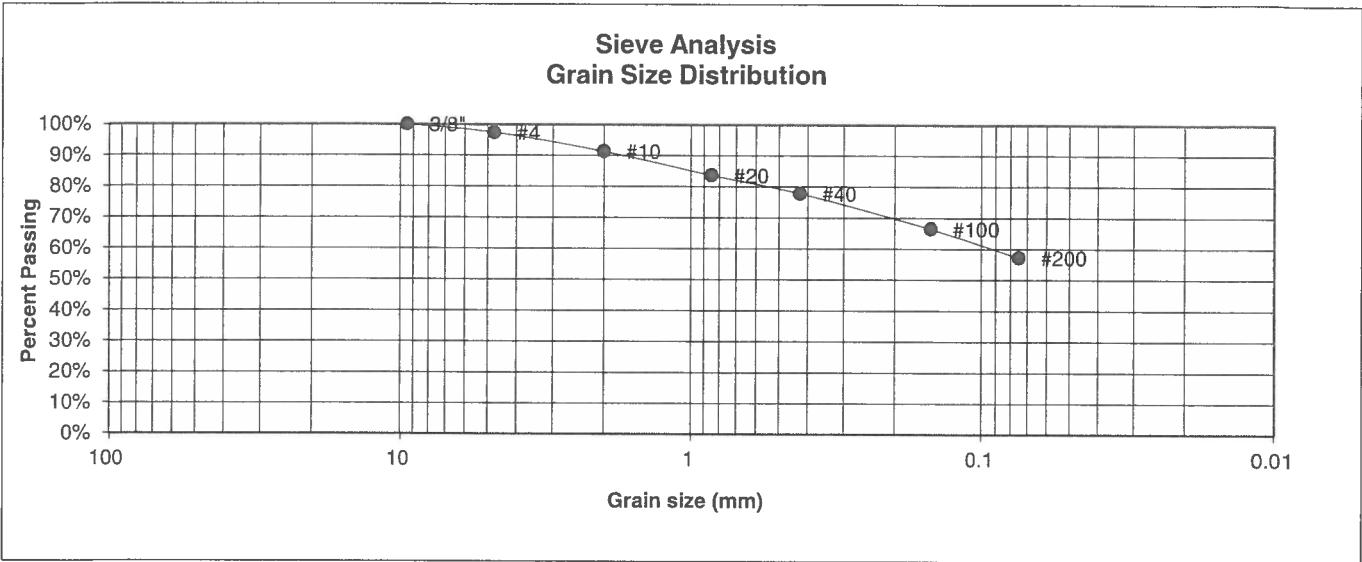
C-2

Soil Type 2 is a sandy clay to very sandy clay (CL). The clay soils were encountered in Test Boring No. 3, and in Test Pit Nos. 1 and 2. The clays were encountered at the existing ground surface and extended to depths of 3 feet bgs in Test Boring No. 3, and to the termination of the test pits (6 to 8 feet). The clay was encountered at firm to stiff consistencies and dry to moist conditions. The samples tested had 57 to 77 percent of the soil size particles passing the No. 200 sieve. Expansion pressure of 580 psf was determined by laboratory tests on samples of the clay soils. This magnitude of expansion is in the low expansion range.

<u>Swell</u>	
Moisture at start	7.9%
Moisture at finish	20.9%
Moisture increase	13.0%
Initial dry density (pcf)	103
Swell (psf)	580

Mitigation: Should expansive soils be encountered beneath the foundation; mitigation will be necessary. Mitigation of expansive soils will require special foundation design. Overexcavation and replacement with non-expansive soils at a minimum of 95% of its maximum Modified Proctor Dry Density, ASTM D-1557 is a suitable mitigation, which is common in the area. Floor slabs on expansive soils should be expected to experience movement. Overexcavation and replacement has been successful in minimizing slab movements.
