June 18, 2021

Subject: Geologic Hazard Evaluation
Mayberry Development
aka Ellicott Town Center, Filings 1 through 4
Highway 94 and Log Road
Ellicott, Colorado
CTL|T Project No. CS18969-105

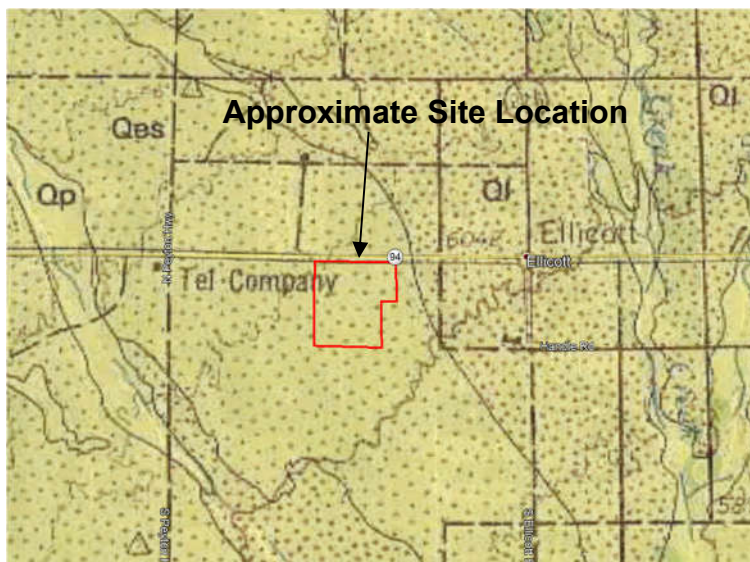
Geologic Map

The site is mapped as Holocene and Pinedale Glaciation of the Pleistocene age eolian sand (wind-deposited sediment), overlying the Dawson Formation. The Dawson Formation typically consists of sandstone interbedded with claystone in this area. Our subsurface investigation and observations generally confirm the mapping, although no bedrock was encountered to depths of up to 30-feet. Some areas in the northeast portion of the site have been disturbed by previous development activities.
