Carvana Fountain, CO – Existing Facility Improvements

Geologic Hazard Report

10610 Charter Oak Ranch Road

May 4, 2026 | Terracon Project No. 23265036B

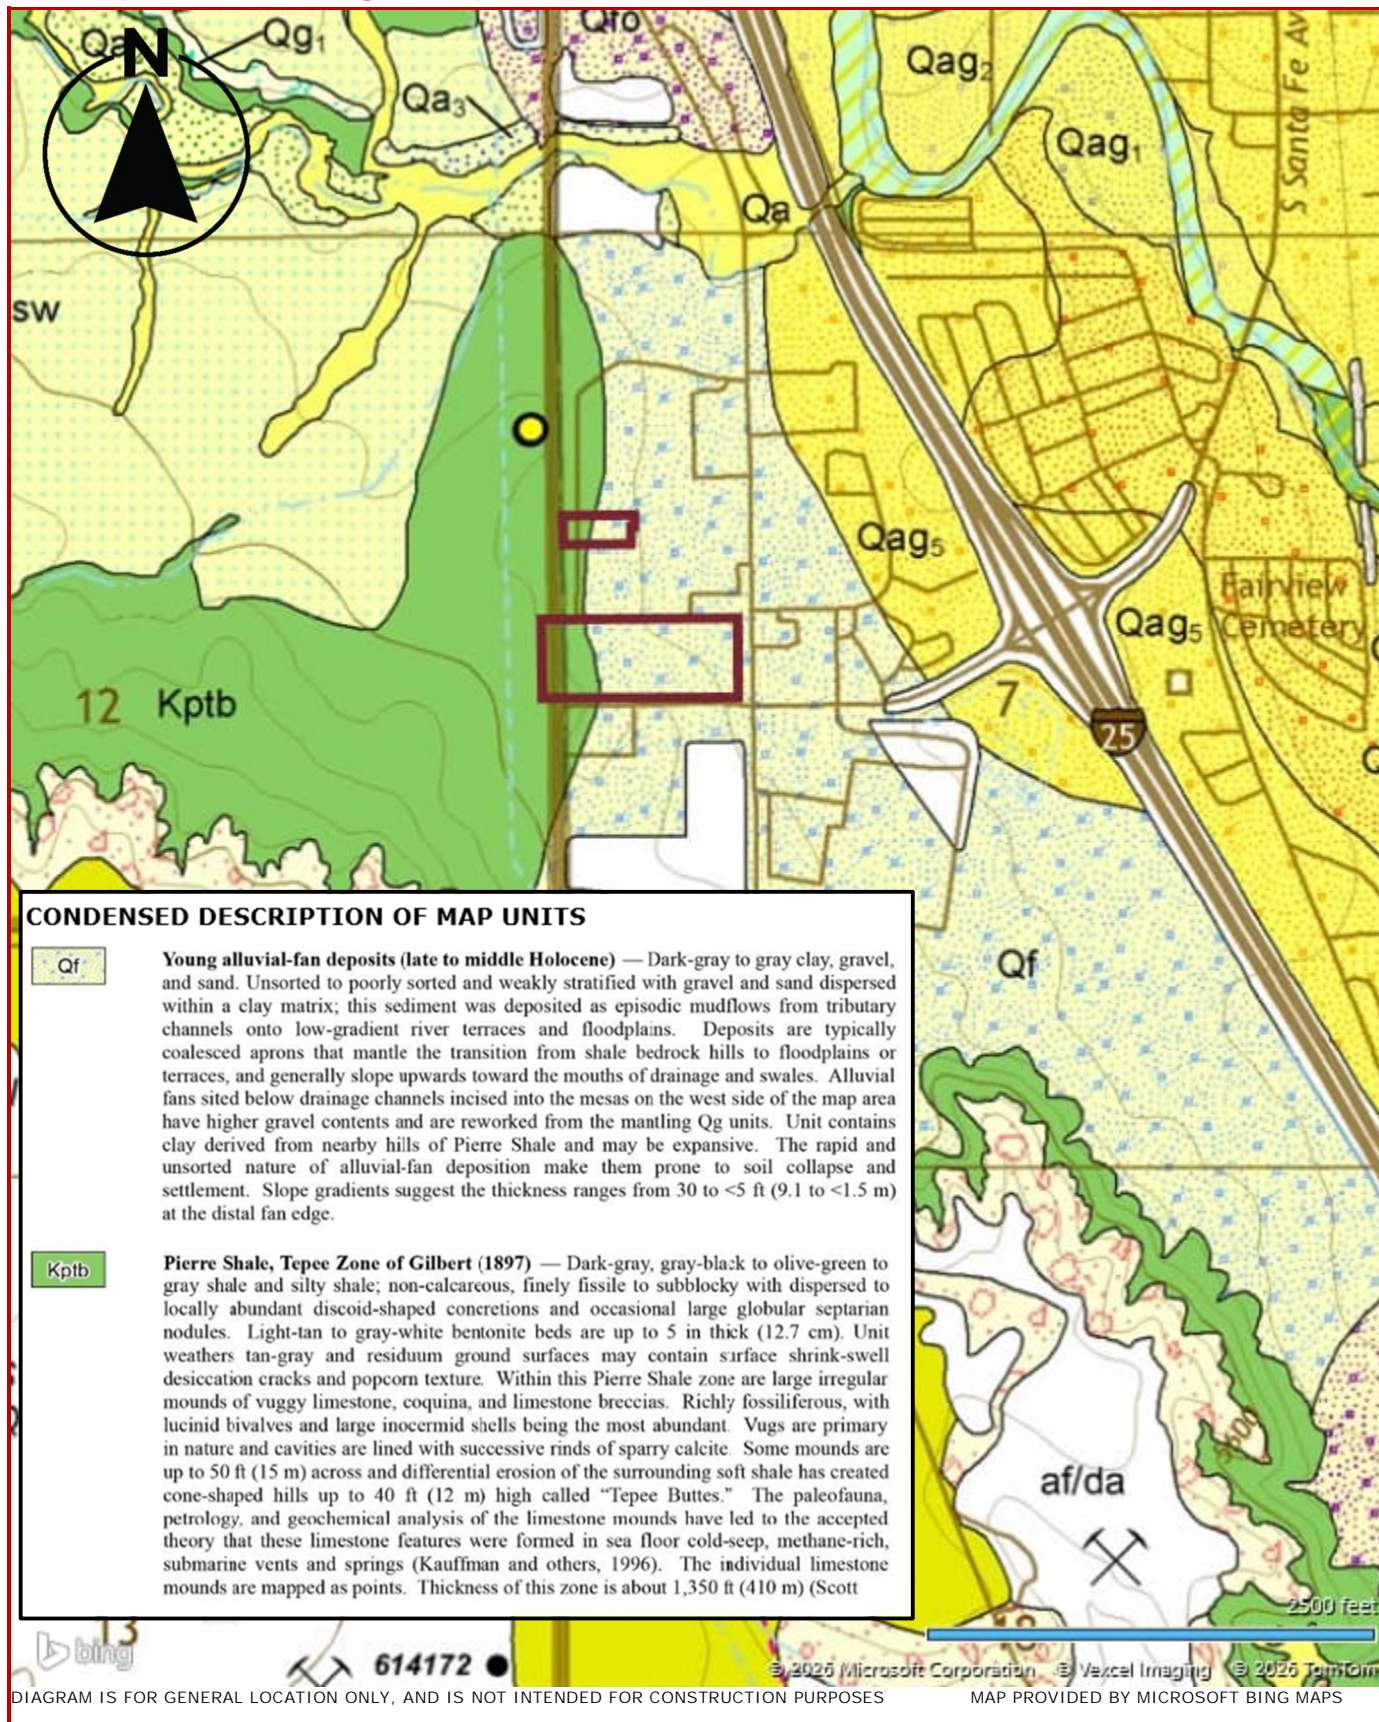
Site-Specific Geologic Map

Surficial geologic conditions at the site, as mapped by the Colorado Geological Survey (CGS) (¹White, et al., 2017), consist of Holocene-age Young Alluvial Fan deposits. The Young Alluvial Fan deposits in this area have been reported to consist of clay, gravel, and sand. The clay minerals in the Alluvial deposits are reported to be prone to swelling.

Bedrock underlying the mapped surficial units and occupying the northeast corner of the site consists of the Pierre Shale Formation of Upper Cretaceous age. The Pierre Shale within this area has been reported to include dark-gray to tan-gray to olive-gray shale and claystone. CGS mapping indicates the Pierre Shale is particularly susceptible to slope instability in steep areas.
