February 11, 2021

**ENTECH**  
ENGINEERING, INC.

Re: Soil, Geology, and Geologic Hazard Study  
Terra Benedetta Subdivision  
Portions of Parcel No. 62000-00-461  
13580 Bridle Bit Road  
El Paso County, Colorado

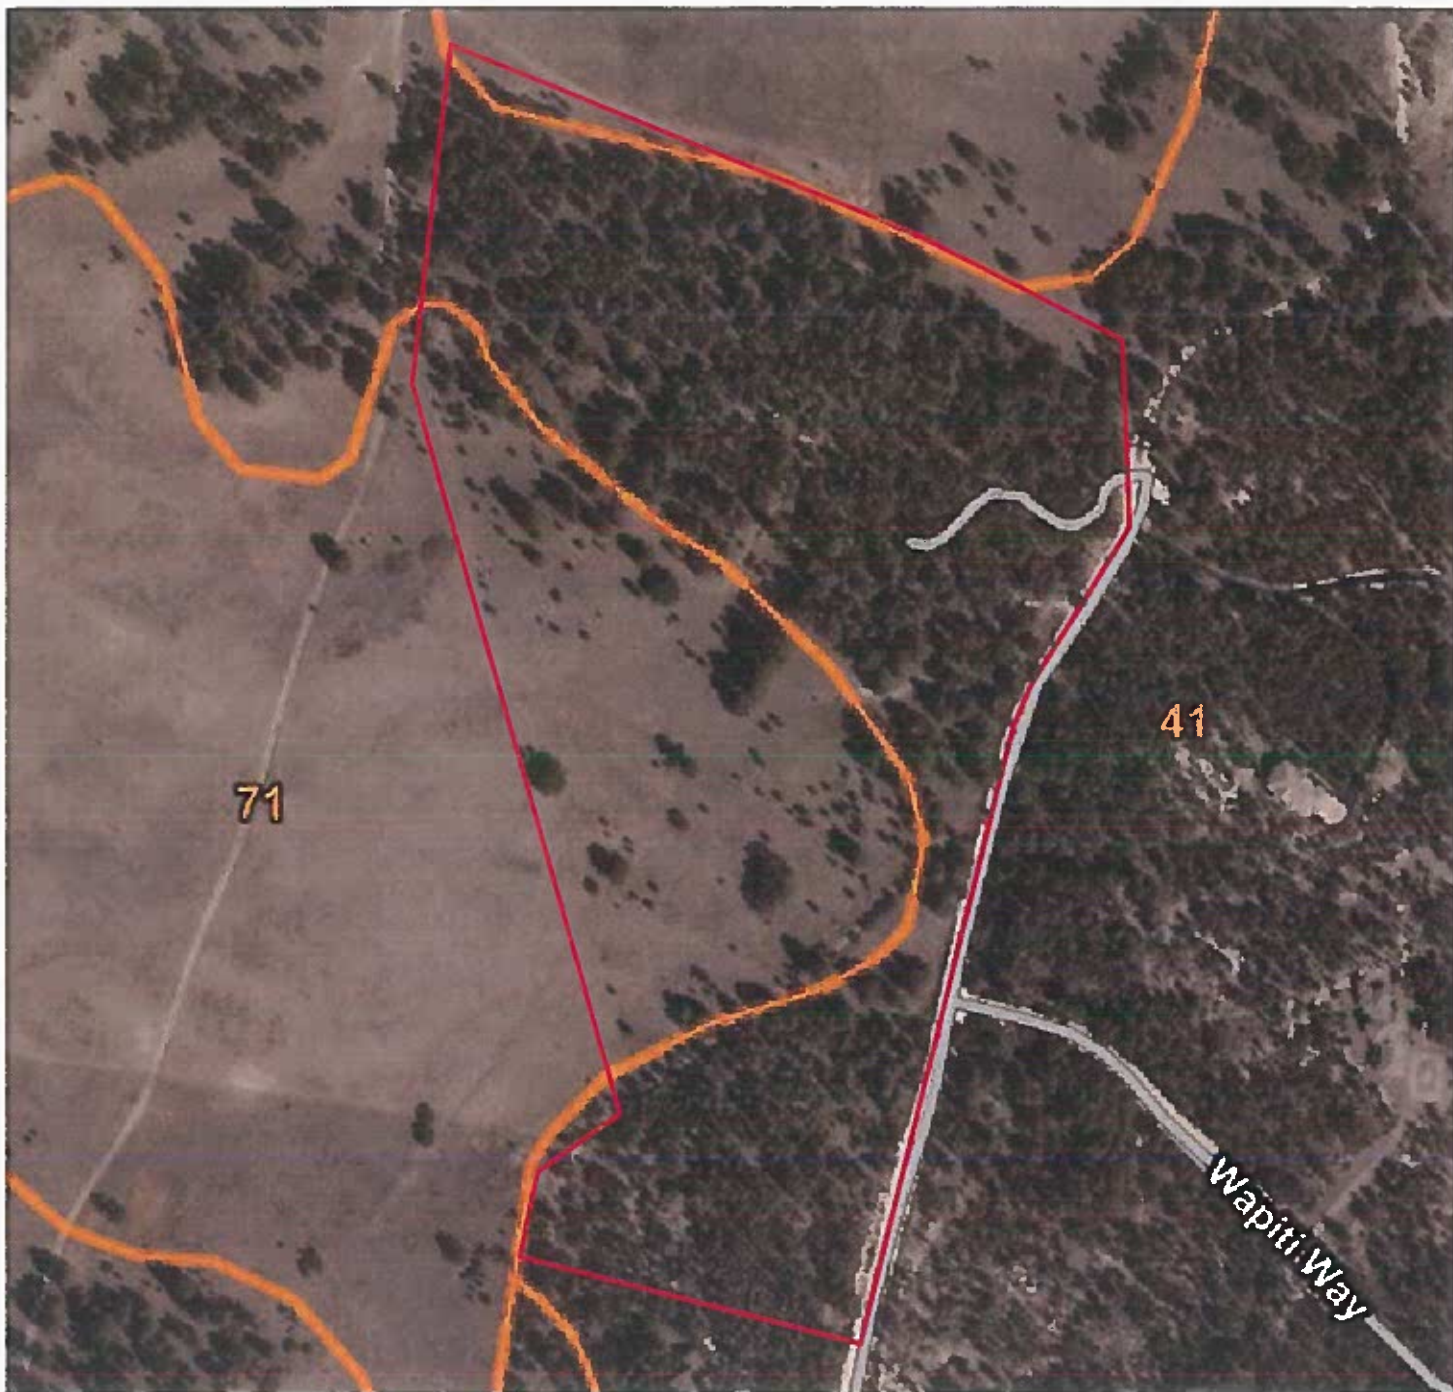
FIG NO.:  
4

The Natural Resource Conservation Service (NRCS) (Reference 1, Figure 4), previously the Soil Conservation Service (Reference 2) has mapped two soil types on the site. Complete descriptions of the soil types are presented in Appendix D. In general, the soils consist of sandy loam to gravelly loamy sand. The soils are described as follows:

The soils have been described to have moderate to rapid permeabilities. The soils are described as well suited for use as homesites. Possible hazards with soils erosion are present on the site. The erosion potential can be controlled with vegetation. The soils have been described to have moderate erosion hazards (Reference 2).

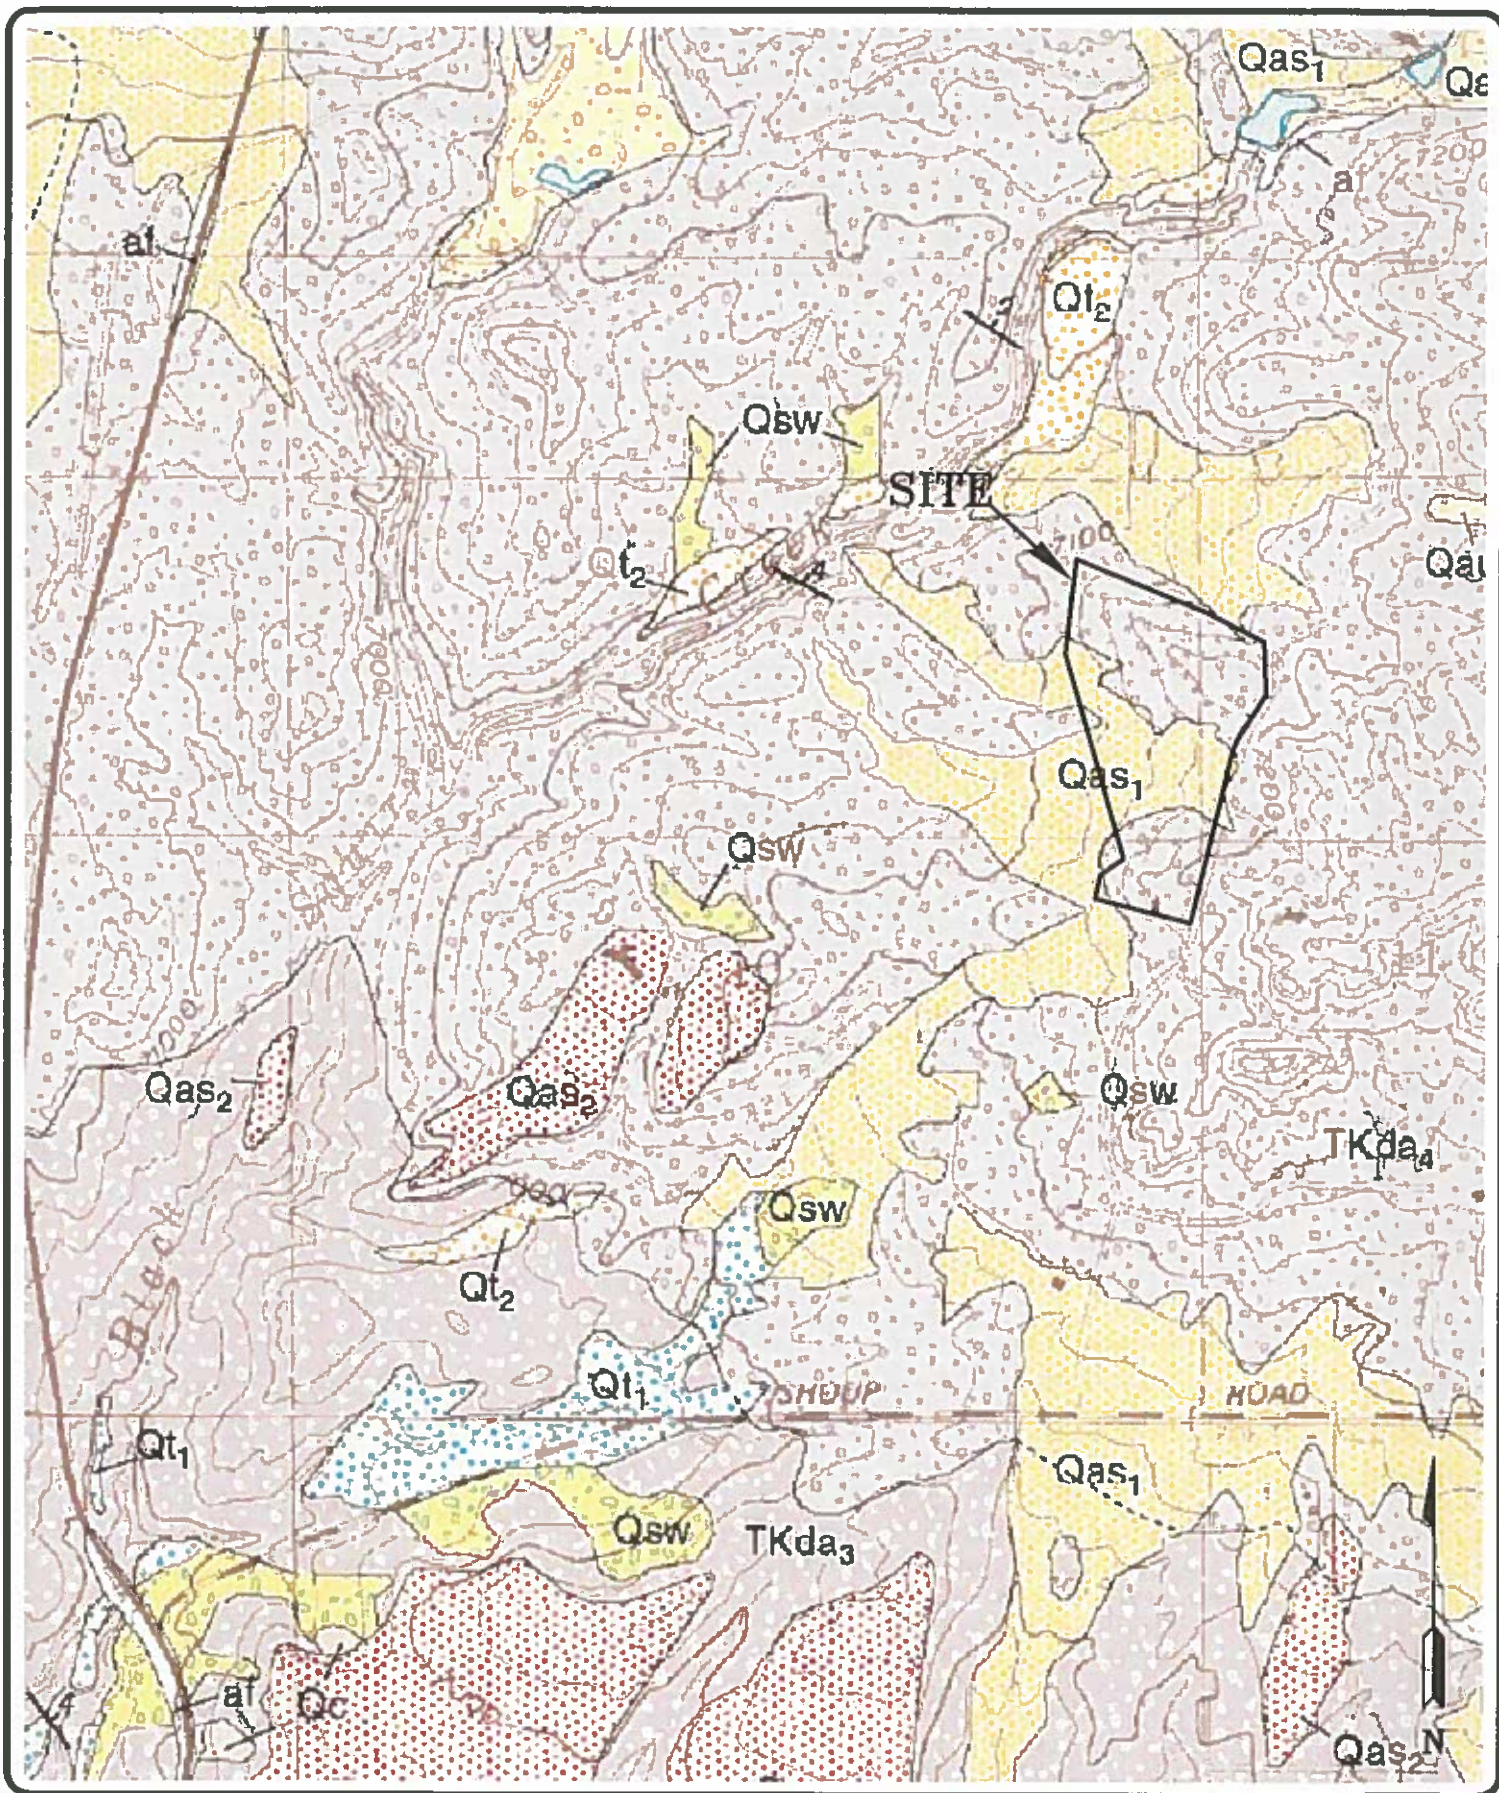
FIG NO.:  
5

The geology of the site was evaluated using the *Geologic Map of the Monument Quadrangle*, by Thorson in 2003, (Reference 4, Figure 5). The Geology Map for the site is presented in Figure 6. Two mappable units were identified on this site which is described as follows:

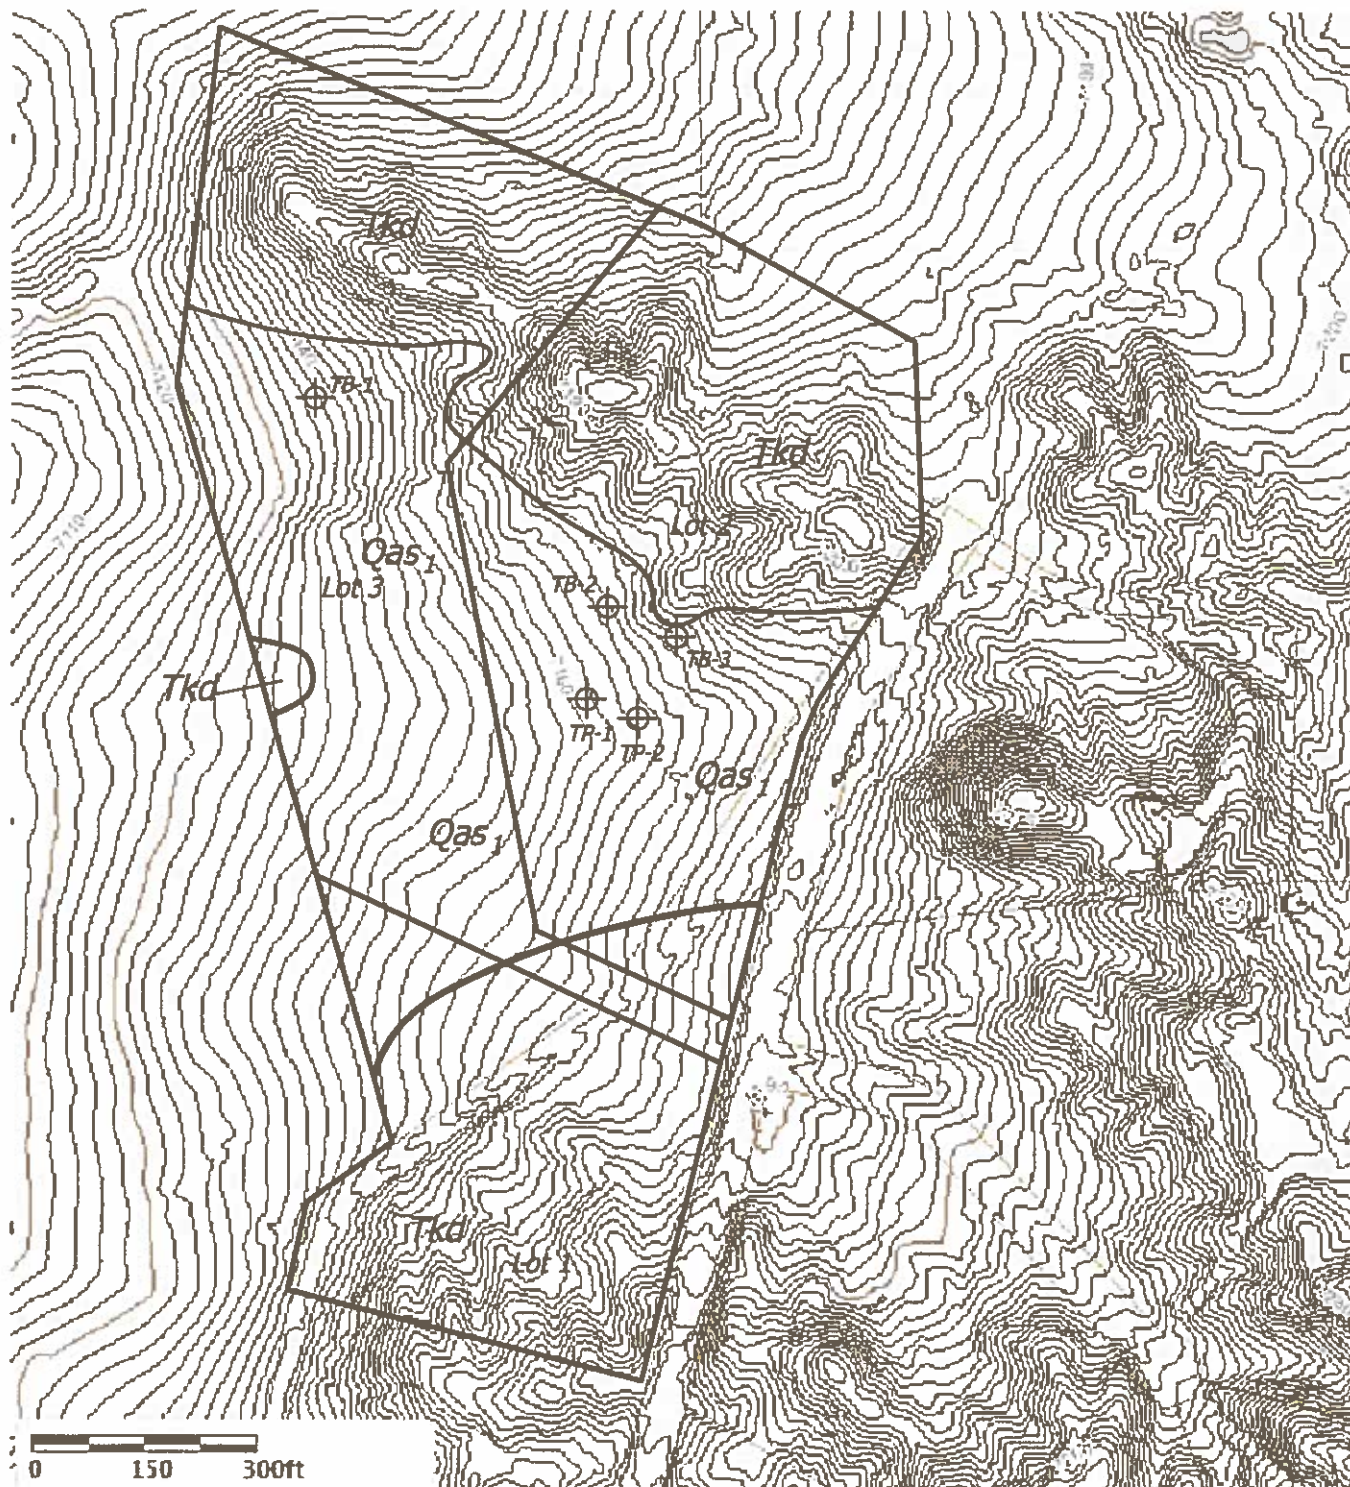
FIG NO.:  
6

The soils listed above were mapped from site-specific mapping, the *Geologic Map of the Monument Quadrangle* distributed by the Colorado Geologic Survey in 2003 (Reference 4, Figure 5), the *Geologic Map of the Colorado Springs-Castle Rock Area*, distributed by the US Geological Survey in 1979 (Reference 5), and the *Geologic Map of the Denver 1° x 2° Quadrangle*, distributed by the US Geological Survey in 1981 (Reference 6). The test pits were used in evaluating the site and are included in Appendix A. The Geology Map prepared for the site is presented in Figure 6.

Mapping has been performed on this site to identify areas where various geologic conditions exist of which developers should be cognizant during the planning, design and construction stages where new construction is proposed. The engineering geologic hazards identified on this site include potentially seasonal shallow groundwater areas. These hazards and recommended mitigation techniques are discussed as follows:

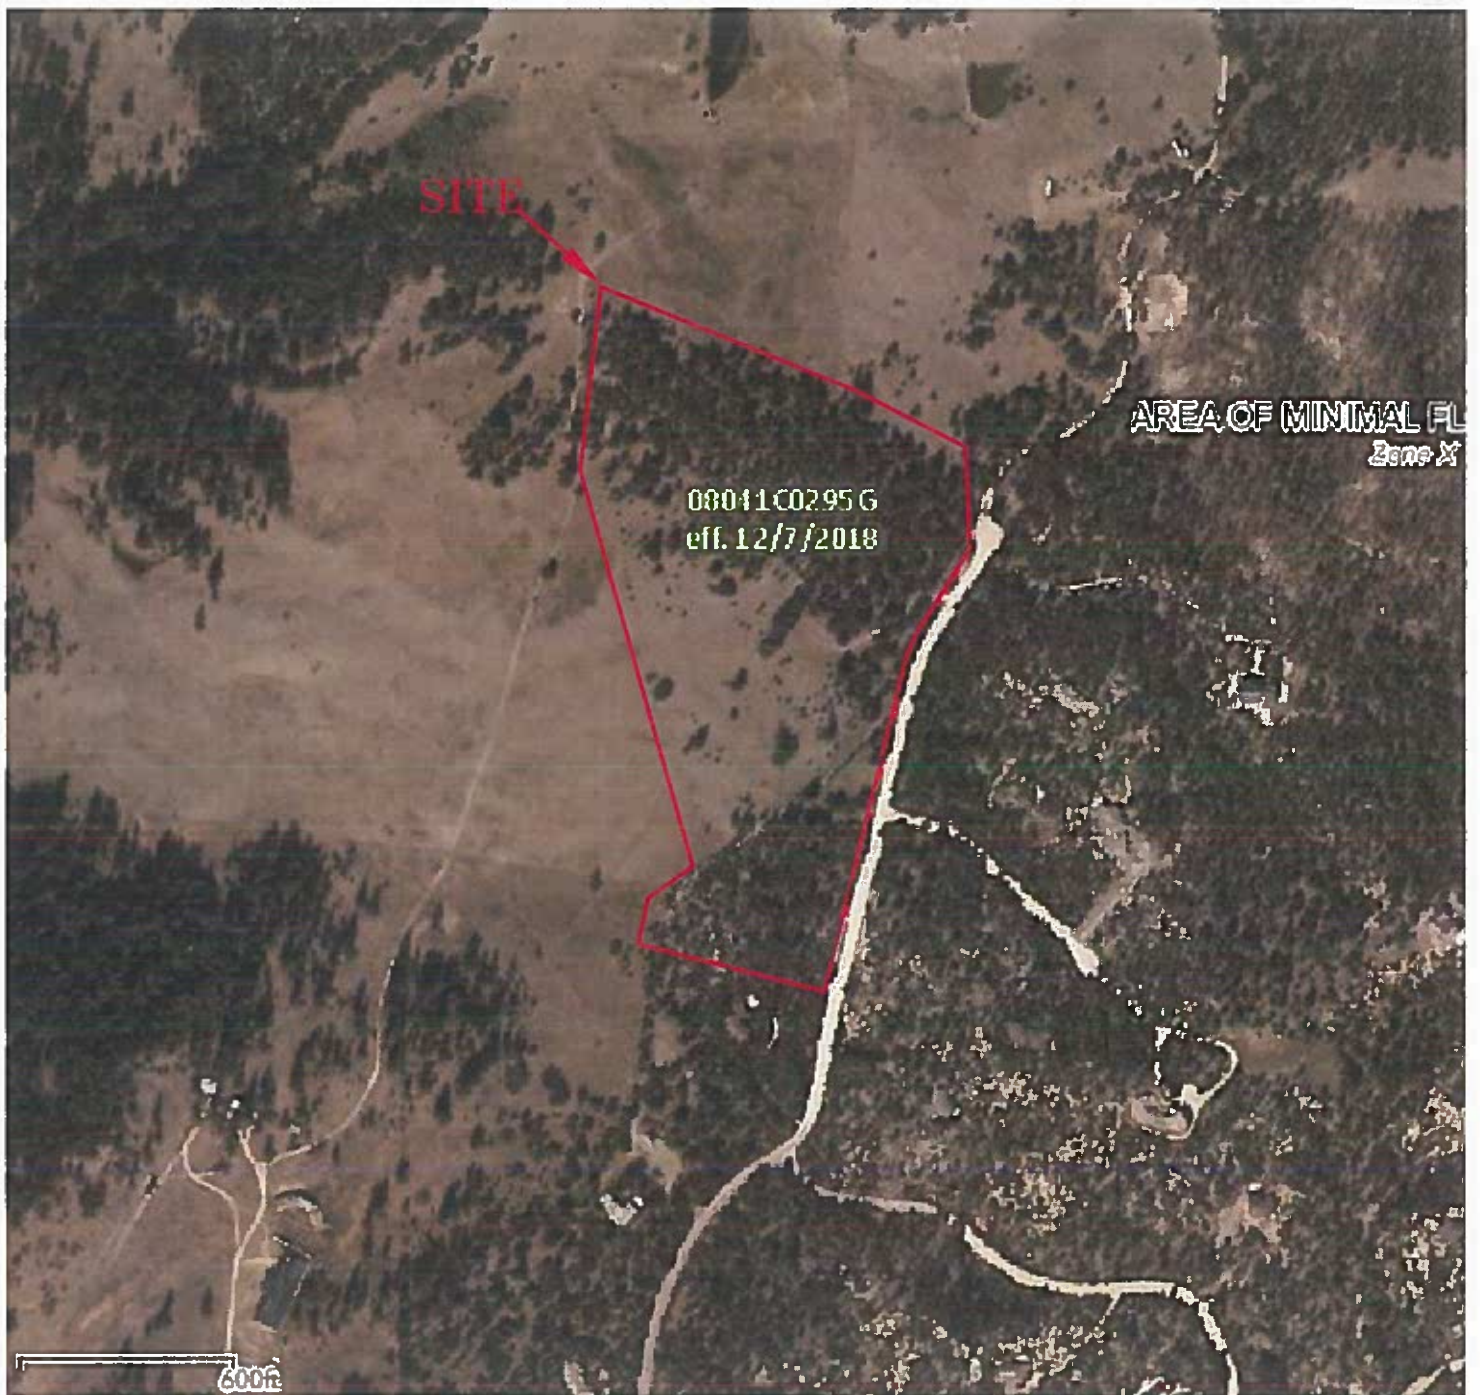
FIG NO.:  
7

Several minor drainage swales exist on the site along the ridges in the northern and southern portions of the site. No water was observed flowing in the drainage swales at the time of the investigation, however, these areas have the potential for seasonal shallow groundwater. Due to the size of the proposed lots these areas can either be avoided or redirected around proposed structures or proposed soil treatment areas. The site does not lie within any floodplain zones

according to the FEMA Map No. 08041CO295G dated December 7, 2018 (Figure 7, Reference 7). Exact locations of floodplain and specific drainage studies are beyond the scope of this report.
