**SOIL, GEOLOGY AND GEOLOGIC HAZARD STUDY
SANCTUARY OF PEACE FILING NO. 1
15760 HIGHWAY 83 AND BENET LANE
EL PASO COUNTY, COLORADO**

PUDSP – 19 – 002

February 11, 2019
Revised October 28, 2019

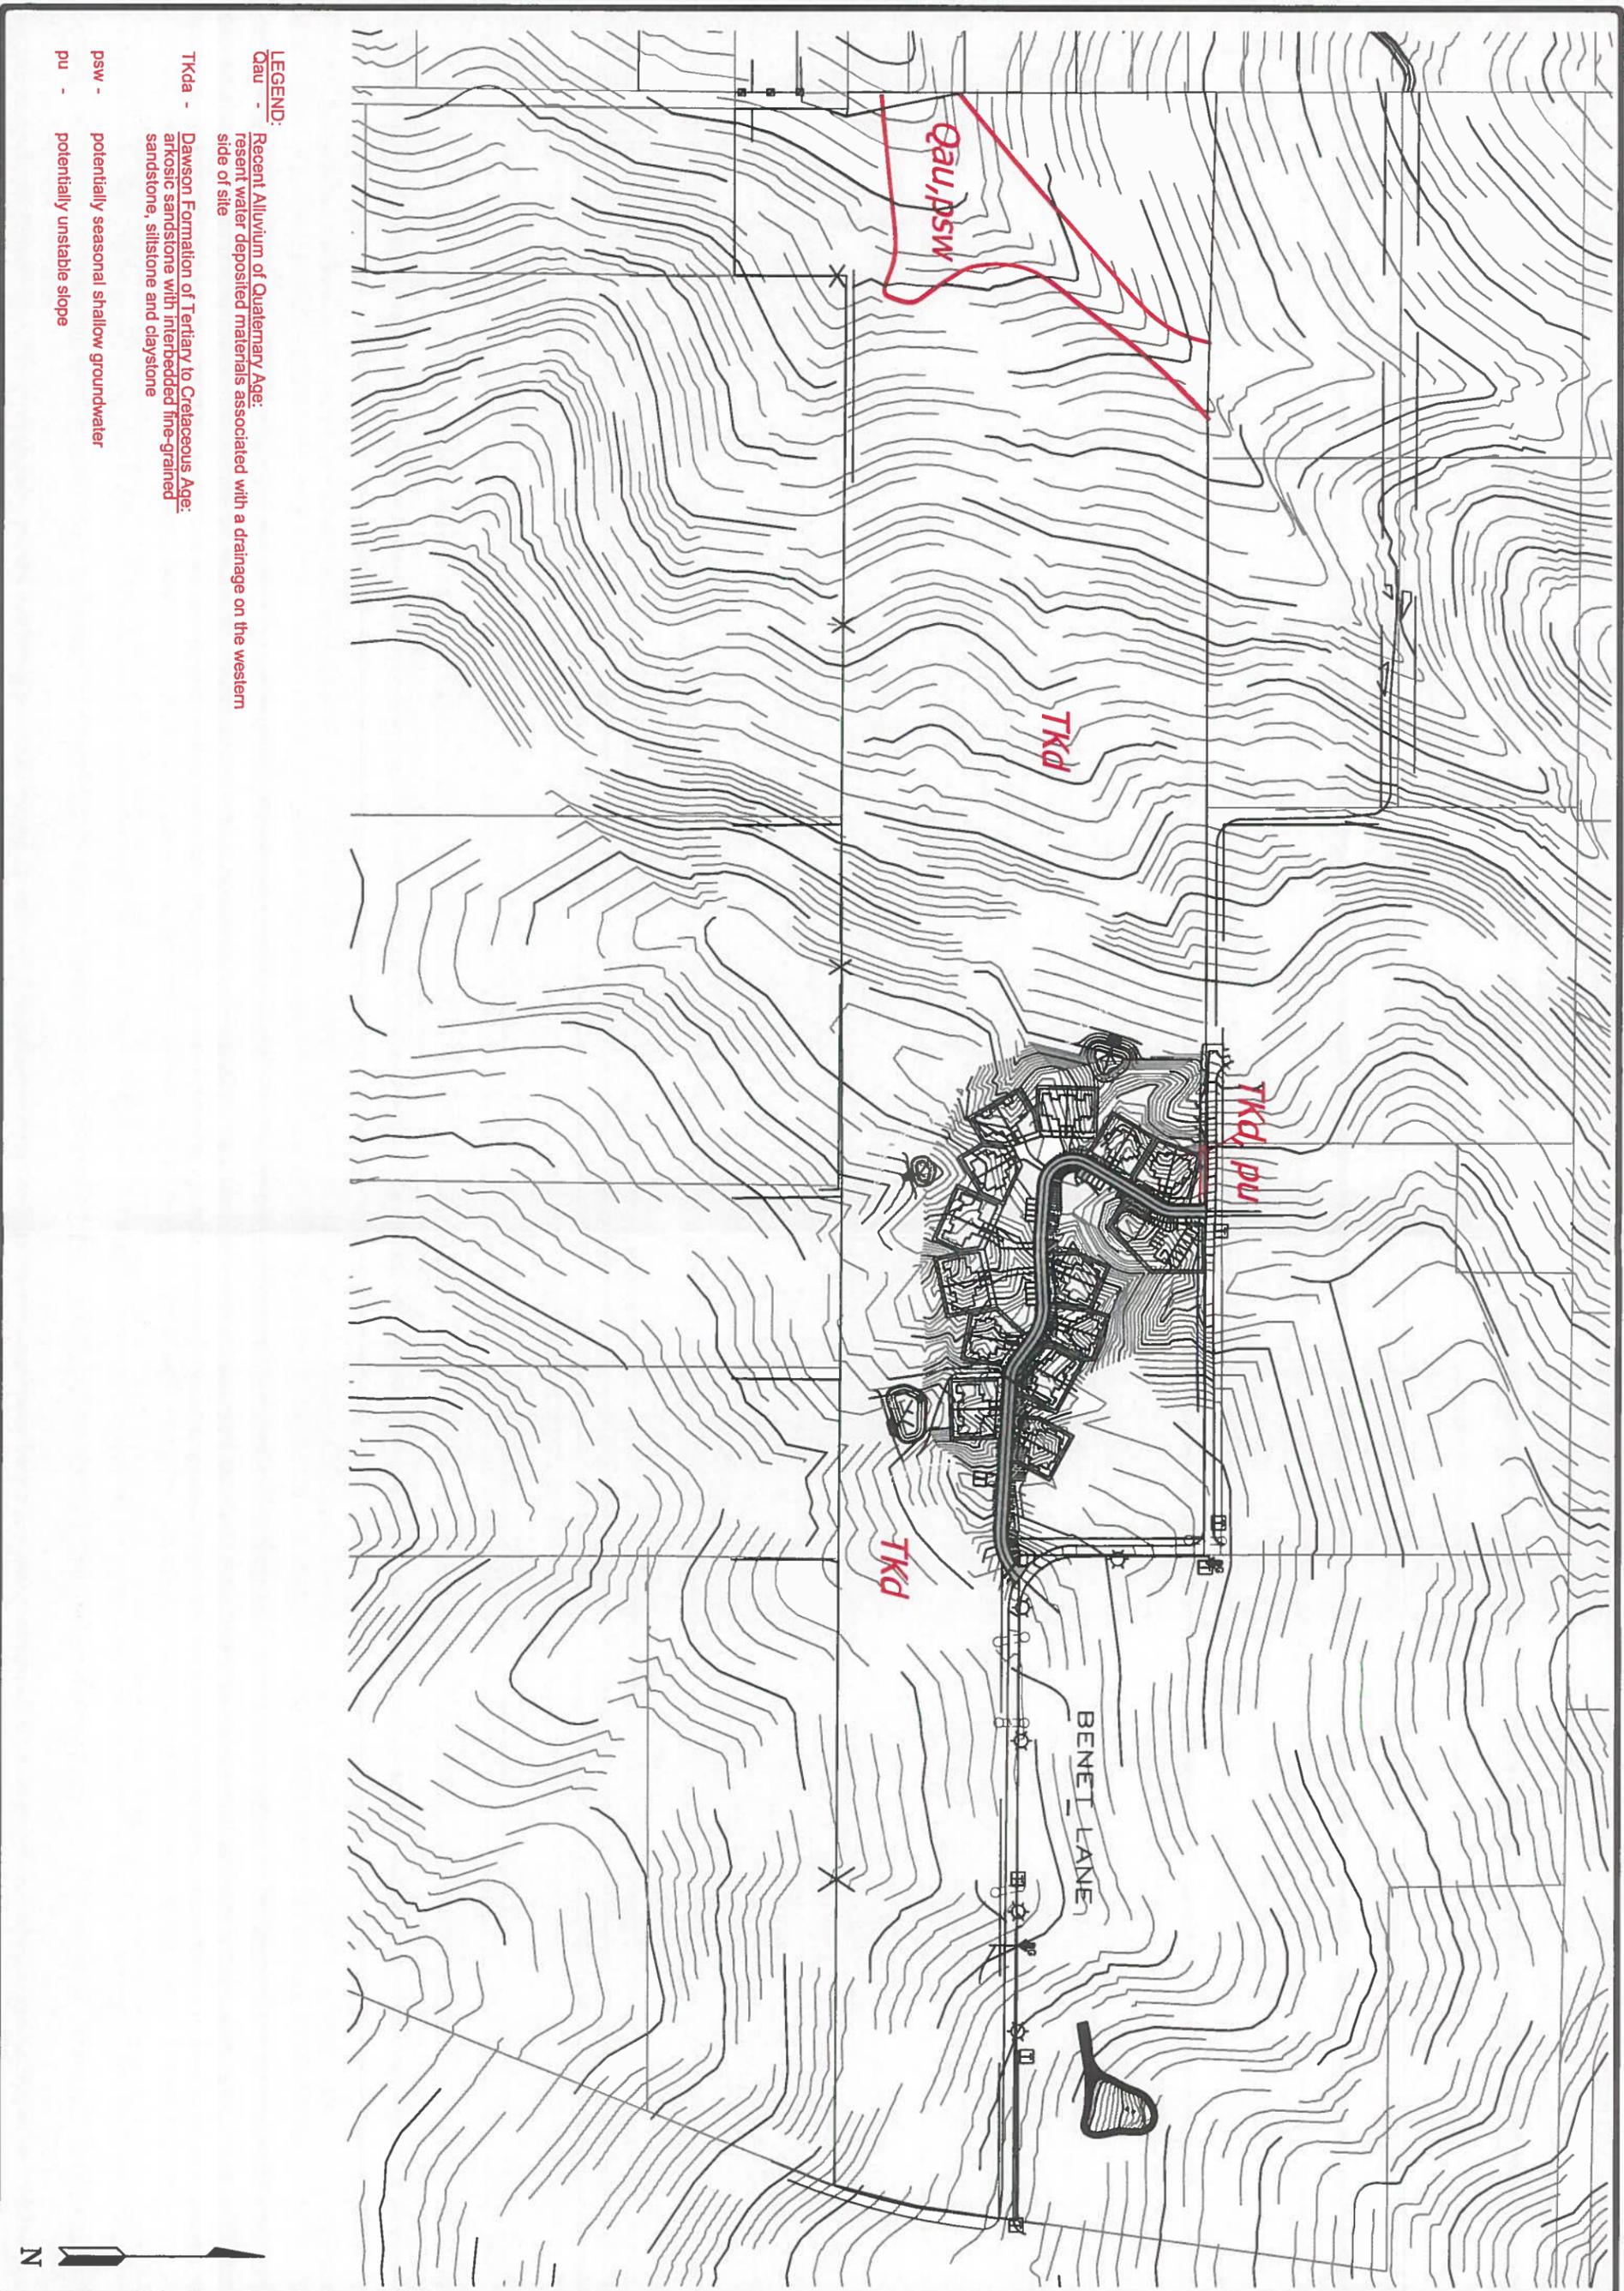
GEOLOGY/ENGINEERING GEOLOGY MAP
 SANCTUARY OF PEACE FILING NO. 1
 BENET LANE AND HIGHWAY 83
 EL PASO COUNTY, CO.
 FOR: MVE, INC.

As mentioned previously, detailed mapping has been performed on this site to produce an Geology/Engineering Geology Map (Figure 6). This map shows the location of various geologic conditions of which the developers should be cognizant during the planning, design and construction stages of the project. These hazards and the recommended mitigation techniques are as follows:

A steep road cut along Benet Lane in the north-central portion of the site has been identified as potentially unstable on the Geology/Engineering Geology Map Figure 6. A detail of the area is shown on Figure 6A. The road cut is not excessively high and is cut in primarily sandstone bedrock. Exposed Dawson Sandstone with an overlying layer of residual soils was observed in the road cut and it appears to be relatively stable in its present condition. Care should be taken that unstable conditions are not created by development. A building setback that allows for a 2.5:1 projection from the toe of the slope to structures is recommended unless further investigation is conducted. The recommended building setback is indicated on Figure 6A.

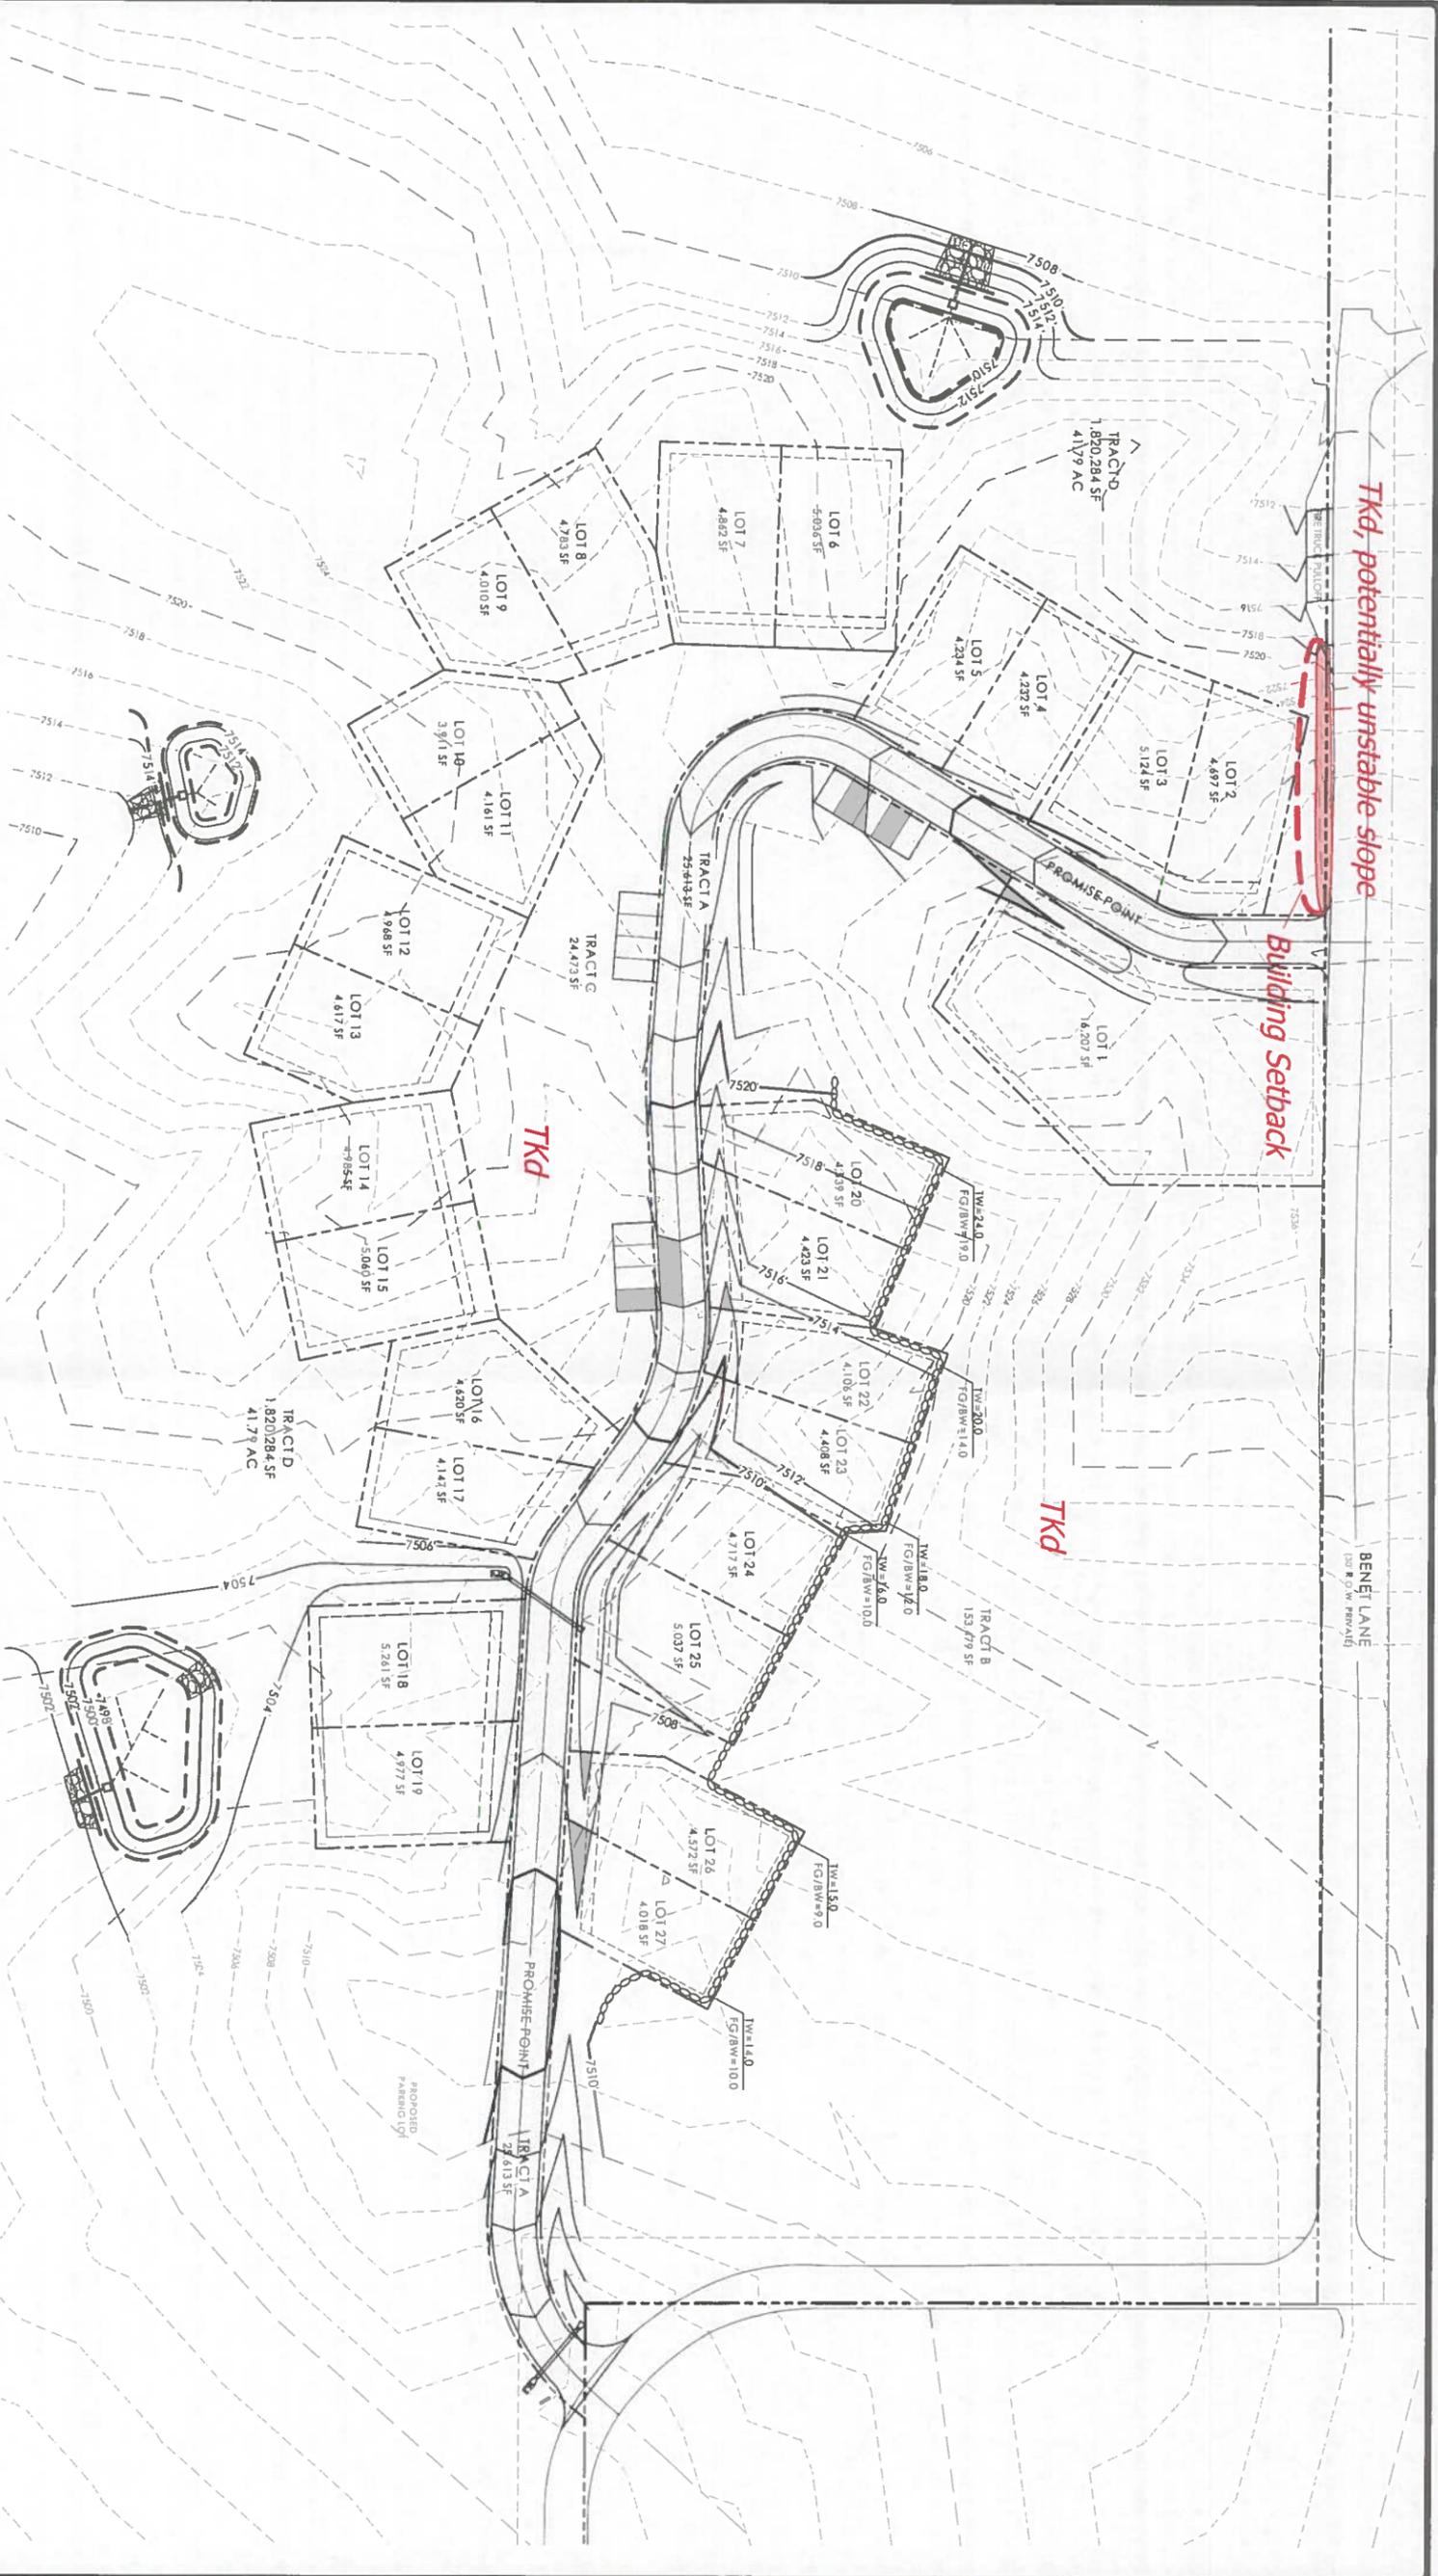
GEOLOGY/ENGINEERING GEOLOGY MAP DETAIL
SANCTUARY OF PEACE FILING NO. 1
BENET LANE AND HIGHWAY 83
EL PASO COUNTY, CO.
FOR: MVE, INC.

A potentially unstable slope has been mapped in the north-central portion of the site associated with a road cut along Benet Lane as indicated on Figures 6 and 6A. Sandstone was observed exposed in the road cut. A Building setback that allows for a 2.5:1 projection from the toe of the slope to the structures is recommended unless further investigation is conducted. The recommended building setback is indicated on Figure 6A. Structures that encroach on the road cut may require stepping down the foundation to prevent added surcharges to the slope. Additional reinforcement may also be required, such as tie beams or buttresses. Other

Mitigation: According to the development plan, the proposed building areas are outside the recommended setback area as indicated on Figure 6A. Foundations immediately adjacent to the road cut may require stepping down to avoid adding surcharges to the road cut. Additional reinforcement, such as tie beams or buttresses, may also be required. Surface stabilization of the soils to prevent erosion may also be necessary, depending on the location from the

proposed structures. Another option is to stabilize the slope. Stabilization could involve regrading the slope to no steeper than 2:1 or the use of engineer-designed retaining wall. It is anticipated the development can avoid the potentially unstable slope with the recommended building setback.

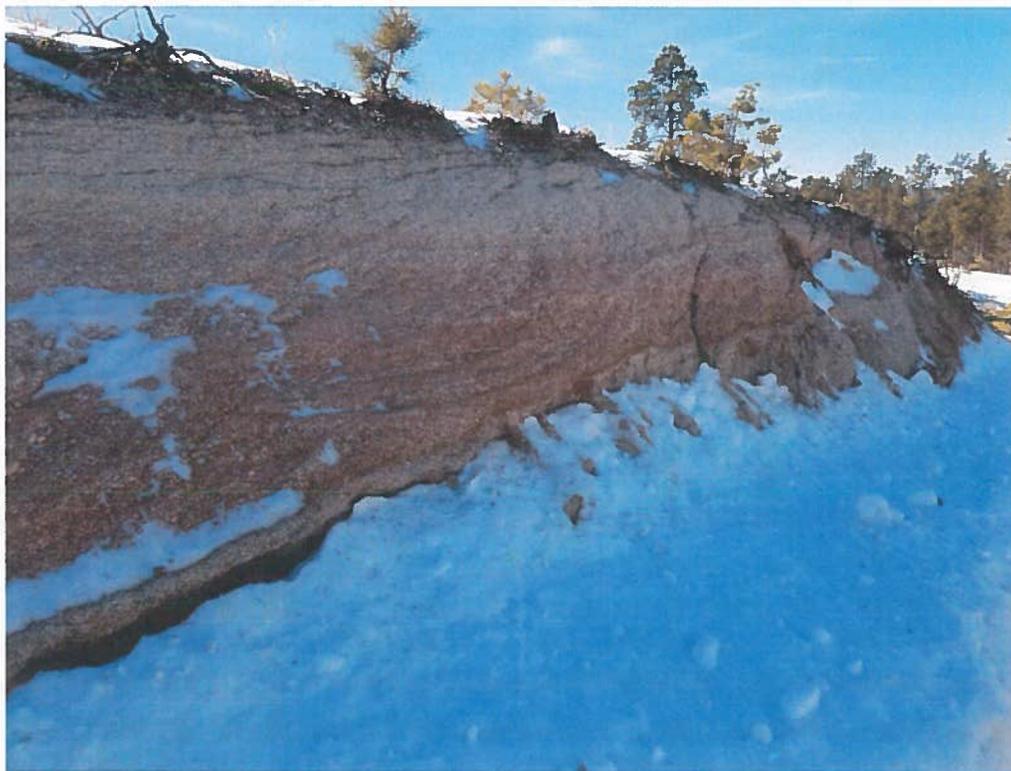
**Looking southwest at
road cut in northern
portion of the site.**
