**SOIL, GEOLOGY AND GEOLOGIC HAZARD STUDY
SANCTUARY OF PEACE FILING NO. 1
15760 HIGHWAY 83 AND BENET LANE
EL PASO COUNTY, COLORADO**

MVE, Inc.
1903 Lelaray Street, Suite 200
Colorado Springs, Colorado 80909

February 11, 2019

Entech Job No. 190118
AAprojects/2019/190118 countysoil/geo

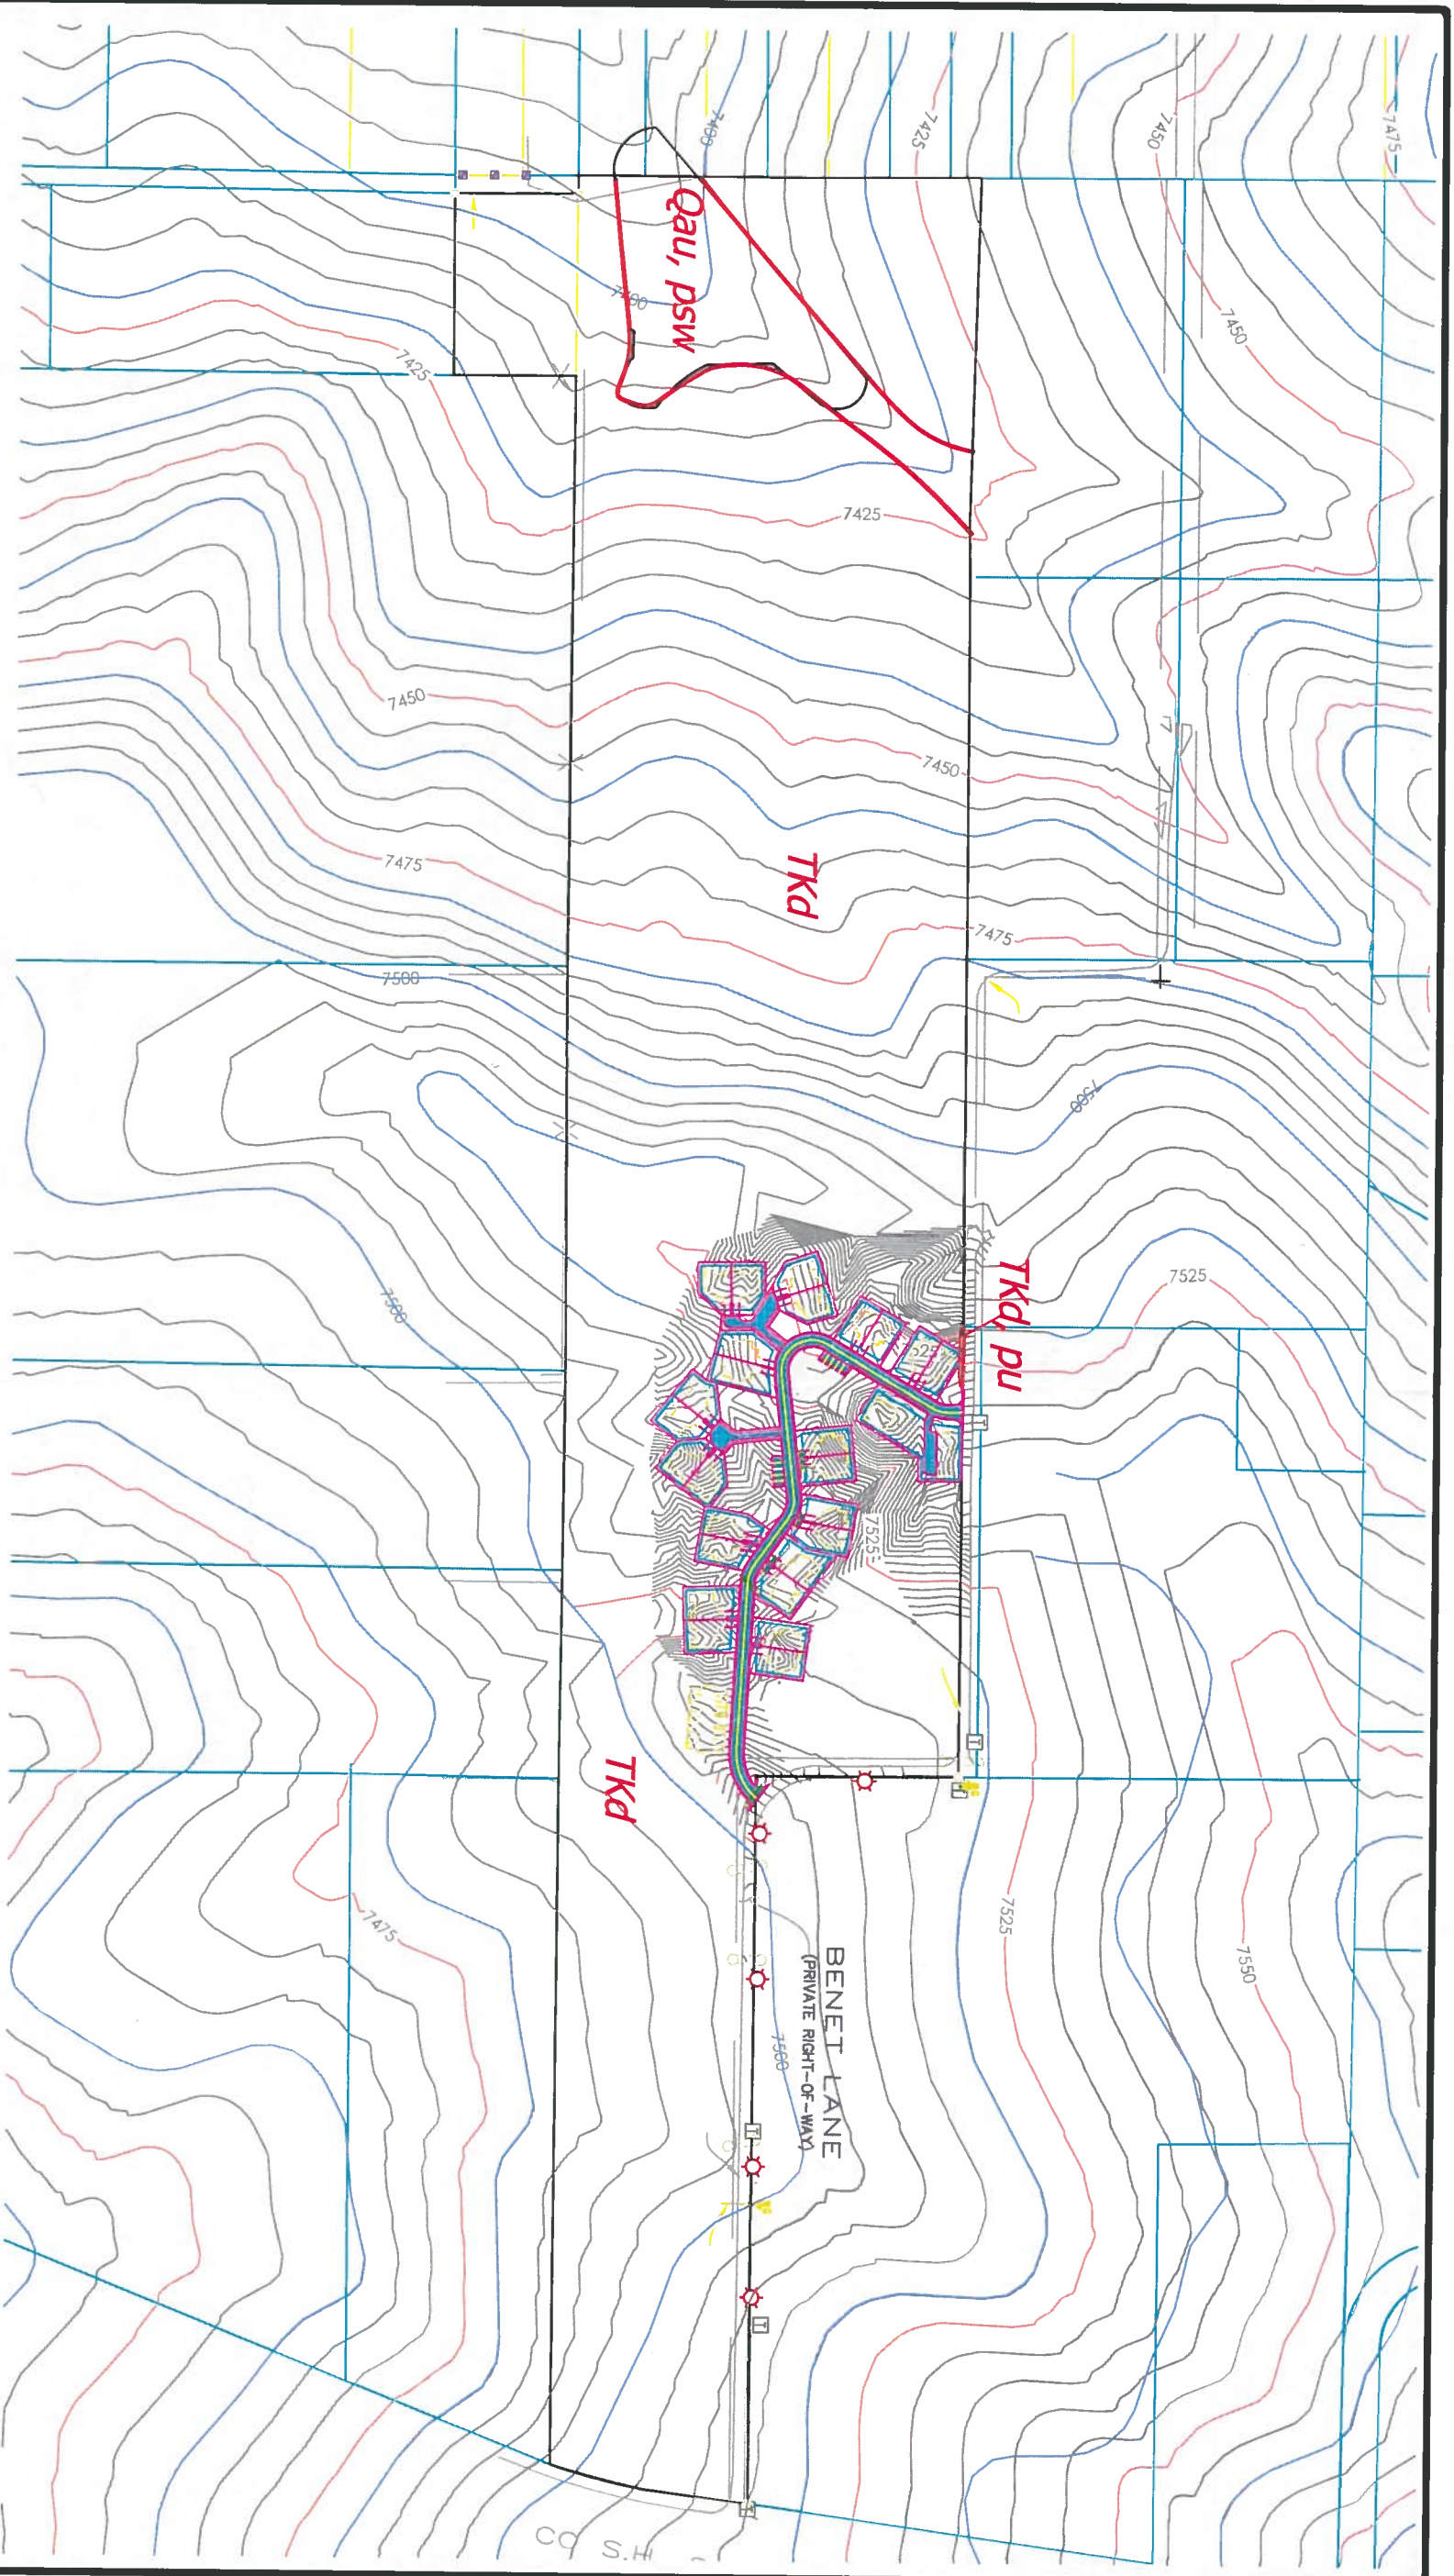
DATE	2/8/19
SCALE	AS SHOWN
BY	AS SHOWN
DATE	190118
FIGURE NO.	6

As mentioned previously, detailed mapping has been performed on this site to produce an Geology/Engineering Geology Map (Figure 6). This map shows the location of various geologic conditions of which the developers should be cognizant during the planning, design and construction stages of the project. These hazards and the recommended mitigation techniques are as follows:

A steep road cut along Benet Lane in the north-central portion of the site has been identified as potentially unstable. The road cut is not excessively high and is cut in sandstone bedrock. Exposed Dawson Sandstone with an overlying layer of residual soils was observed in the road cut and it appears to be relatively stable in its present condition. Care should be taken that unstable conditions are not created by development. Structures are proposed near this road cut that may require mitigation.

A potentially unstable slope has been mapped in the north-central portion of the site associated with a road cut along Benet Lane. A structure is proposed adjacent to the road cut. Sandstone was observed exposed in the road cut. It is recommended the foundation for structures that encroach on the road cut should be stepped down to prevent added surcharges to the slope. Additional reinforcement may also be required, such as tie beams or buttresses. Other alternatives include the use of drilled pier foundation systems or stabilizing the slope. Stabilization could involve regrading the slope to no steeper than 2:1 or the use of engineer-designed retaining walls.

psw - potentially seasonal shallow groundwater
 pu - potentially unstable slope

Mitigation: Foundations immediately adjacent to the road cut will require stepping down to avoid adding surcharges to the road cut. Additional reinforcement, such as tie beams or buttresses, may also be required. Surface stabilization of the soils to prevent erosion may also be necessary, depending on the location from the proposed structures. Another option is to stabilize the slope. Stabilization could involve regrading the slope to no steeper than 2:1 or the use of engineer-designed retaining wall. Specific recommendations should be made after additional investigation and when grading plans are finalized.

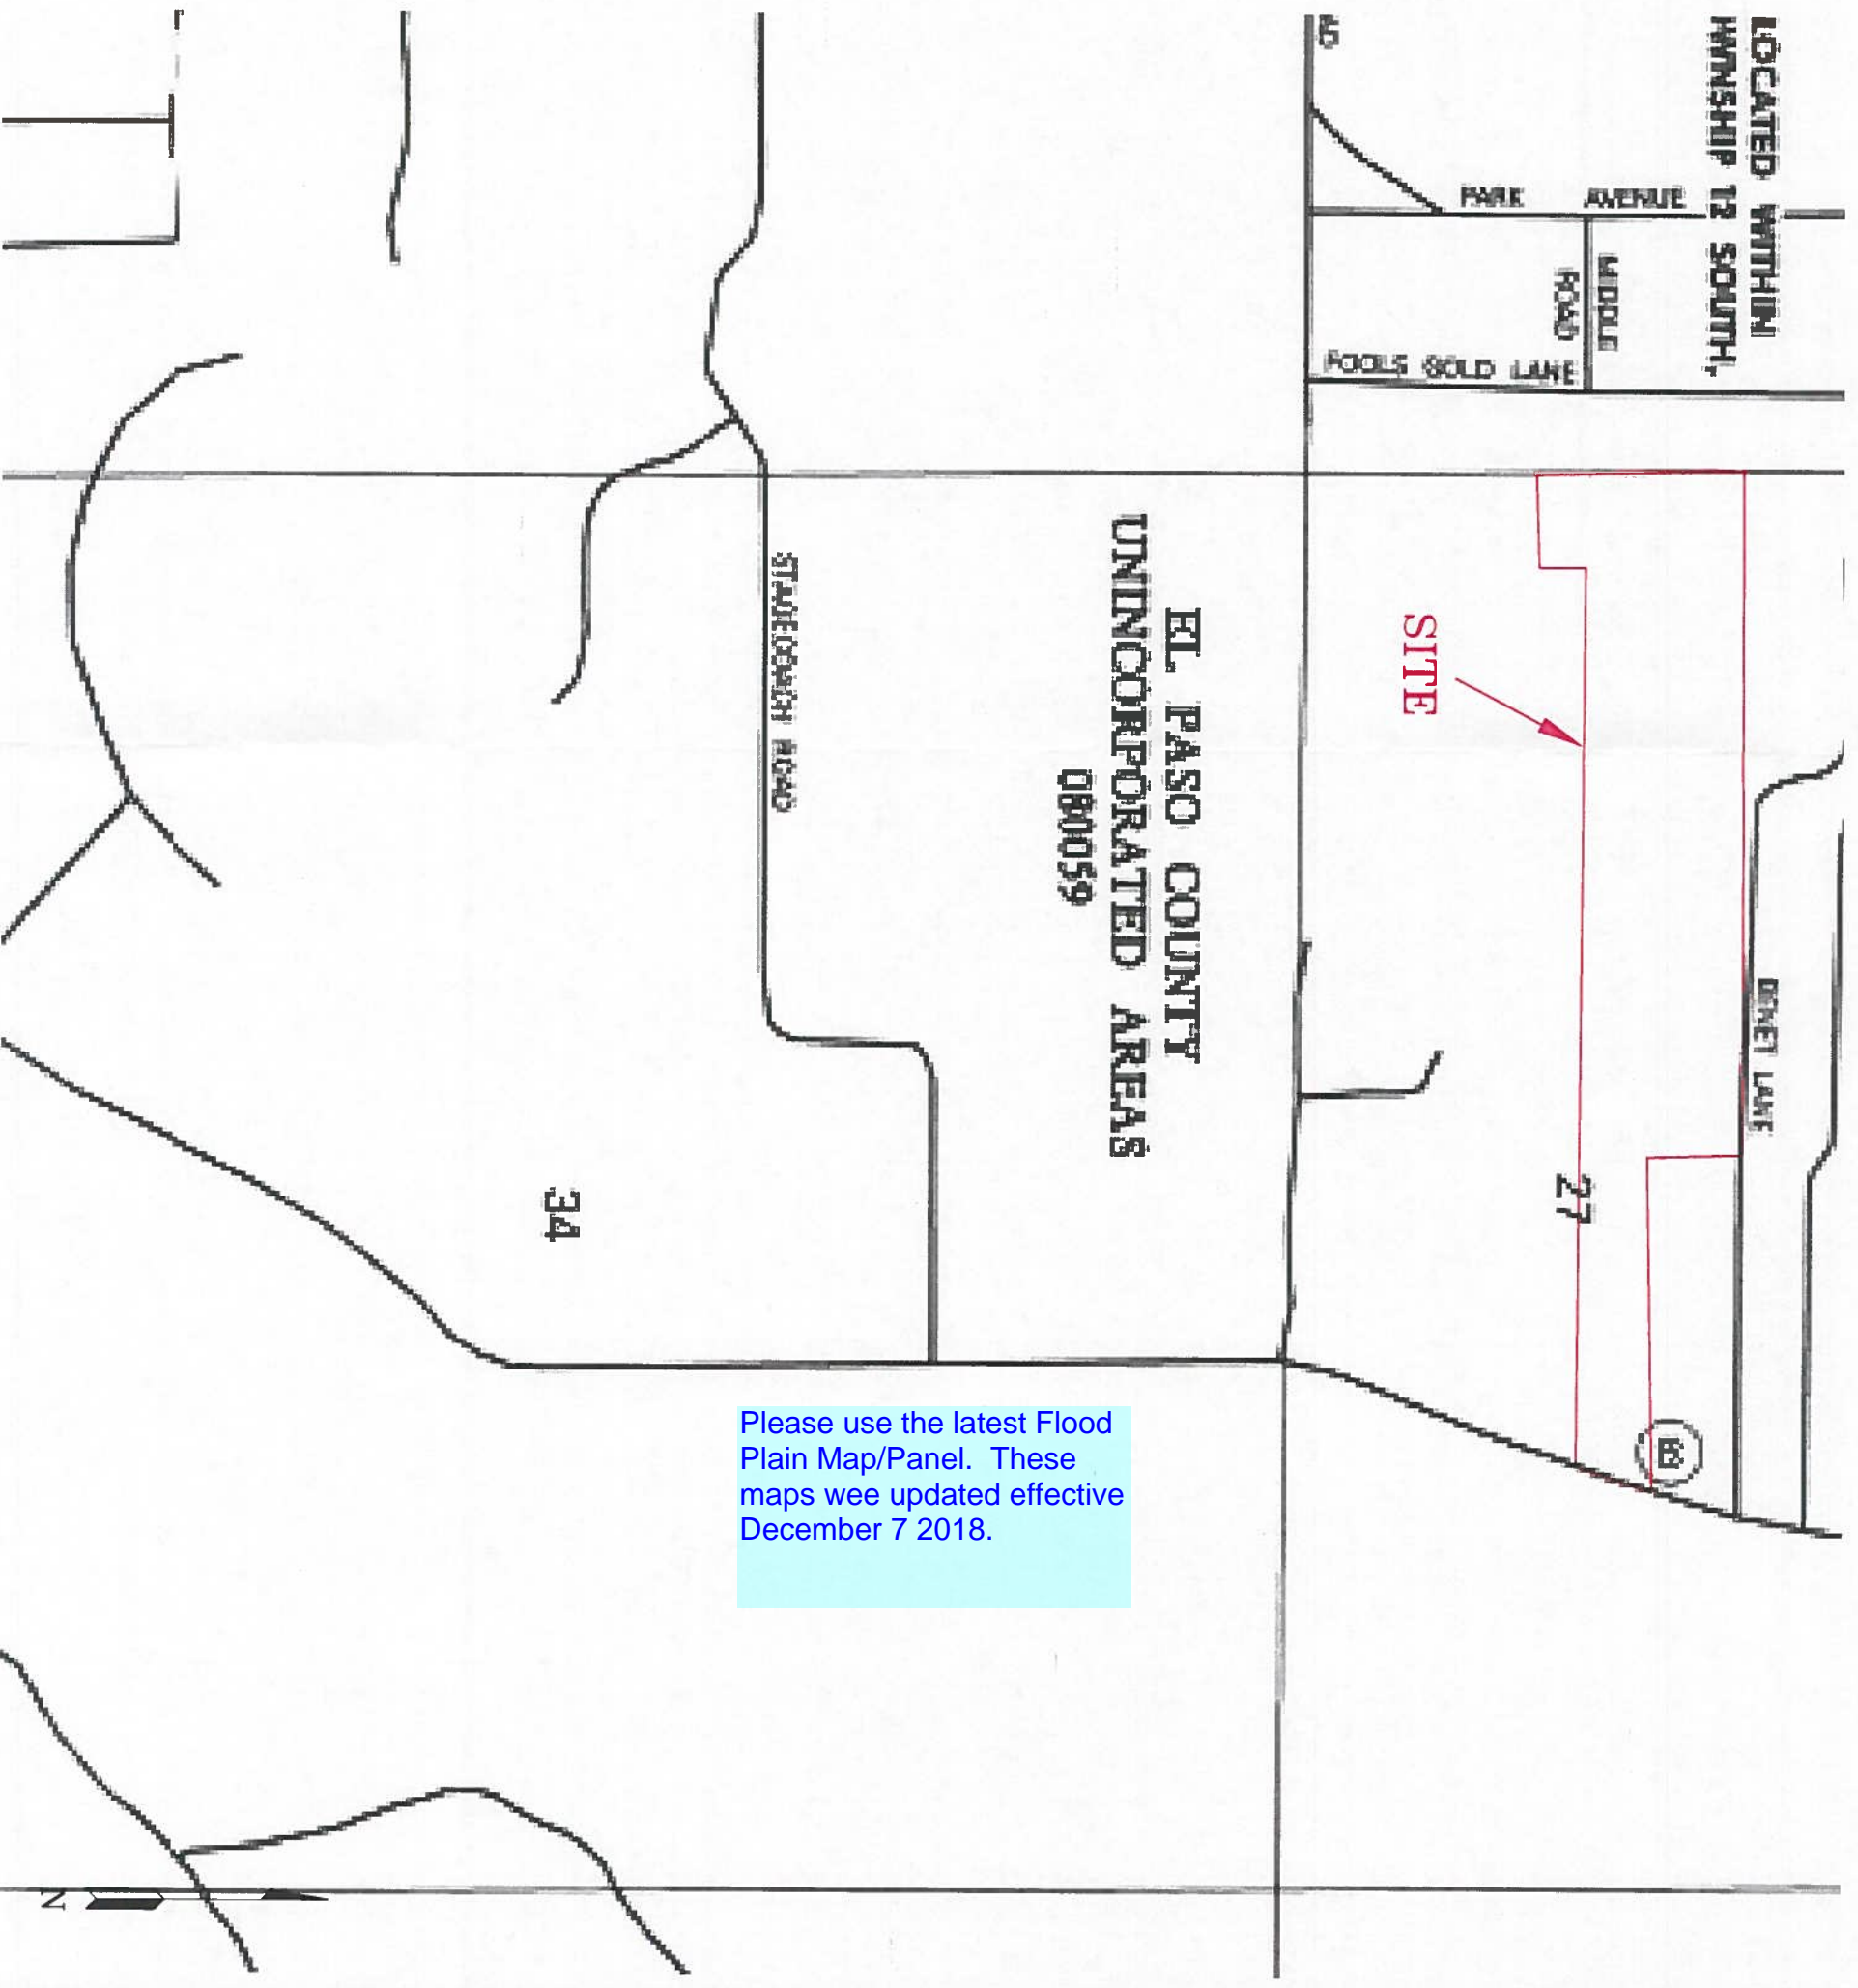
DATE	2/5/19
CHECKED	AS SHOWN
DRAWN	JOB NO. 190118
KAM	FIGURE NO. 7

The site is not mapped within any floodplains according to the FEMA Map No. 08041CO295F, (Figure 7, Reference 8). Areas of potentially seasonal shallow groundwater were observed in

Please use the latest Flood Plain Map/Panel. These maps were updated effective December 7 2018.

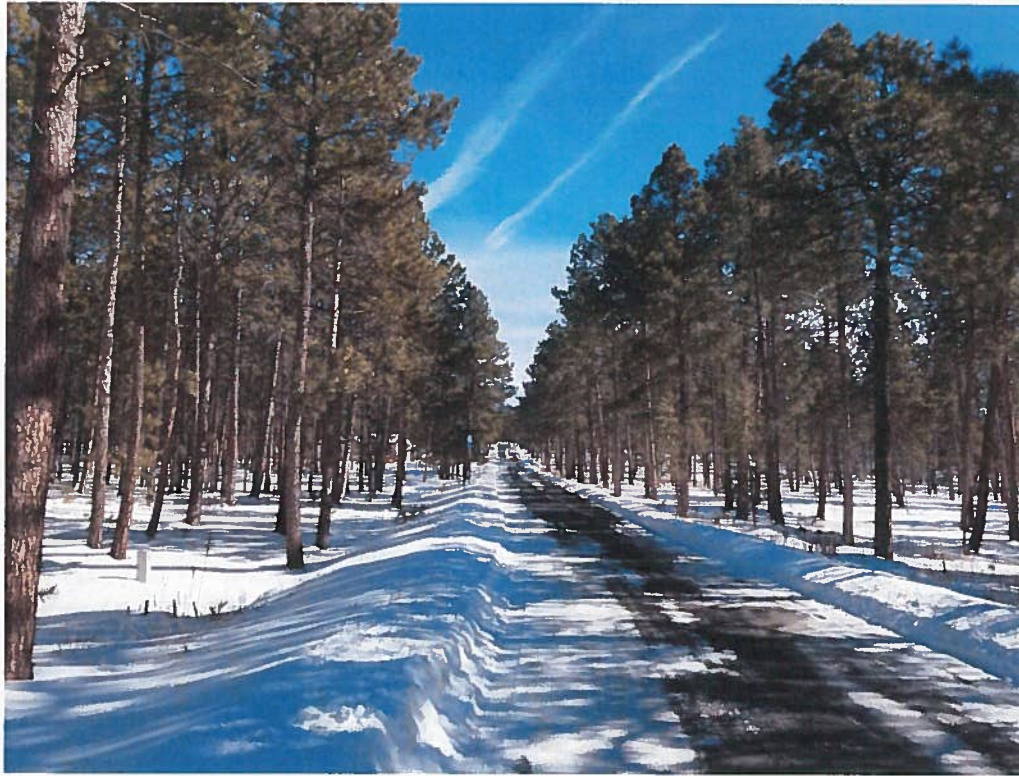
**Looking east along
main road eastern side
of site.**

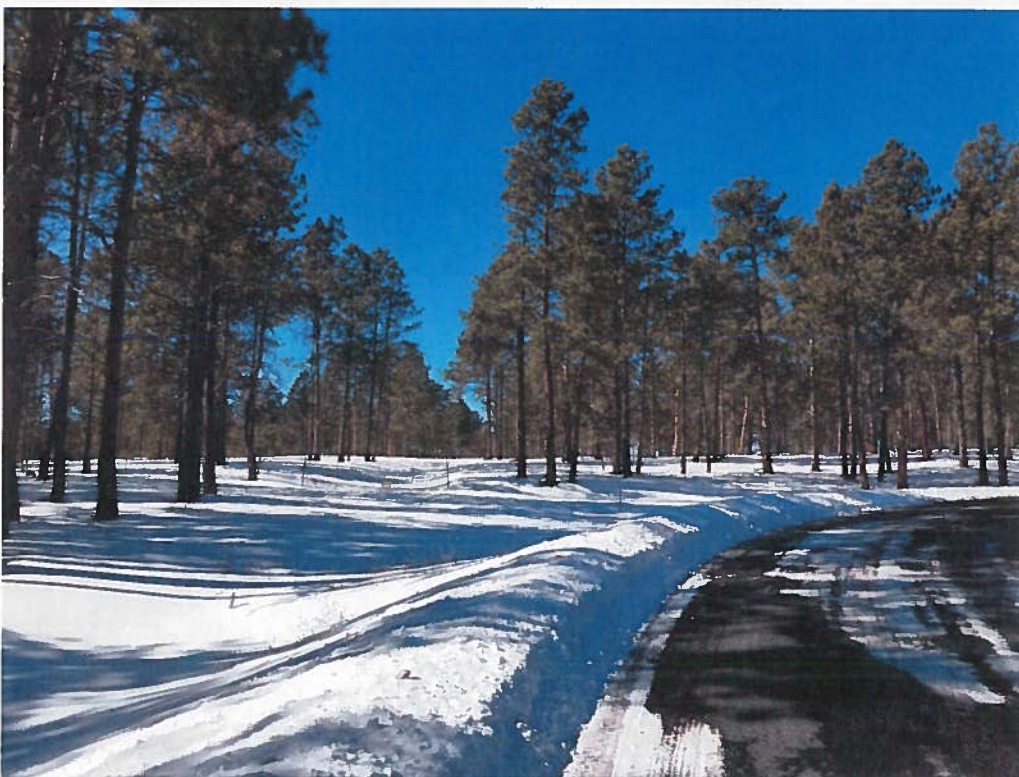
**Looking west from the
eastern side of the
site.**

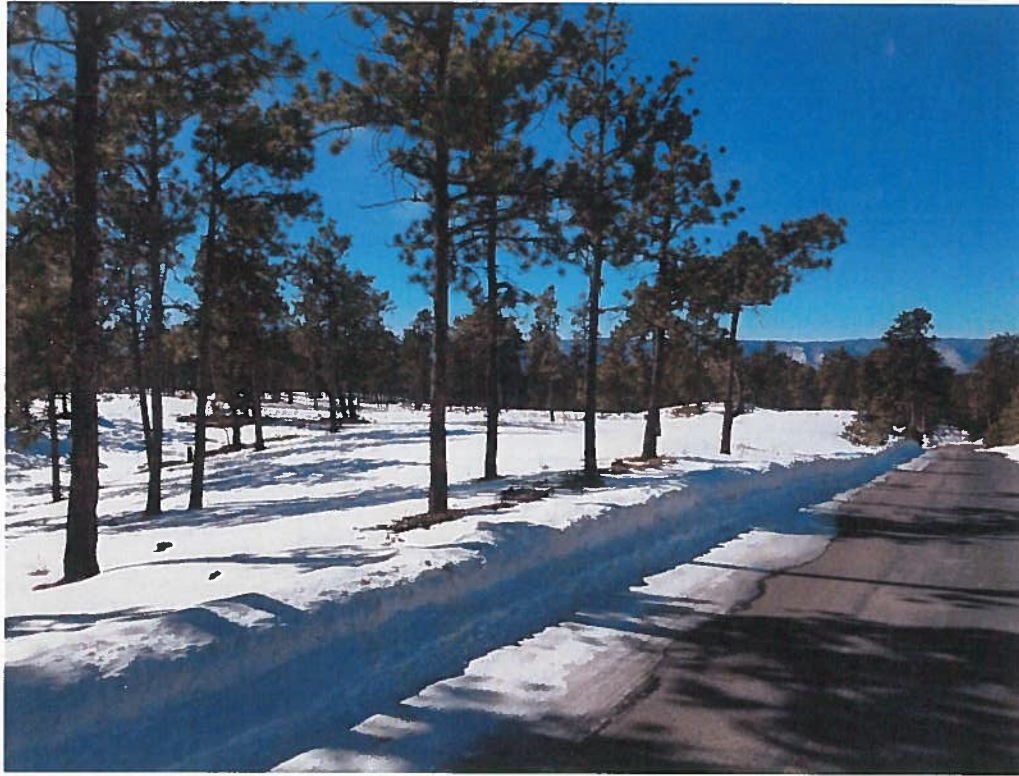
**Looking southwest
from the northern side
of the site.**

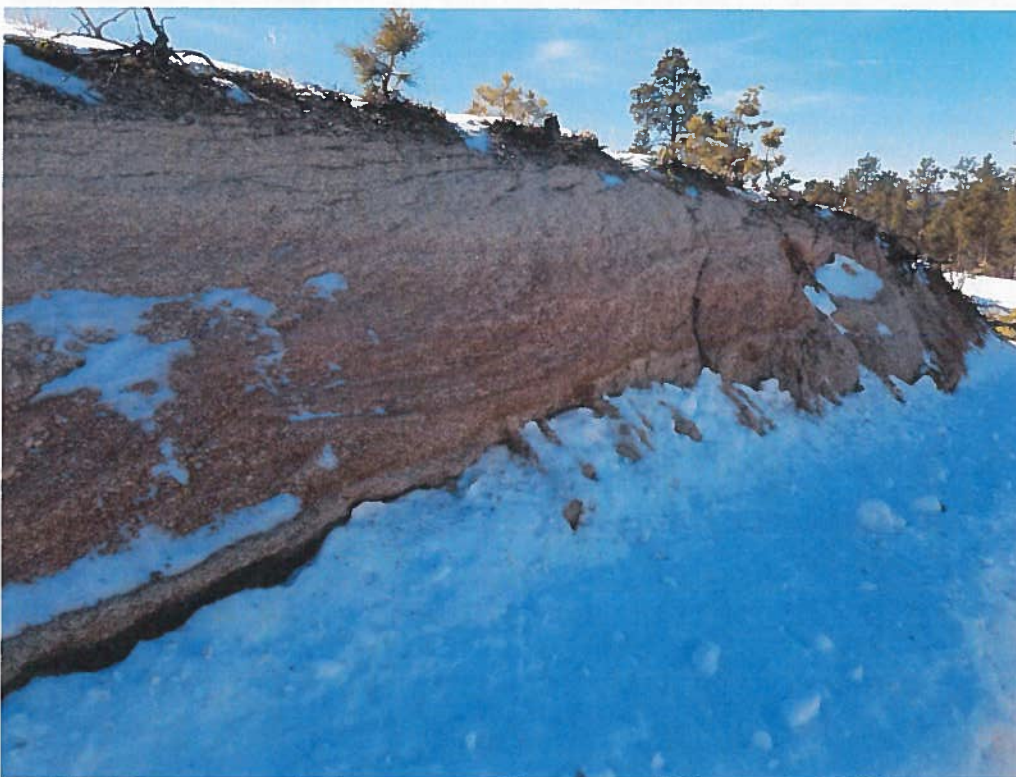
**Looking southwest at
road cut in northern
portion of the site.**
