**SOIL, GEOLOGY, AND GEOLOGIC HAZARD STUDY
WINSOME SUBDIVISION – FILING NO. 3
PORTIONS OF PARCEL NOS. 51000-00-497 & 51000-00-510
17480 MERIDIAN ROAD NORTH
EL PASO COUNTY, COLORADO**

May 21, 2021

Entech Job No. 210539
AAprojects/2021/210539 countysoil/geo/ww

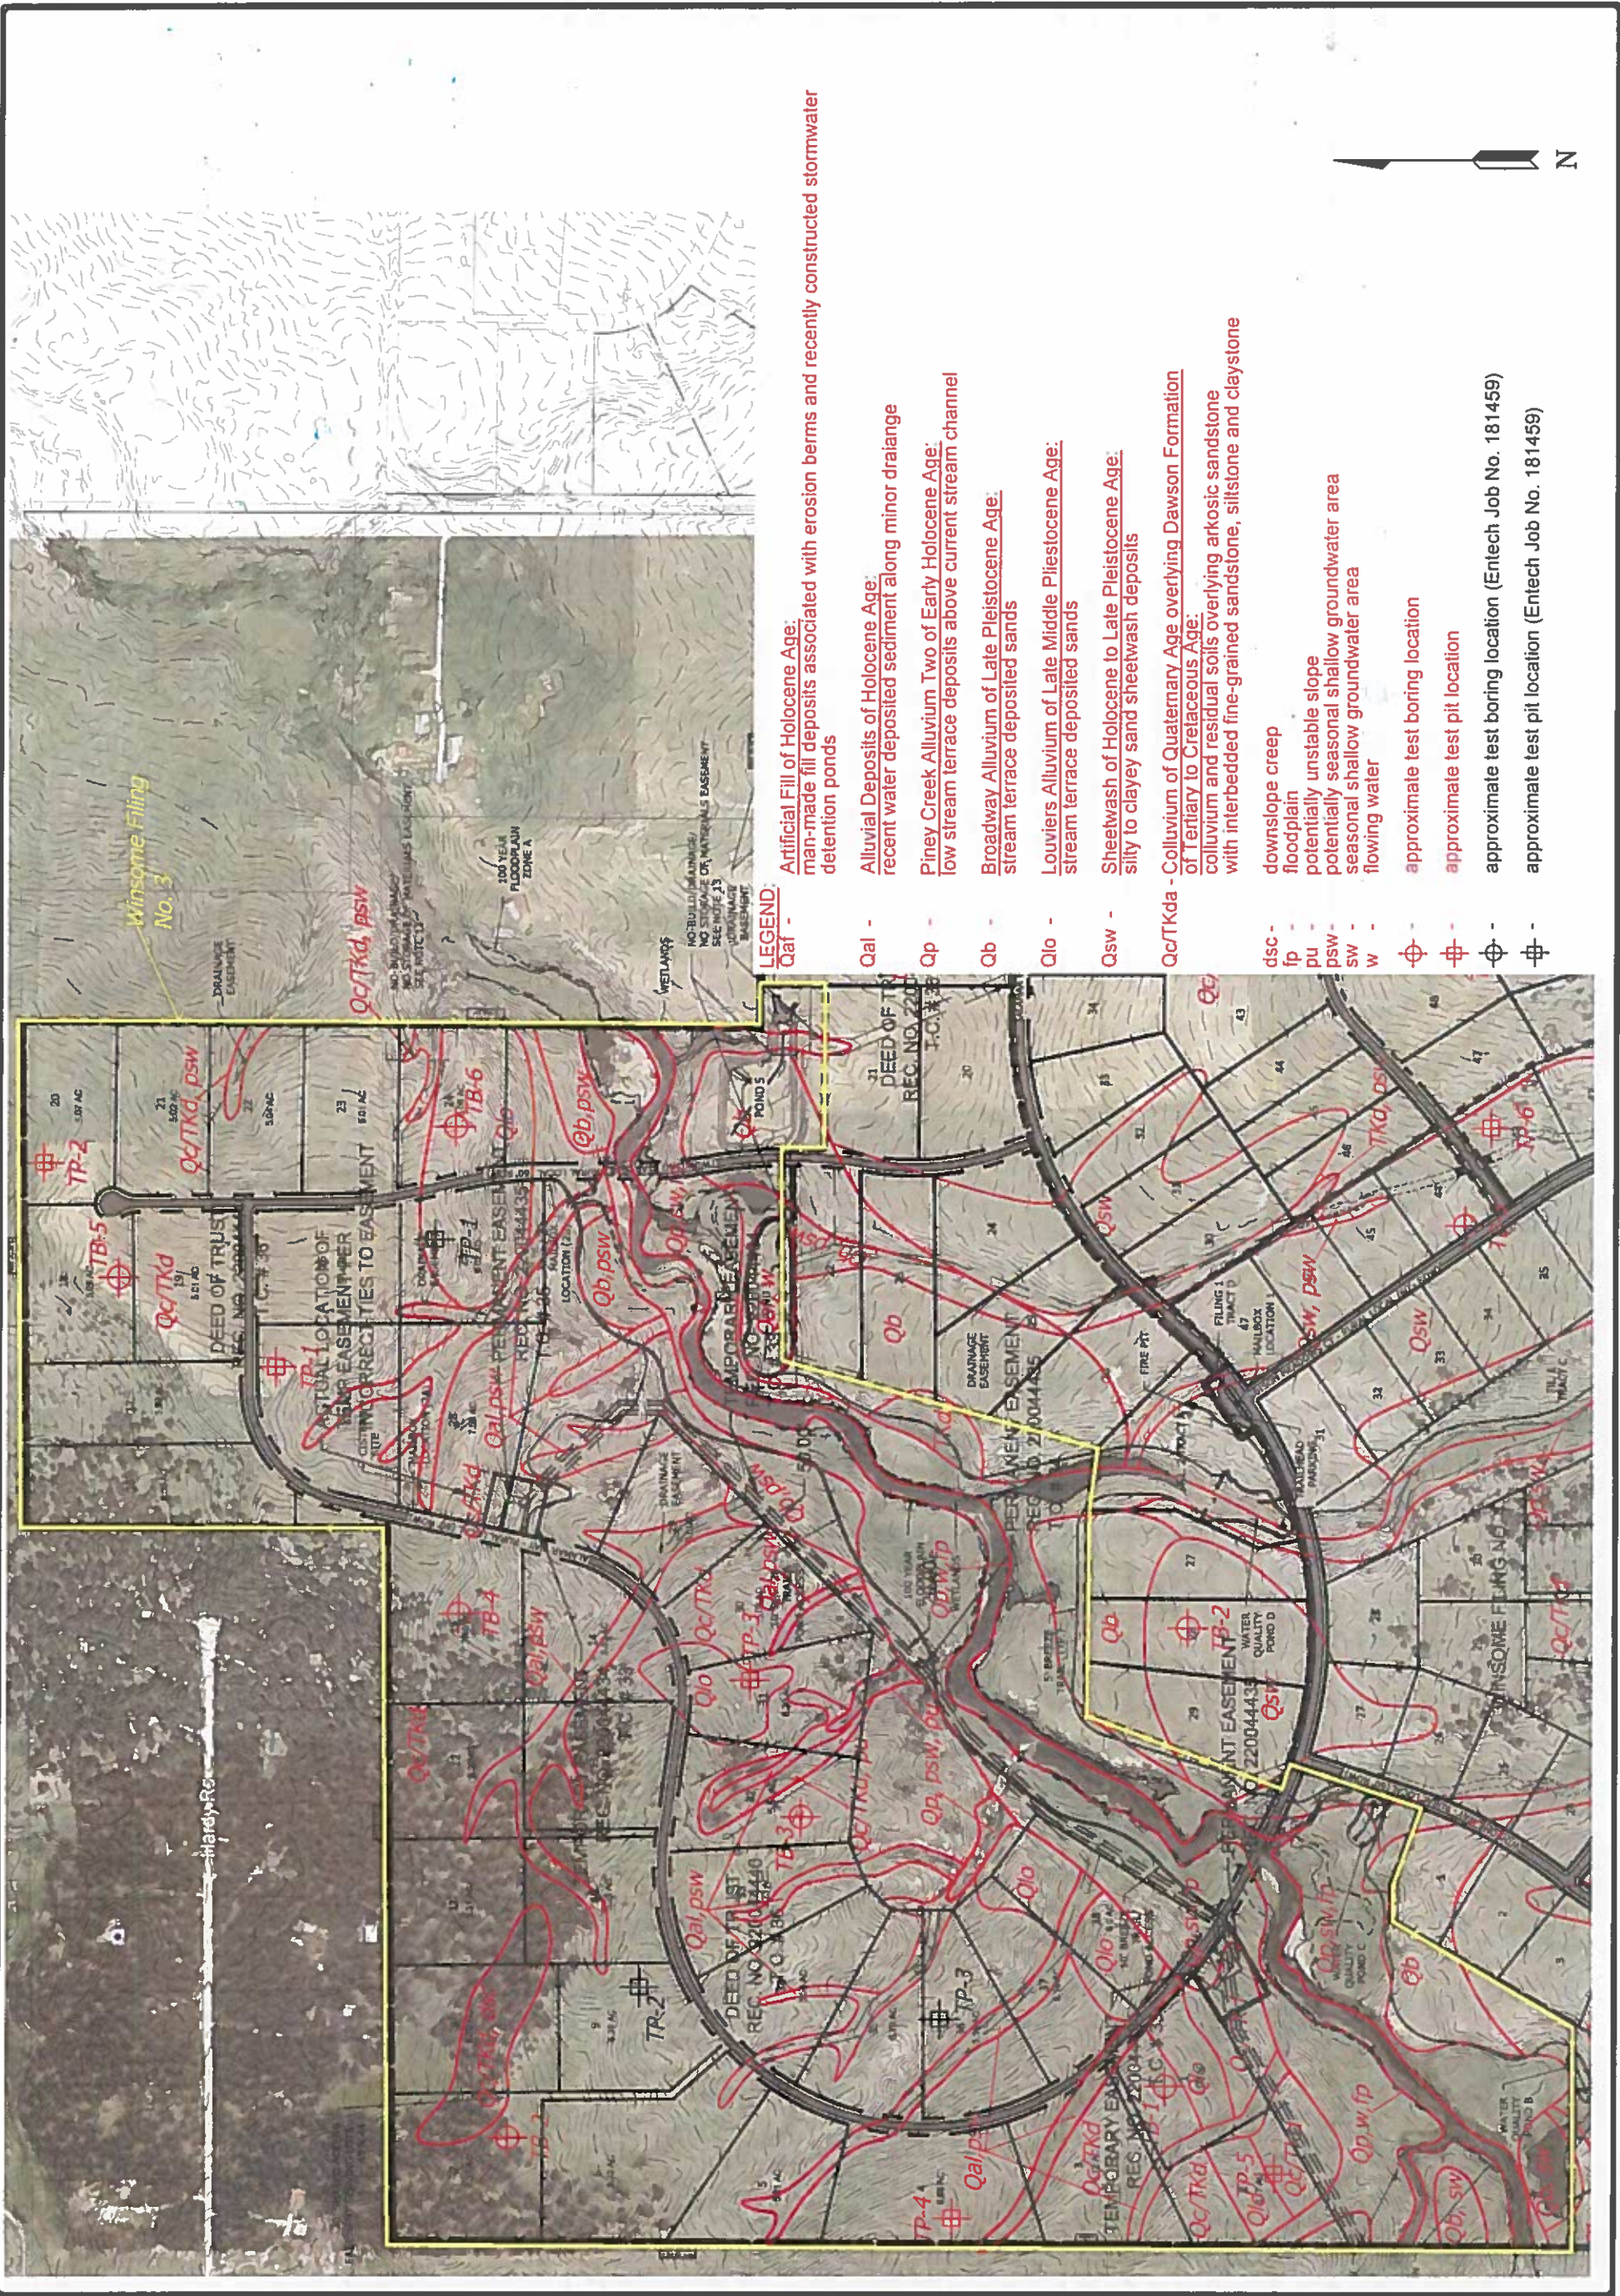
As mentioned previously, detailed mapping has been performed on this site to produce a Geology/Engineering Geology Map (Figure 6). This map shows the location of various geologic conditions of which the developers should be cognizant during the planning, design and construction stages of the project. These hazards and the recommended mitigation techniques are as follows:

The majority of the slopes in the building areas on site are gently to moderately sloping and do not exhibit any past or potential unstable slopes or landslides. However, the steeply sloping areas along the drainage in the central portion of the site have been identified as potentially unstable slopes. Additionally, areas of downslope creep have been mapped on the site. These areas are identified on the Geology/Engineering Geology Map, Figure 6. The recommendations for these areas are as follows:

The area identified with this hazard is located along a portion of a minor drainage where cut banks have created potentially unstable slopes. Considerable care must be exercised in these areas not to create a condition which would tend to activate instability.

The areas identified with this hazard includes some of the steeper slopes on site, particularly in the northwest portion of the site. In these areas, we would anticipate lateral and vertical movement of the near surface soils in the downslope direction. These areas are acceptable as building sites with the following constraints on construction.

Mitigation: Building should be avoided in these areas. The lots most significantly affected by potentially unstable slopes are Lot 31 and 32. The structures on these lots should be set back a minimum of 30 feet from the crest of these slopes. The recommended setback lies within the proposed no build area. There is sufficient room on the lots to avoid this hazard. Proper control of drainage at both the surface above the slope and the subsurface is extremely important. Areas of ponded water at the surface should be avoided. Utility trenches, basement excavations and other subsurface features should not be permitted to become water traps which may promote saturation of the subsurface materials. Drainage should not be permitted over the potentially unstable slope but directed in a non-erosive manner away from the slope. Irrigation above these slopes should be kept to a minimum to prevent saturation of the subsurface soils. The use of xeriscape landscaping utilizing native plantings is recommended to reduce the need for irrigation.

Mitigation: Building is possible in these areas if the following engineering and construction mitigation steps are taken: This type of movement will increase lateral pressures against foundation walls on the uphill side of structures. The design of foundations in these areas should account for this additional pressure. Additionally, the foundation should be designed to withstand pressures where steeper areas slope away from the foundation. Tie beams and buttresses are recommended to stiffen the foundation system.
