**SOIL, GEOLOGY, GEOLOGIC HAZARD,
AND WASTEWATER STUDY,
HODGEN ROAD SUBDIVISION
PARCEL NO. 51990-01-009
NORTHWEST OF HODGEN ROAD
AND BLACK FOREST ROAD
EL PASO COUNTY, COLORADO**

April 20, 2018

Entech Job No. 180368
AAprojects/2018/180368 countysoil/geo/ww

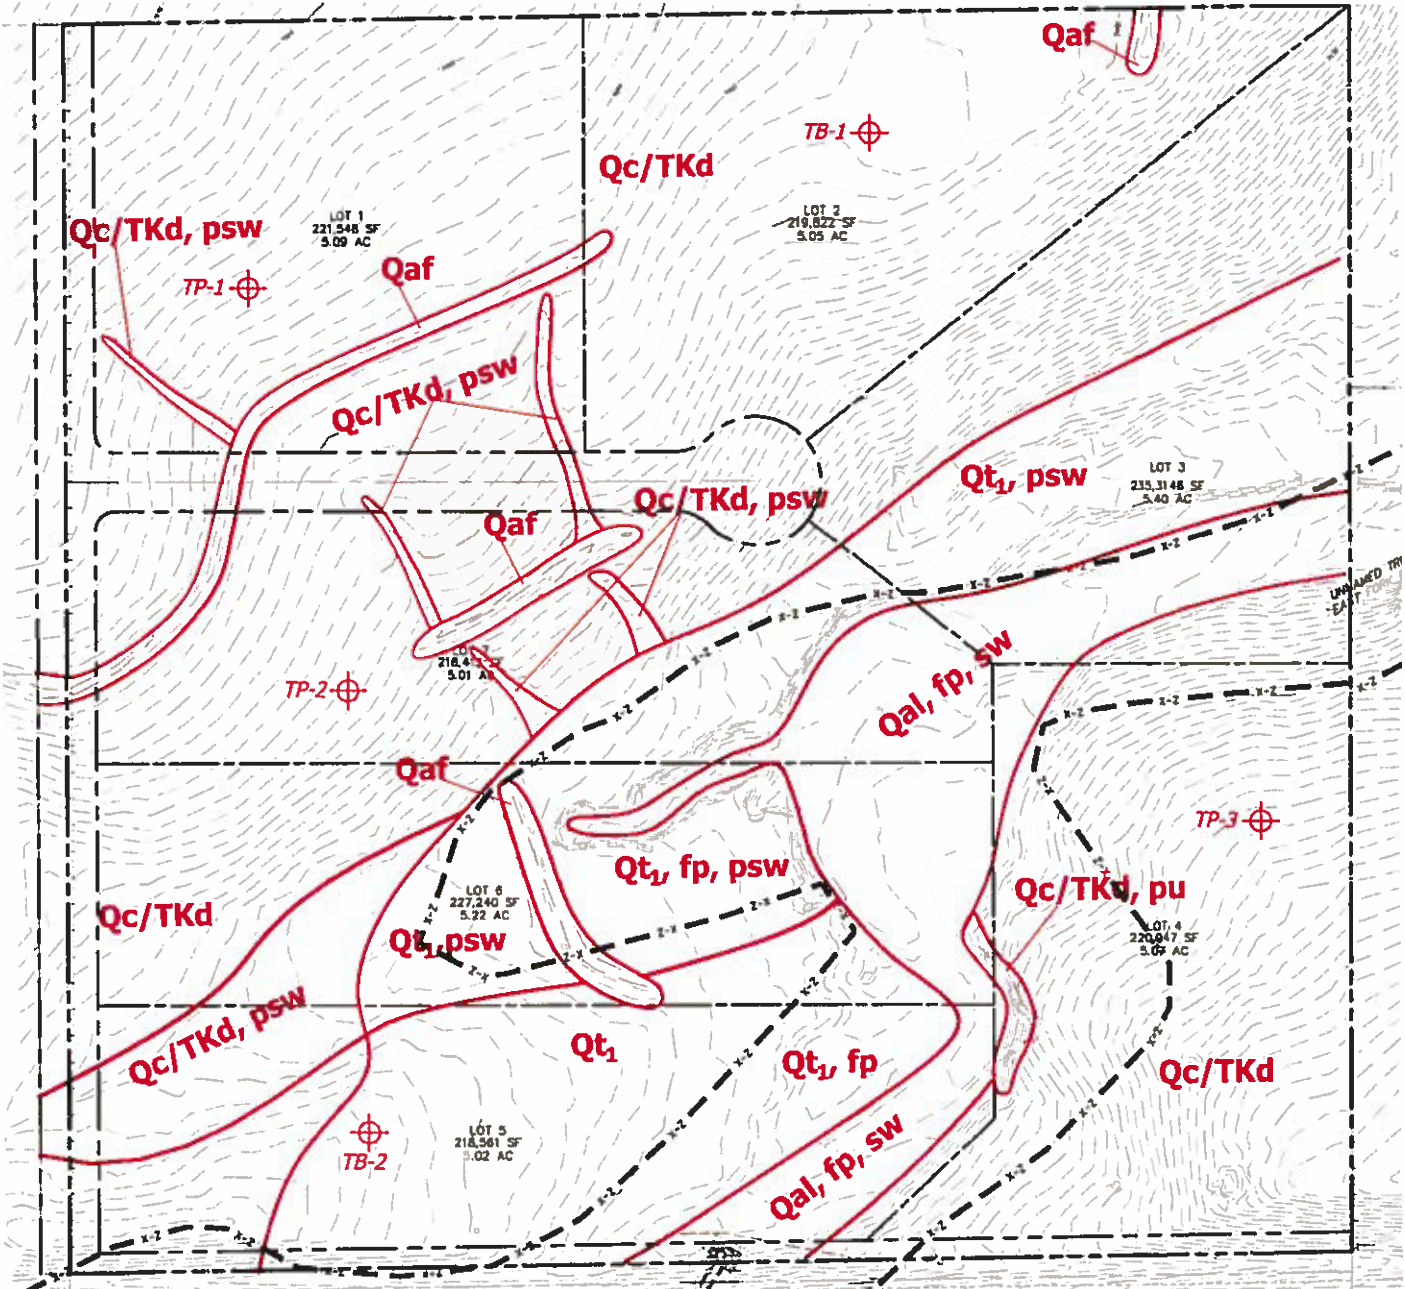
FIG NO.:
6

As mentioned previously, detailed mapping has been performed on this site to produce an Geology/Engineering Geology Map (Figure 6). This map shows the location of various geologic conditions of which the developers should be cognizant during the planning, design and construction stages of the project. These hazards and the recommended mitigation techniques are as follows:

The majority of the slopes in the building areas on site are gently to moderately sloping and do not exhibit any past or potential unstable slopes or landslides. However, the steeply sloping areas along the drainage in the southeastern portion of the site have been identified as potentially unstable slopes. These areas are identified on the Geology/Engineering Geology Map, Figure 6. The recommendations for these areas are as follows:

The area identified with this hazard is located along the southeastern side of the drainage where a cut bank of the tributary has created an unstable slope. The slope is located in portions of Lots 4, 5, and 6. These slopes are considered stable in their present condition; however, considerable care must be exercised in these areas not to create a condition which would tend to activate instability.

Mitigation: Building should be avoided in these areas. The lot most significantly affected by potentially unstable slope is Lot 4. The structure on this lot should be set back a minimum of 40 feet from the crest of this slope. There is sufficient room on the lot to avoid this hazard. Proper control of drainage at both the surface above the slope and the subsurface is extremely important. Areas of ponded water at the surface should be avoided. Utility trenches, basement excavations and other subsurface features should not be permitted to become water traps which may promote saturation of the subsurface materials. Drainage should not be permitted over the potentially unstable slope but directed in a non-erosive manner away from the slope. Irrigation above these slopes should be kept to a minimum to prevent saturation of the subsurface soils. The use of xeriscope landscaping utilizing native plantings is recommended to reduce the need for irrigation.

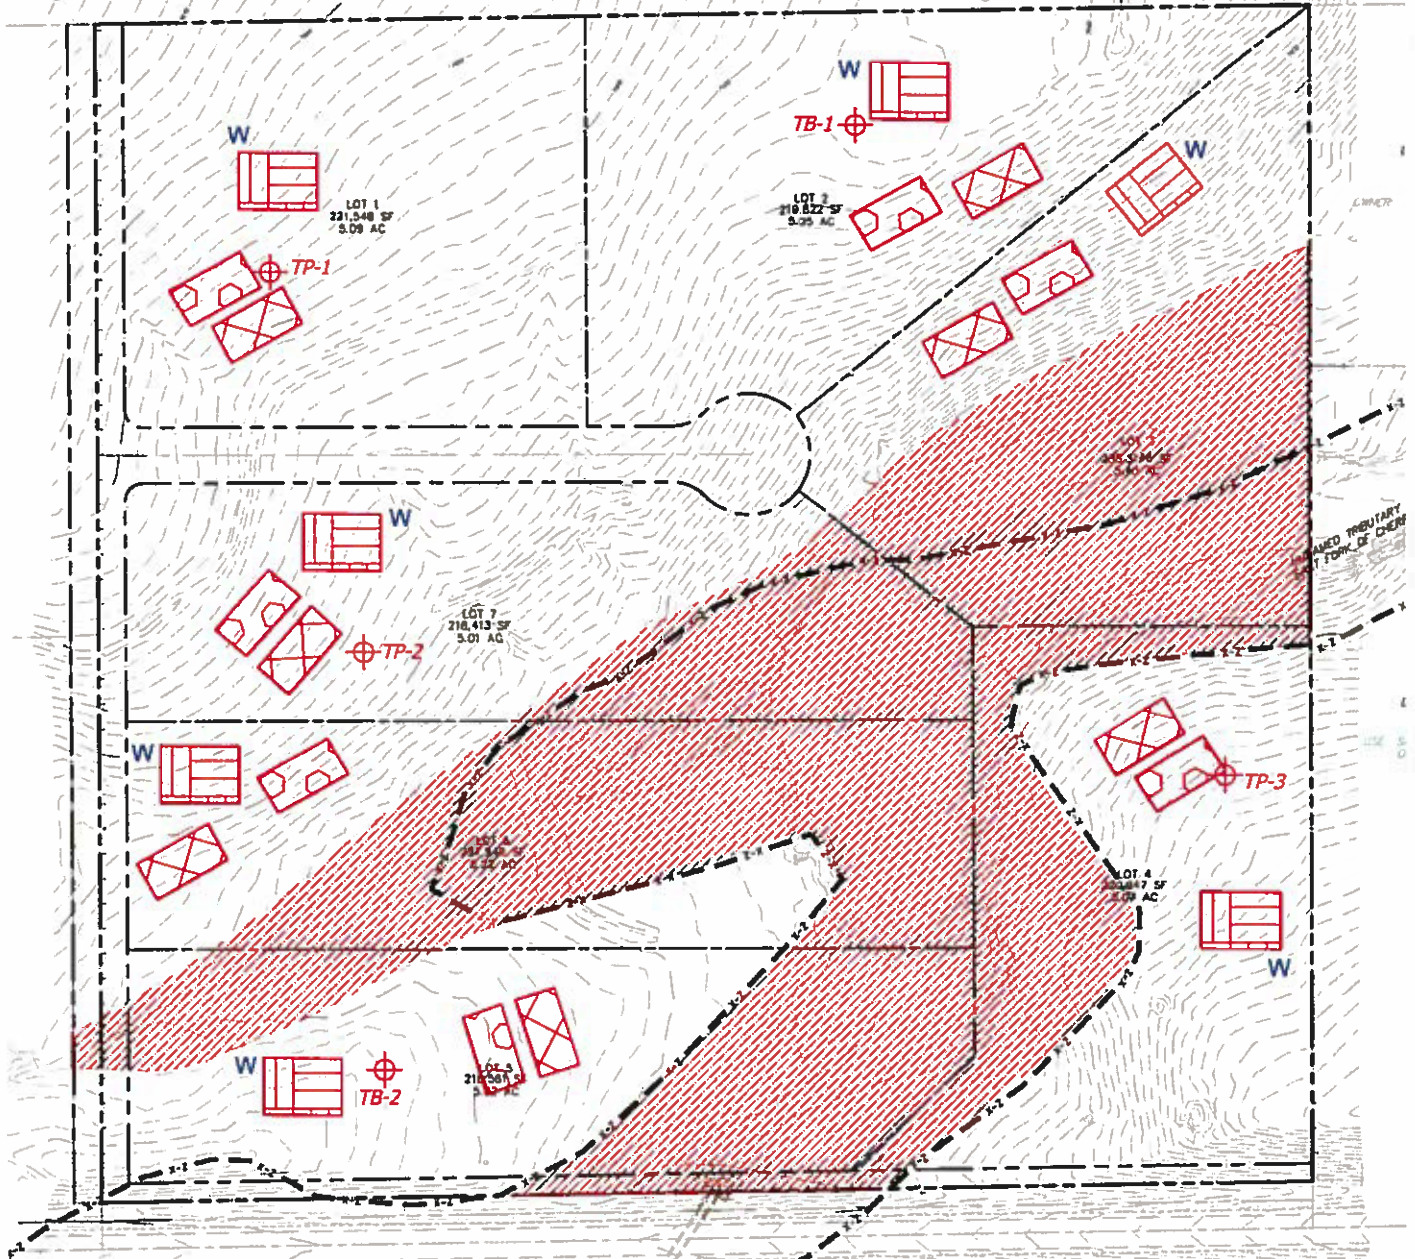
FIG NO.:
 9

Soils encountered in the tactile test pits consisted of loamy sand, sandy clay loam and sandy clay. Bedrock was not encountered in the test pits which were excavated to 8 feet. The limiting layers encountered in the test pits are the sandy loam (Soil Type 2), and sandy clay (Soil Type 4) which corresponds to LTAR values of 0.60 to 0.20 gallons per day per square foot. The conditions encountered in the Test Pit Nos. 1 and 2 will require a designed system. Additional investigation may identify areas where suitable for conventional systems could be used.

- AREAS WHERE OWTS ARE NOT RECOMMENDED

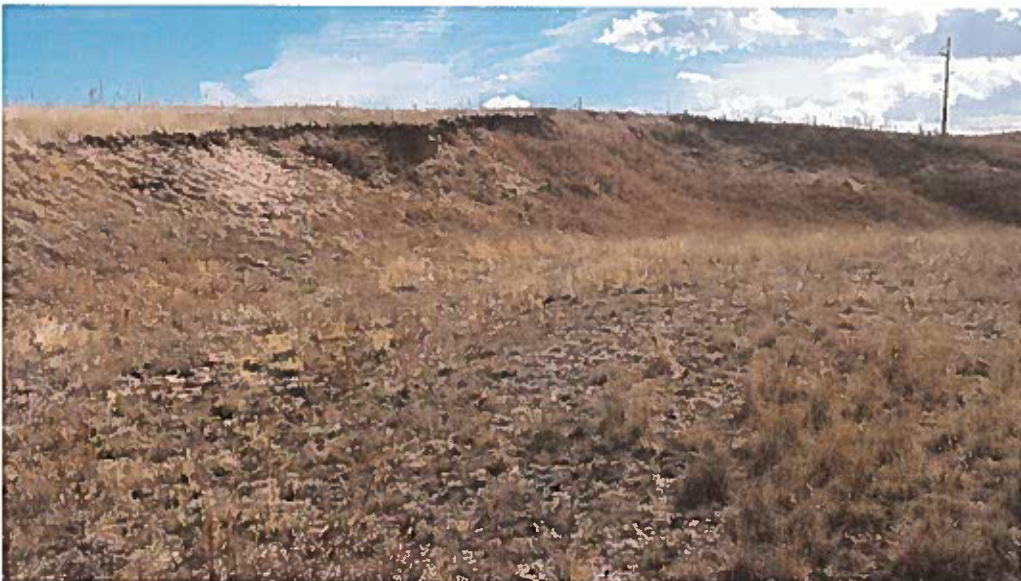
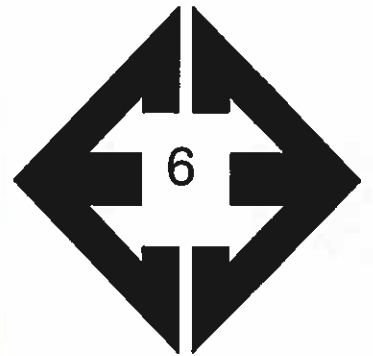
**Looking southeast
towards the potentially
unstable slope on Lot
4.**

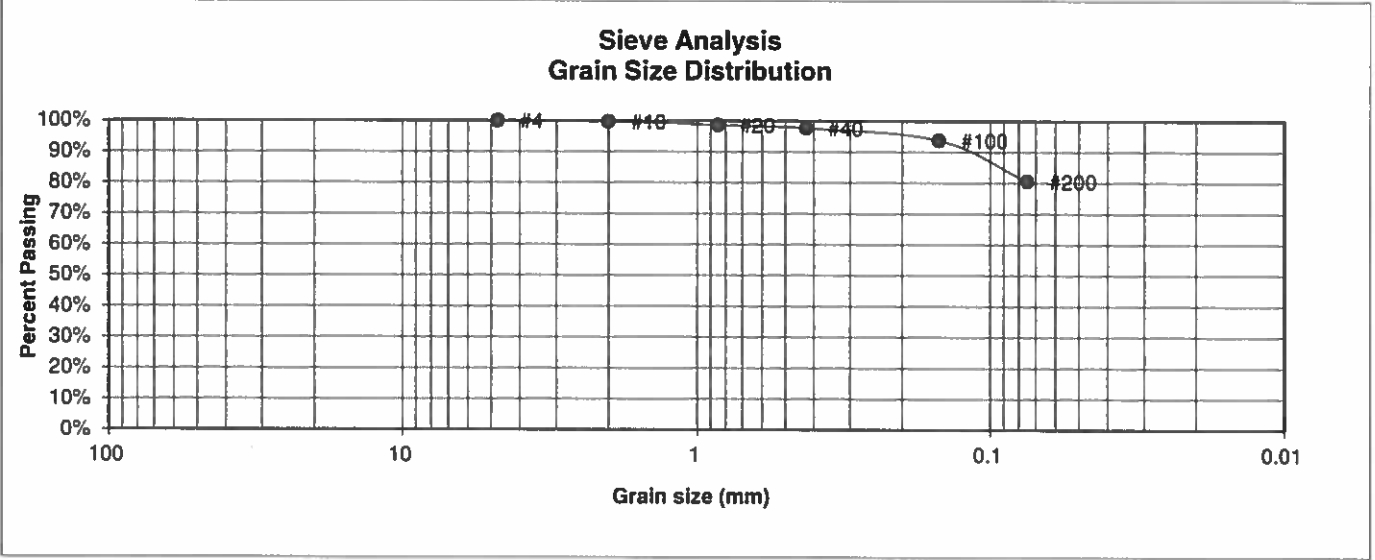
FIG NO.:
C-4

Soil Type 2 is a sandy clay (CL). This material was encountered in Test Boring No. 1 and in Test Pit Nos. 1 and 2. The clays were encountered at the existing surface grade and extended to depths up to 10 feet bgs. The clays were encountered at firm to stiff consistencies and moist conditions. Samples tested had 51 to 83 percent of the soil sized particles passing the No. 200 sieve. FHA Swell Testing on a sample of clayey sand resulted in an expansion pressure of 540 psf. Swell/Consolidation Testing resulted in a volume change of 1.1 percent. These test results indicated the clay exhibits a low to moderate expansion potential.

Swell	
Moisture at start	15.5%
Moisture at finish	20.3%
Moisture increase	4.8%
Initial dry density (pcf)	99
Swell (psf)	540

Mitigation: Should expansive soils be encountered beneath the foundation, mitigation will be necessary. Mitigation of expansive soils will require special foundation design. Overexcavation and replacement with non-expansive soils at a minimum of 95% of its maximum Modified Proctor Dry Density, ASTM D-1557 is a suitable mitigation, which is common in the area. Another alternative in areas of highly expansive soils is the use of drilled pier foundation systems. Typical minimum pier depths are on the order of 20 feet or more and require penetration into the bedrock material a minimum of 4 to 6 feet, depending upon building loads. Floor slabs on expansive soils should be expected to experience movement. Overexcavation and replacement has been successful in minimizing slab movements. The use of structural floors should be considered for
