Preliminary Acceptance Punchlist
El Paso County – Department of Public Works - Stormwater Section

Project Name:	Retreat at TimberRidge F2
EDARP Filing Number(s):	SF2121 CON2229
ESQCP Number:	ESQ2224
Attendees:	DPW SW: Ben Jones, Glenn Reese, Mikayla Hartford, Dylan Finley DPW Dev Services: David Parkerson Developer: Adam Doyle
Date of Walk-Thru:	05/23/2023
Walk-Thru Number:	1

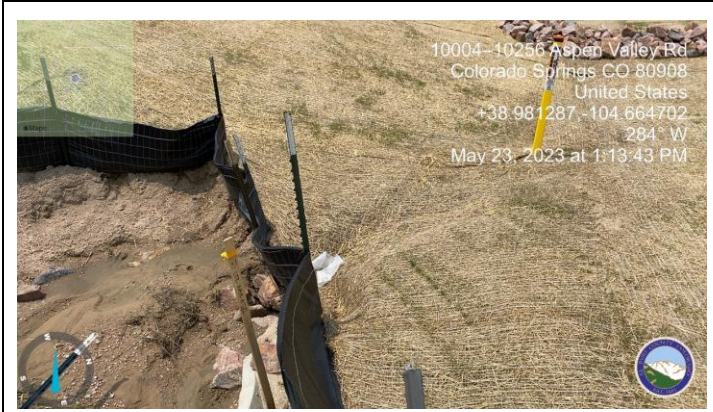
- Rill erosion occurring where utility lines were bored into the ground (West Portion of Site). Reference Photos 1-7.

Photo 1: Rill erosion occurring under straw mat where utilities were bore into the ground.

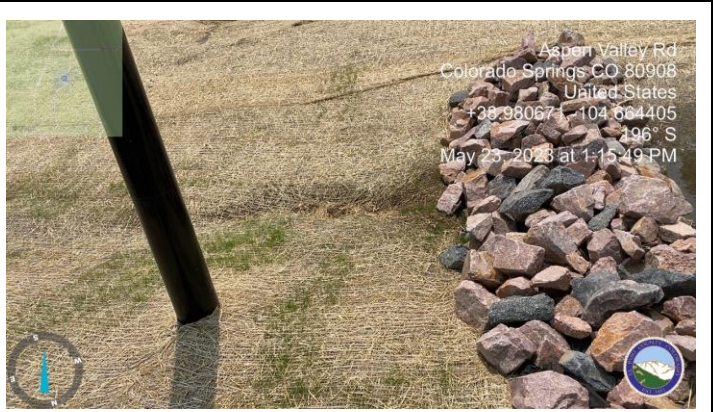
Photo 2: Rill erosion occurring near check dams on Aspen Valley Rd.

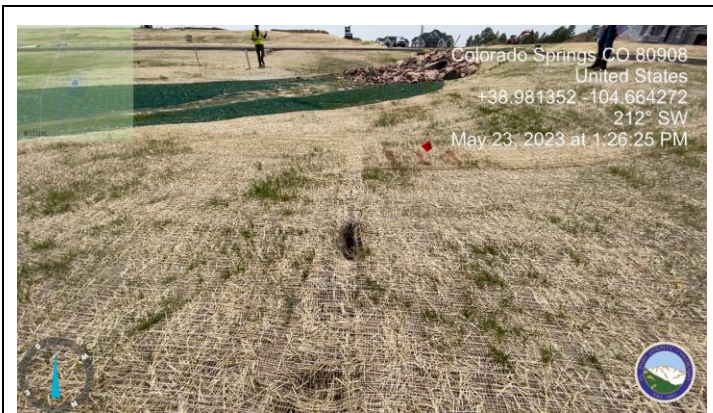
Photo 3: Rill erosion occurring under straw mat where utilities were bore into the ground.

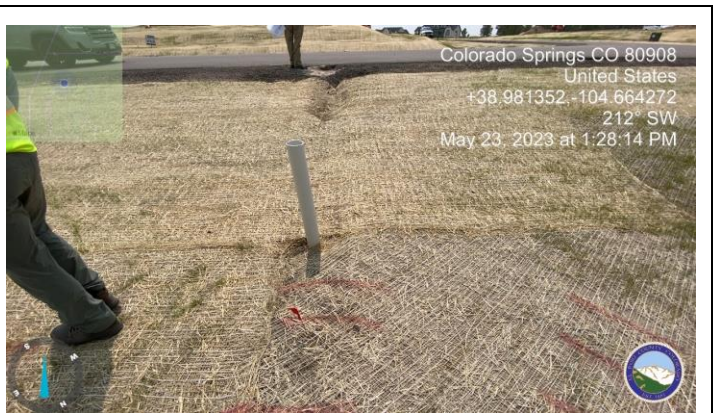
Photo 4: Rill erosion occurring under straw mat where utilities were bore into the ground.

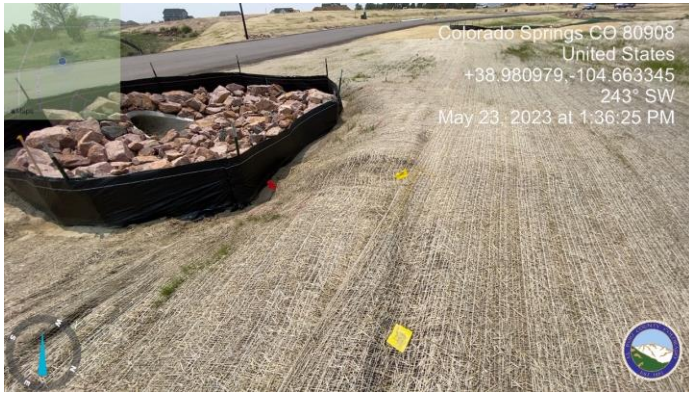
Photo 5: Rill erosion occurring under straw mat where utilities were bore into the ground.

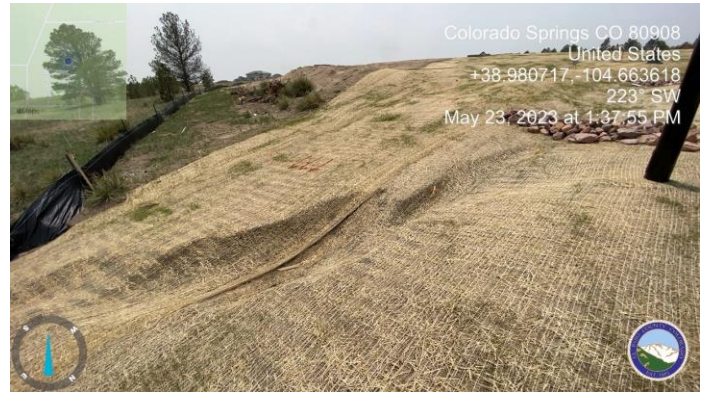
- Significant erosion at outlet of culvert lot 10 where the Temporary Sediment Basin is shown on plans (Page 3 of CD's). Reference Photo 6.
- Regrade ditch at Lot 10 (8872 Falcon Nest Court) to promote positive drainage. Currently standing water in ditch. Reference Photo 11

Photo 6: Rill erosion occurring underneath straw mat.

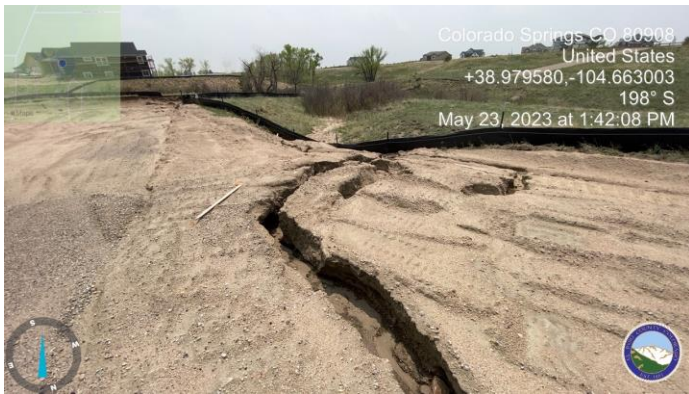
Photo 7: Rill erosion occurring. Regrade and temporary stabilize.

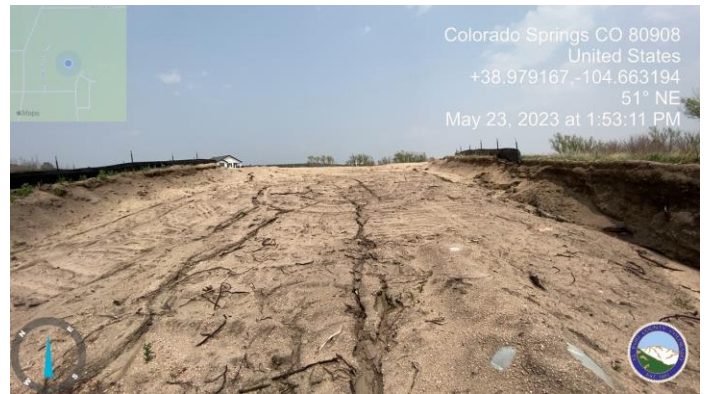
Photo 8: Soil riprap at pond spillway not installed per plan. Soil riprap needs to be installed to existing grade. (Page 21 of CD's)

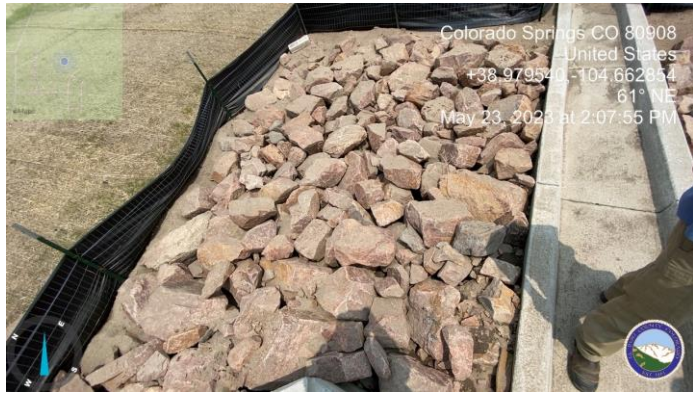
- Soil riprap around forebay not installed per specification. Photos 9 and 10
- Re-grade pond bottom to top of trickle channel curb with a 3% slope towards trickle channel for positive drainage.
 - Pond appears to have insufficient capacity with higher elevations between trickle channel and access road than what is shown on plans. We will verify this on as-builts.
- Erosion/undercutting around inlet pipe
- Soil riprap at pond spillway not installed per plan. Soil riprap needs to be installed to existing grade.
- Erosion at northeast corner of pond embankment.
- Maintenance access road not installed per plans. Does not extend to outlet structure.

Photo 9: Soil riprap around forebay not installed per spec. (Page 21 of CD's)

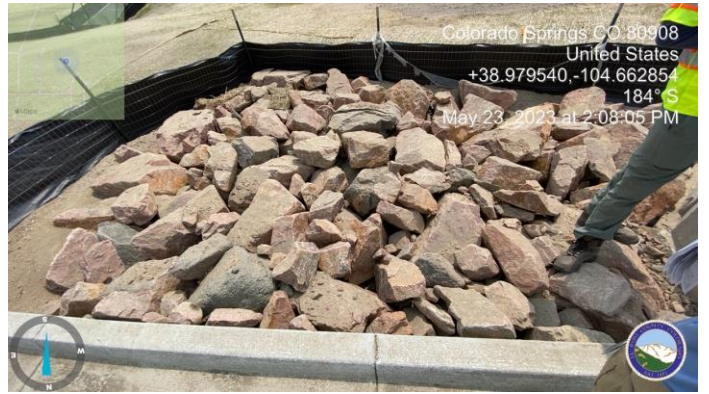
Photo 10: Soil riprap around forebay not installed per spec. (Page 21 of CD's)

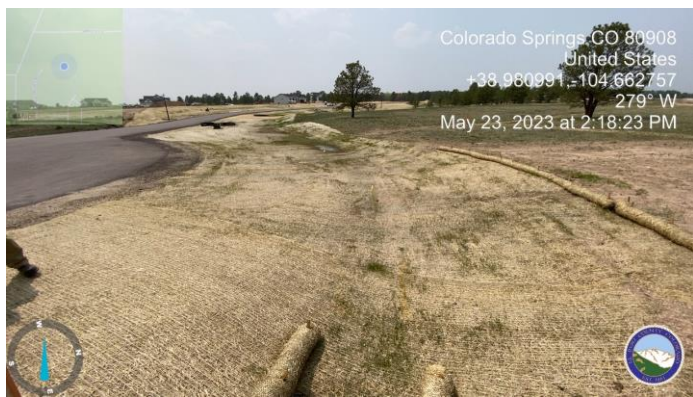
Photo 11: Regrade ditch at 8872 Falcon Nest Court where standing water is present.

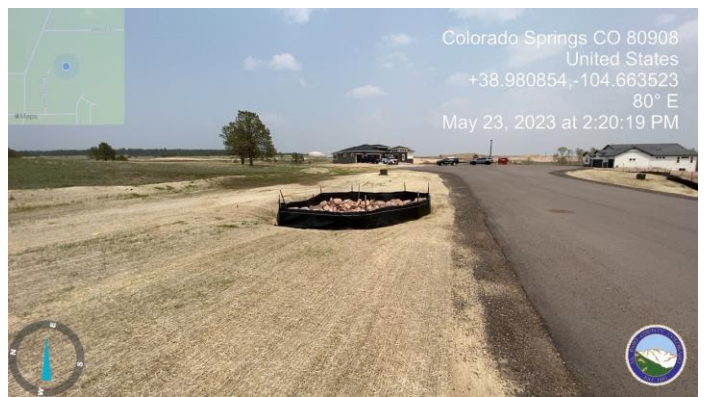
Photo 12: Remove silt fence and address erosion around riprap
